Barbican Estate
Barbican Residential Blocks
Mountjoy House – Fire Strategy
Report

Rev A | 7 September 2022

Job number 279095-01

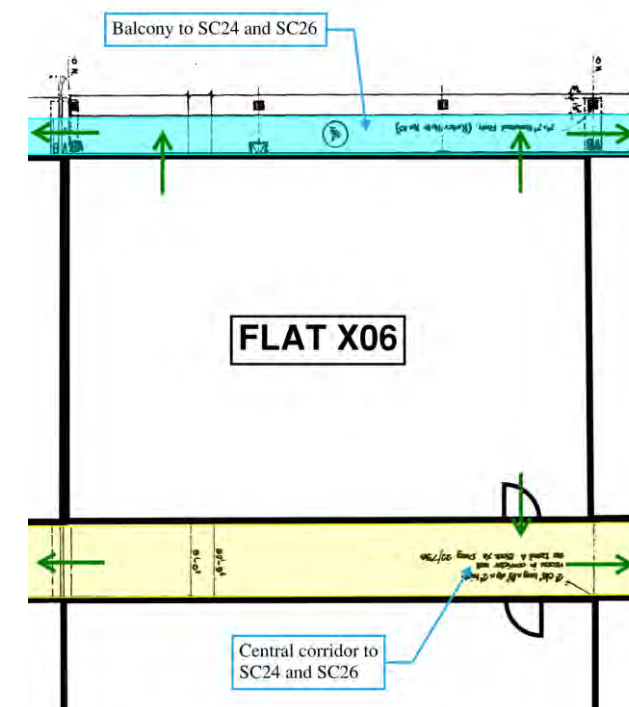
Figure 4: Means of escape from a flat

For occupants who are able-bodied (refer to Section 4.1.6 for evacuation Persons with Reduced Mobility, PRM), the flats are provided with two escape routes; via the flat entrance and via the balcony connected to the flat as shown in Figure 4.

The current means of escape arrangement is considered acceptable.

All flats are provided with alternative escape routes from the habitable rooms via the balcony.

- It is recommended to maintain the management procedure in place to keep the balconies clear of any obstacles at all times. This is to provide a clear escape route for occupants to evacuate in an emergency.

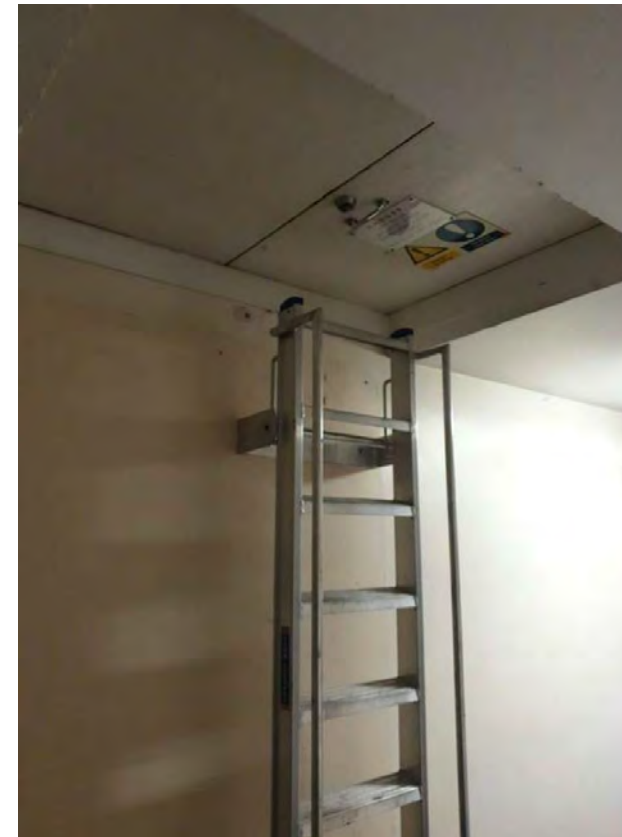
Figure 6: Fixed ladder to plant area in L7 Staircase 26

BE confirmed the plant rooms are located above L7 and can be accessed by the fixed ladders provided within the protected lobby of Staircase 26 as shown in Figure 6.

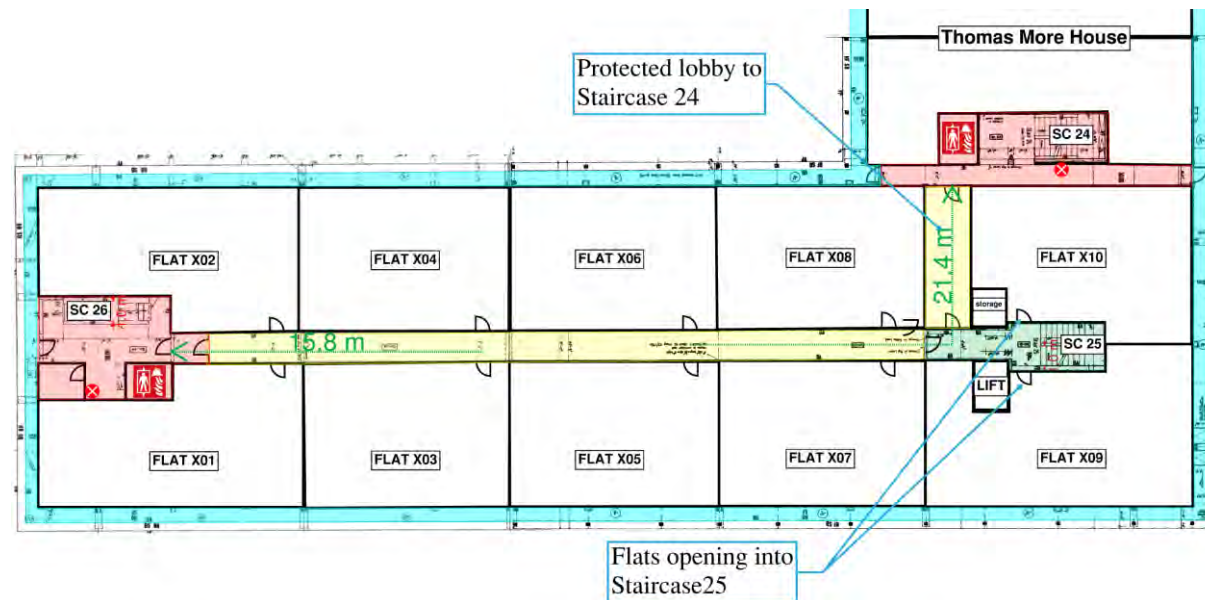
Figure 7: Connection to the stairs from the flats in Mountjoy House

Flats X01 to X08 opens into the central corridor, with Staircase 25 and 26 at either ends of the corridor. Both stairs are separated from the corridor by a door. However, Flats X09 and X10 opens directly into the Staircase 25. There is access to Staircase 24 from the landing of Staircase 25 via a protected lobby, as shown in Figure 7 below. The furthest travel distance to reach a protected stair from any of the flats is 21.4m (Flat X05 & 06 to Staircase 24).

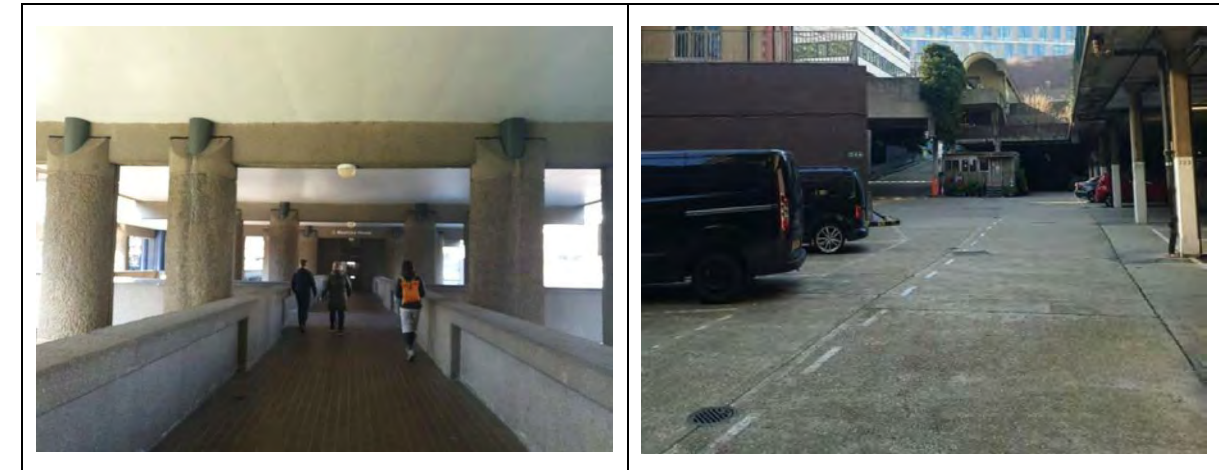
Figure 8: Final exit on to Podium Level (left) and L03 Carpark level (right)

It has been confirmed during the site visit that Podium level is an open public walkway and L03 is an open car park as shown in Figure 8 where both areas are mainly non-combustible construction. Both Podium level and L03 is levelled/step free.

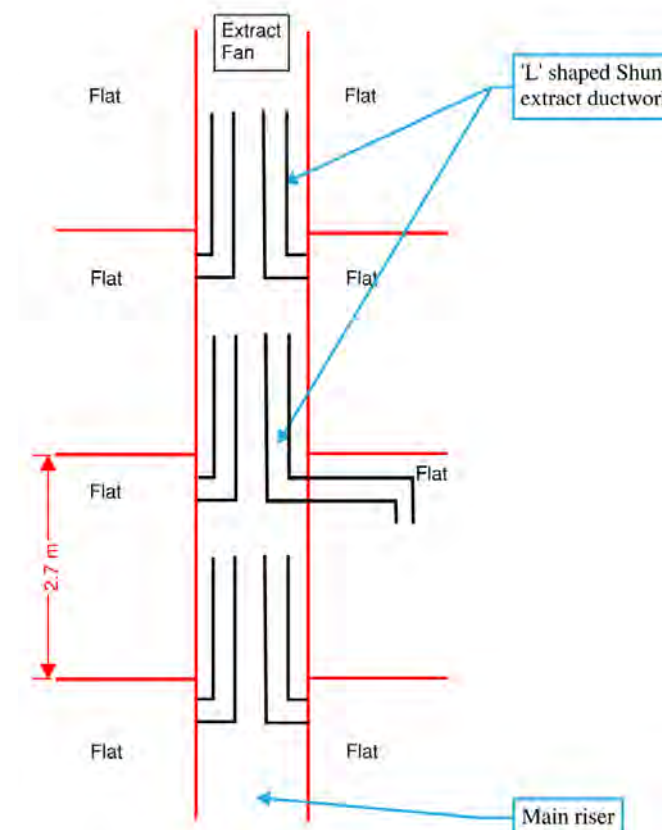
Figure 12: Existing layout of shunt duct system in Mountjoy House

In the Barbican Residential Development, it is understood that a common approach to maintain fire separation between flats is to use shunt duct arrangement for the kitchen and toilet extract ventilation ducts. The purpose of shunt duct is to avoid the need for fire protection using the methods described above. A shunt duct arrangement comprises of branch ductwork ('s' or inverted 's' shaped) that are connected to the main extract ductwork as shown as Figure 11. In addition to the downward bend of the shunt duct, a fan at the top of the main extract ductwork maintains a negative pressure that stops smoke from spreading out of the ductwork.

Shunt duct arrangement is a recognised approach in BS 5588-9:1999 – *Fire precautions in the design, construction and use of buildings Part 9: Code of practice for ventilation and air conditioning ductwork*, for extract ductworks serving toilets. However, it is not normally acceptable for use in kitchen extraction because of the fire risk inherent in kitchens. The guidance mentions that if a shunt duct is used for kitchen extraction, careful consideration should be given to possible pressure differentials within the system to avoid the transfer of smoke and other products of combustion from one dwelling to another by means of the ductwork system. This guidance has been withdrawn and is no longer referenced in other current standards including the Approved Document B.

In Mountjoy House, it is understood that the main kitchen extract riser and the shunt ducts are of concrete construction. Dimensions of the concrete construction are unknown, but likely to have some inherent fire rating. The kitchen extract riser is located within the kitchen and serves all the flats on the same vertical stack. The extract fan is located at the top of the main riser and on continuous operation (BE confirmed the capacity of the current fans are 10 cbm/s). BE also confirmed that the shunt ducts are ‘L’ shaped as shown in Figure 12 instead of the more common ‘S’ shaped as shown in Figure 11. The frequency of maintenance and cleaning, and the internal grease builds up within the vertical portion of the shunt ducts and within the main extract risers are unknown.

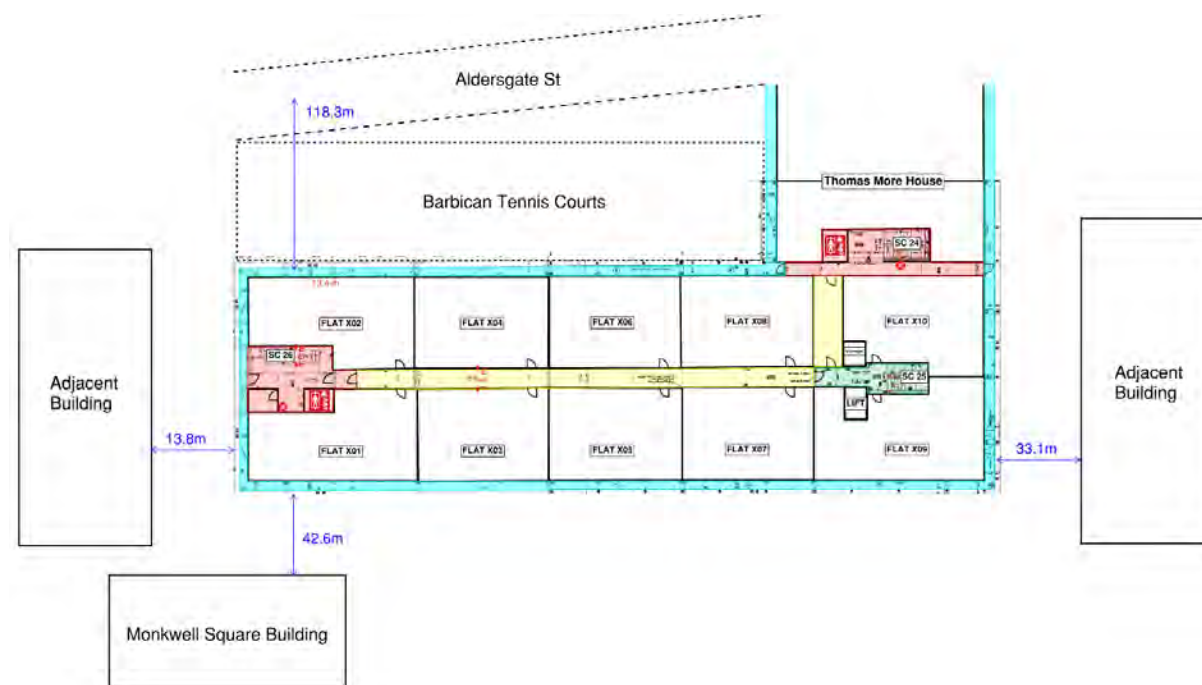
Figure 13: Existing arrangement for Mountjoy House and adjacent buildings

There is no information available on the location of the site boundary in relation to Mountjoy House. If there are no site layout available, the building boundaries or the relevant boundaries will be measured using Google Maps as shown in Figure 13 and as follows:

- North: 118.3 m
- East: 33.1 m
- South: 42.6 m
- West: 13.8 m

An external fire spread calculation has been undertaken for a single flat using the above assumed boundary distances and Figure 13. The enclosing rectangle method in line with BR 187 was carried out. The results show that no protection is required to the facades. Please refer to Appendix B for the calculation.

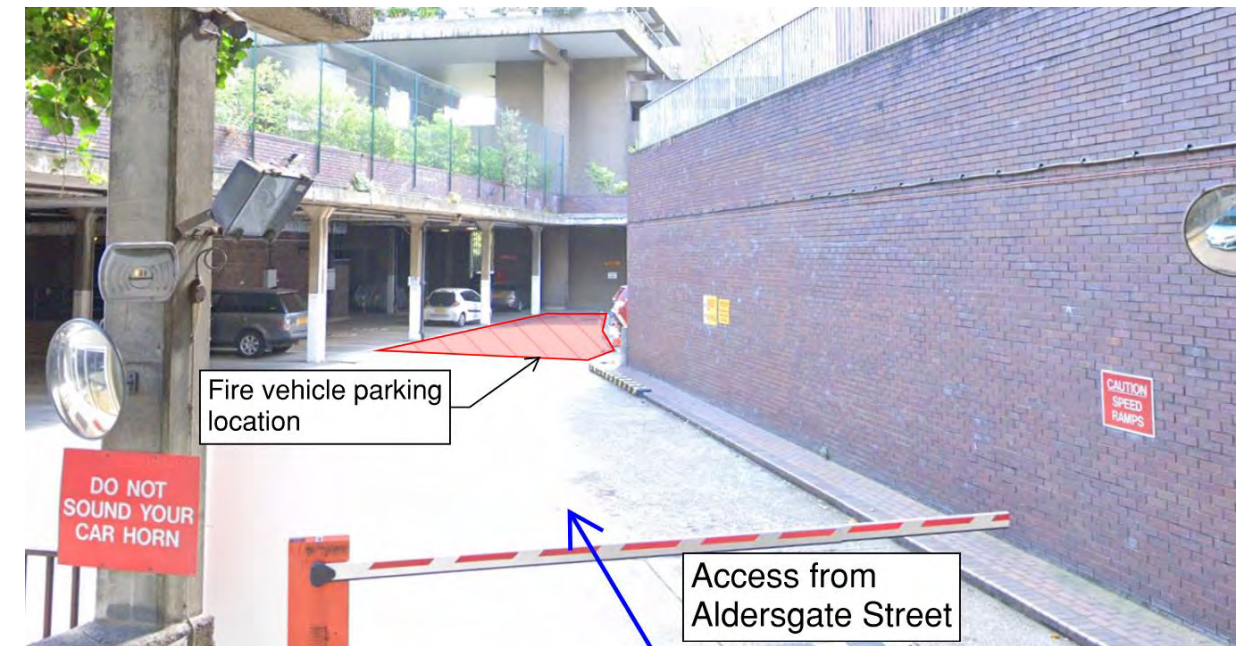
Figure 15: Fire vehicle parking location

Firefighting access into the building is directly from the carpark area at L03, accessed via Aldersgate Street where the firefighting vehicle has space to park in front of either Mountjoy House or Thomas More House as shown in Figure 15. The distance between the fire service vehicle parking location and the inlet point needs **to be confirmed by BE**.

- Engagement with London Fire Brigade to familiarise them with the firefighting access and facilities to Mountjoy House, in particular the sharing of Staircase 24 with Thomas More House.
- Amend the label for the dry riser inlet for Staircase 24, to include the name for Mountjoy House.

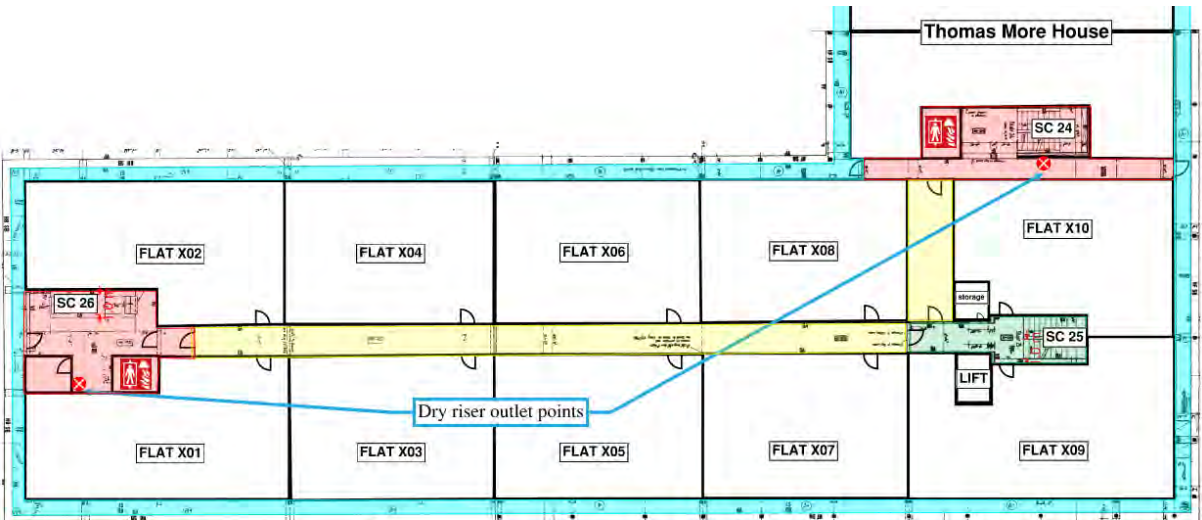
Figure 19: Dry riser outlet points in the building

There are dry riser outlets located within each of the firefighting stair enclosures as shown in Figure 19. All areas of the building are within 45 m.

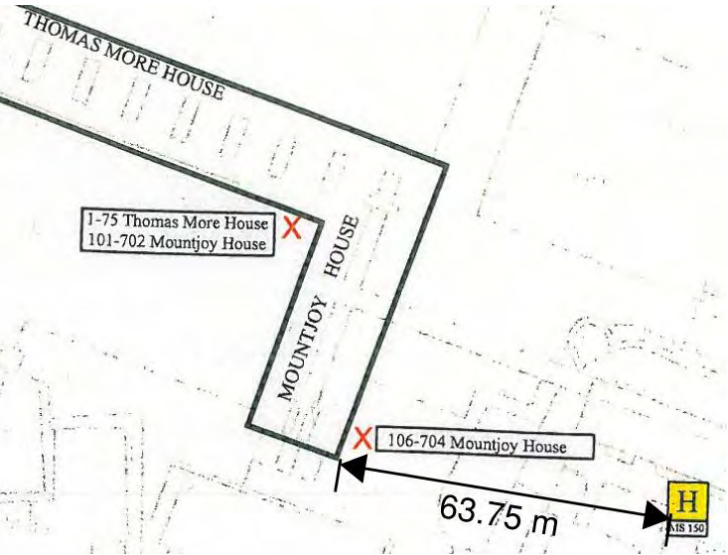
Figure 20: Location of existing fire hydrant

External hydrants should be provided within 90 m of a dry fire main inlet. Based on the information provided from BE, existing hydrant is within 90 m of Mountjoy House.

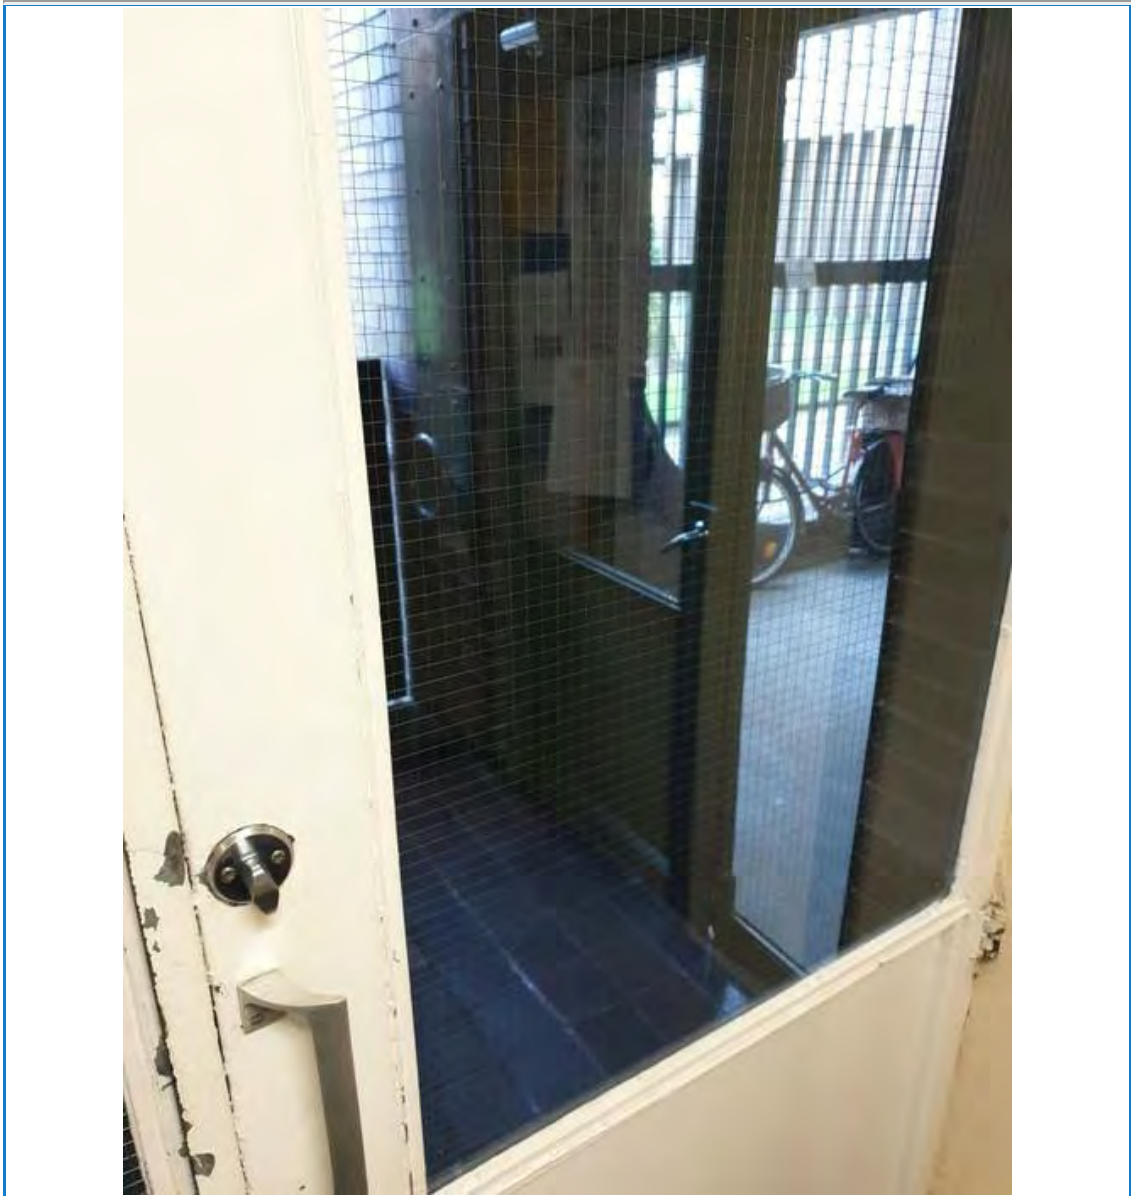
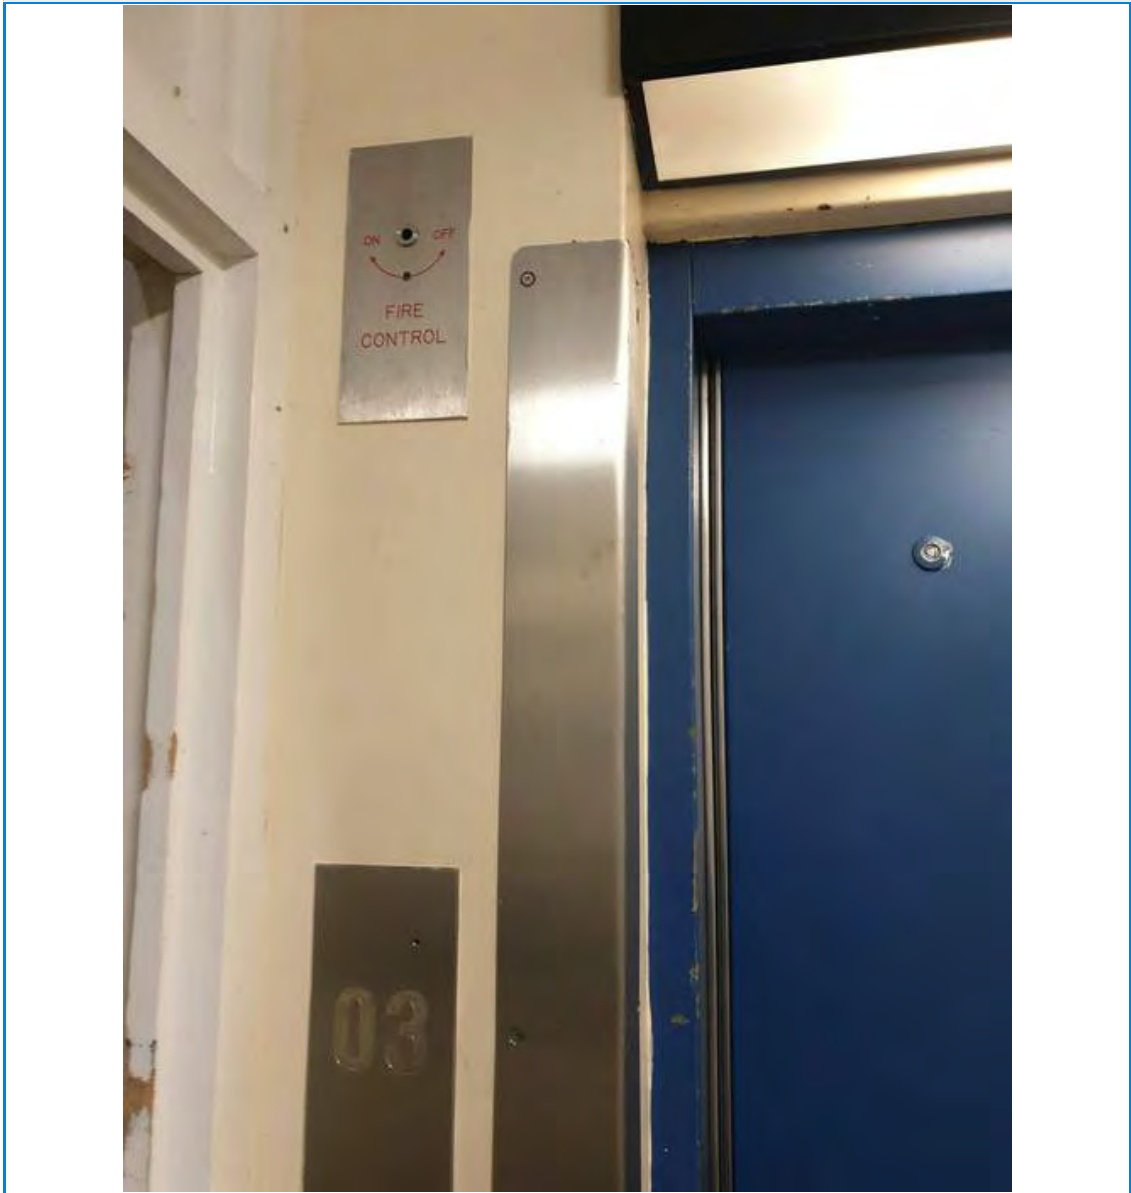
Title: lobby protected, ff lift control on I03
ID: 4
Created by: Arup Fire Plan Radar 9
Updated: 07/03/2022 02:14 PM
Date:
Compliant with the Fire Strategy?: No
Details:

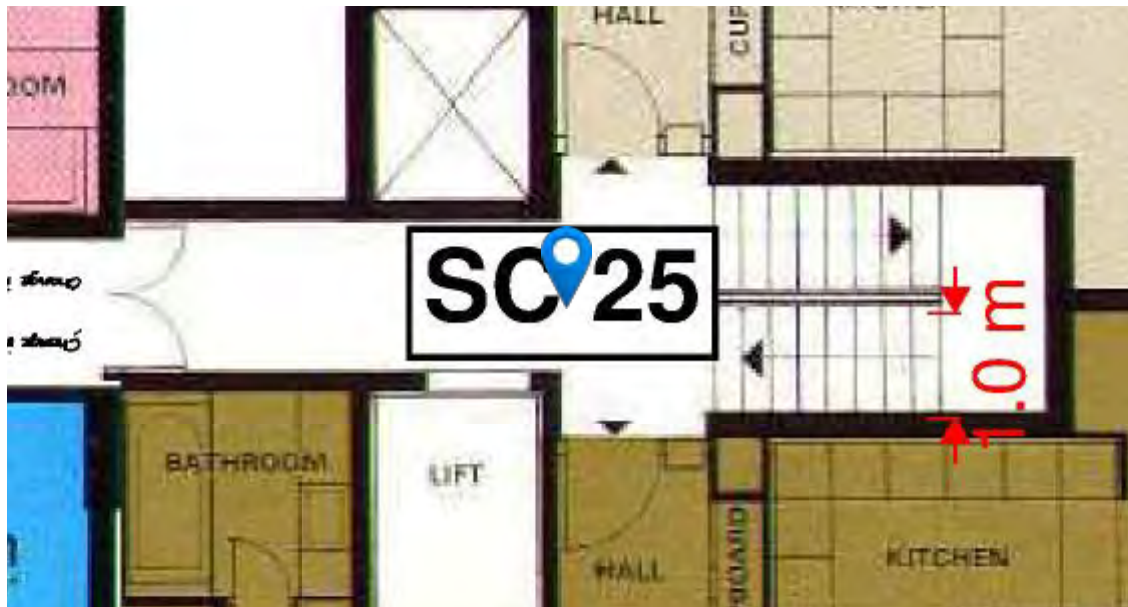
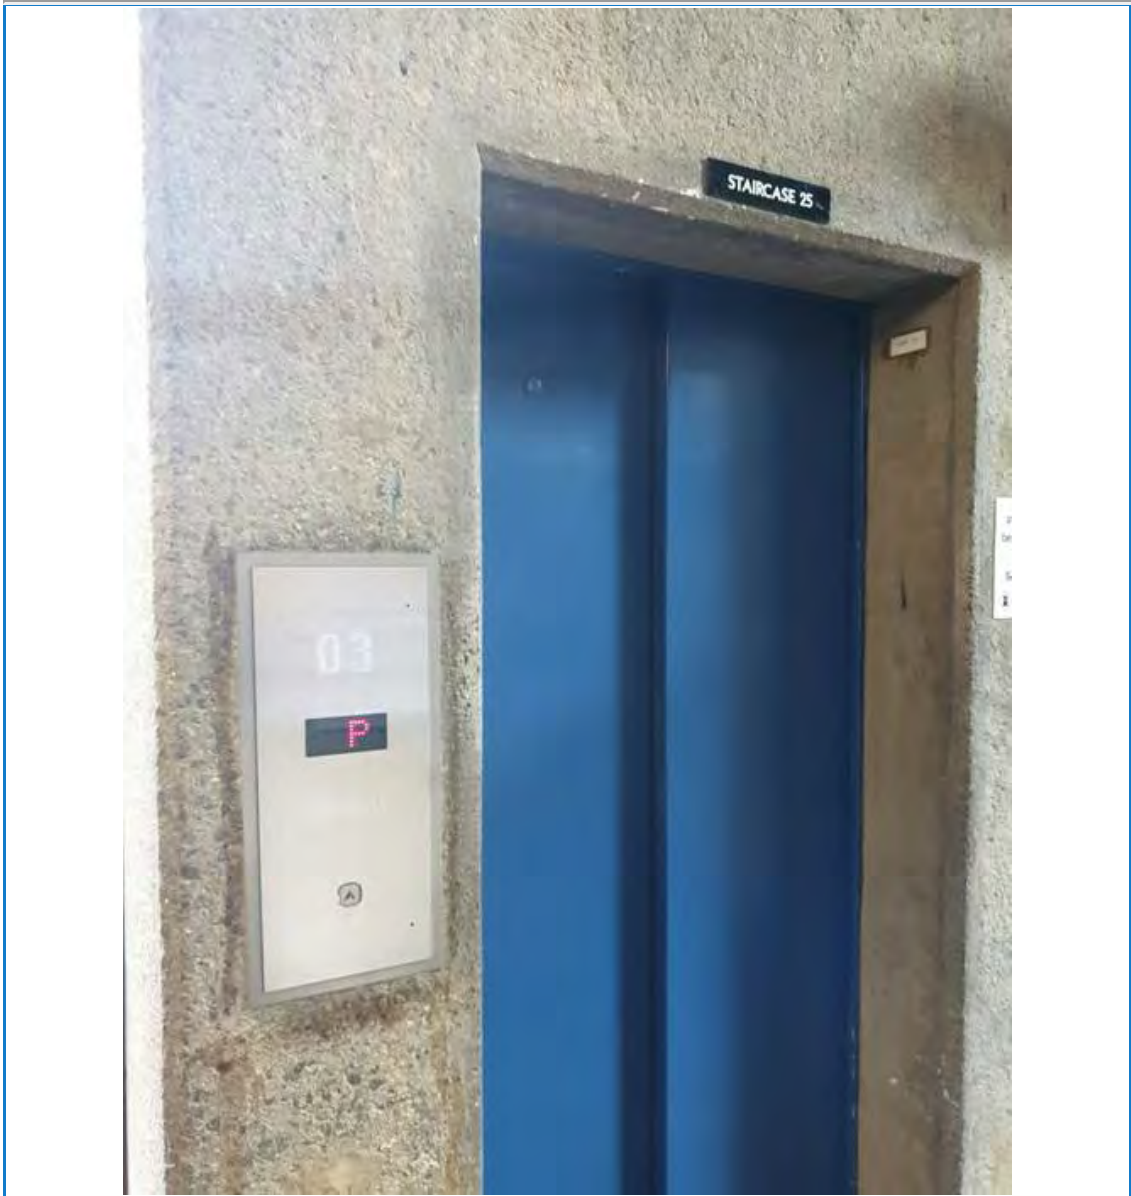
Title: I03 lift sc 25 doesnt have fire control
ID: 45
Created by: Arup Fire Plan Radar 9
Updated: 07/03/2022 04:14 PM
Date:
Compliant with the Fire Strategy?: No
Details:

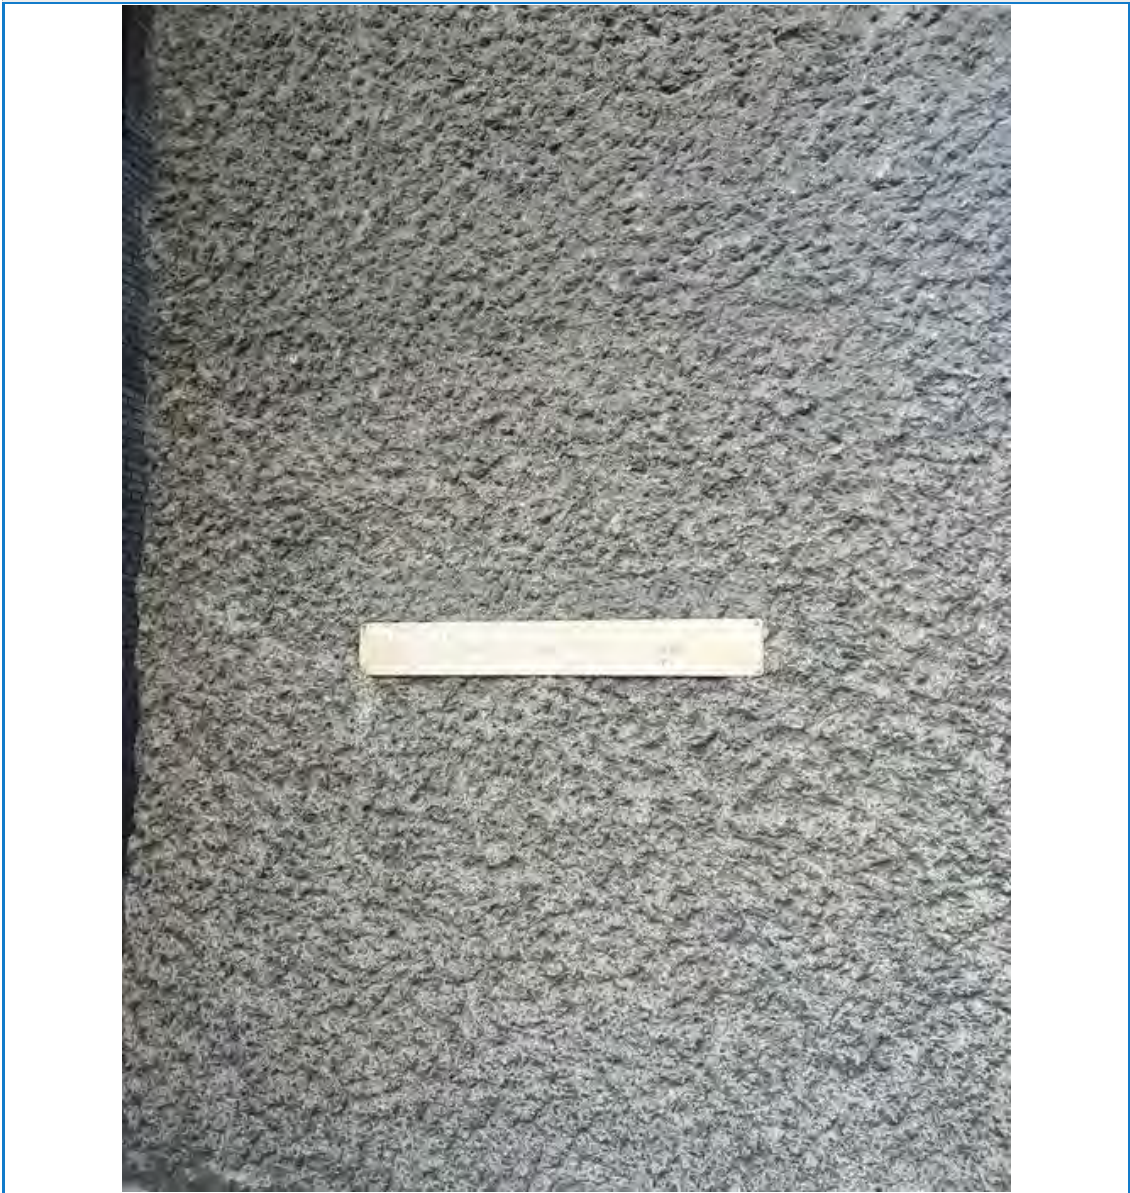
Title: dry riser inlet point for fireman in sc24
ID: 48
Created by: Arup Fire Plan Radar 9
Updated: 07/03/2022 04:18 PM
Date:
Compliant with the Fire Strategy?: No
Details:

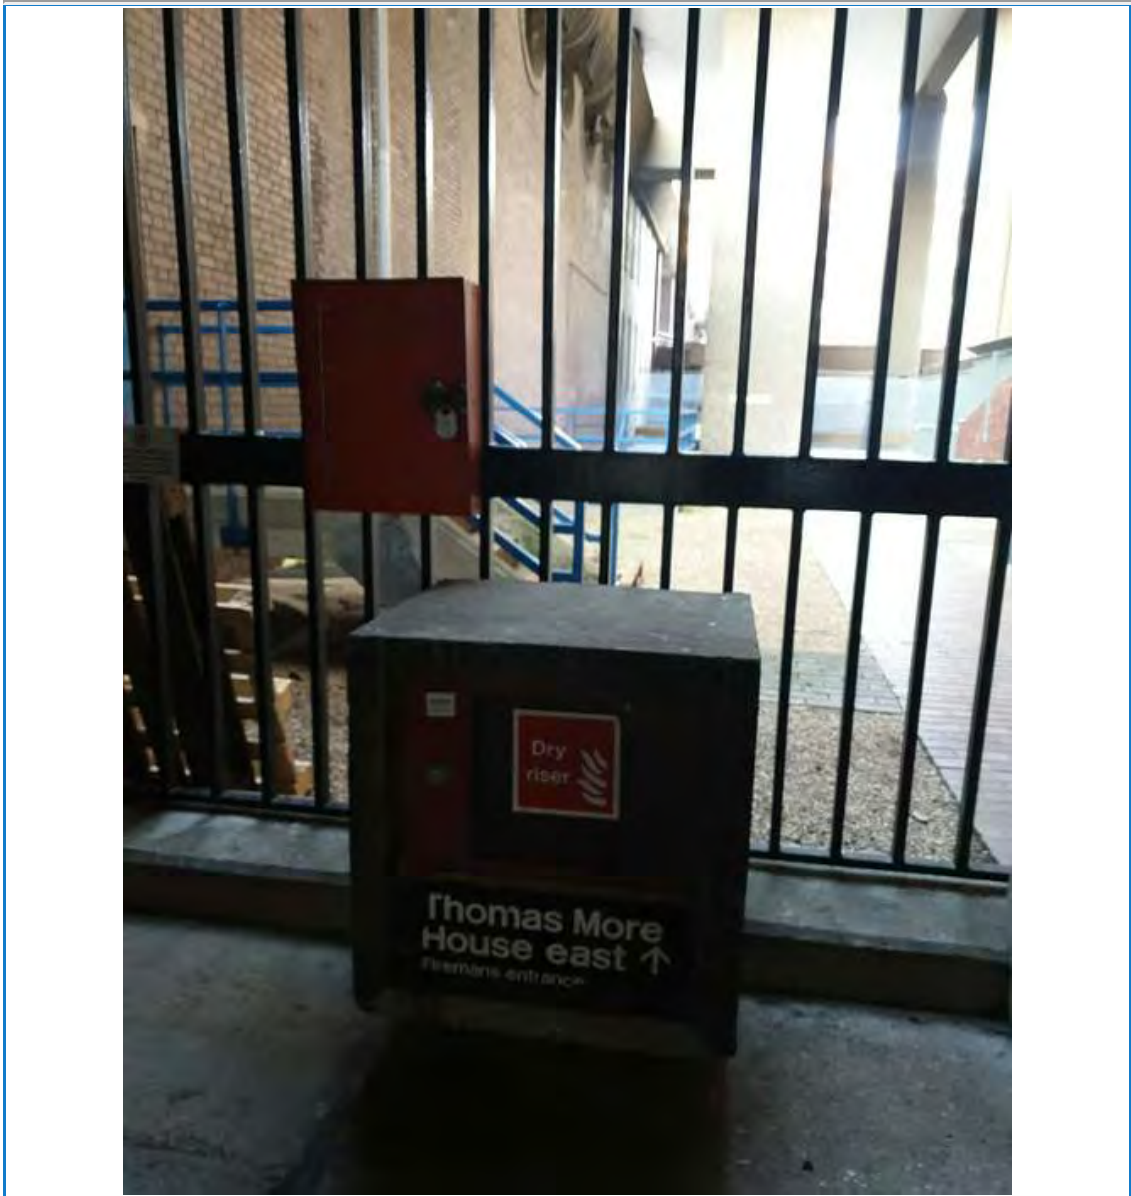
Title: I03 sc 26 width 1m
ID: 49
Created by: Arup Fire Plan Radar 9
Updated: 07/03/2022 04:20 PM
Date:
Compliant with the Fire Strategy?:No
Details:

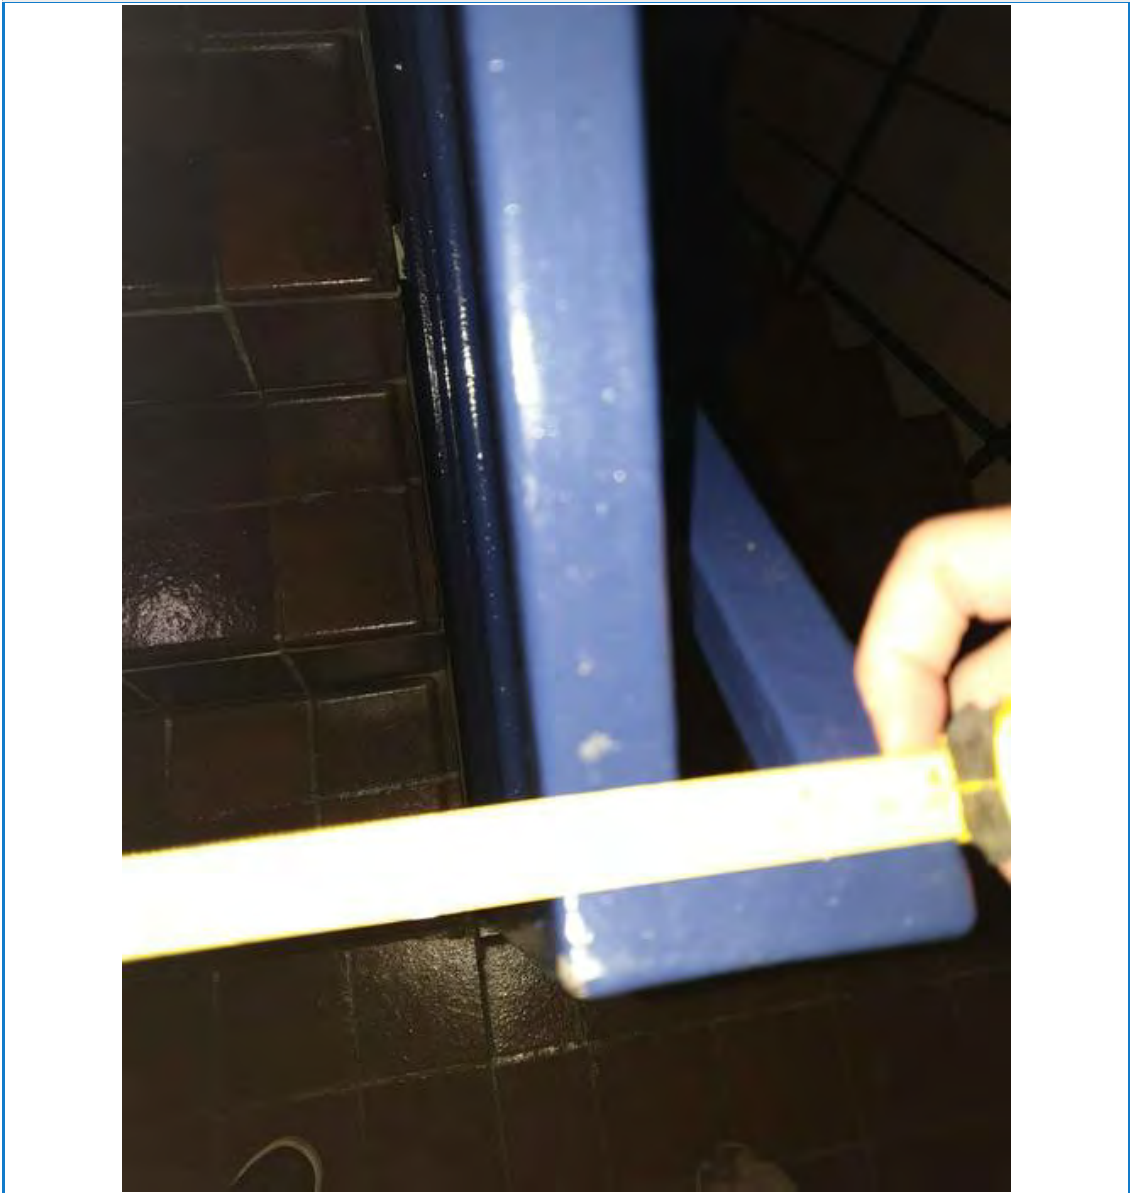
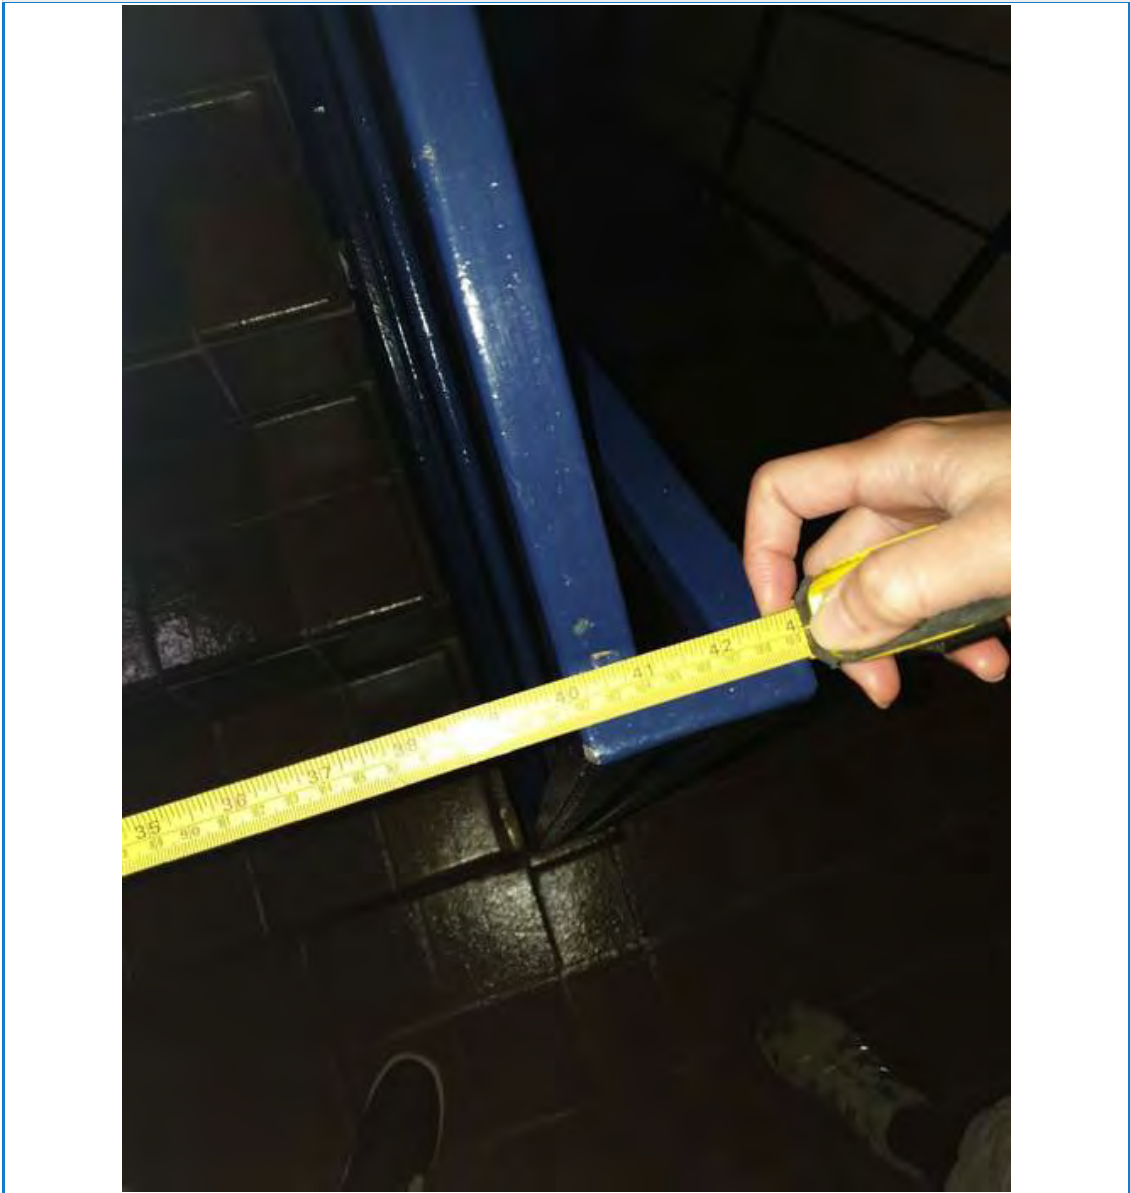
Title: sc26 down to l04
ID: 50
Created by: Arup Fire Plan Radar 9
Updated: 07/03/2022 04:20 PM
Date:
Compliant with the Fire Strategy?:No
Details:

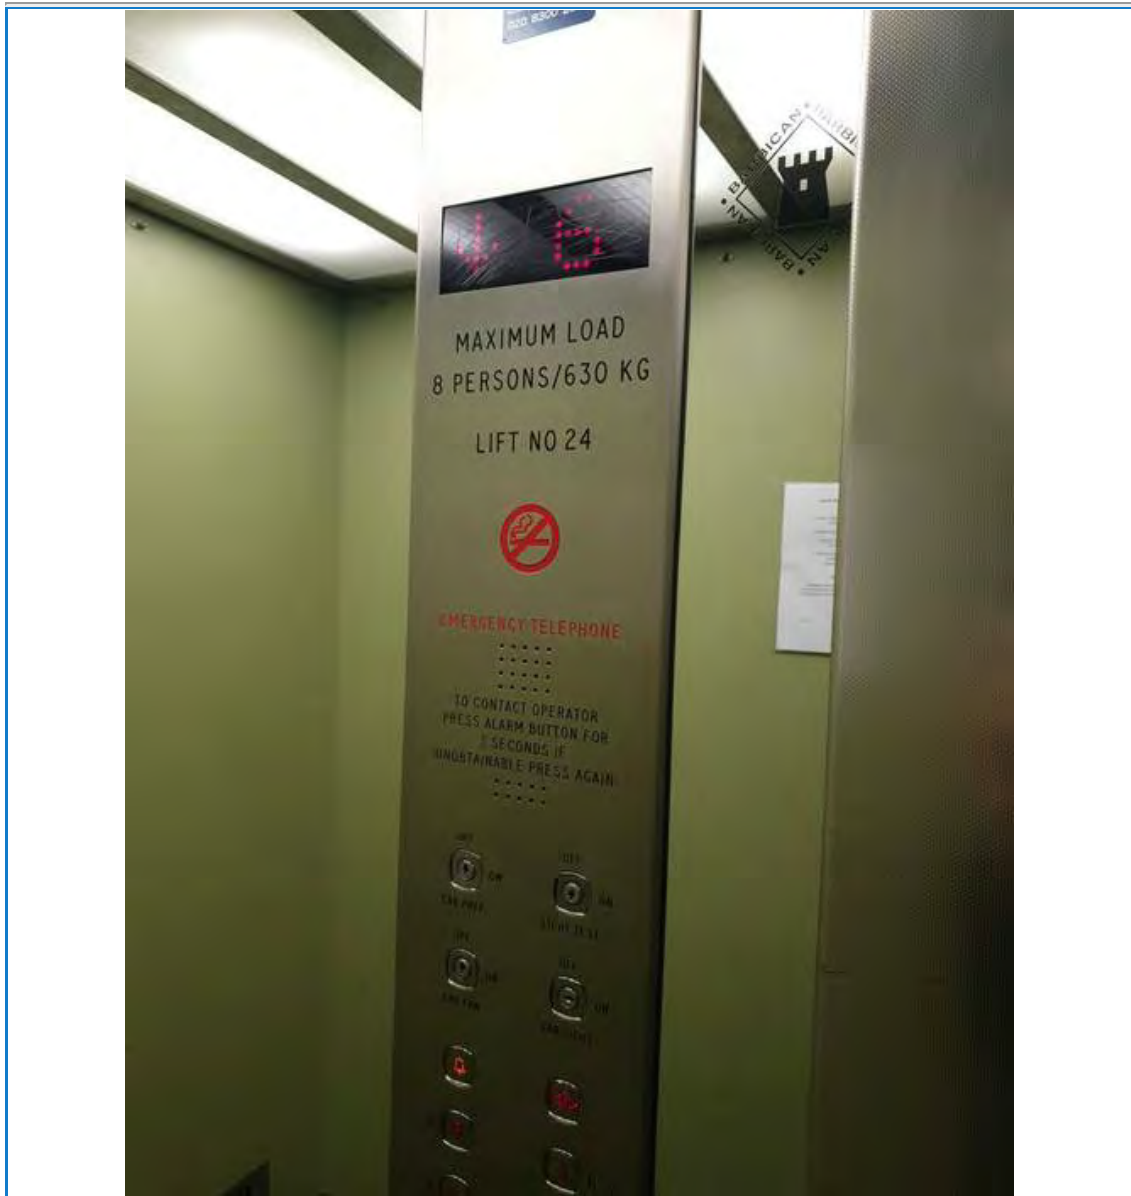
Title: lift 24 in l6
ID: 24
Created by: Arup Fire Plan Radar 9
Updated: 07/03/2022 03:10 PM
Date:
Compliant with the Fire Strategy?:No
Details:

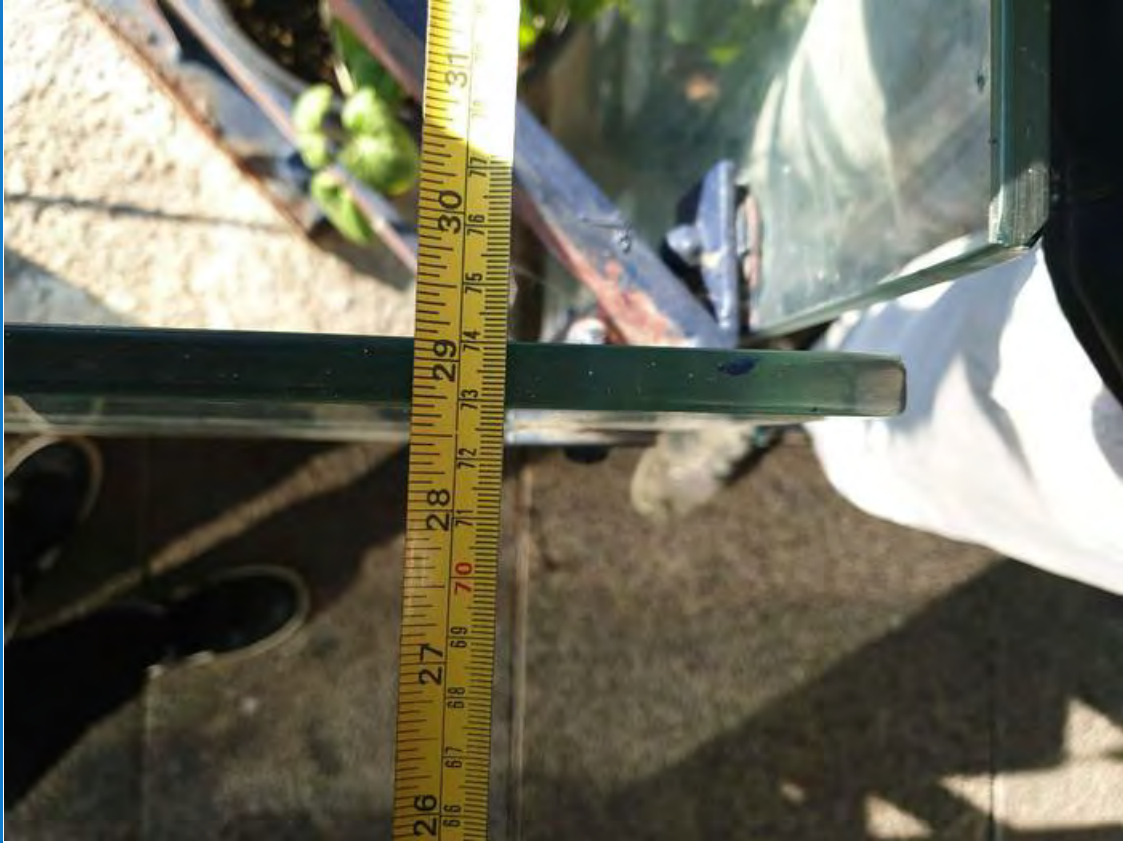
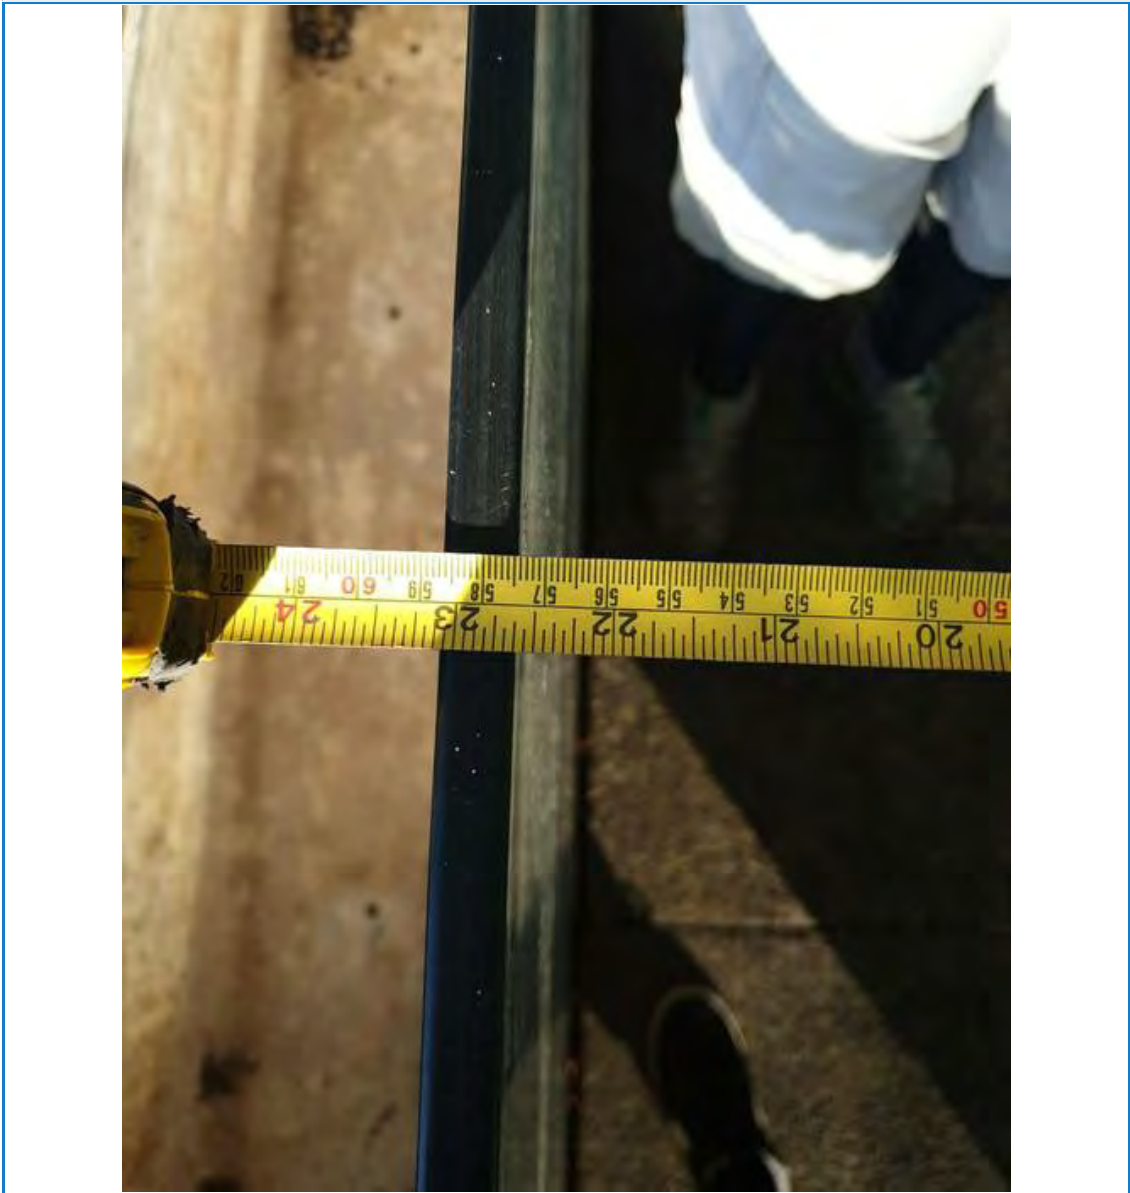
Form: General	Title: balcony widths 560 privacy screen
Layer: 220218 Mountjoy_Site drawings (1)	ID: 27
Number of extensions: 0	Created by: Arup Fire Plan Radar 9
Created on: 07/03/2022 03:15 PM	Updated: 07/03/2022 03:15 PM
Updated by: Arup Fire Plan Radar 9	Date:
Time:	Compliant with the Fire Strategy?: No
Non compliant with the Fire Strategy: No	Details:

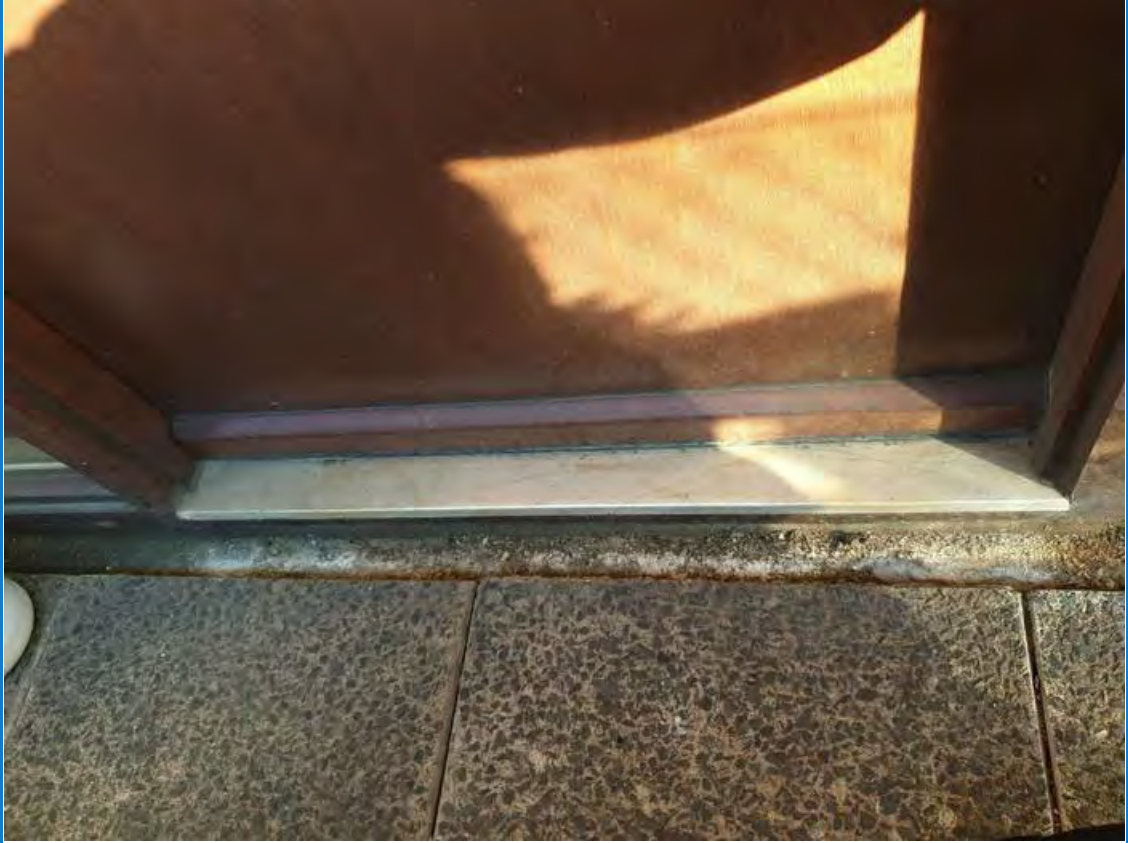
Form: General	Title: level change between balcony and flat
Layer: 220218 Mountjoy_Site drawings (1)	ID: 28
Number of extensions: 0	Created by: Arup Fire Plan Radar 9
Created on: 07/03/2022 03:16 PM	Updated: 07/03/2022 03:16 PM
Updated by: Arup Fire Plan Radar 9	Date:
Time:	Compliant with the Fire Strategy?: No
Non compliant with the Fire Strategy: No	Details:
