Barbican Estate
Barbican Residential Blocks
Mountjoy House – Fire Strategy
Report

Rev A | 7 September 2022

Job number 279095-01

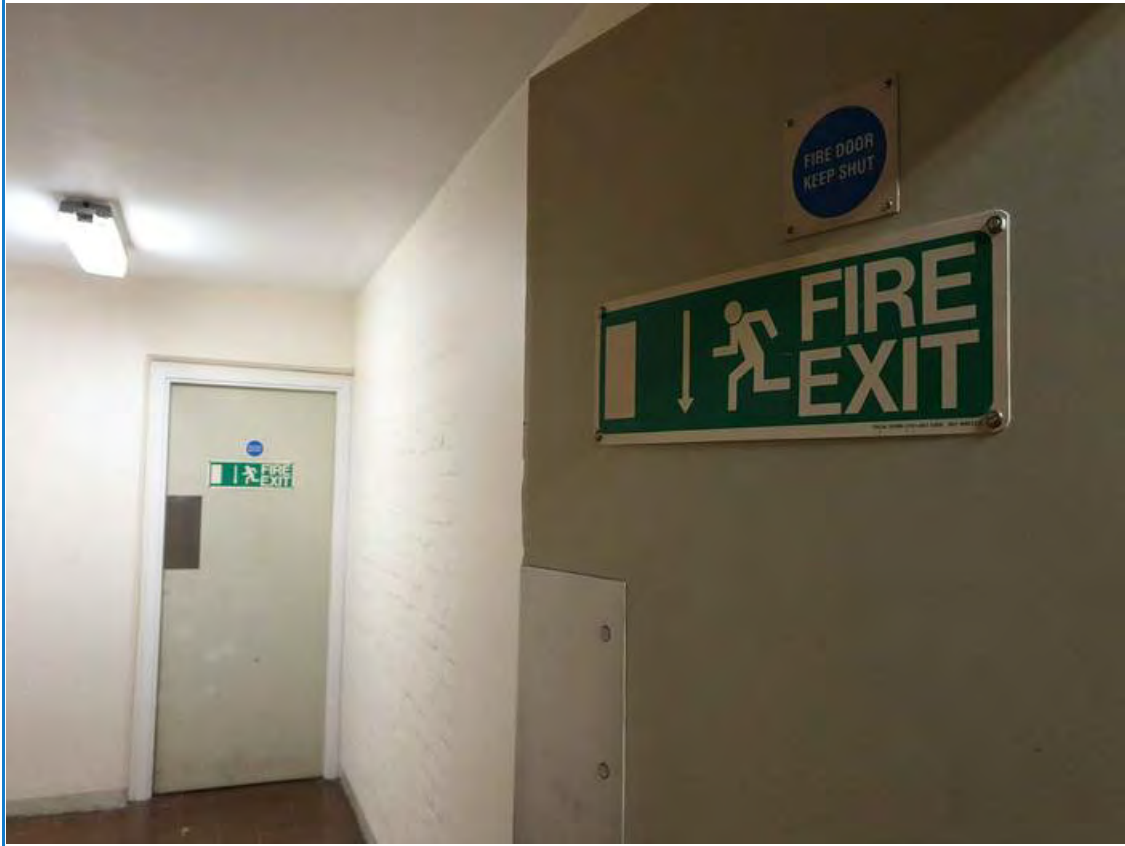
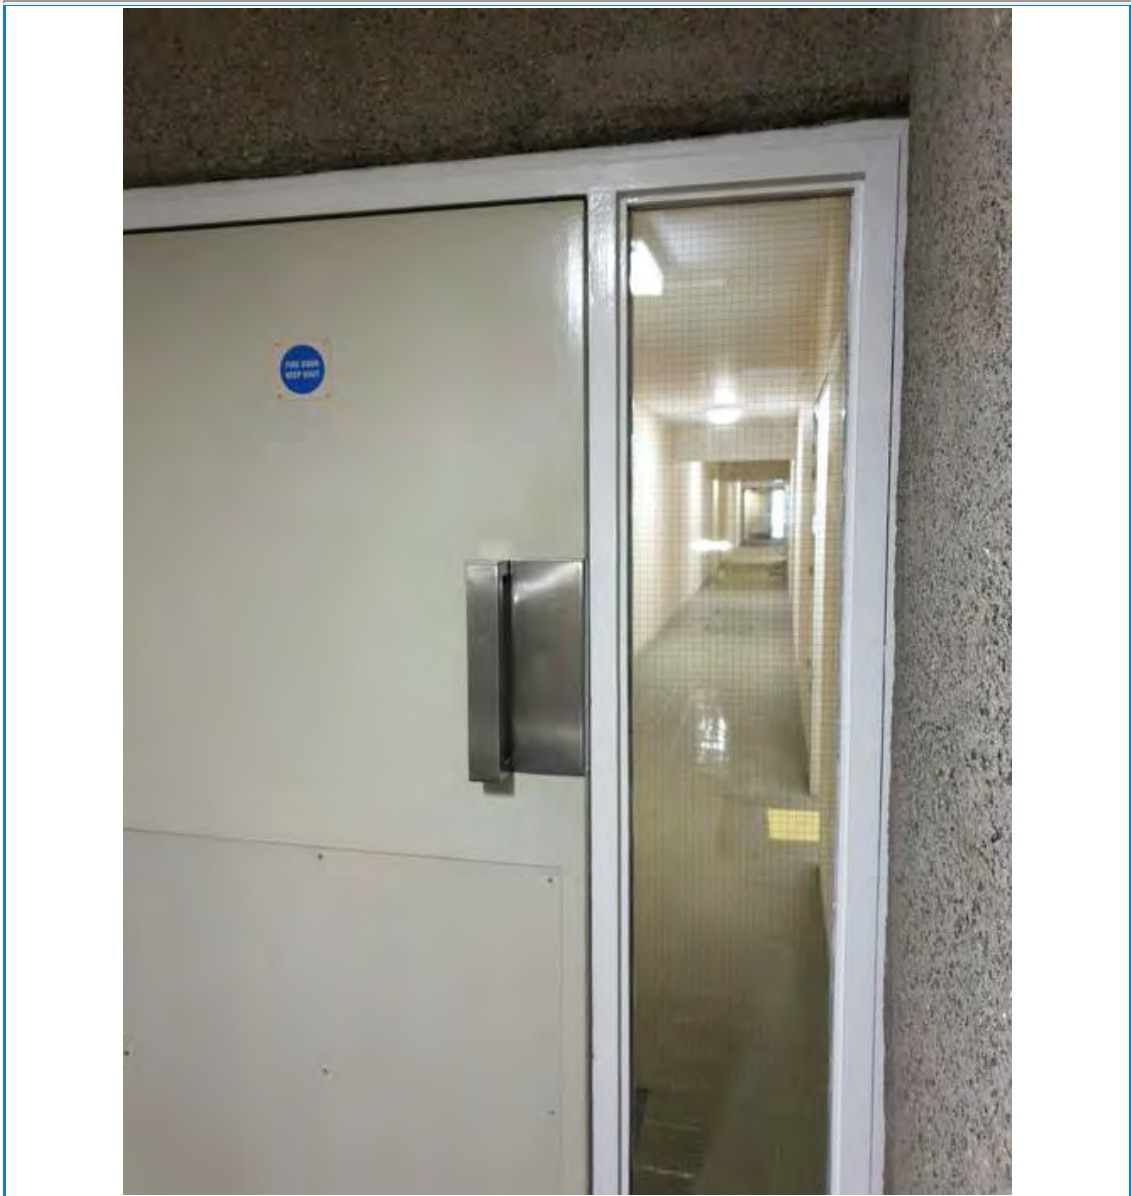
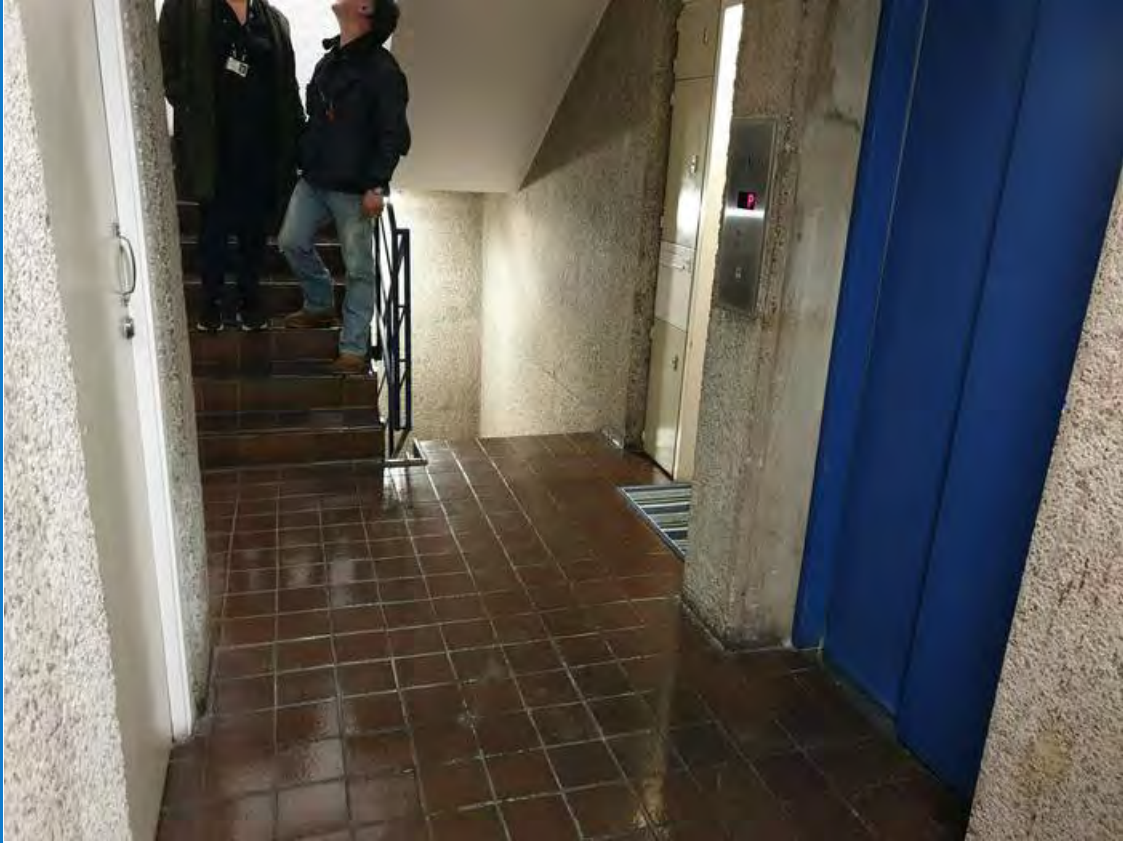
Form: General	Title: l6 1. lobby from sc24 to sc25 2. fire door to central corridor 3. lift and sc 25
Layer: 220218 Mountjoy_Site drawings (1)	ID: 29
Number of extensions: 0	Created by: Arup Fire Plan Radar 9
Created on: 07/03/2022 03:21 PM	Updated: 07/03/2022 03:21 PM
Updated by: Arup Fire Plan Radar 9	Date:
Time:	Compliant with the Fire Strategy?: No
Non compliant with the Fire Strategy: No	Details:

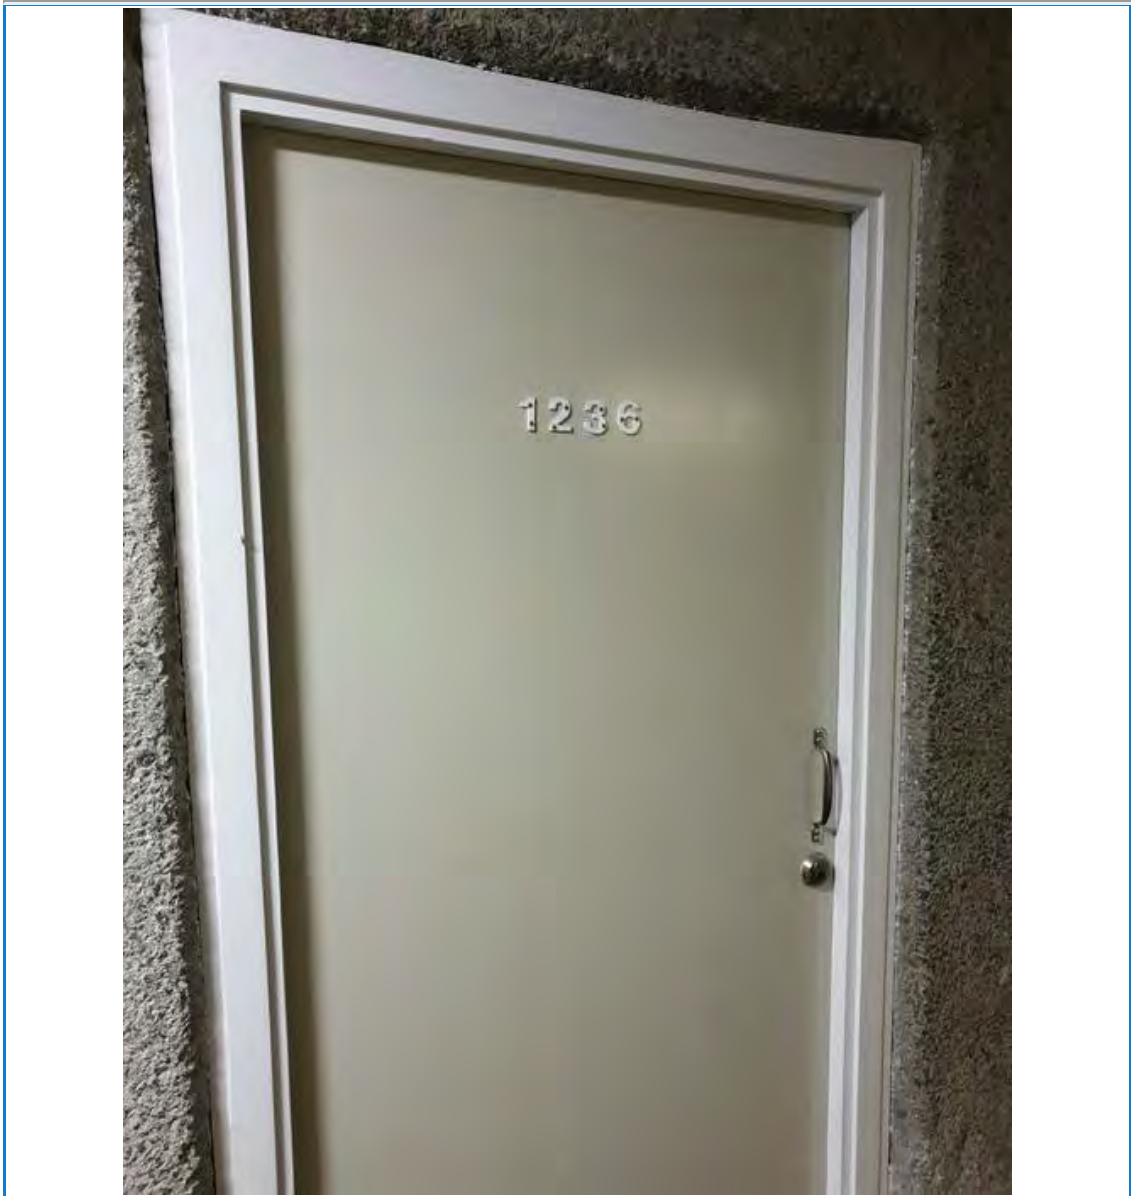
Form: General	Title: residential store room from l1 to l6 in sc 25
Layer: 220218 Mountjoy_Site drawings (1)	ID: 30
Number of extensions: 0	Created by: Arup Fire Plan Radar 9
Created on: 07/03/2022 03:22 PM	Updated: 07/03/2022 03:22 PM
Updated by: Arup Fire Plan Radar 9	Date:
Time:	Compliant with the Fire Strategy?: No
Non compliant with the Fire Strategy: No	Details:

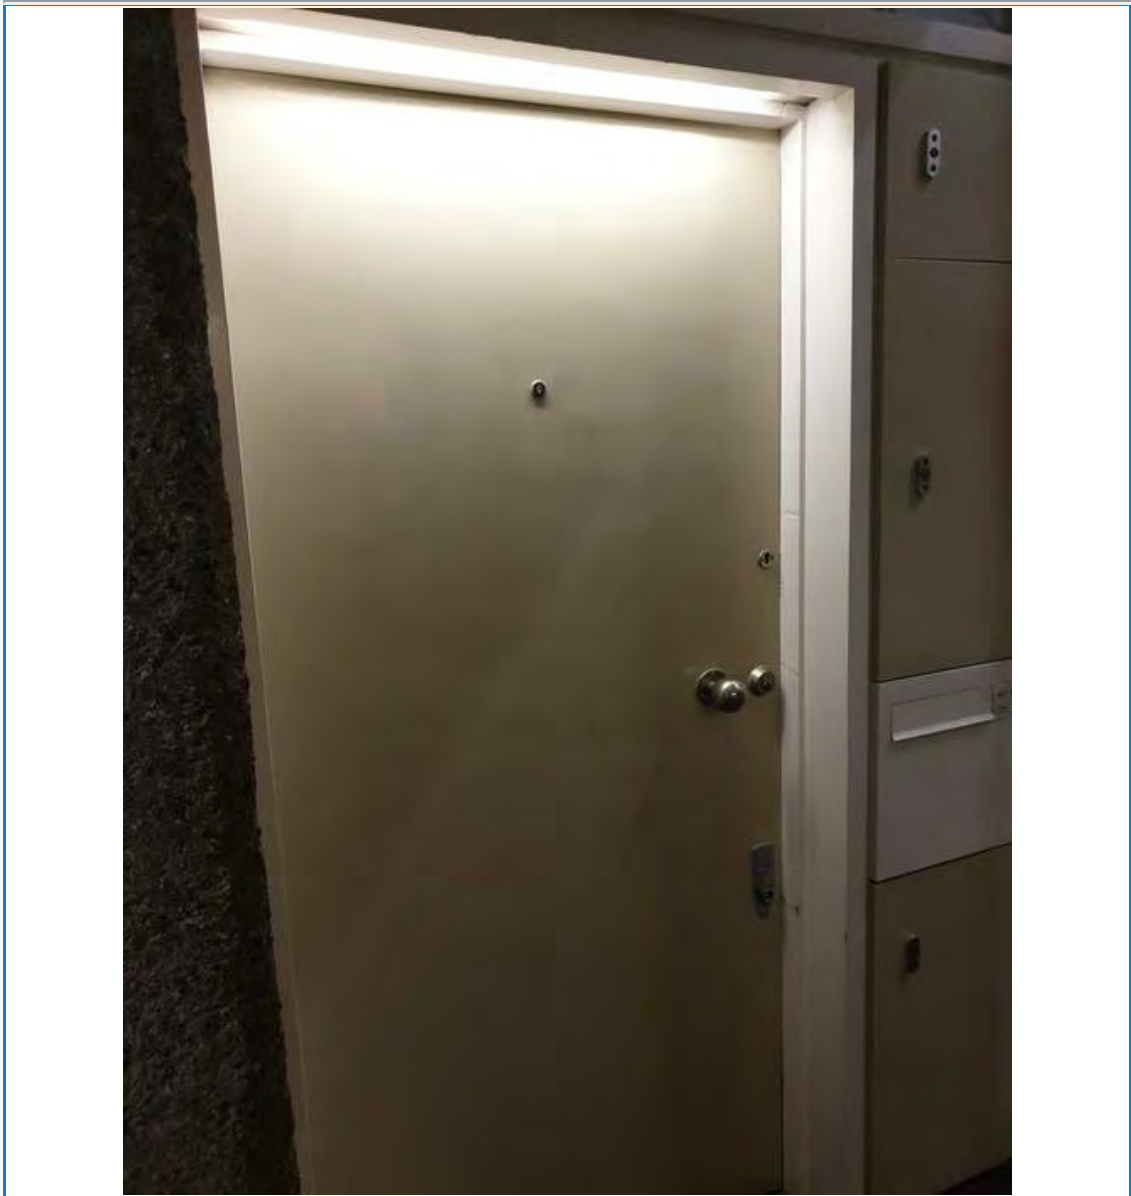
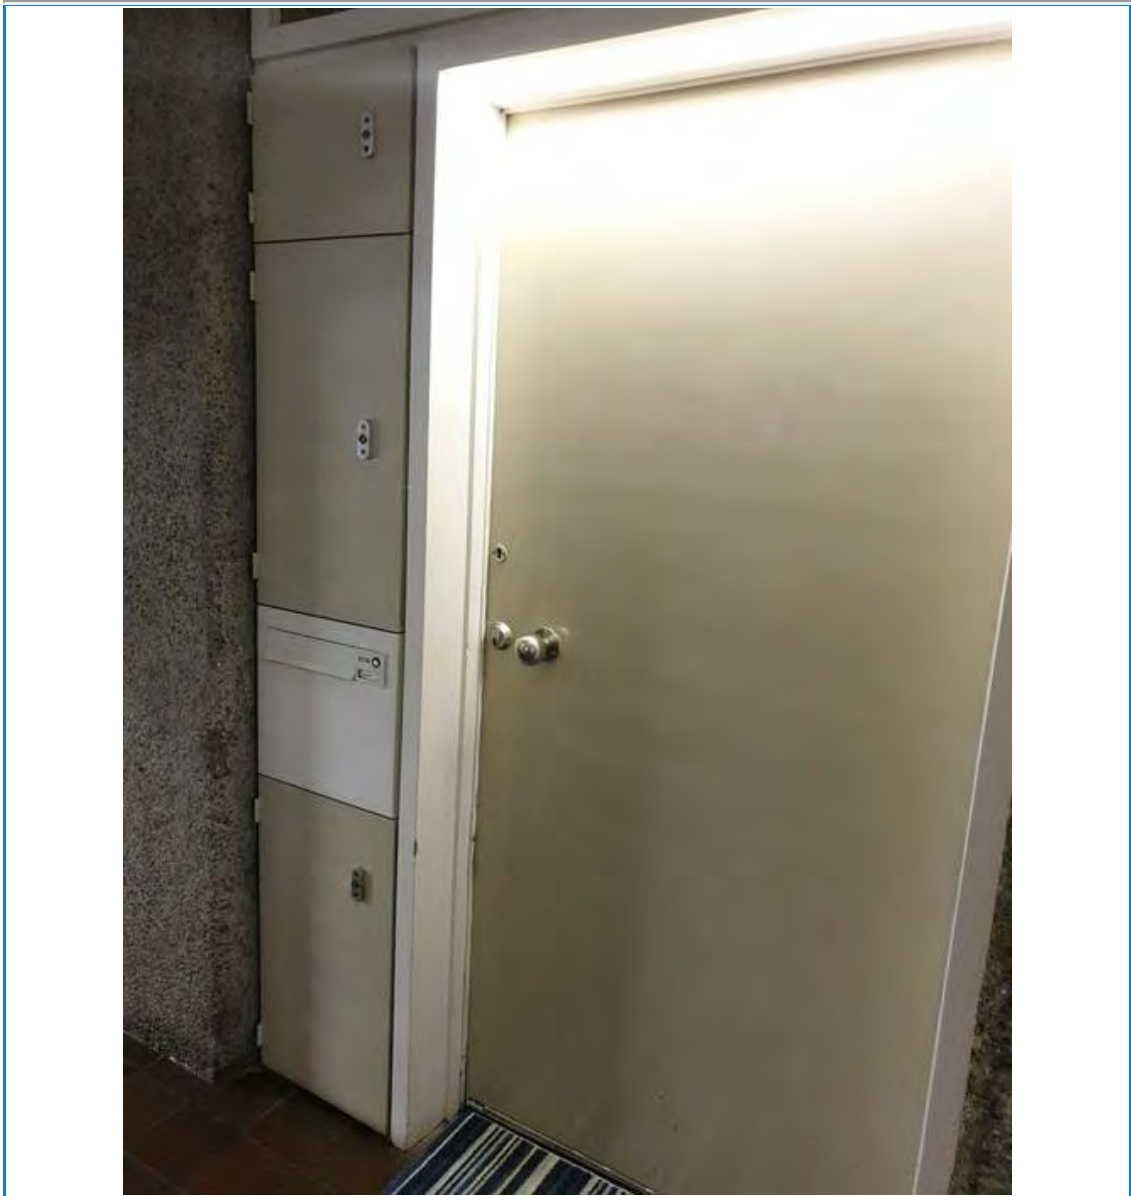
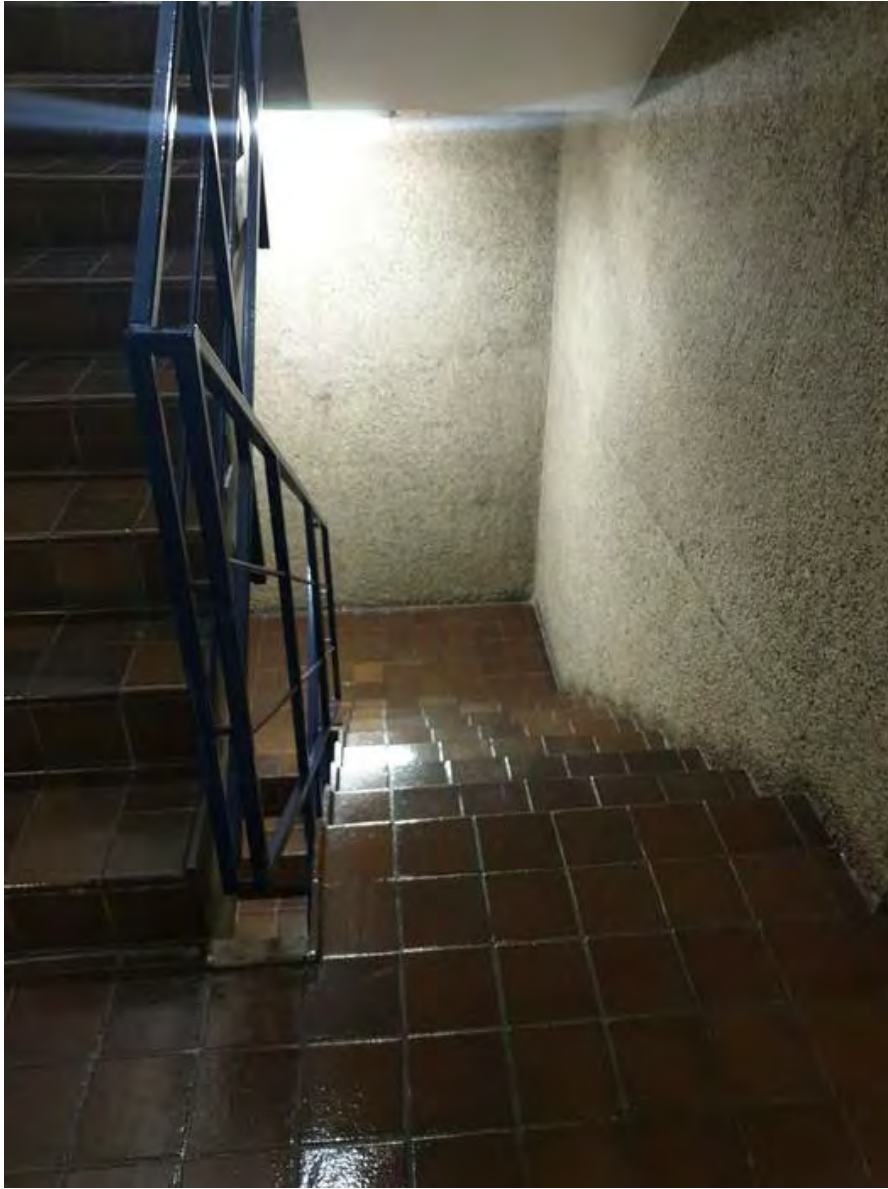
Title: flats open on to sc25
ID: 31
Created by: Arup Fire Plan Radar 9
Updated: 07/03/2022 03:23 PM
Date:
Compliant with the Fire Strategy?:No
Details:

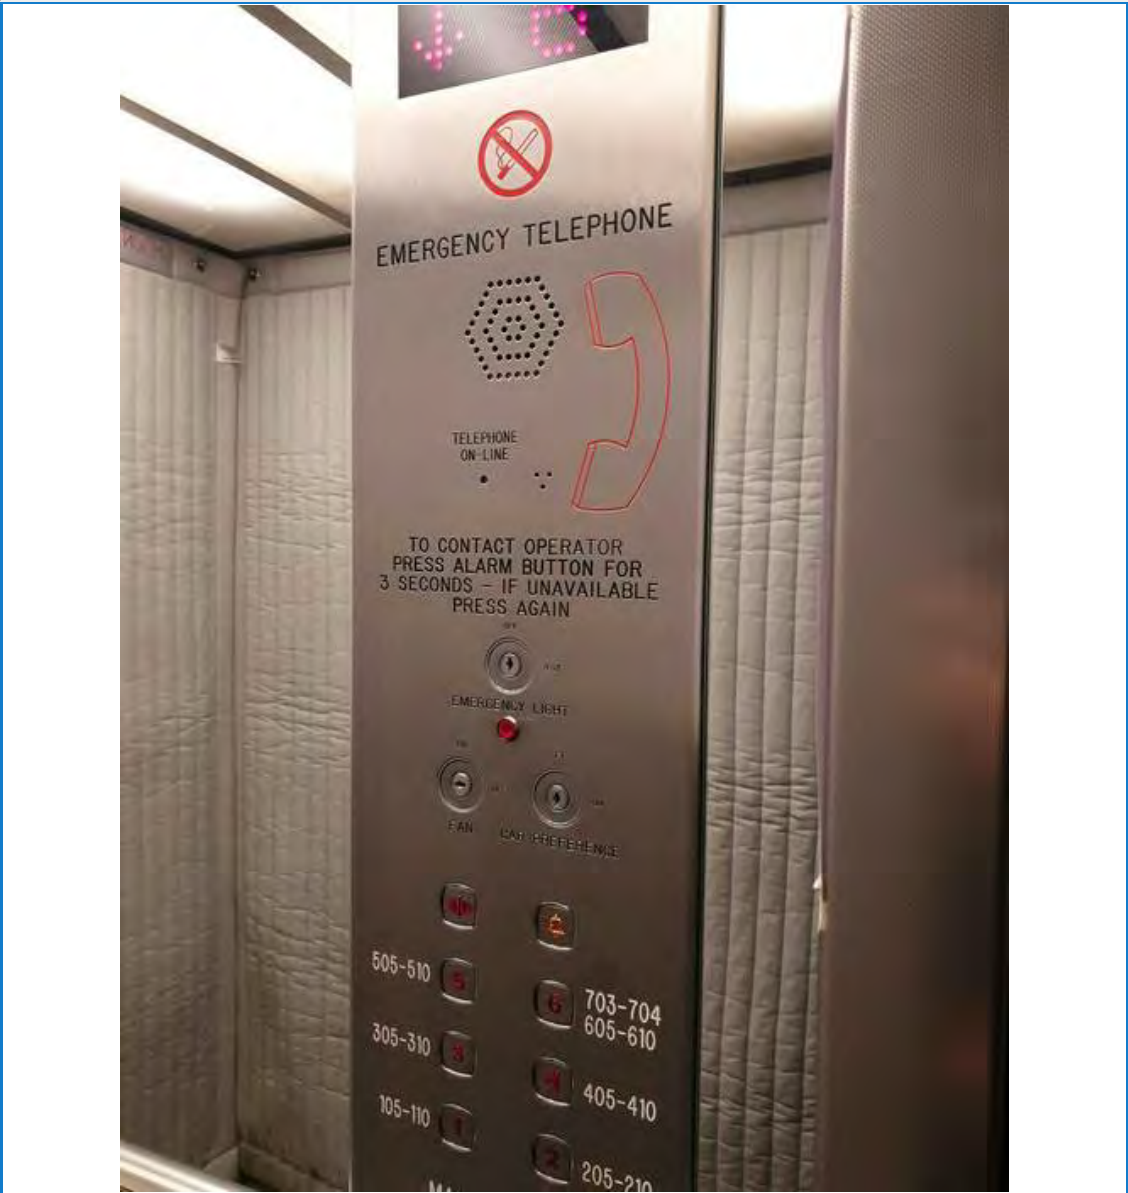
Title: sc 25 lift
ID: 32
Created by: Arup Fire Plan Radar 9
Updated: 07/03/2022 03:24 PM
Date:
Compliant with the Fire Strategy?: No
Details:

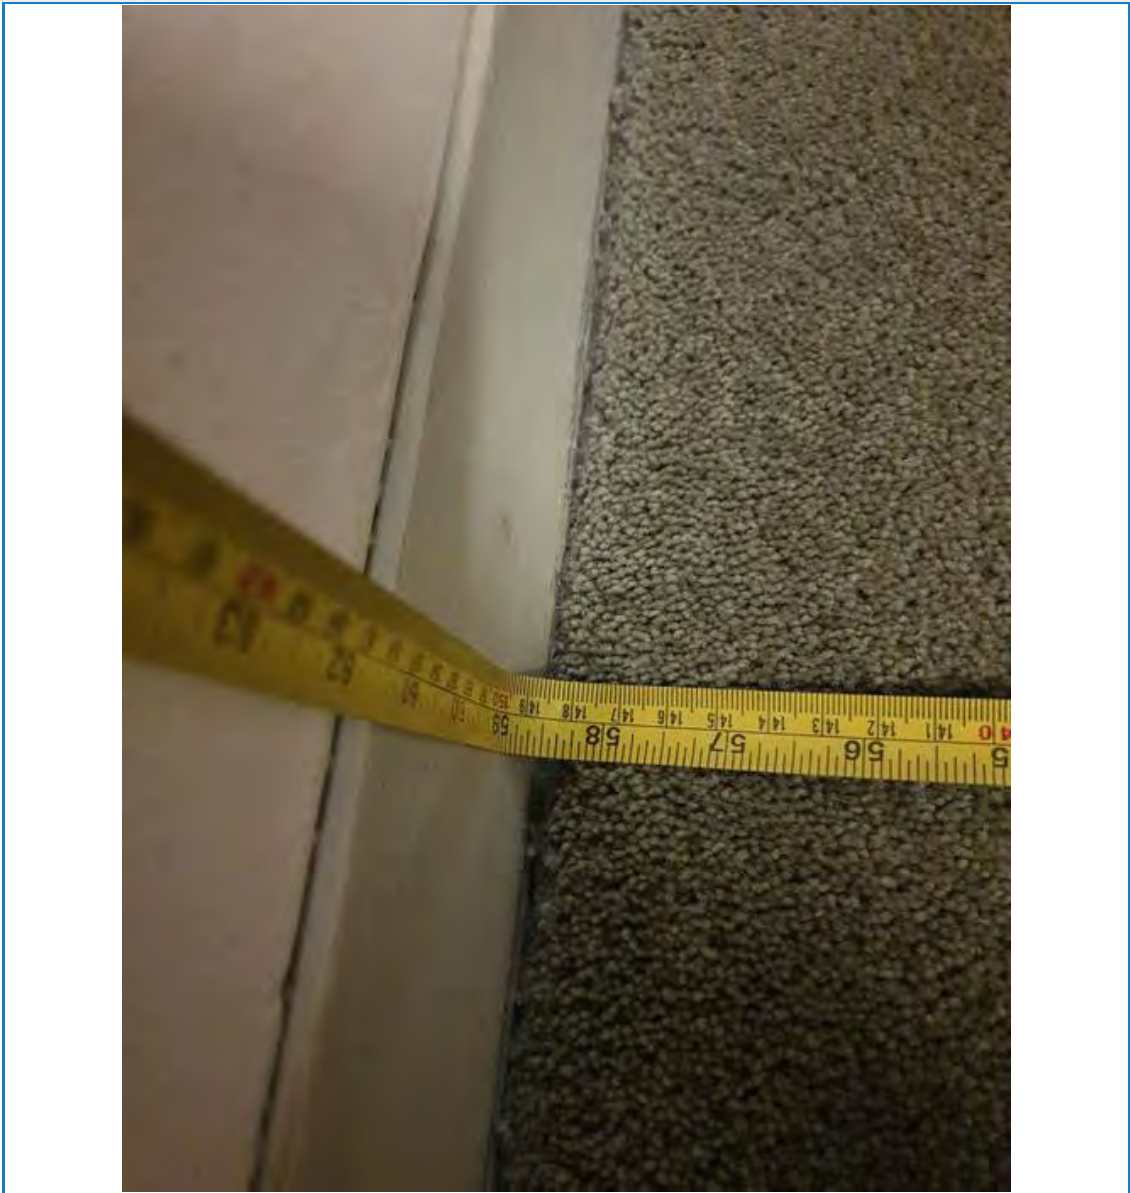
Form: General	Title: corridor width 1480
Layer: 220218 Mountjoy_Site drawings (1)	ID: 37
Number of extensions: 0	Created by: Arup Fire Plan Radar 9
Created on: 07/03/2022 03:44 PM	Updated: 07/03/2022 03:44 PM
Updated by: Arup Fire Plan Radar 9	Date:
Time:	Compliant with the Fire Strategy?: No
Non compliant with the Fire Strategy: No	Details:

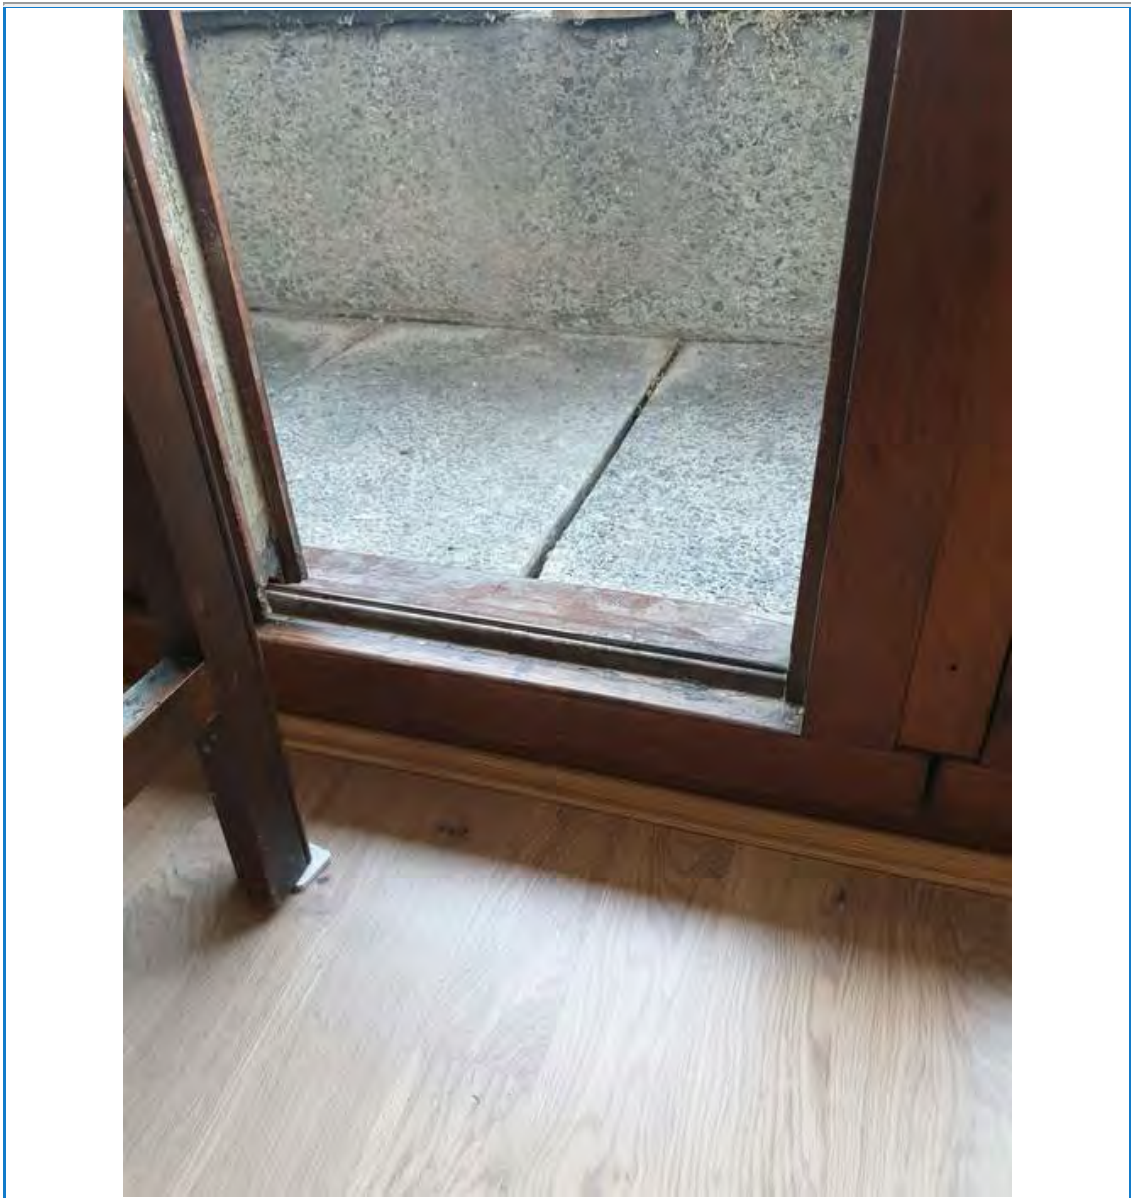
Title: level change in flat 210
ID: 39
Created by: Arup Fire Plan Radar 9
Updated: 07/03/2022 03:57 PM
Date:
Compliant with the Fire Strategy?:No
Details:

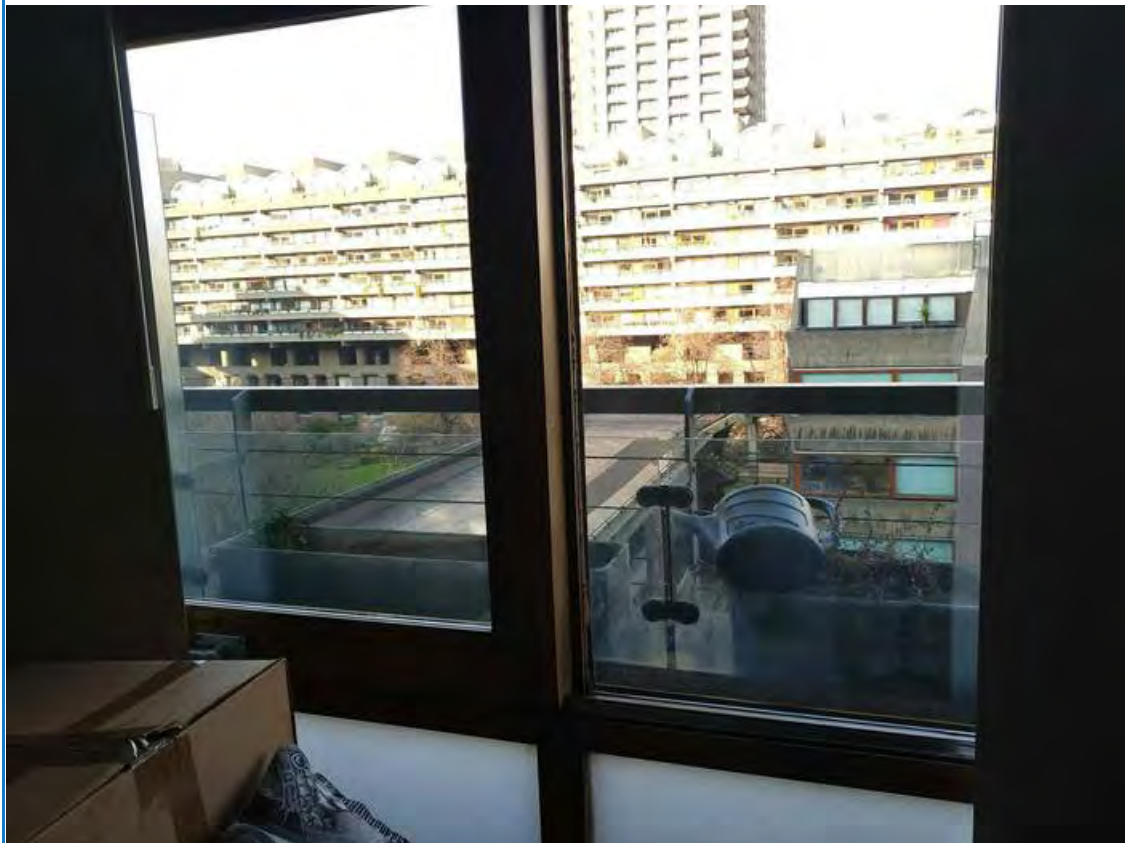
Form: General	Title: flat 210 access to balcony from the bedroom available through a window. the different flats are windows and doors mixture access
Layer: 220218 Mountjoy_Site drawings (1)	ID: 41
Number of extensions: 0	Created by: Arup Fire Plan Radar 9
Created on: 07/03/2022 04:03 PM	Updated: 07/03/2022 04:04 PM
Updated by: Arup Fire Plan Radar 9	Date:
Time:	Compliant with the Fire Strategy?: No
Non compliant with the Fire Strategy: No	Details:

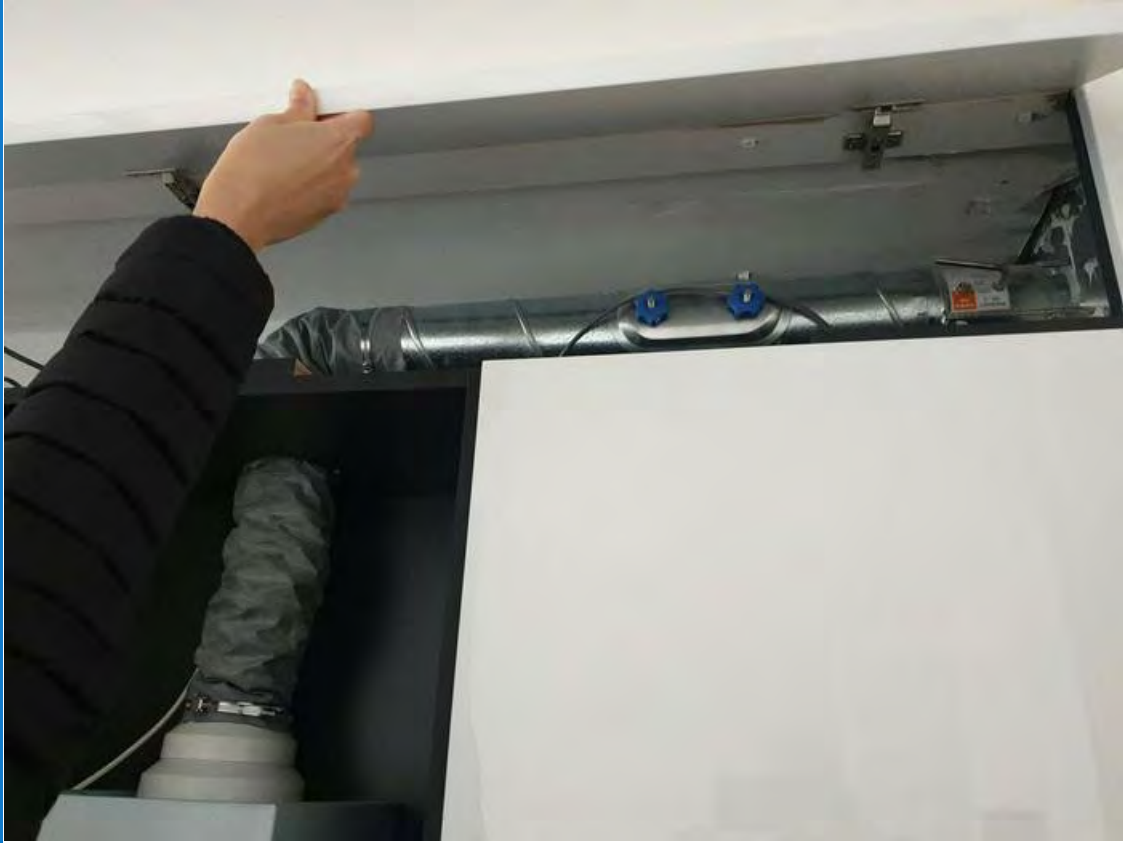
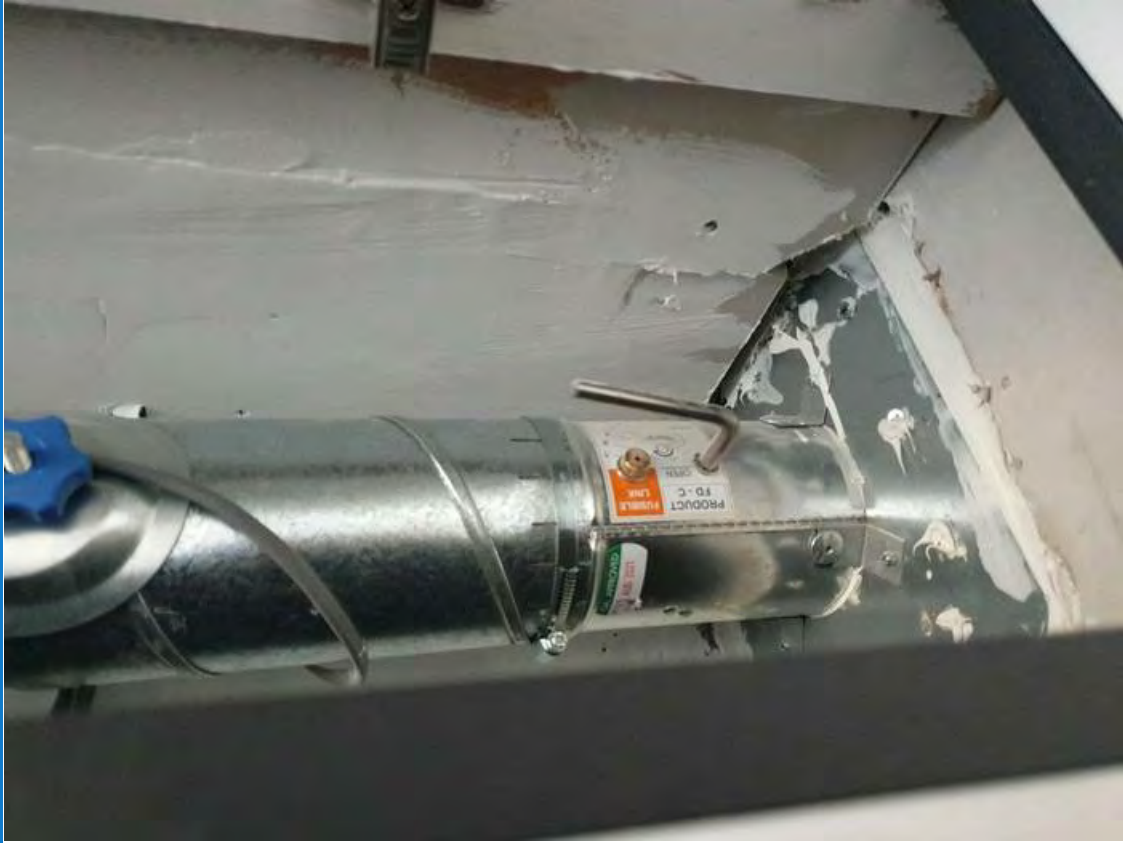
However, those standards that recognise allow the use of shunt ducts do not recommend them for kitchen extract risers. The presence of grease in the duct may affect the effectiveness of the shunt system in maintaining fire and smoke separation. Failure of compartmentation between the flats presents a life safety risk to the occupants.

Title: flat 210 kitchen duct to shunt duct
ID: 42
Created by: Arup Fire Plan Radar 9
Updated: 07/03/2022 04:08 PM
Date:
Compliant with the Fire Strategy?:No
Details:

It is recommended to replace the existing kitchen extract hoods with recirculation type hoods, and implement one of the following:

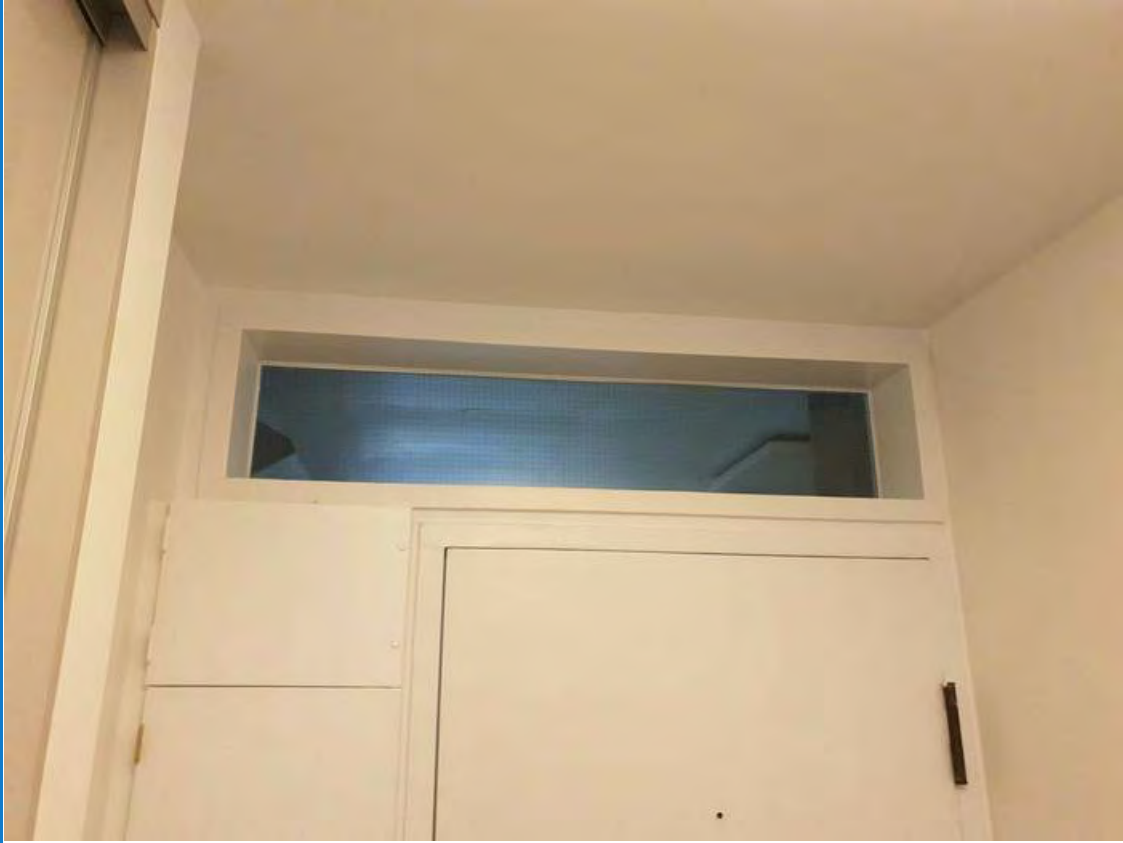
Form: General	Title: main entrance with louvred cent on top
Layer: 220218 Mountjoy_Site drawings (1)	ID: 43
Number of extensions: 0	Created by: Arup Fire Plan Radar 9
Created on: 07/03/2022 04:10 PM	Updated: 07/03/2022 04:10 PM
Updated by: Arup Fire Plan Radar 9	Date:
Time:	Compliant with the Fire Strategy?: No
Non compliant with the Fire Strategy: No	Details:

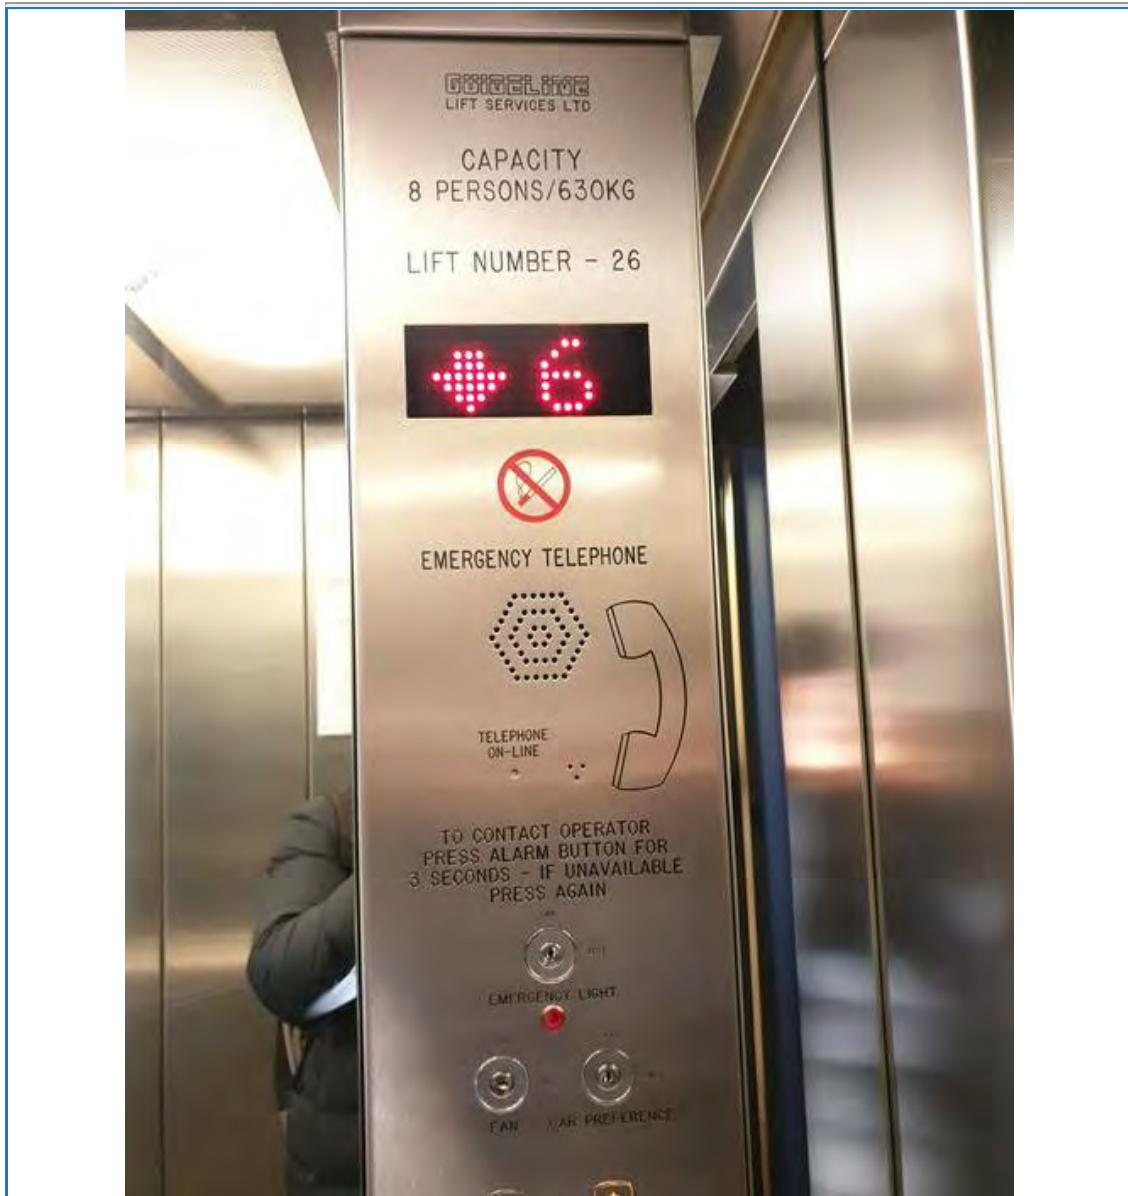
Title: L6 lift sign for sc26
ID: 12
Created by: Arup Fire Plan Radar 9
Updated: 07/03/2022 02:49 PM
Date:
Compliant with the Fire Strategy?:No
Details:

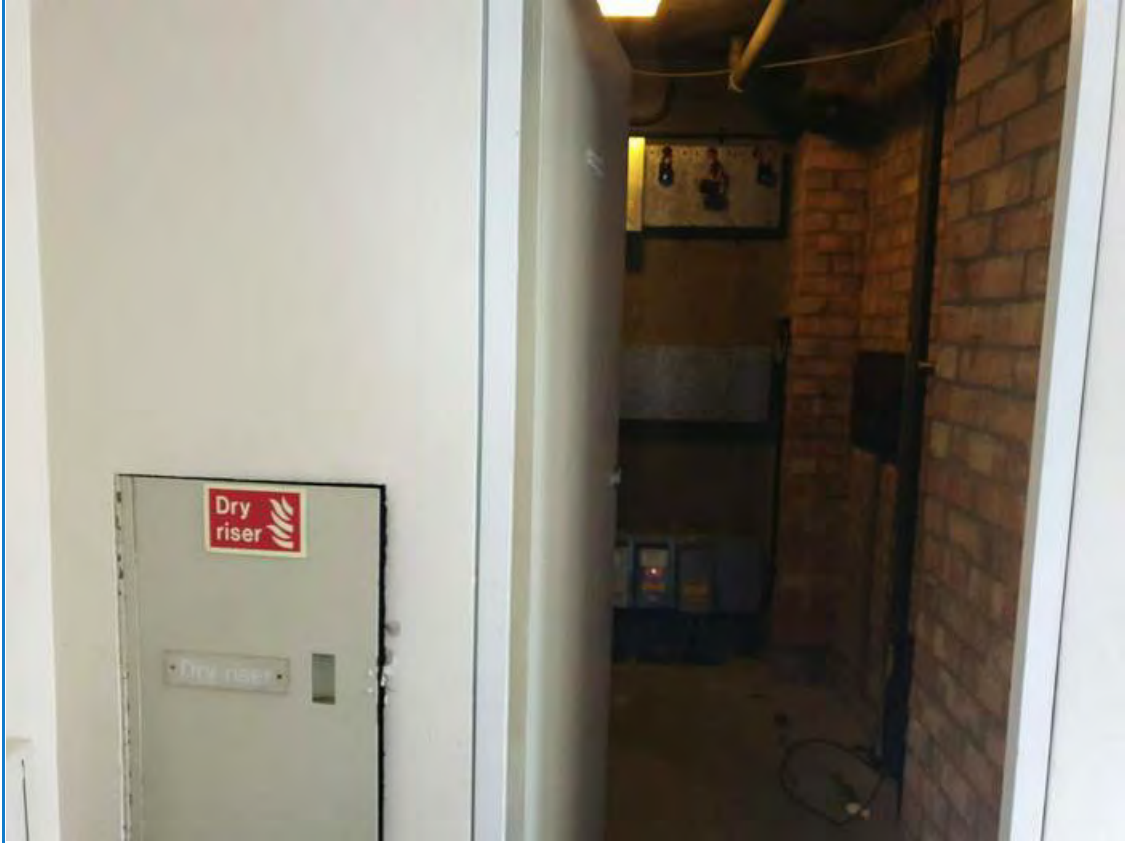
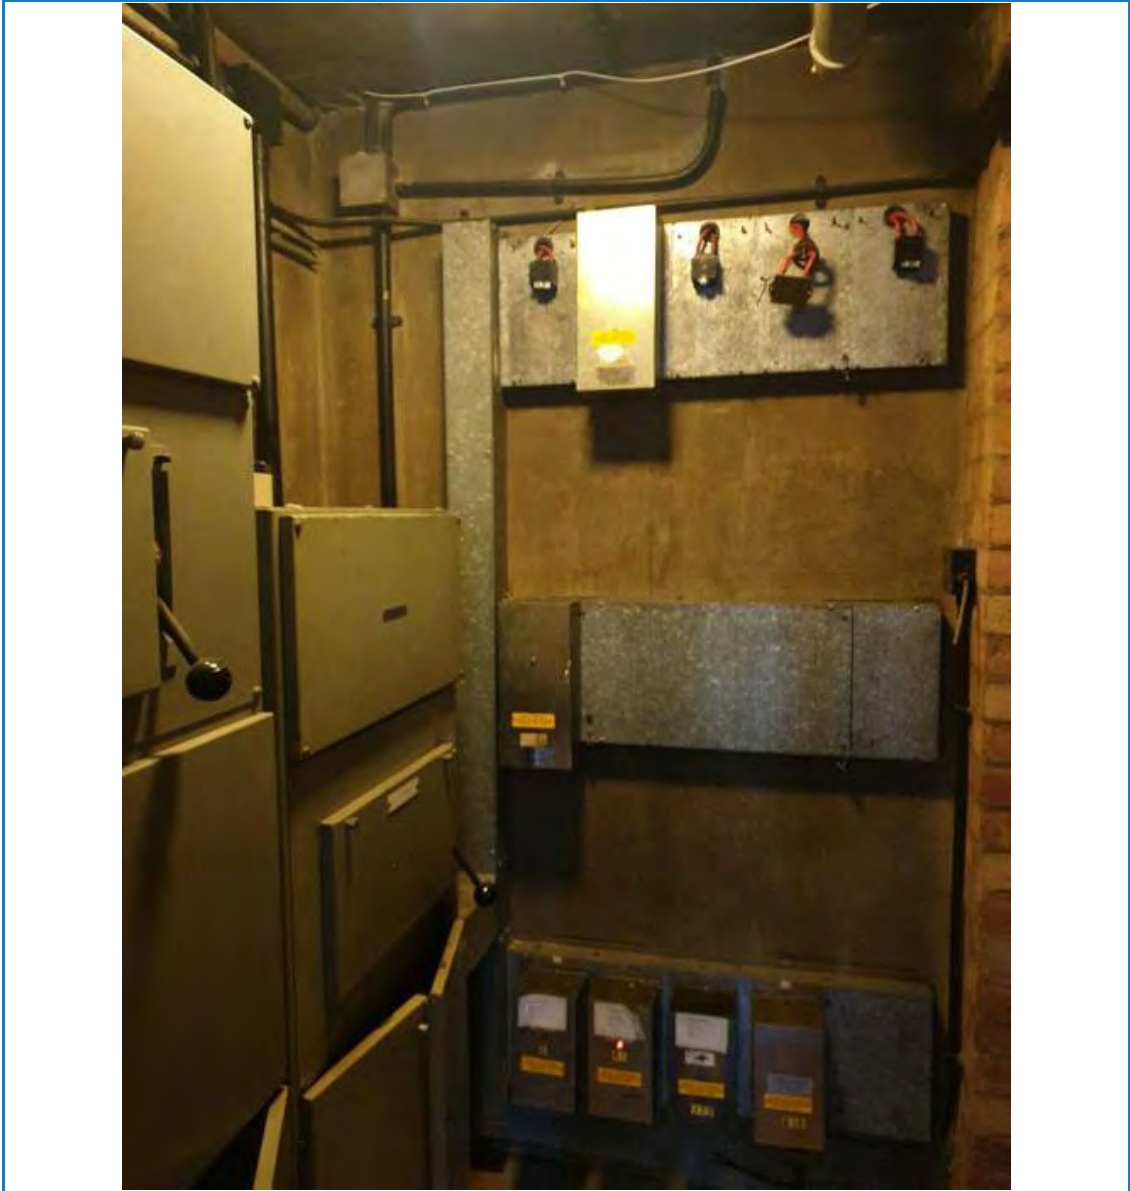
Form: General	Title: l6 dry riser outlet in front of the lift with EDB electric distribution board plant room
Layer: L7	ID: 13
Number of extensions: 0	Created by: Arup Fire Plan Radar 9
Created on: 07/03/2022 02:43 PM	Updated: 07/03/2022 02:49 PM
Updated by: Arup Fire Plan Radar 9	Date:
Time:	Compliant with the Fire Strategy?: No
Non compliant with the Fire Strategy: No	Details:
