Barbican Estate
Barbican Residential Blocks
Mountjoy House – Fire Strategy
Report

Rev A | 7 September 2022

Job number 279095-01

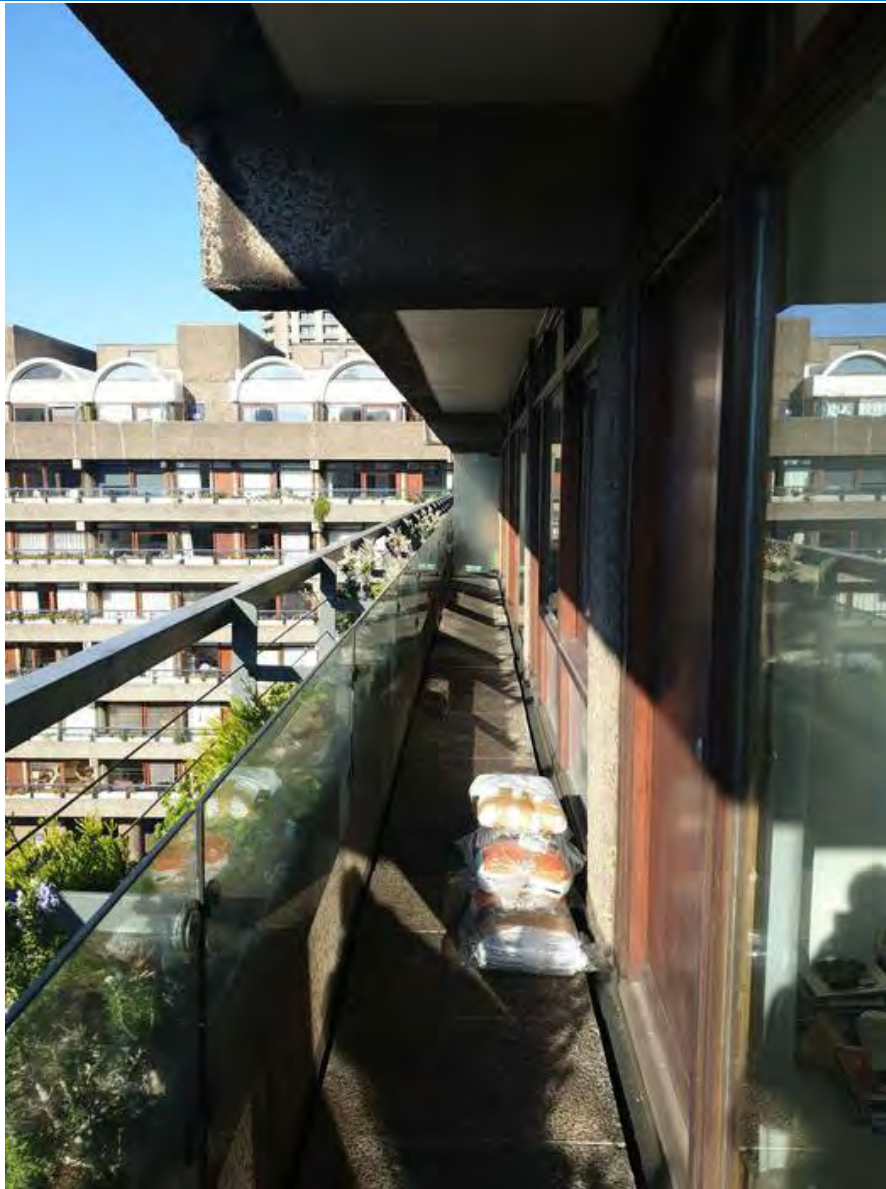
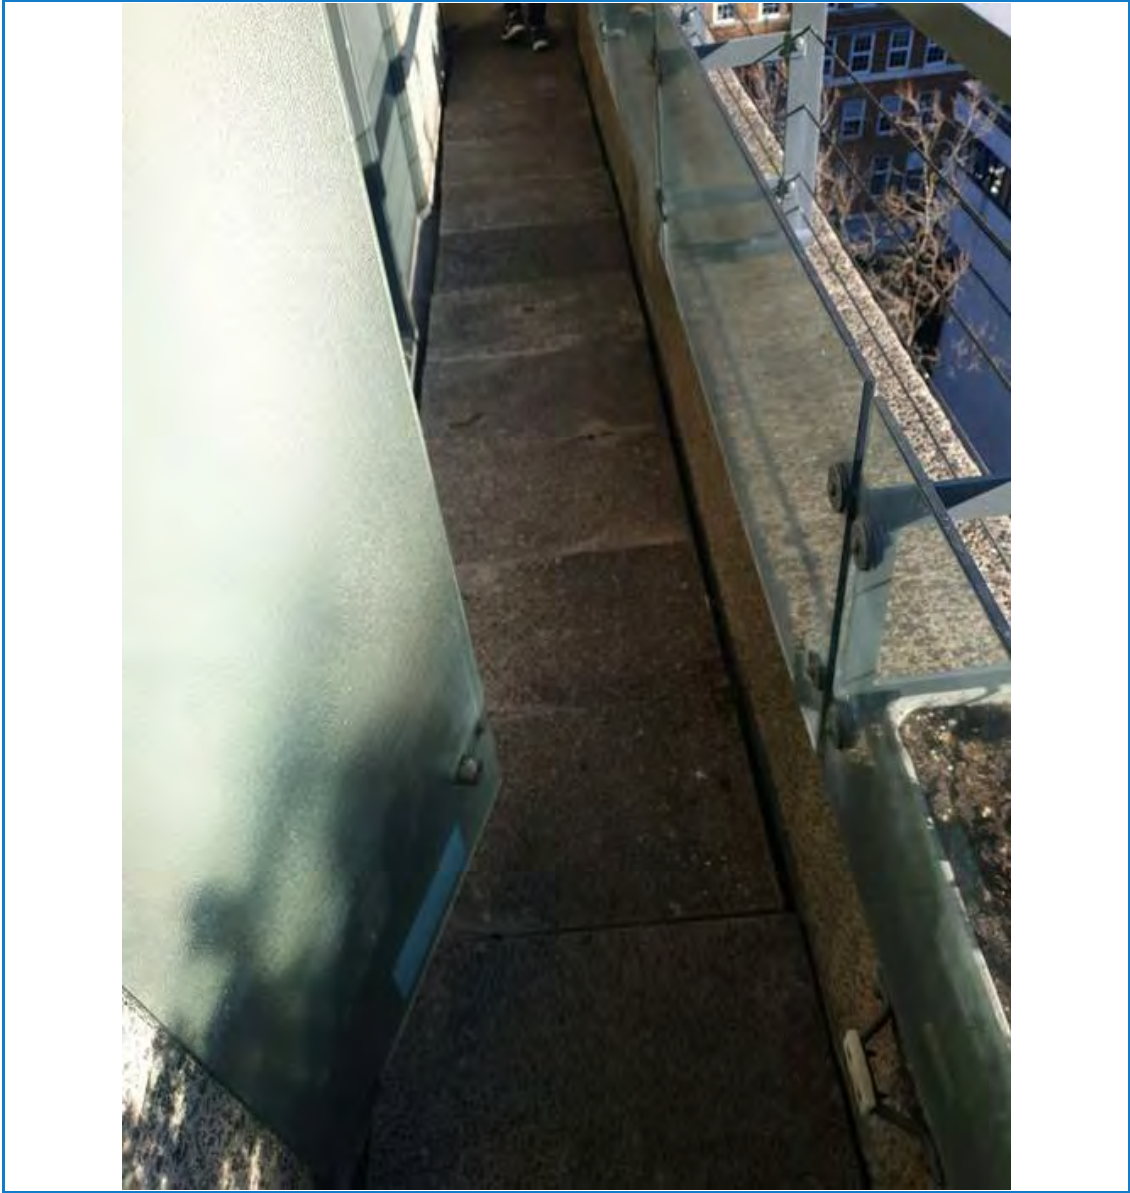
Form: General	Title: L6 balconies around the building perimeter like andrewes with panels
Layer: L7	ID: 14
Number of extensions: 0	Created by: Arup Fire Plan Radar 9
Created on: 07/03/2022 02:46 PM	Updated: 07/03/2022 02:47 PM
Updated by: Arup Fire Plan Radar 9	Date:
Time:	Compliant with the Fire Strategy?: No
Non compliant with the Fire Strategy: No	Details:

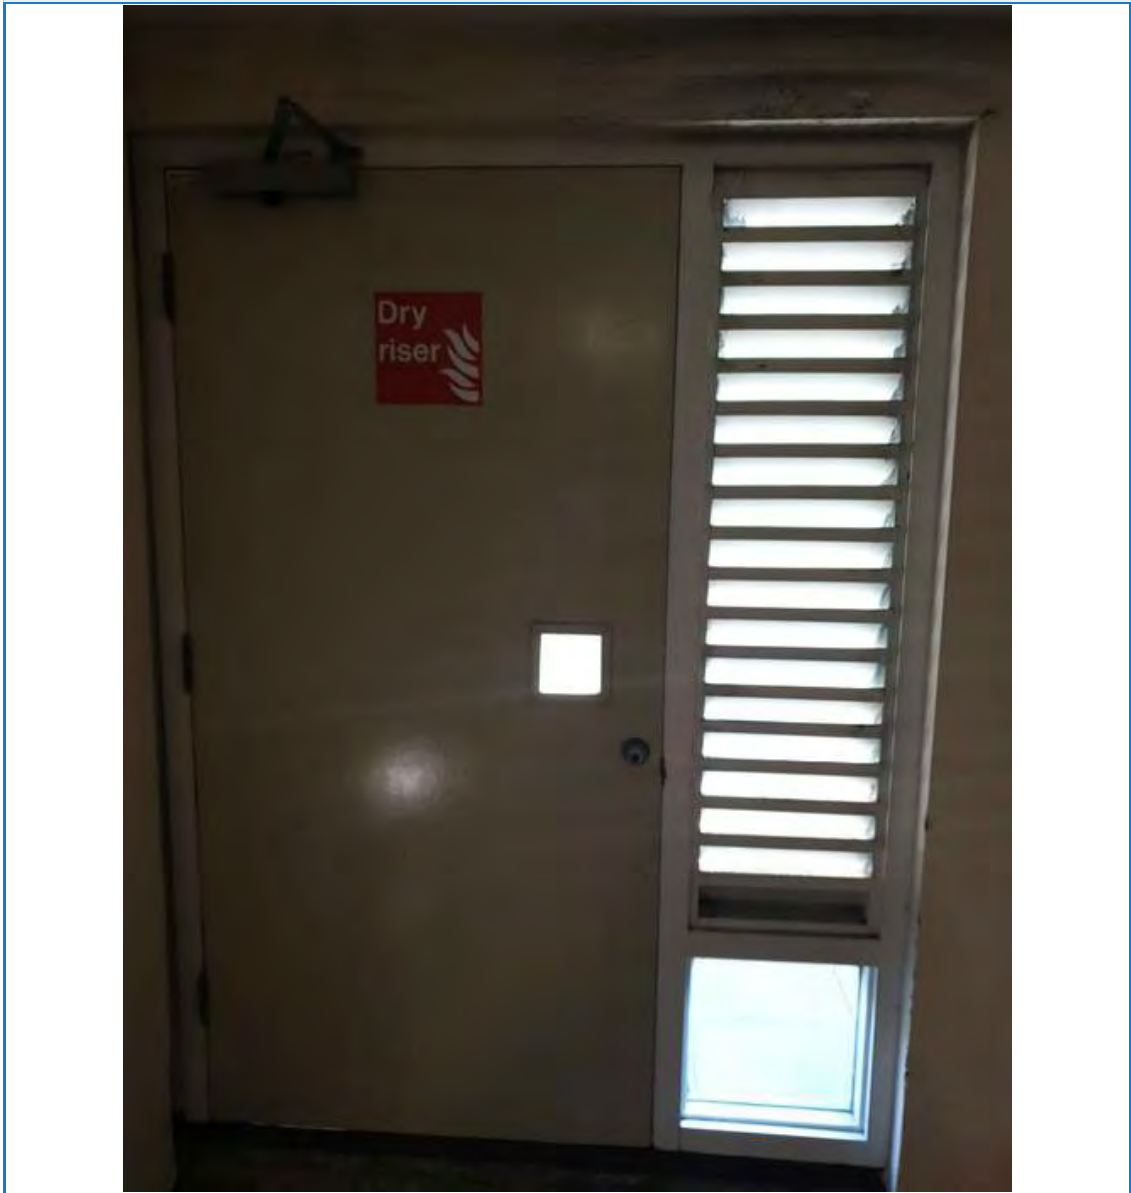
Form: General	Title: I7 fire door from stair 26 to outside balcony
Layer: L7	ID: 15
Number of extensions: 0	Created by: Arup Fire Plan Radar 9
Created on: 07/03/2022 02:48 PM	Updated: 07/03/2022 02:48 PM
Updated by: Arup Fire Plan Radar 9	Date:
Time:	Compliant with the Fire Strategy?: No
Non compliant with the Fire Strategy: No	Details:

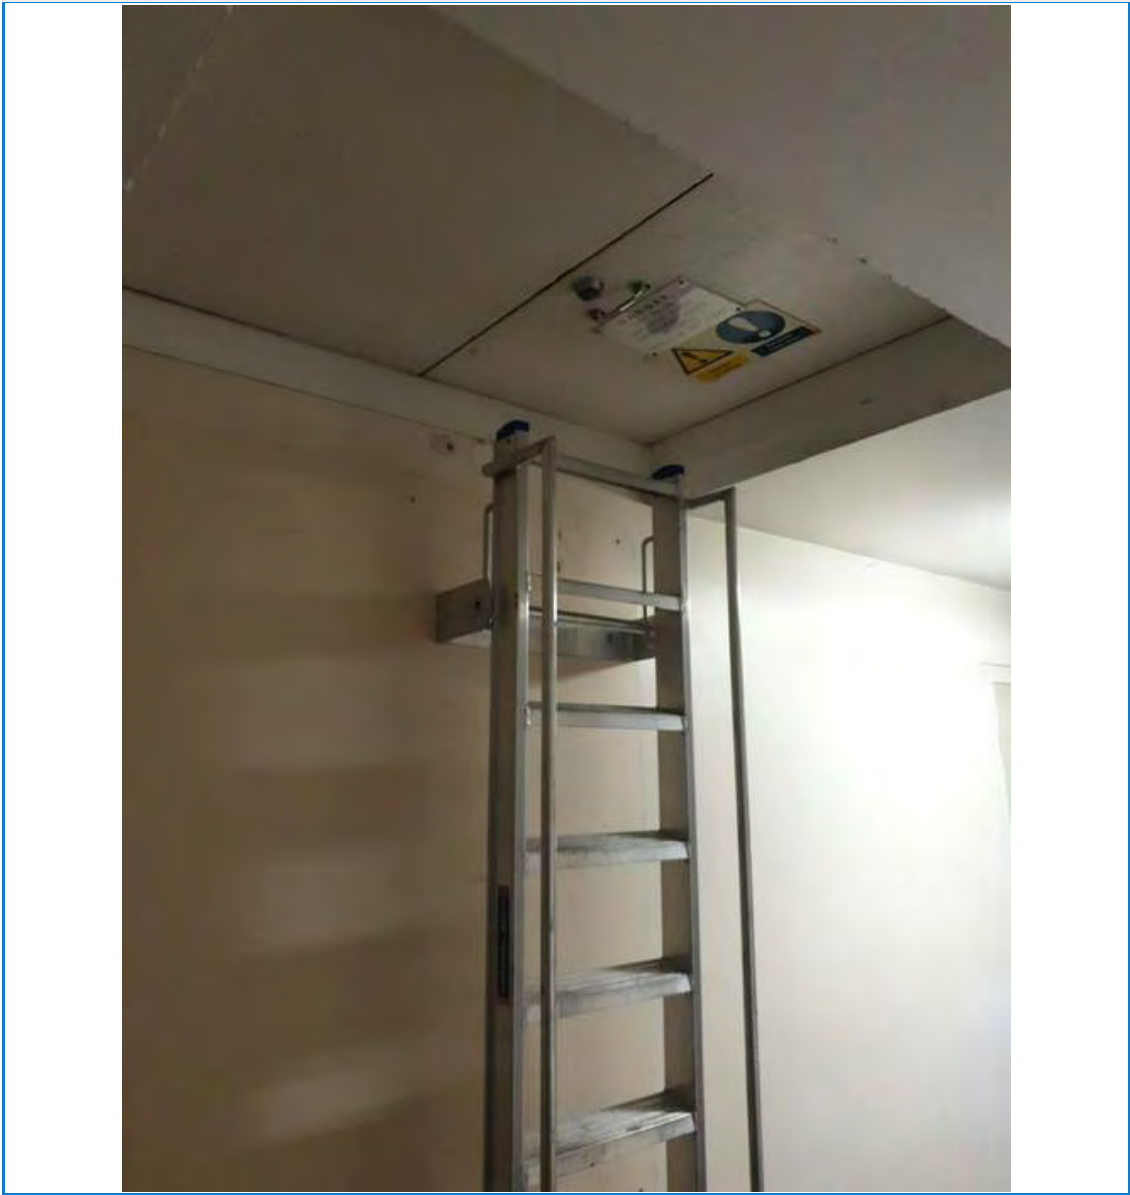
Title: I7 access to roof plant area
ID: 16
Created by: Arup Fire Plan Radar 9
Updated: 07/03/2022 02:50 PM
Date:
Compliant with the Fire Strategy?:No
Details:

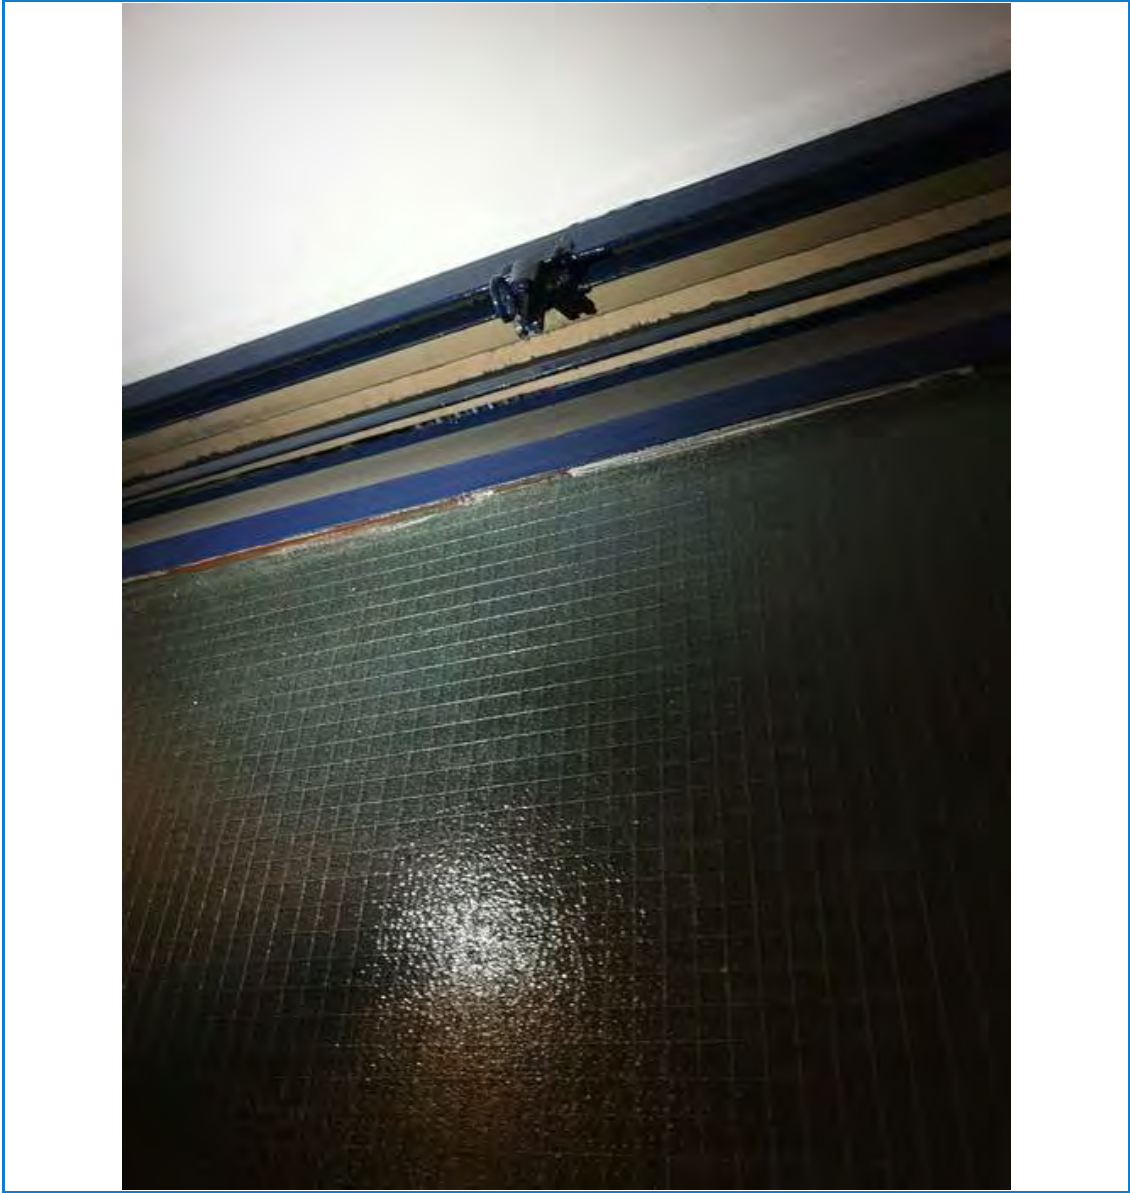
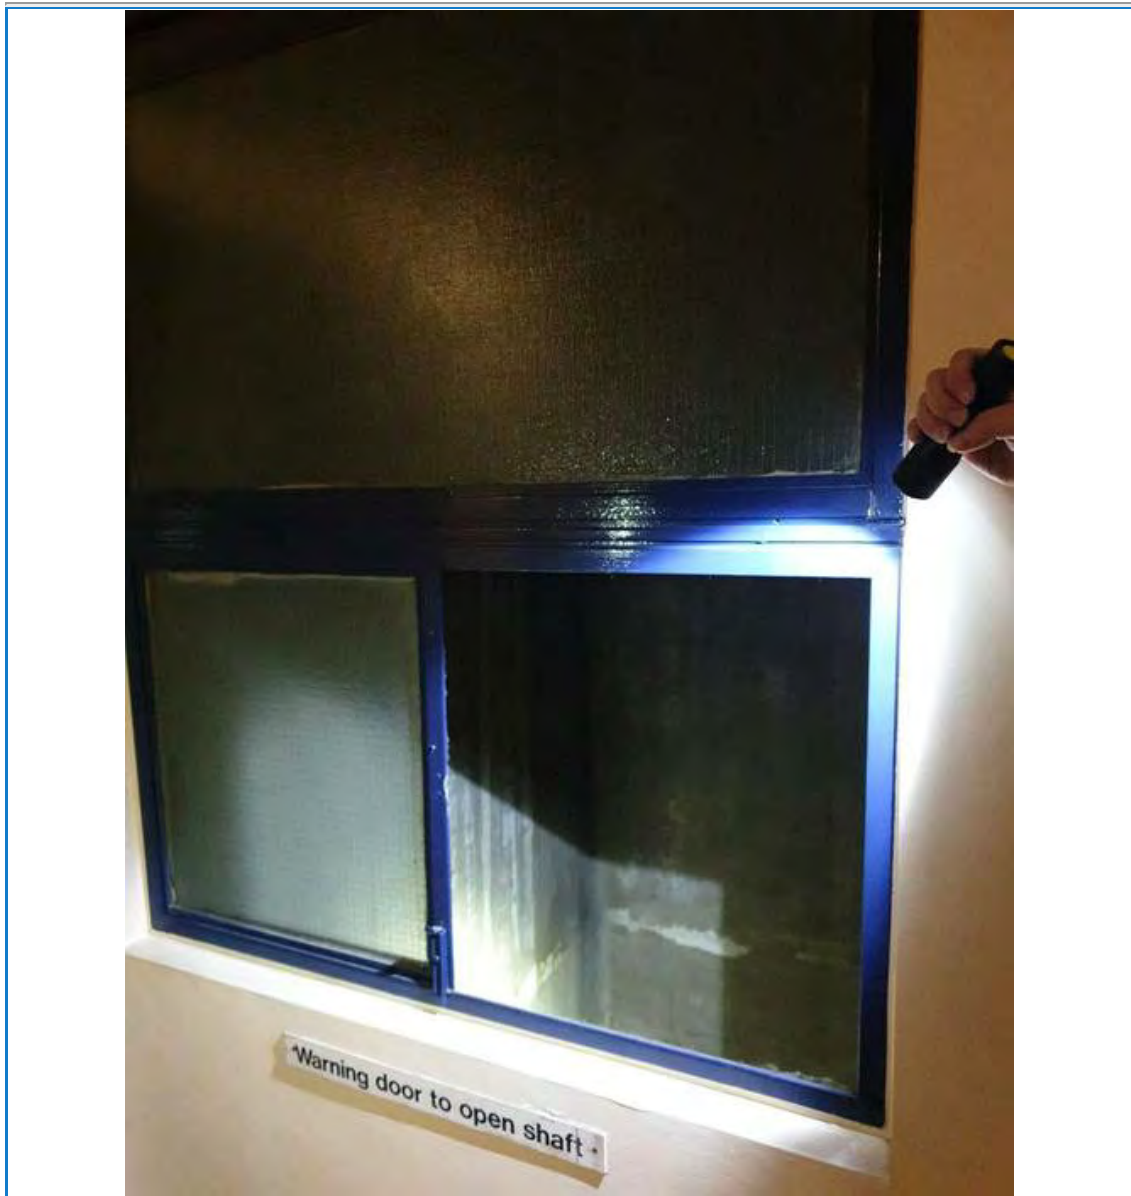
Title: I7 vent shaft for the stair lobby
ID: 17
Created by: Arup Fire Plan Radar 9
Updated: 07/03/2022 02:52 PM
Date:
Compliant with the Fire Strategy?:No
Details:

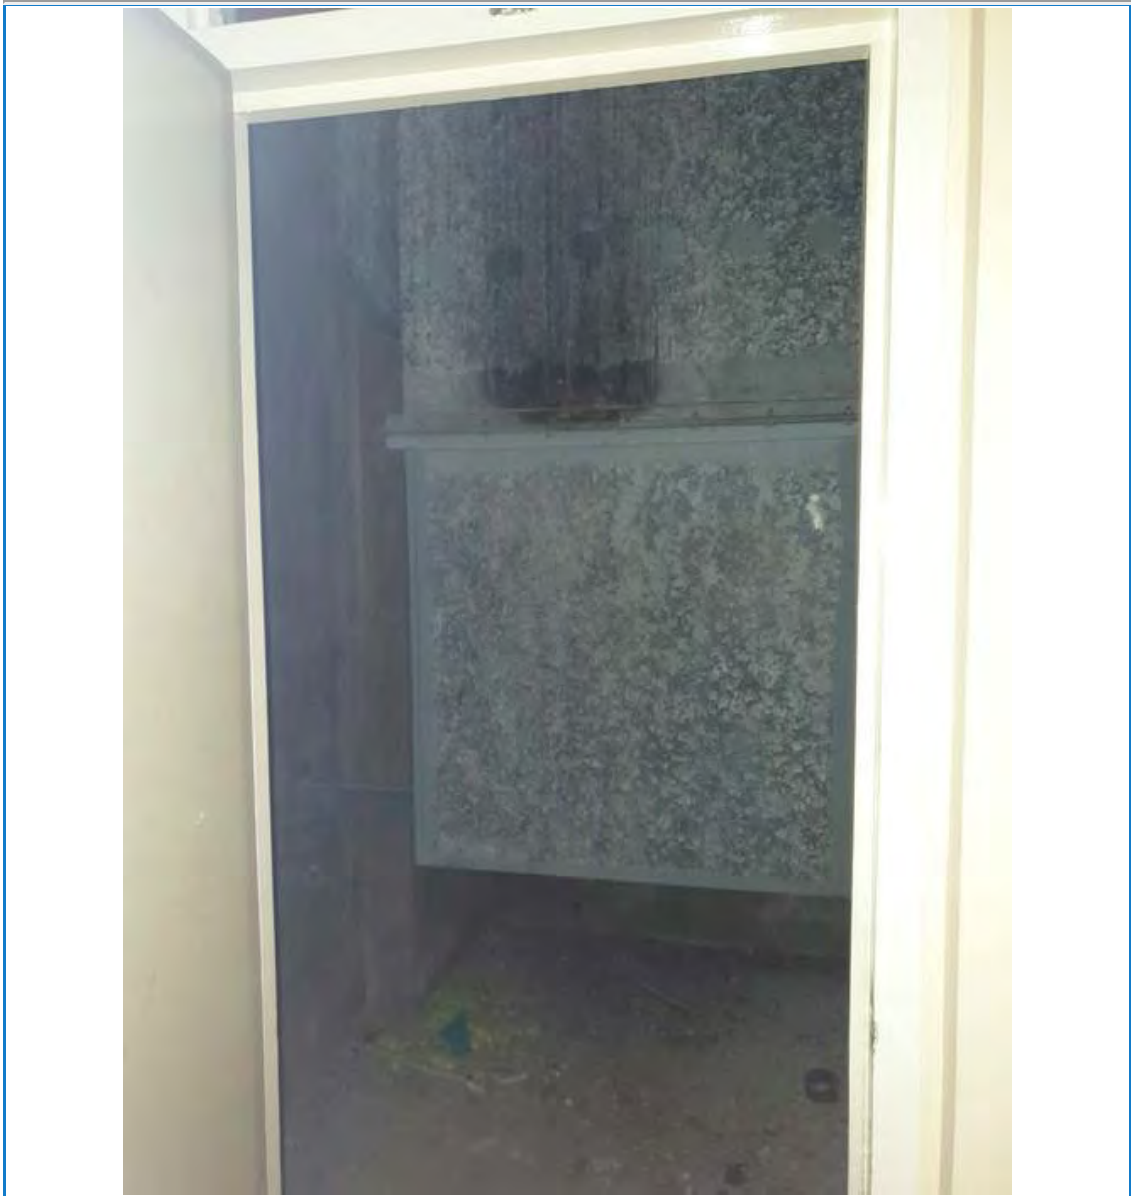
Title: plant lift motor room for lift 26
ID: 19
Created by: Arup Fire Plan Radar 9
Updated: 07/03/2022 02:56 PM
Date:
Compliant with the Fire Strategy?:No
Details:

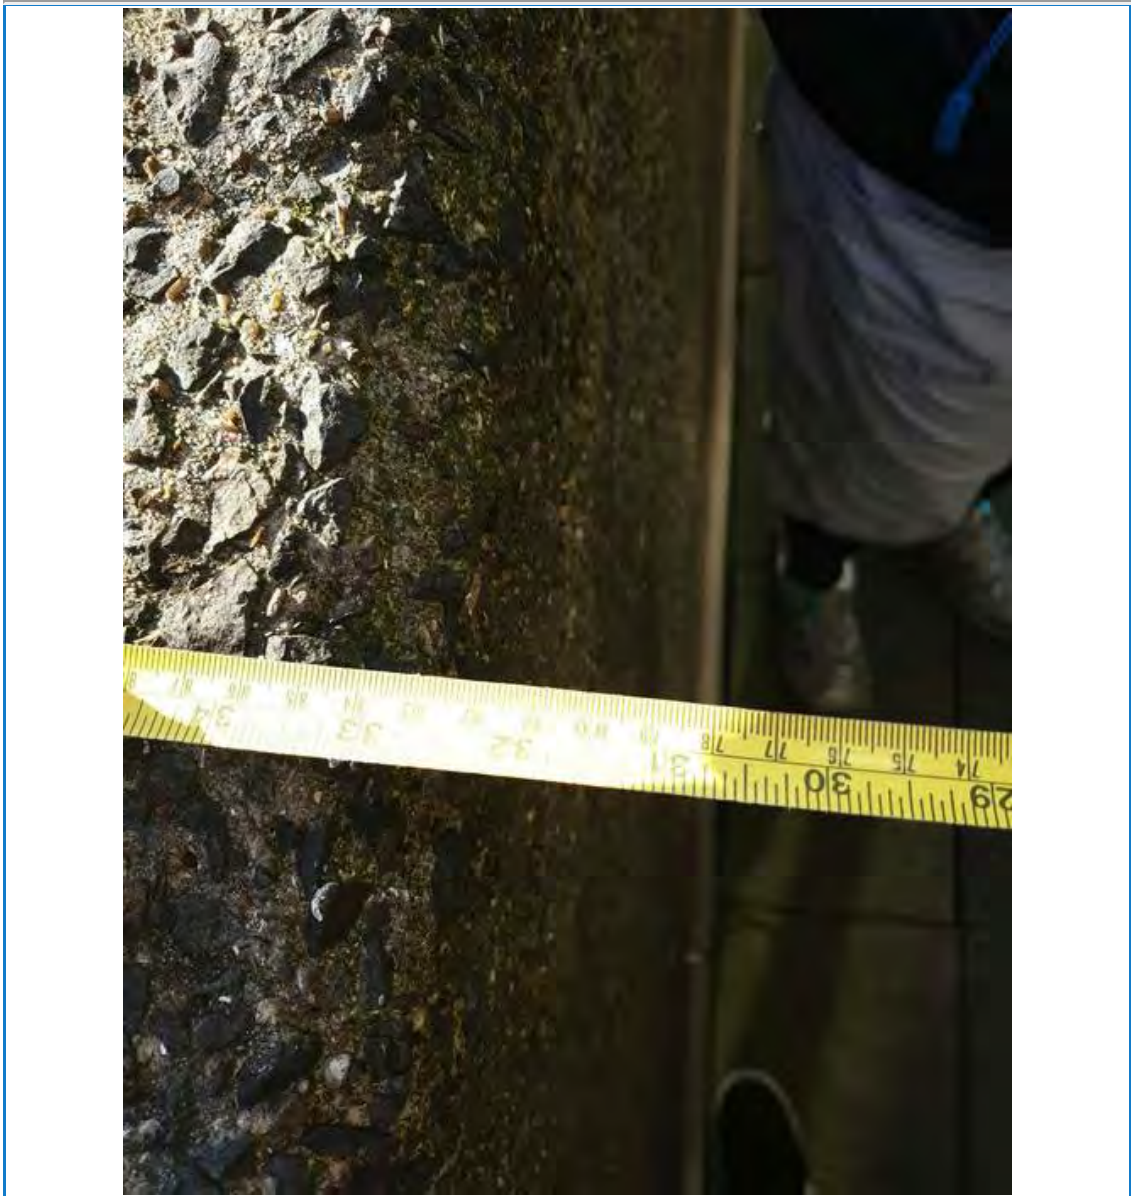
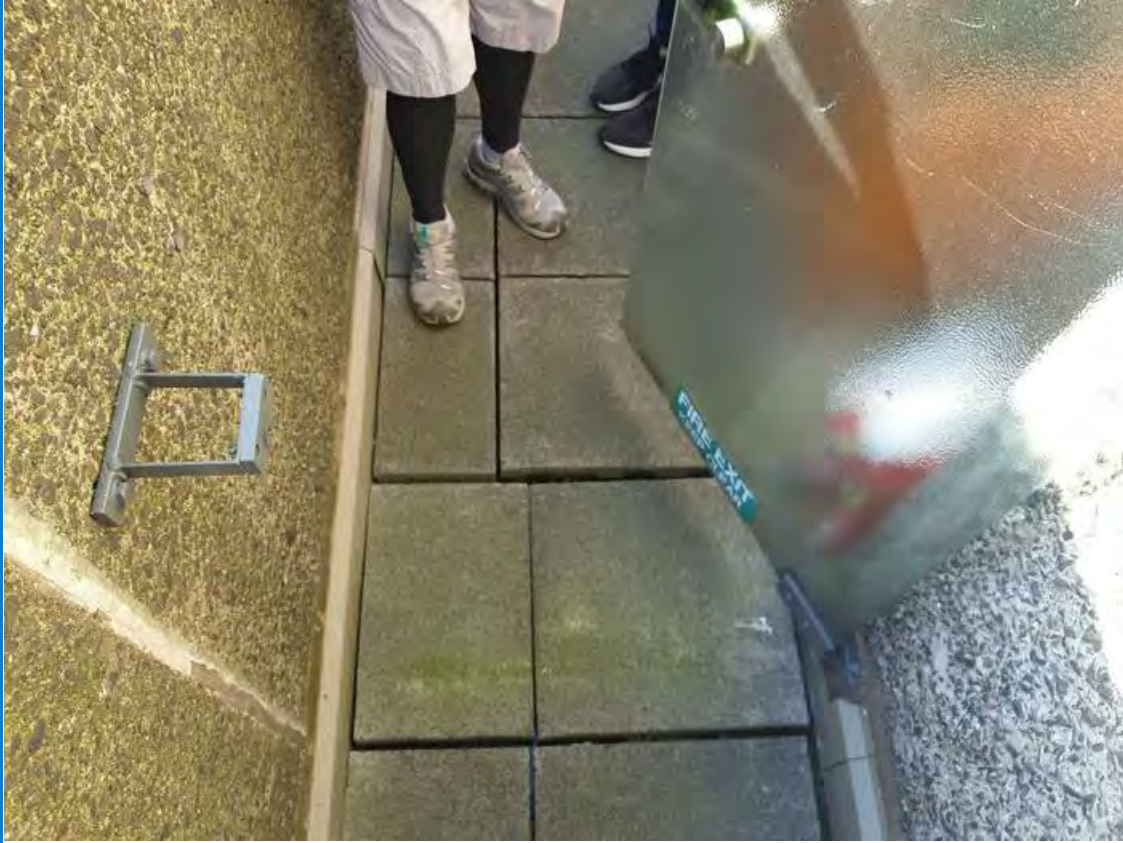
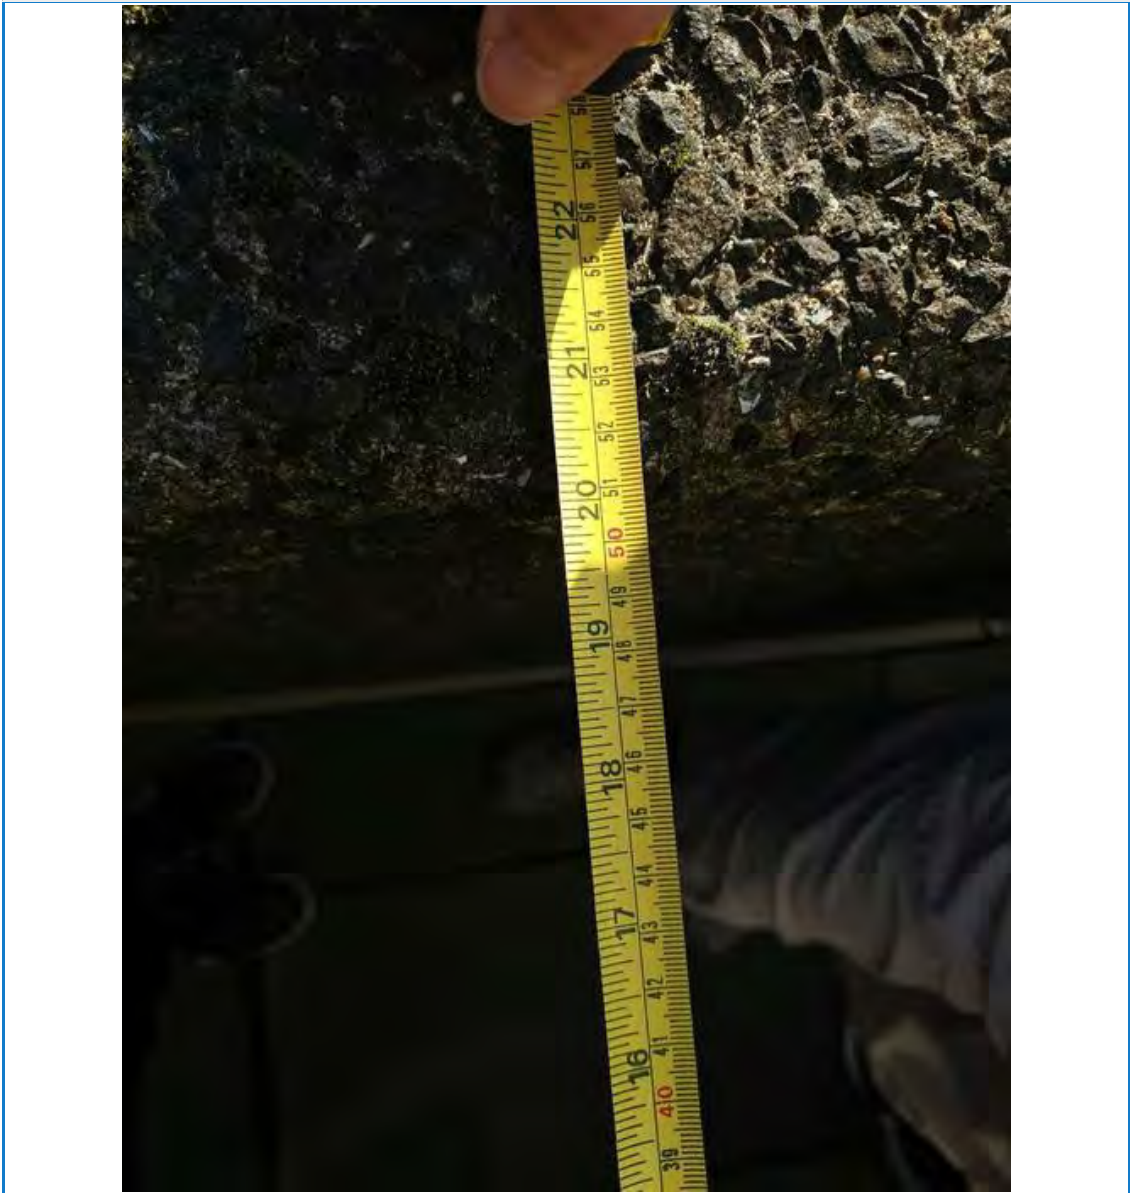
Form: General	Title: L7 balcony width 830mm and at pinch point 500mm
Layer: L7	ID: 21
Number of extensions: 0	Created by: Arup Fire Plan Radar 9
Created on: 07/03/2022 02:59 PM	Updated: 07/03/2022 03:00 PM
Updated by: Arup Fire Plan Radar 9	Date:
Time:	Compliant with the Fire Strategy?: No
Non compliant with the Fire Strategy: No	Details:

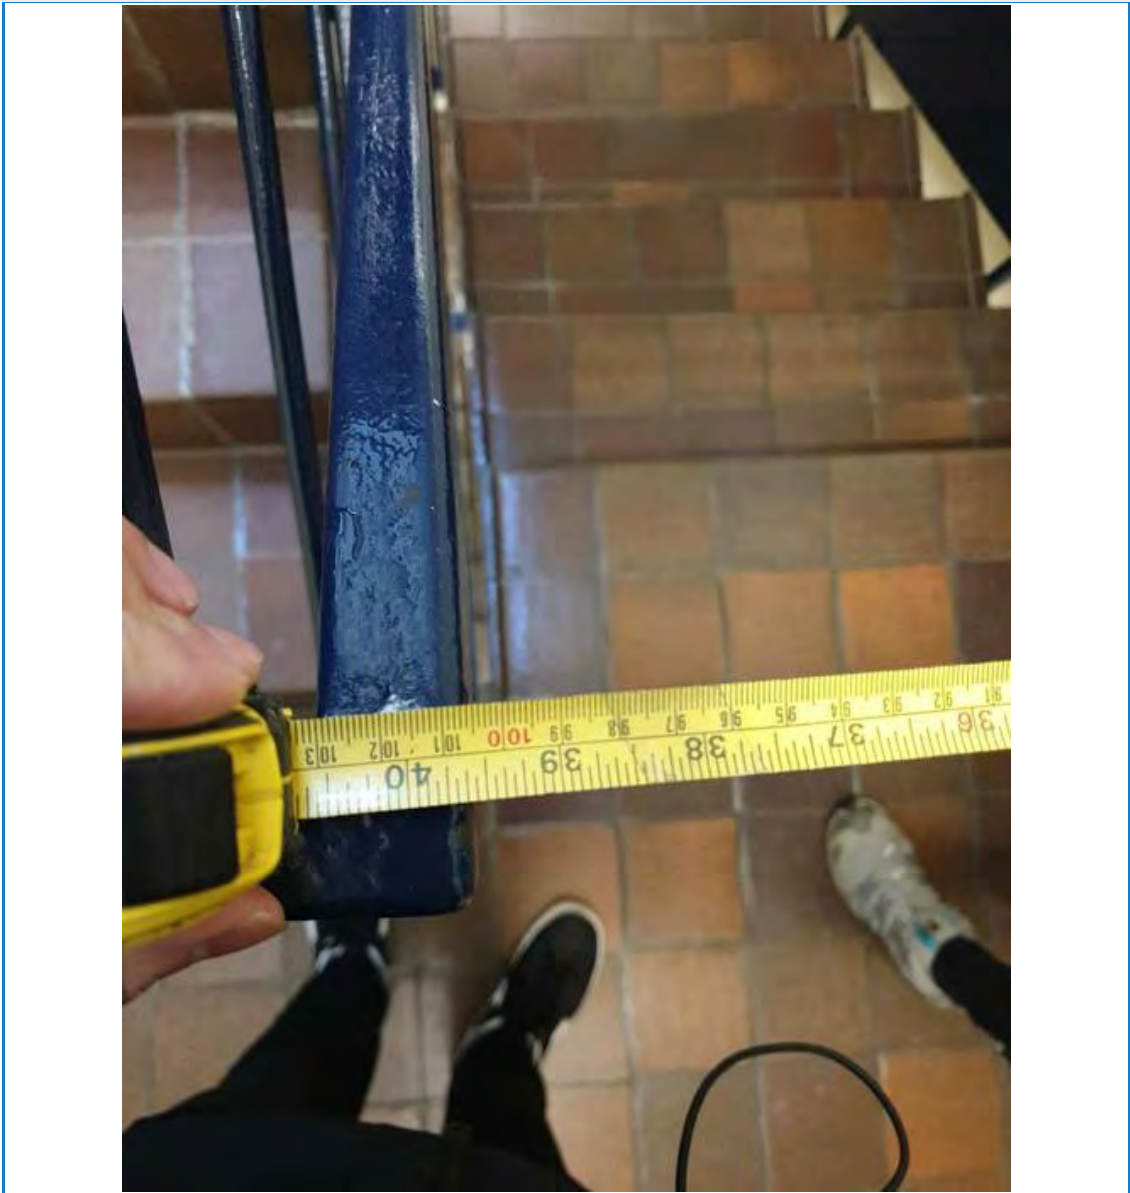
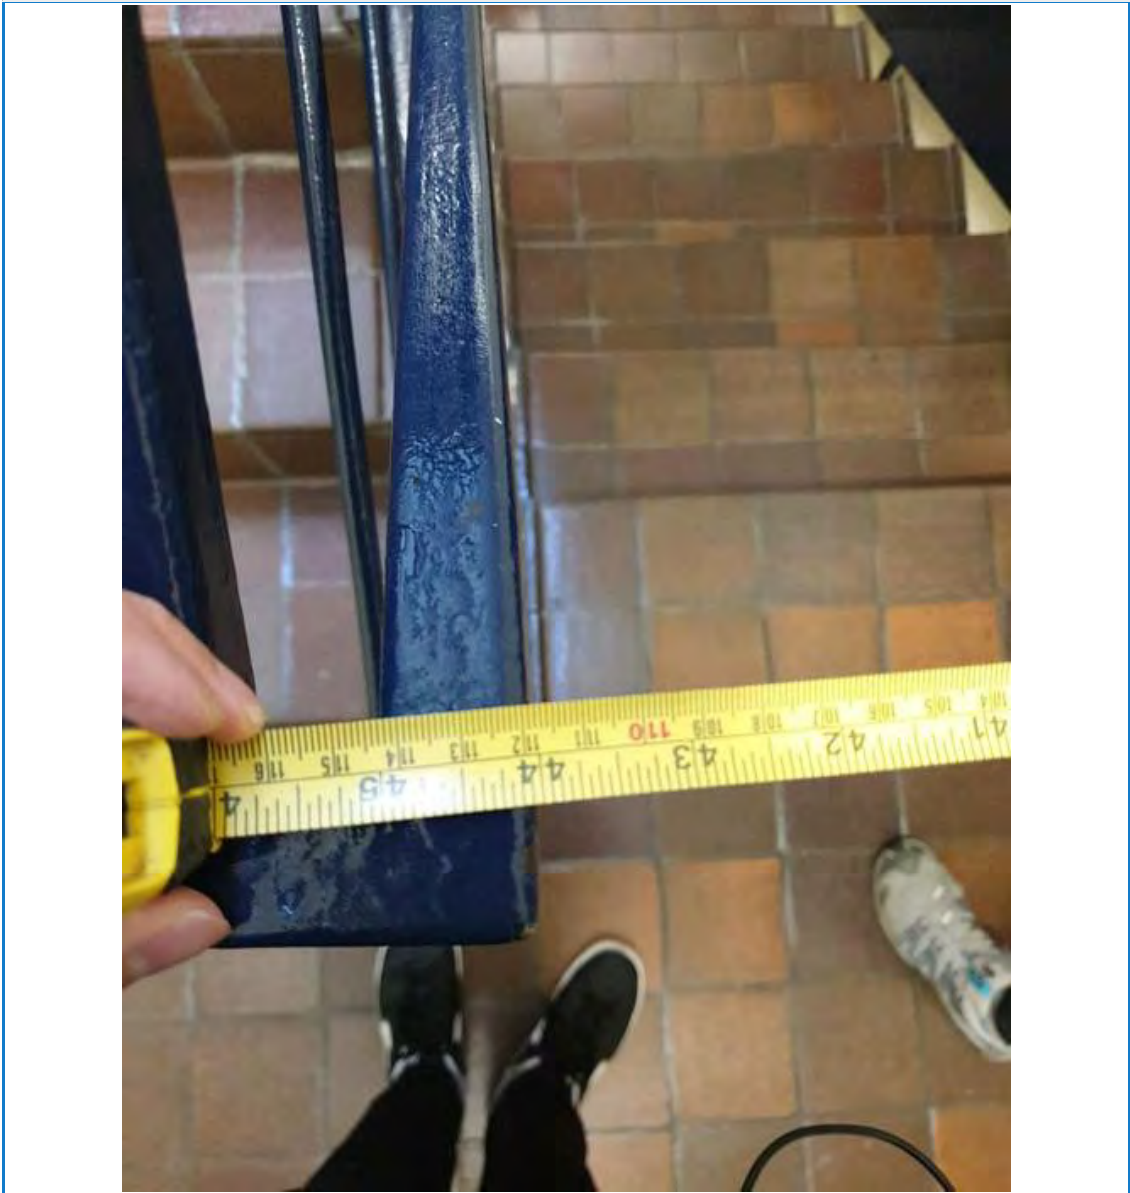
Title: sc24 width 1100mm
ID: 23
Created by: Arup Fire Plan Radar 9
Updated: 07/03/2022 03:08 PM
Date:
Compliant with the Fire Strategy?:No
Details:

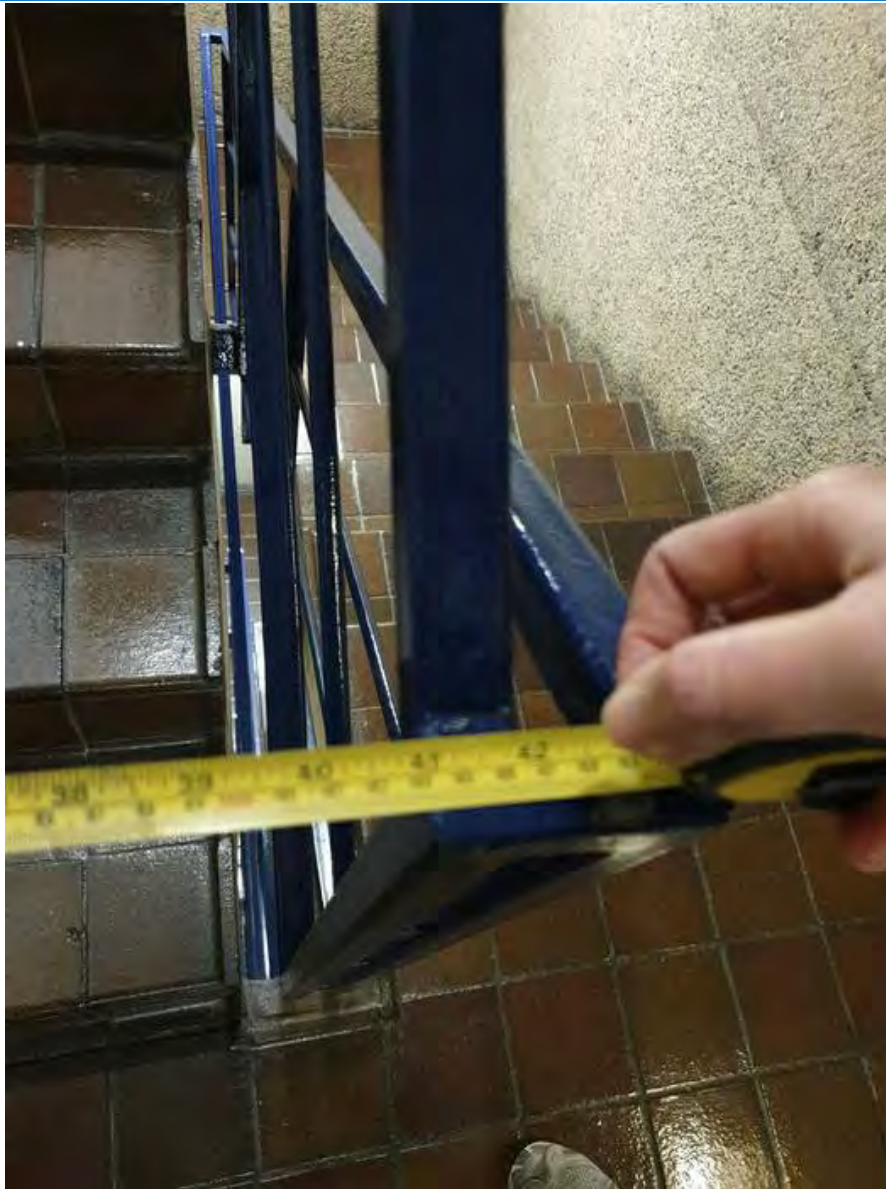
1. 07/03/2022 03:27 PM

Title: 1.03m staor 25
ID: 34
Created by: Arup Fire Plan Radar 9
Updated: 07/03/2022 03:27 PM
Date:
Compliant with the Fire Strategy?:No
Details:

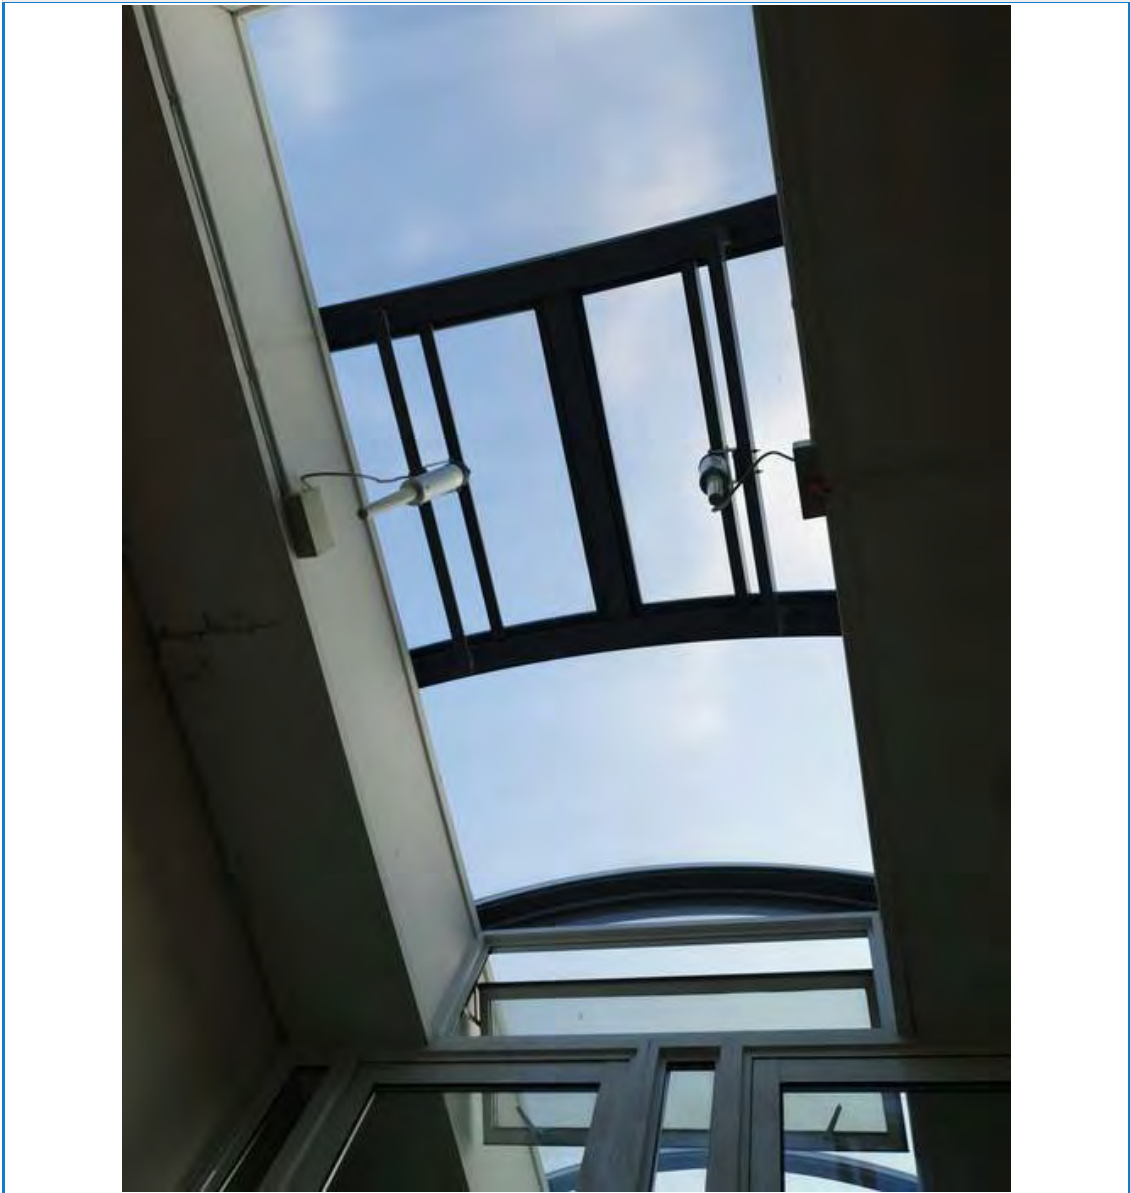
1. 07/03/2022 03:47 PM

Form: General	Title: Thomas More staircase 24 1. 2. top of the stair above I7 3. I7 permanently open vent door 1.5m by 0.55m
Layer: L7	ID: 38
Number of extensions: 0	Created by: Arup Fire Plan Radar 9
Created on: 07/03/2022 03:48 PM	Updated: 07/03/2022 03:48 PM
Updated by: Arup Fire Plan Radar 9	Date:
Time:	Compliant with the Fire Strategy?: No
Non compliant with the Fire Strategy: No	Details:

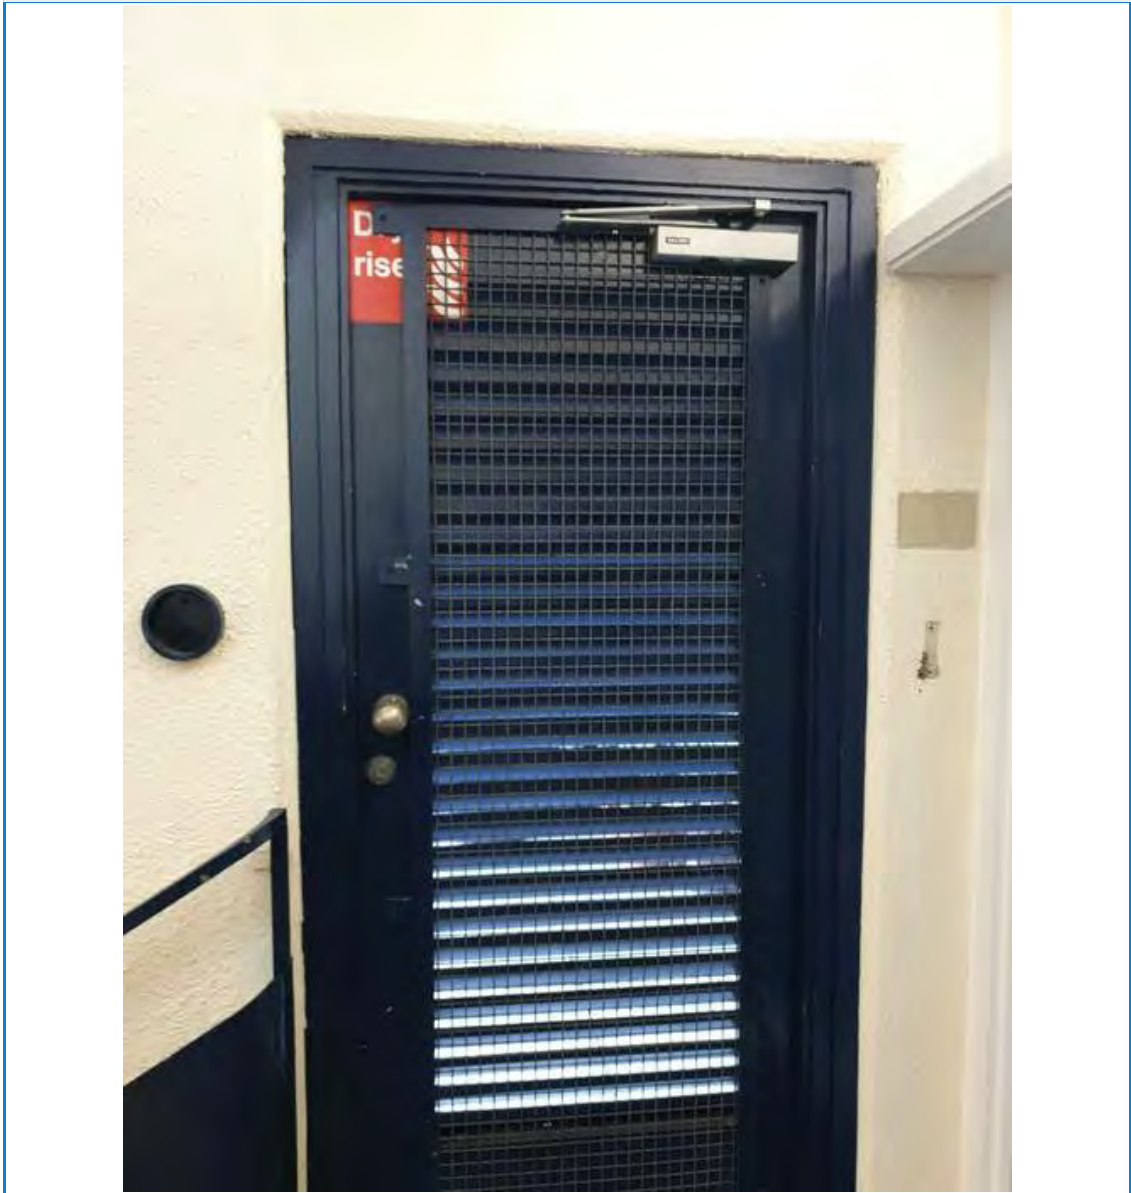
3. 07/03/2022 03:48 PM

Staircase 26 has a louvred door (louvre area is 1.5m x 0.55 m – unlikely to achieve 1m² free area) at the top of the stair that opens onto the external balcony. The lift is within the stair enclosure. A lobby separates the stair from the common corridor at each level. The lobby opens into a vent shaft at every level via an openable window as shown in Figure 18 (with Georgian-wired glass). Some of these windows were in the open position and will cause smoke to spread between the floors if smoke were to enter the lobby.
