Site Visit Report

Barbican Estates, London EC2Y 8EN

Specification Dulux Pyroshield Matt

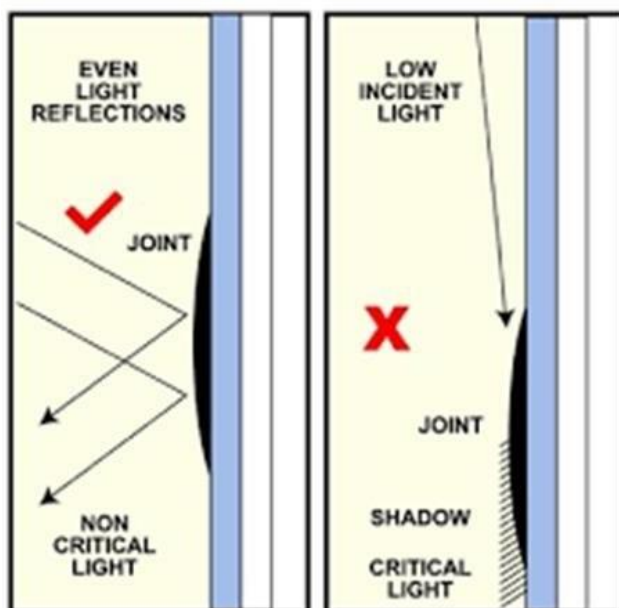
- Due to the lighting conditions and the surface profile of the walls & ceilings (not smooth & even due to repairs) this has caused the finish to look patchy in areas

Fig 1, Walls & ceiling affected by critical lighting
