Access Audit

Common parts of Petticoat Square
Artizan Street
London

Prepared on Behalf of
City of London

Date: 26th January 2022

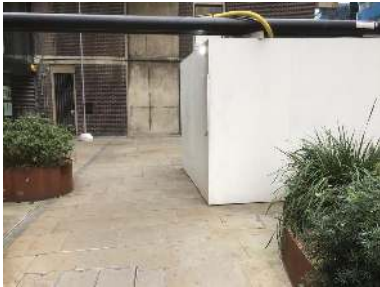
1.2	The temporary hoarding serving what we assume is temporary plant is not particularly well contrasted against the paving posing a risk of collision to some visually impaired users.	Apply contrasting markings at base and head level to hoarding	2	A

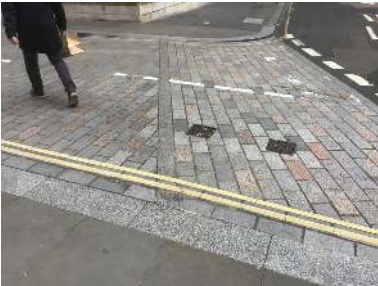
1.5	<p>Outdoor seating areas can pose a particular risk of collision to visually impaired person as they tend to be inconsistent with users bags and other items obstructing the pavement.</p> <p>As a result it is good practice to highlight these areas using contrasted paving or by requiring businesses to cordon off with temporary, well contrasted barriers.</p>	<p>Require tenants to cordon off seating areas</p>	2	Zero

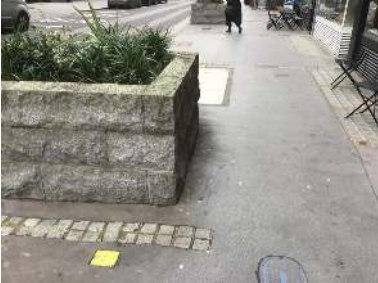
1.6	<p>The granite planters are poorly contrasted to their surroundings and thus a visually impaired person will be at risk of collision.</p> <p>Contrasting bands should ideally be applied around the head of the planters. A capping could achieve this but a better alternative may be to simply plant more colourful species.</p>	Improve contrast of planters	2	B

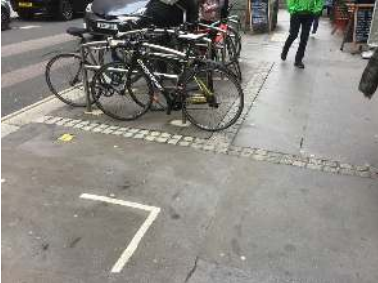
1.7	<p>Granite setts have been used to delineate and highlight cycle parking areas to Harrow Lane. These will provide a useful clue to visually impaired users but the introduction of a highly contrasted surface would improve this further.</p> <p>This will also apply to Gravel Lane. In this instance parking is well positioned between planters.</p>	Install high contrast surface to cycle parking areas	3M / 3R	B

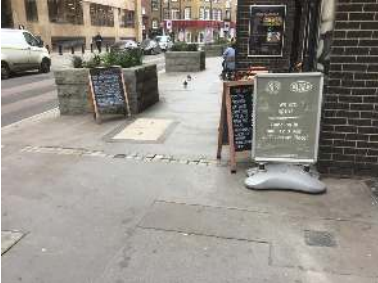
1.8	<p>Similar to outdoor seating A board signs can pose a risk of collision to visually impaired users.</p> <p>The signs in place during our visit were generally well contrasted and positioned clear of main pedestrian routes but their use should be controlled.</p>	<p>Require A boards to be kept clear of pavements</p>	2	Zero

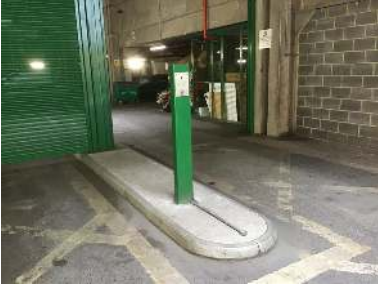
1.13	<p>We understand that there is no visitor parking within the car park.</p> <p>Flat occupants can rent spaces and it would be appropriate to discuss any individual requirements for these bays with the occupant rather than creating accessible bays in anticipation unless you create wheelchair accessible units in which case we would then suggest creating accessible bays to complement these.</p>

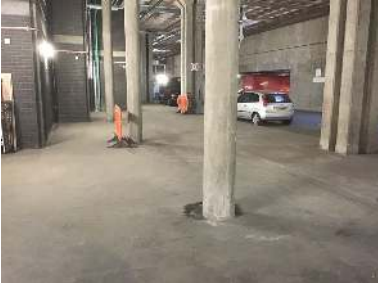
1.14	<p>The concrete columns to the car park are poorly contrasted to their surroundings and thus a visually impaired person will be at risk of collision.</p> <p>Contrasting bands of at least 150mm in depth should be applied at 1500mm above ground level.</p>	<p>Apply contrasting markings to concrete columns</p>	3R	A

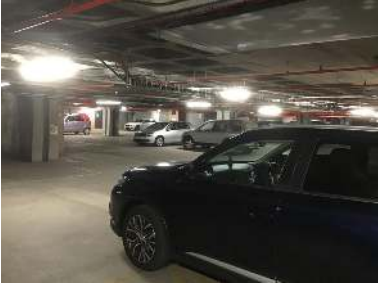
1.15	<p>Headroom to the basement car park is less than 2.2m when services are taken into account which would not be sufficient for many roof loading adapted vehicles.</p> <p>You already offer parking at ground floor which is a suitable alternative for a resident with roof loading vehicle.</p>

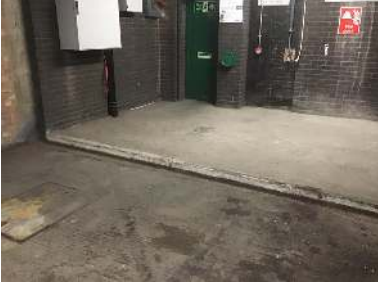
1.16	<p>There is stepped access to core 4. There is plenty of space to break this out and replace the step with a short ramp.</p> <p>We'd suggest you aim to achieve 1:21 which is considered a gentle slope for the purposes of best practice.</p>	<p>Form ramp access to core 4 from car park</p>	3R	B

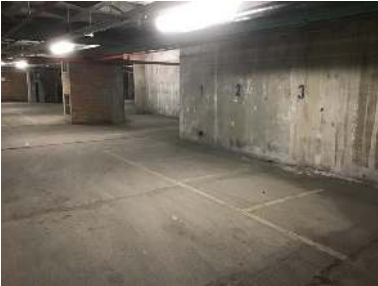
1.19	There is little if any contrast between wall and floor surfaces to the basement car park but given the nature of the environment and likelihood of a visually impaired person being here alone we consider there is little merit in addressing this.			
	2.0	Entrances

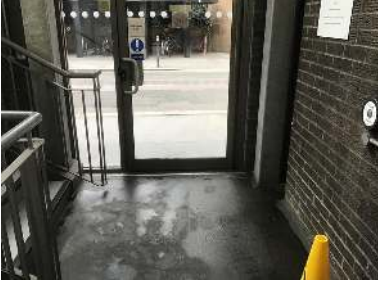
2.7	<p>Power assisted side hung doors can pose a risk of collision to a visually impaired user.</p> <p>Thus we suggest that the door swing zone is highlighted using a contrasted landing.</p>	Form contrasted landing to door swing zone	3R	A

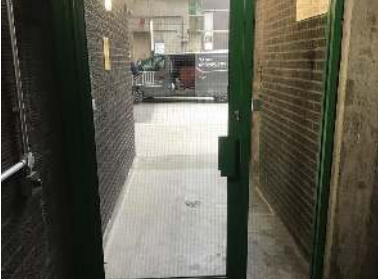
2.8	<p>The rear entrance door to no. 1 entrance is poorly manifested making it difficult to identify by a visually impaired user, putting him or her at risk of collision.</p> <p>Manifestation should be solid colour and be set at around 1500mm above floor level.</p>	Apply manifestation to entrance door	3R	A

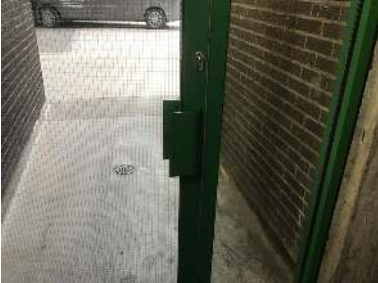
2.9	<p>The entrance door handle is also poorly contrasted against the door frame making it difficult to identify by a visually impaired person.</p> <p>New handles should be of a lever, bar or 'D' handle type and aim to achieve a 30 point difference in light reflectance value with the frame. Knob handles should be avoided.</p>	Fit new well contrasted door handle	3R	A

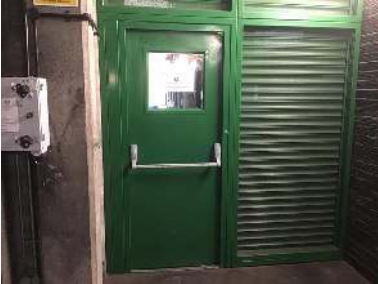
2.10	<p>Entrances tend to look very similar and we'd suggest some form of colour coding is rolled out when renewing entrance doors or signage to give an additional aid to orientation for a visually or mentally impaired user.</p>	Colour code entrances	3R	Info

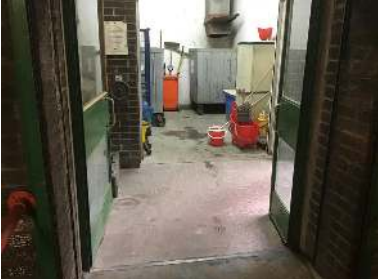
2.14	<p>Doors to this entrance appear to be permanently held open.</p> <p>The slave leaf does pose some risk of collision to a visually impaired user but is well contrasted.</p>

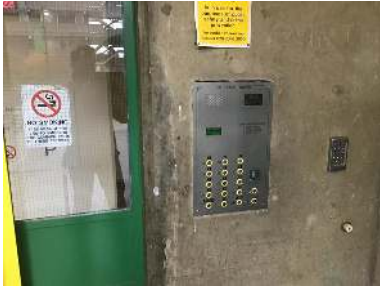
2.18	<p>It is not clear whether the intercoms incorporate inductive couplers which would then transmit audio direct to a users hearing aid.</p> <p>If not in place this should be rolled out when replacing these units.</p>	Fit inductive couplers to intercoms	3R	B

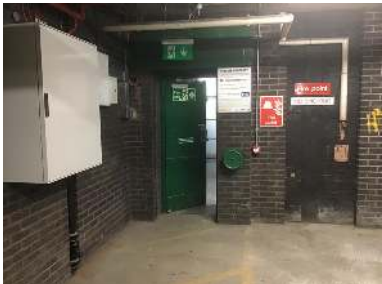
3.8	Lift cores are poorly signed from the basement and ground floor car parks and whilst residents will likely be familiar with the layout a simple sign over each exit point would be of benefit to all but particularly someone with learning difficulties or a mental impairment.	Install signs over car park exits	3R	B

To the basement area this should include directional signage on route as this is a particularly confusing space. Colour coding of entrances and signage will again help orientation.

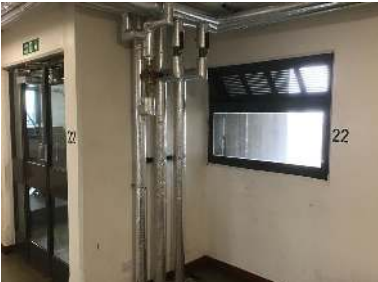
3.9	<p>Stencilled floor level signs are used to the tower. These are relatively effective but would be easier to locate by a visually impaired user if mounted on a well contrasted back board but given the likely familiarity of users this is not a high priority.</p> <p>However when replacing finishes or decorating the tower lift lobbies we do suggest you aim to introduce some individuality to make it easier for users to discern which floor they are on such as alternating floor colour by odd and even floor numbers.</p> <p>You have allowed residents to install artwork to some floors which would also provide a useful clue.</p>

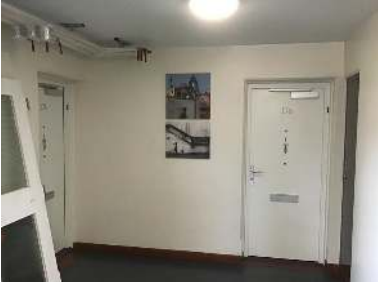
3.10	<p>At podium level of the tower the stairs do not extend down to the lower floors.</p> <p>We suggest signage is installed here to confirm this and indicate alternative stair access to the lower floors.</p>	<p>Install sign at podium tower core indicating alternative stairs to lower levels</p>	3R	A

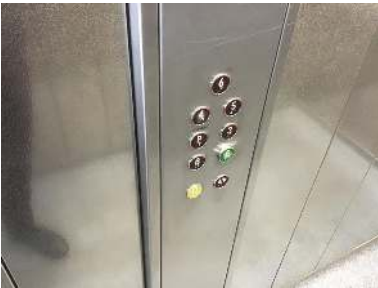
4.1.2	The control panels could be better contrasted against the lift walls making them more difficult to locate by a visually impaired person.	Fit well contrasted control panels	3R	C

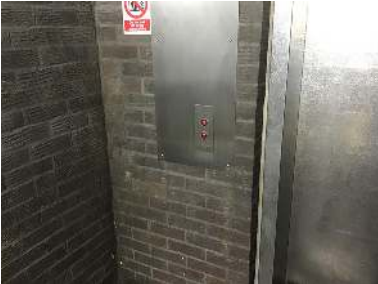
4.2.1	<p>Lift call points could be better contrasted against wall surfaces when mounted direct or into stainless steel plate making them difficult to locate by a visually impaired person.</p> <p>Where they are mounted against directory signs they are well contrasted.</p>	<p>Install signage or apply contrasting markings to call points to highlight their position</p>	3R	A

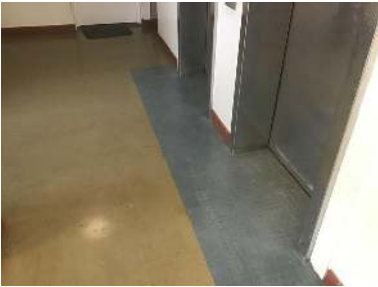
4.7	<p>A textured and contrasted vinyl is used to the tower lift thresholds. This may prove a useful clue for a visually impaired user and should be maintained on re-covering and perhaps even extended but take care to avoid very dark colours which may appear as a hole in the floor to some visually and mentally impaired users.</p>

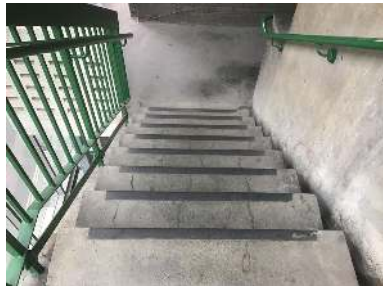
5.1	<p>The stair nosings achieve adequate contrast where the stairs are clean and well lit but where soiled, in shade or poorly lit they lose their efficacy making it very difficult for a visually impaired person to identify the step edges thus posing a significant trip hazard.</p> <p>Nosings should achieve a 30 point difference in light reflectance value to the treads and risers.</p>	Fit lighter nosings	3R	D

In the longer term lighter nosings would likely achieve a more sustainable solution.

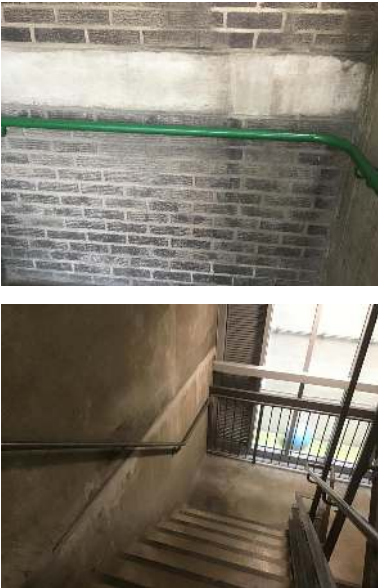
5.3	<p>Stairs generally have handrails of a suitable profile to either side providing a good means of support for a mobility impaired user and visual clue of the flights.</p> <p>The green colour to the podium and grey to the tower could achieve better tonal contrast against the walls by using a lighter tone.</p> <p>When repainting we'd suggest you consider a different colour to each stair consistent with the colour coding of entrances as set out previously which will give a useful wayfinding clue to a visually or mentally impaired user.</p>	<p>Paint handrails in contrasting colour</p>	3R	Zero
	5.4	<p>Ideally handrails would be warm to the touch as cold rails will prove difficult to grip by some users with sensitive hands such as someone with arthritis but in this setting the low maintenance steel rails do seem appropriate.</p>

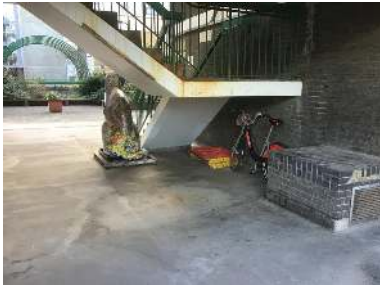
5.8	<p>The open bulkhead to the stairs in the podium cycle park area poses a risk of collision to a visually impaired user who may scan the ground for obstacles so be unaware of obstructions at high level.</p>	Guard bulkhead up to head level	3R	A

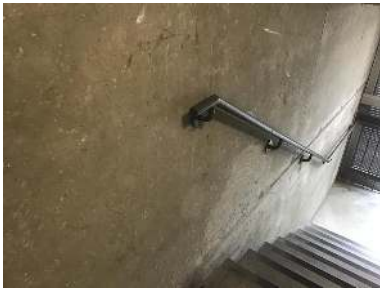
5.10 Ideally handrails should turn down at the ends to prevent catching sleeves but this is only a matter to consider if replacing the rails anyway.

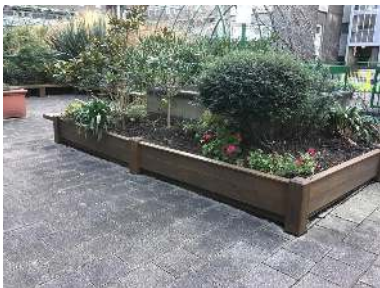
6.1 We assume that you maintain the raised planters.

If residents were allowed to cultivate these raised planters with kneespace would allow ease of access by wheelchair users.

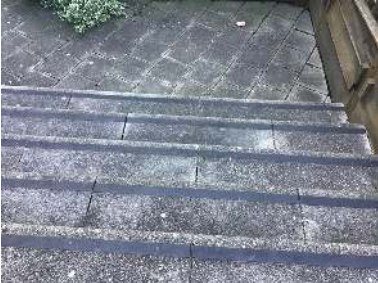
6.4	<p>Nosings to the external steps are losing their efficacy due to soiling of the steps posing a trip hazard to all but particularly a visually impaired user.</p>	Deep clean steps	2	A

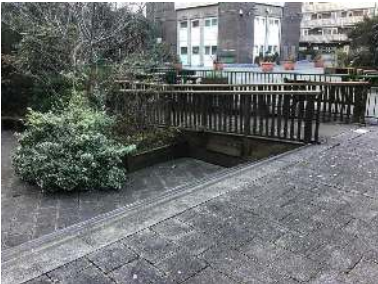
6.5	<p>The external steps to the lower level are not fitted with any handrails and thus there is no means of support for an elderly or mobility impaired person, putting these users at increased risk of accident.</p>	<p>Fit new handrails to either side of steps or single central rails</p>	3R	B
		<p>Handrails should be fitted to either side to provide a means of support when going up or down to a user with no strength or mobility to one side of the body such as an amputee.</p>			
		<p>New rails should ideally be tubular and between 40-50mm in diameter so that they are easy to grip and should extend a minimum of 300mm beyond the top and bottom steps so they can be gripped before mounting or dismounting the steps.</p>

<p>The new rails should also be well</p>

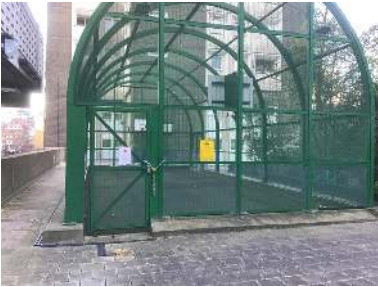
6.8	The MUGA was closed during our inspection but we see no reason this should not be accessible to all.

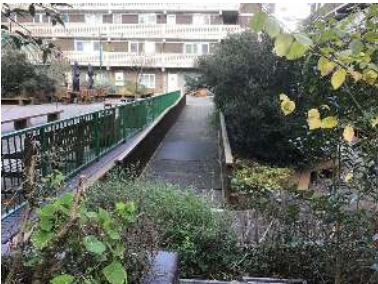
6.9	<p>Lighting to the external steps and ramp is likely to be poor given the type, number and location of light fittings, making it more difficult for a visually impaired user to identify key features such as step edges, level changes and handrails.</p> <p>In this location best practice recommends that a lux level of 30lux is achieved at step level.</p>	Install lighting to ramp and steps	3R	B

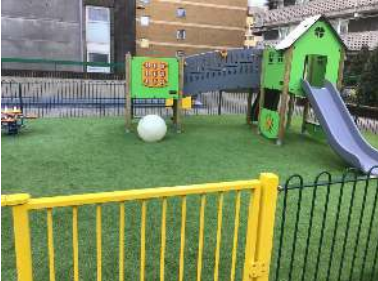
6.11	<p>Play equipment is colourful with activities at low and high level and seems appropriate for setting.</p> <p>Ideally a level access roundabout or the like would be offered but the solid deck will pose a practical constraint to this.</p>

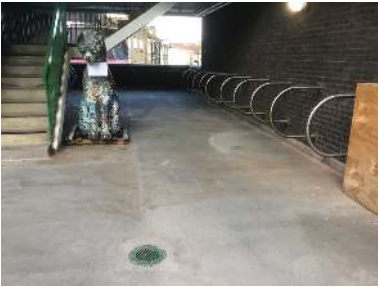
6.12	<p>The bike store does not seem to be used. It is well sited clear of main pedestrian routes but in the longer term we do suggest you use a contrasted marking/ floor paint at the entry to this area to give a means of warning to a visually impaired user.</p>	<p>Apply contrasting markings at entrance to cycle parking area</p>	3R	A
<p>7.0 Horizontal Circulation</p>

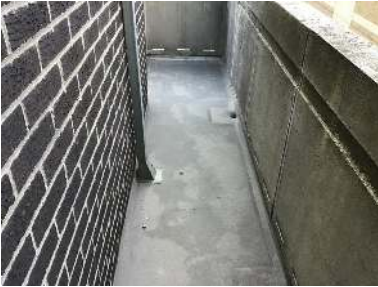
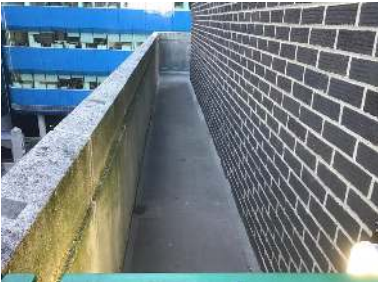
7.1	<p>Some walkways are relatively narrow at around 790mm pinching down to as little as 710 in some areas.</p>

<p>Gates narrow to as little as 640mm.</p> <p>This may make these walkways difficult to access by wheelchair users. There is no practical adjustment but this restriction should be recognised when formulating PEEPS for disabled residents.</p>

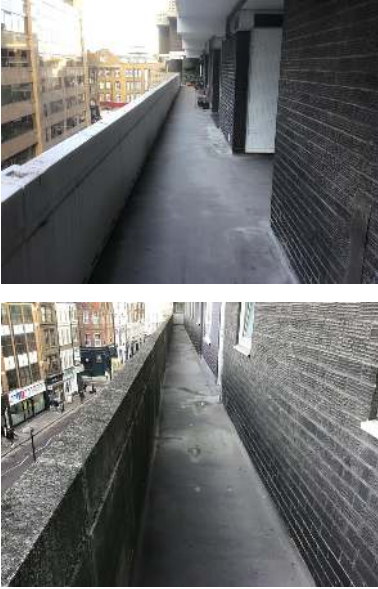
7.3	<p>Main walkways generally achieve an adequate clear width of around 1500mm widening to well in excess of 1800mm at entrances which is sufficient for two wheelchair users to pass.</p> <p>Some residents have sited benches, pots and other objects on the walkway do narrow the effective width. However these objects will act as useful waymarkers for users with a mental impairment such as someone with dementia.</p>	<p>Provided these obstructions are not continuous and a clear width of at least 900mm is maintained we do not consider them to pose a significant barrier.</p> <p>Whilst some walkways narrow to around a metre, making passing difficult there is no practical alteration.</p>

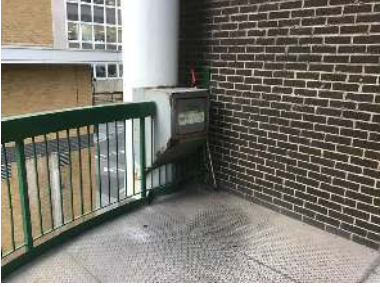
7.6	<p>Rubbish chutes to the Podium are generally set at a suitable height but do require a fair amount of force to operate which may make them difficult to use by some disabled users.</p>	Offer collection service to disabled users	4	Zero

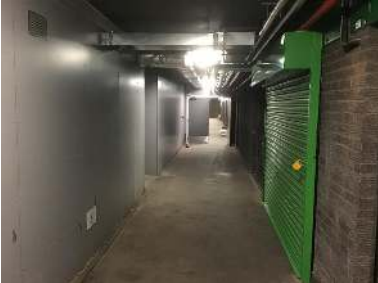
7.7	<p>Lighting is poor to the lobby and corridor linking core 4 to the ground floor car park with lux levels as low as around 25lux noted at floor level.</p> <p>Lighting is also poor to the core 2 entrance point.</p> <p>This will make it more difficult for visually impaired users to navigate the space and</p>	Upgrade light levels to achieve 100lux at floor level	3R	B

<p>avoid obstacles, obstructions and other users.</p>

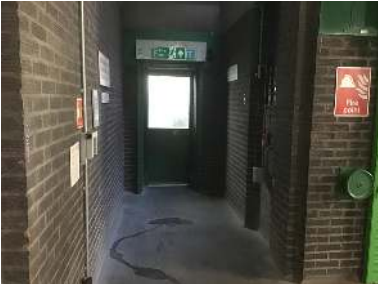
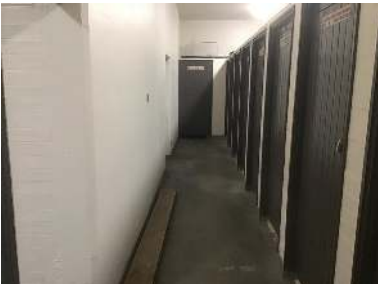
7.8	<p>Lighting is poor to the shed corridors with lux levels as low as around 30lux noted at floor level.</p> <p>This will make it more difficult for visually impaired users to navigate the space and avoid obstacles, obstructions and other users.</p>	<p>Upgrade light levels to achieve 100lux at floor level</p>	3R	B

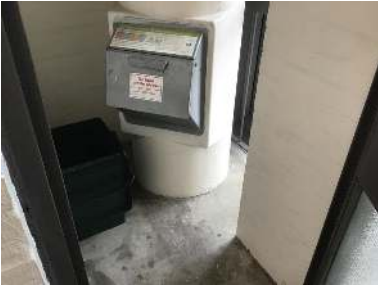
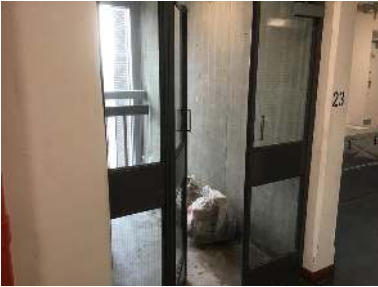
7.9	<p>Access to the refuse chutes in the tower will likely prove difficult for a wheelchair, crutch or frame user due to the restricted door widths on route and lack of manoeuvring space around the chute.</p> <p>To improve access it would be necessary to replace the double lobby doors, which achieve a clear width of only 515mm to one leaf with a single doorset but access to the chute is still likely to prove problematic unless the lobby to the chute can be removed.</p> <p>We assume the lobby is there for fire compartmentation but suggest this is investigated.</p> <p>If this cannot be altered it may be appropriate to provide a collection/ assistance service for disabled residents.</p>	<p>Review access to refuse chutes in tower</p>	<p>3R / EXP</p>	<p>E</p>

Photo	Item	Issues	Recommendations	P	£
		<p>It appears that residents are already leaving bagged rubbish in the lobbies although we assume this is not in accordance with policy as will likely pose a fire risk.</p>

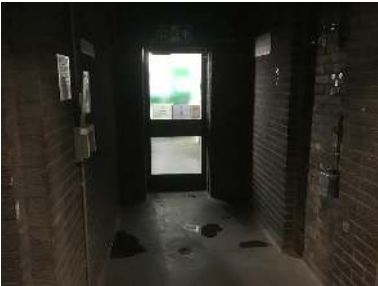
8.7	<p>Whilst this may deal with levels from Podium upwards this would not apply to the shed and basement car park levels.</p> <p>We suggest refuges are designated to</p>	<p>Designate refuges to lower floor levels</p>	1	D

<p>9.0</p> <p>9.1</p>	<p>these levels in consultation with the Local Fire Service. Ideally these refuges should be fitted with intercoms to allow users waiting in a refuge to communicate with the chief fire marshal or fire service.</p> <p>They should also be clearly signed with unique references in order that users can clearly communicate their location.</p> <p>Lift lobbies typically achieve sufficient space to create a refuge area clear of the main escape route.</p> <p>Internal Doors</p> <p>Doors from lift cores to ground floor car park achieve a clear width of 785mm.</p>	<p>Best practice now recommends that all internal doors achieve a clear width of at least 800mm. Clear width is measured between door stop and the face of the door when held open.</p>		
		<p>We consider the doors to be within a reasonable margin of best practice standards and likely accessible by most wheelchair users. We find it unlikely it would be considered reasonable to widen the doors in the short term and suggest</p>

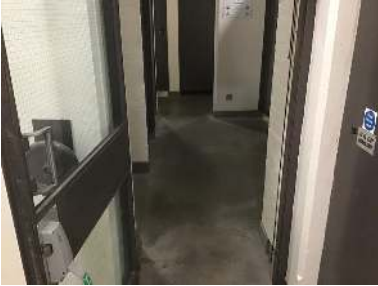
9.2	<p>this issue be addressed when next replacing the door sets.</p> <p>Doors to the storage sheds achieve a clear width of 780mm.</p>	<p>Best practice now recommends that all internal doors achieve a clear width of at least 800mm. Clear width is measured between door stop and the face of the door when held open.</p>

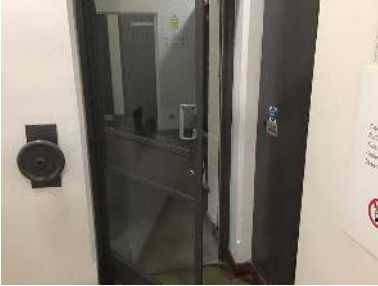
9.3	<p>We consider the doors to be within a reasonable margin of best practice standards and likely accessible by most wheelchair users. We find it unlikely it would be considered reasonable to widen the doors in the short term and suggest this issue be addressed when next replacing the door sets.</p> <p>There is insufficient space to the side of the opening edge of the ground floor shed entrance door to allow a wheelchair user to sit to one side and comfortably pull the door open past his or her chair.</p>	<p>Best practice recommends a space of at least 300mm in width but there is an alternative door to the same space which achieves this.</p>

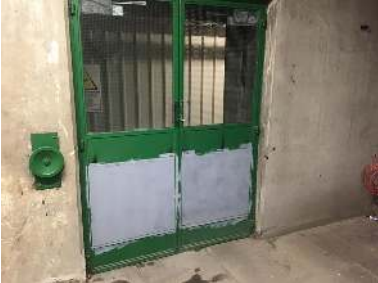
9.5	<p>The double doorsets on route from the basement car park to tower core achieve a clear width of as little as 515mm through a single leaf.</p> <p>This will make them very difficult to operate by many wheelchair users, thus in the longer term we recommend that these double door sets are replaced with door and a half sets to achieve a minimum 800mm clear width through a single leaf.</p> <p>Alternatively, they could be held open on</p>	<p>Replace basement lobby doors with door and a half sets</p>	3R / 3M	C

<p>magnetic catches linked to the fire alarm but then they would still present a hazard in a means of escape situation and given the age of door it would seem more logical to replace them.</p>

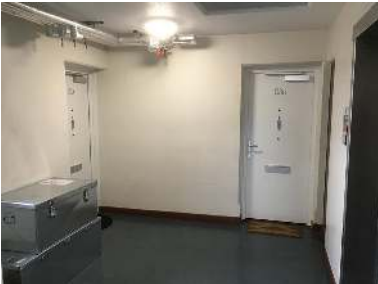
9.6	<p>Flat entrance doors to the tower in particular tend to be poorly contrasted against wall surfaces making the openings difficult to identify by a visually impaired person. The anonymous nature of the openings may also prove confusing to a resident with a mental impairment.</p>	<p>This can be addressed by painting the walls, architraves or doors in a contrasting colour.</p> <p>A 30 point difference in light reflectance values of adjacent surfaces should be achieved. These values are readily available from paint suppliers.</p> <p>This is a matter to be dealt with reactively in this setting and the painting of doors would likely prove a reasonable adjustment upon request by a resident.</p>

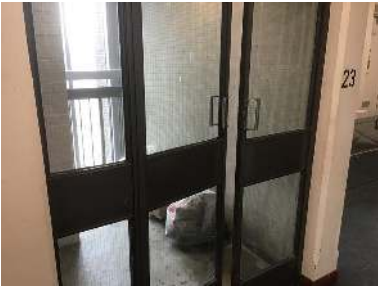
9.7	<p>Stair lobby doors to the tower achieve a clear width of only 515mm through a single leaf.</p> <p>This will make them very difficult to operate by many wheelchair users, thus in the longer term we recommend that these double door sets are replaced with door and a half sets to achieve a minimum 800mm clear width through a single leaf.</p> <p>As these doors only serve the chutes an interim measure may be to assist disabled residents unless these areas are proposed to be used as refuges in which case we would give their replacement a higher priority.</p>	Replace stair/refuse lobby doors with door and a half sets	3R	E

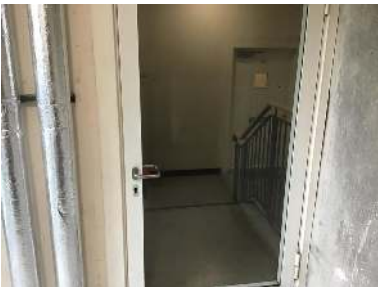
9.8	<p>The tower stair lobby doors at level 3 are poorly manifested making them difficult to identify by a visually impaired user, putting him or her at risk of collision.</p> <p>Manifestation should be solid colour and be set at around 1500mm above floor level.</p>	Apply manifestation to lobby doors	3R	A
