Crescent House
Planning & Transportation Committee

Crescent House

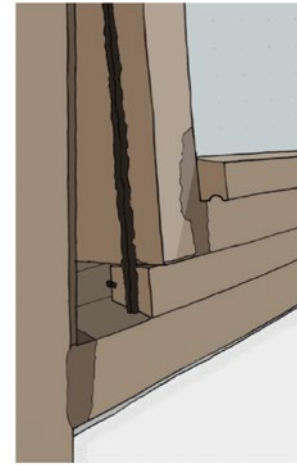
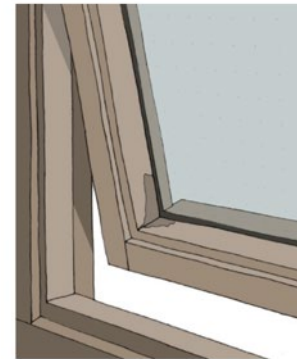
- ① **Minor Repairs**
Small areas of degradation will be repaired using two-part resin to infill the damaged area.

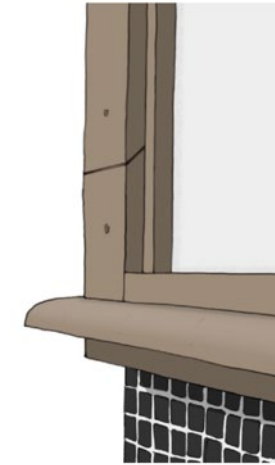
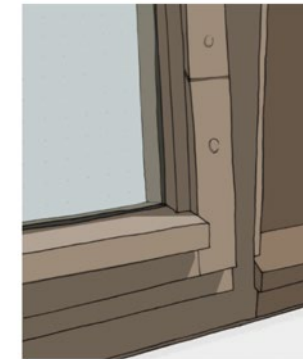
- ② **Small Sections**
Where there are short sections of degraded timber, a new section of timber will be spliced in.

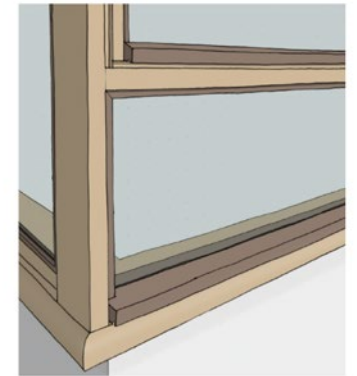
- ③ **Extensive Repairs**
Where the degradation extends along a significant portion of the timber, the whole length will be replaced with a new section of timber. This also applies where a section of timber is missing. Where frames/casements are degraded to such an extent that they cannot be repaired effectively, they will be replaced with a like-for-like replacement.

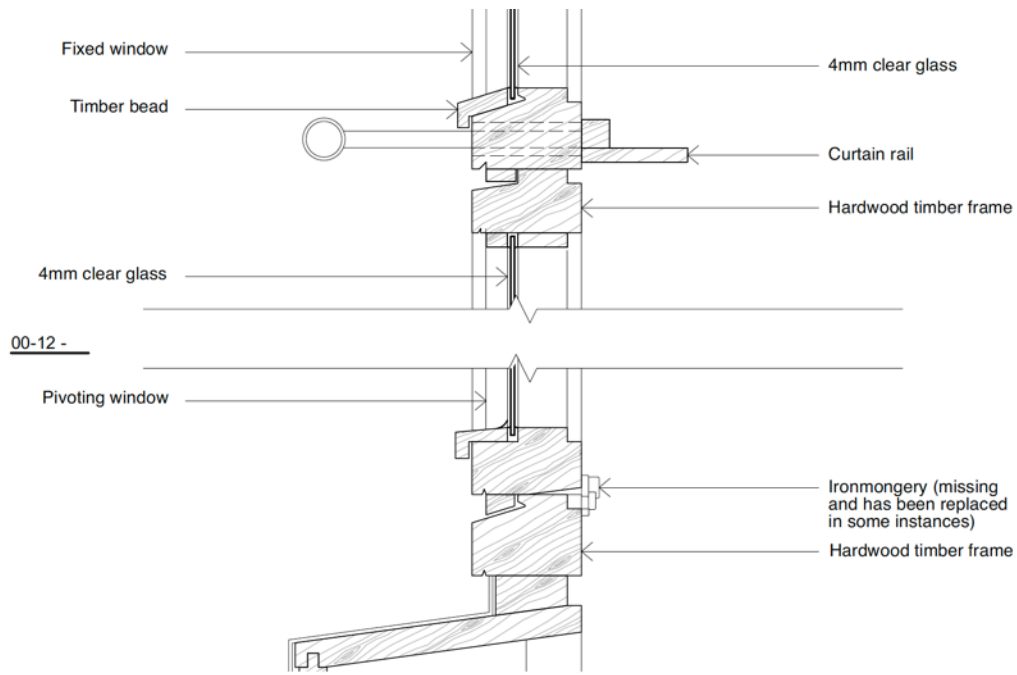
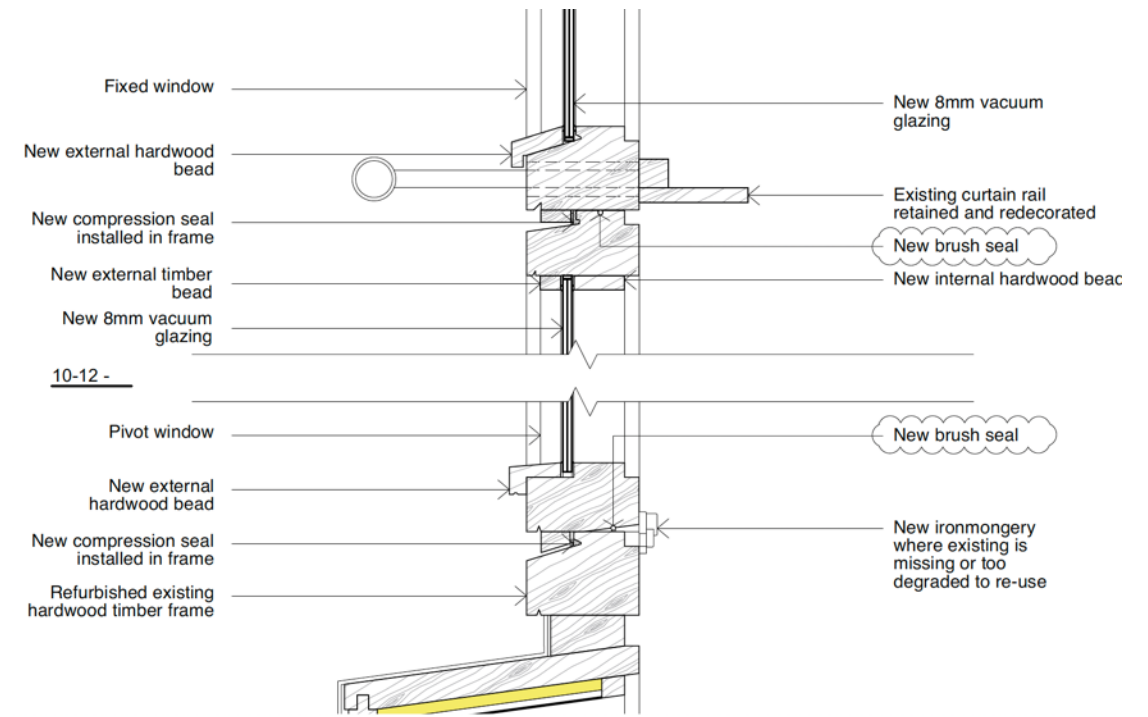
Existing window with single glazing

Proposed window with VIG

VIG can be installed into existing timber window with no adaptations required to the rebates in the window frames. Existing external sapele beads will be replaced with new sapele beads. Brush and compression seals will be installed into the opening window frames.

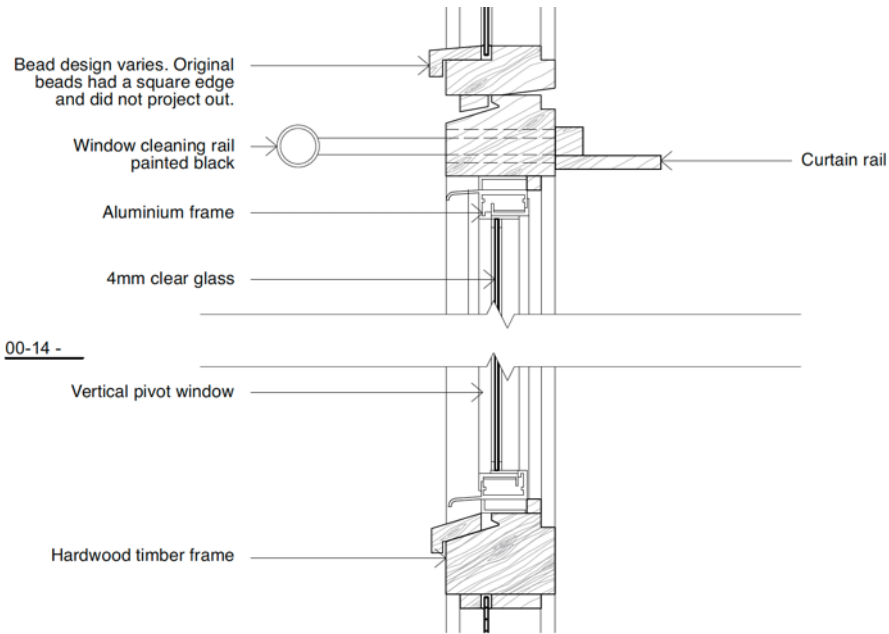
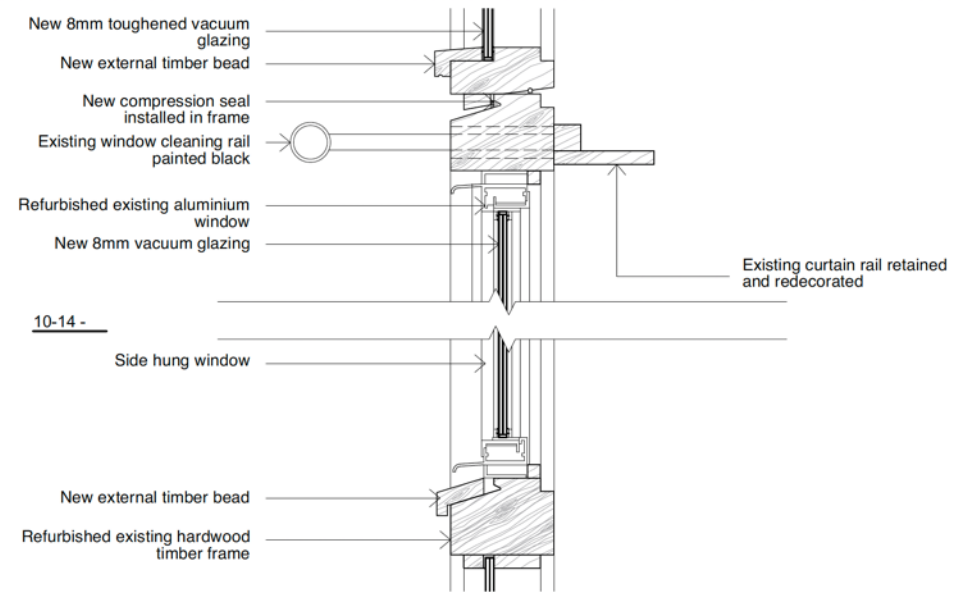
Existing window with single glazing

Existing window with VIG installed

VIG can be installed into the vertical pivot window with no adaption required to the frame.

The existing frame will be cleaned and re-anodized (the original finish).

New compression seals will be installed into the frame.

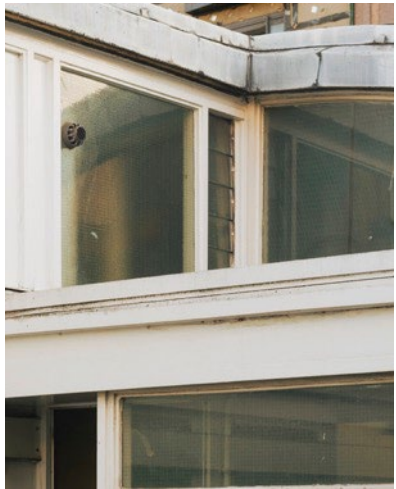
The existing jalousie window is a significant route for heat loss in the home. It is proposed to remove and replace with a fixed panel of VIG.

The BRE testing data shows the air leakage through this window (when closed) accounts for 18% of the measured air leakage from the entire property.

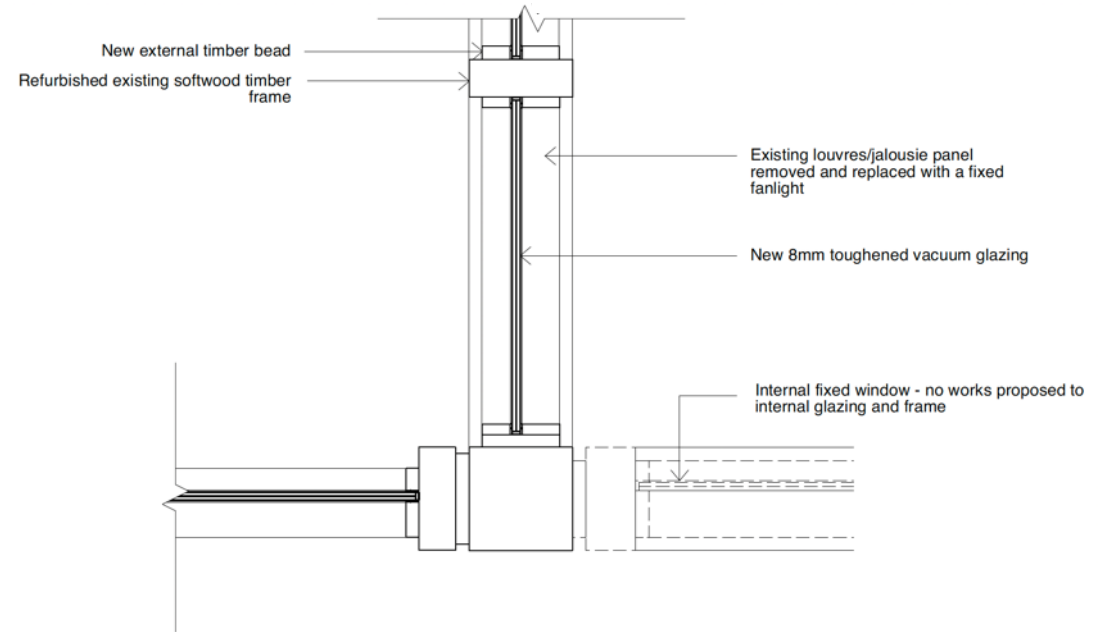
Proposed fixed light with VIG installed

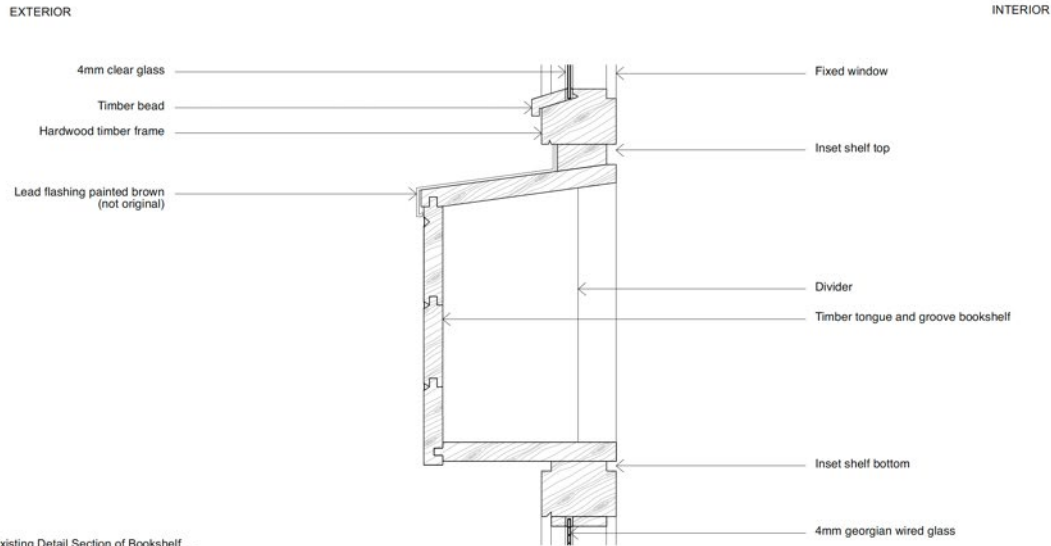
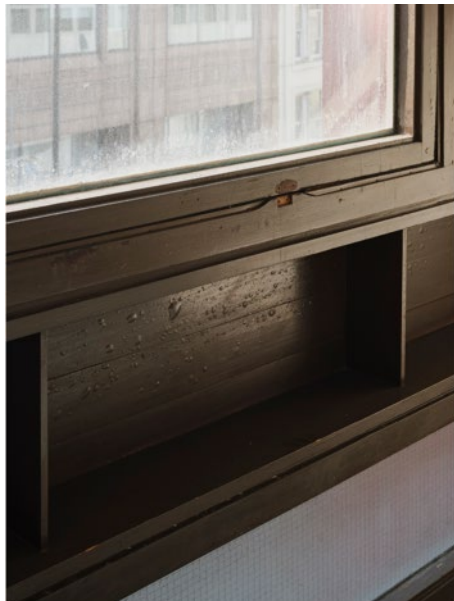
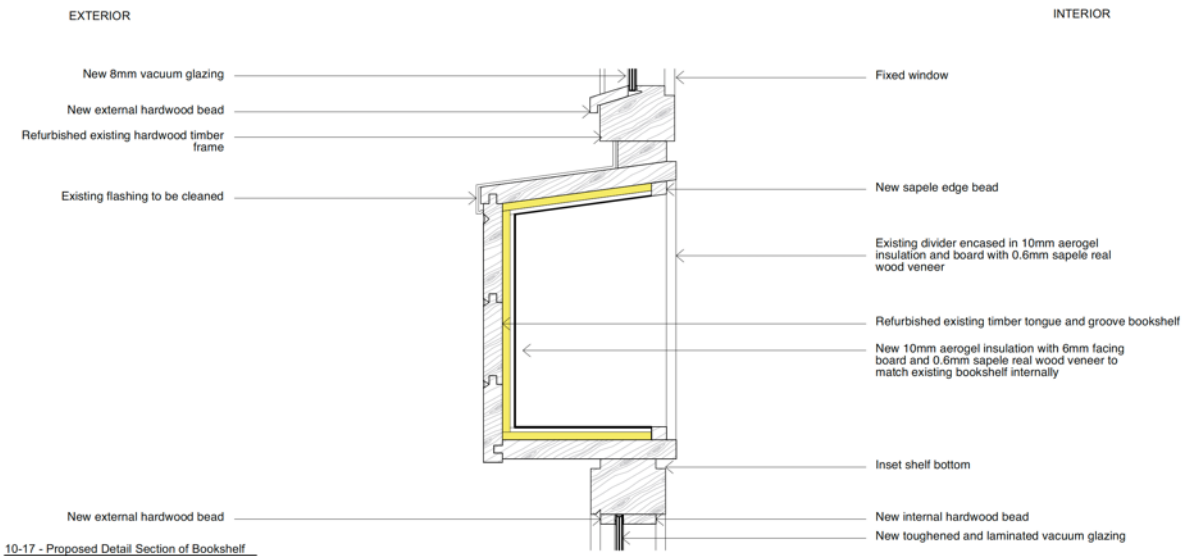
Existing

It is proposed to line the internal face of the bookshelf with a 10mm aerogel insulation, 6mm facing board, and a sapele veneer. The proposal aims to reduce the risk of condensation forming in the bookshelf.
