THE TEMPLE, WANSTEAD PARK
VOLUME 03: CONDITION, MECHANICAL AND ELECTRICAL, AND STRUCTURAL SURVEYS
FINAL ISSUE
MARCH 2024

THE TEMPLE, WANSTEAD PARK: CONDITION, MECHANICAL AND ELECTRICAL, AND STRUCTURAL SURVEYS

CONDITION SURVEY 04

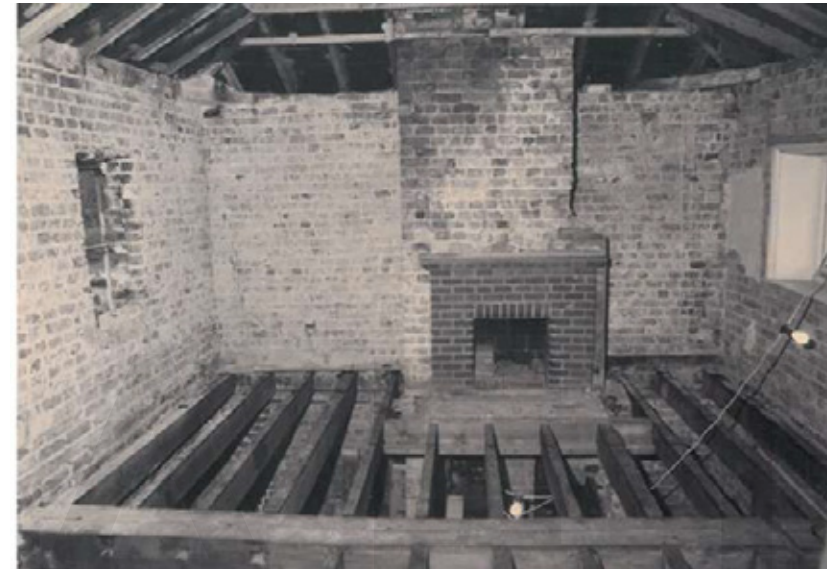
Record photo from 1990. First floor north wall

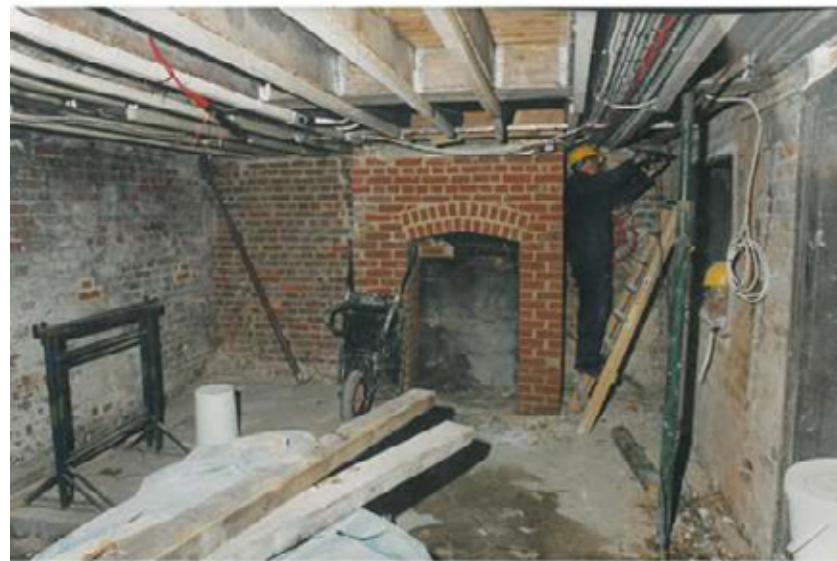
Undated record photo (assumed 1990) at ground floor, north wall, showing work to first floor joists

Structural repairs, including work to the first floor joists and elbow ties to enhance the bond of masonry walls were carried out around 1990 as part of a major refurbishment of the building. There are local hairline cracks to some internal wall finishes at first floor level which are not currently of structural significance. The cracks can be visually monitored by the building occupier so that any significant changes are identified and investigated at an early stage.

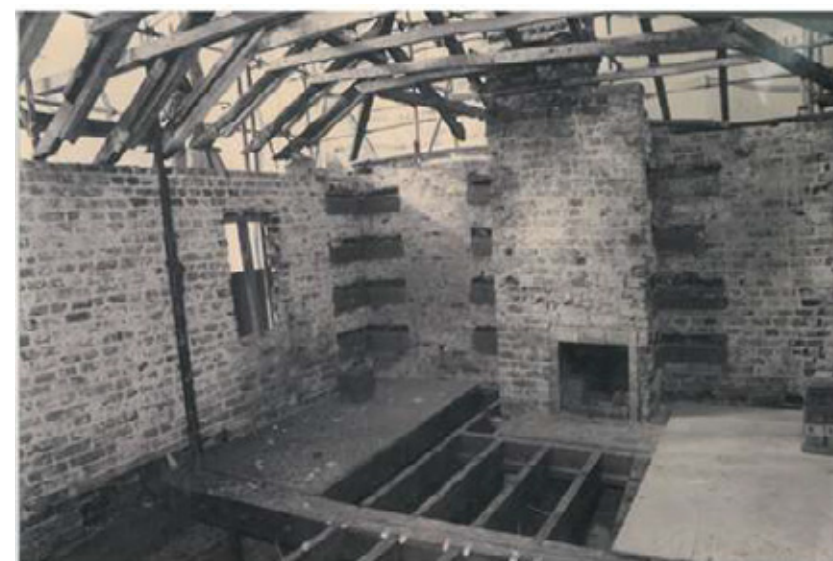
Record photo from 1990. First floor, north and west walls showing elbow ties

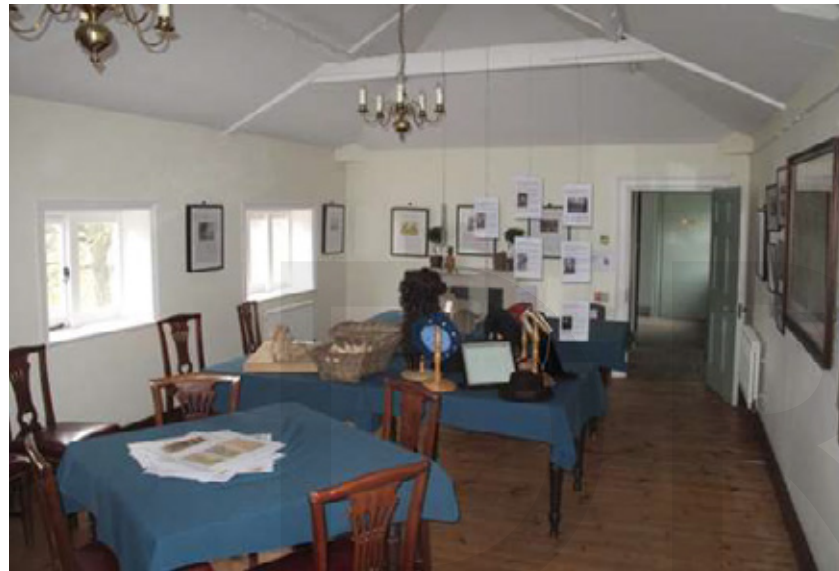
5. Upper ground floor, looking south
