# **Planning Applications Sub-Committee**

4. **CRESCENT HOUSE, GOLDEN LANE ESTATE, LONDON, EC1Y 0SL**  
Report of the Planning & Development Director.
5. **CRESCENT HOUSE GOLDEN LANE ESTATE LONDON EC1Y 0SL - LISTED BUILDING CONSENT**  
Report of the Planning & Development Director.

# **Crescent House**

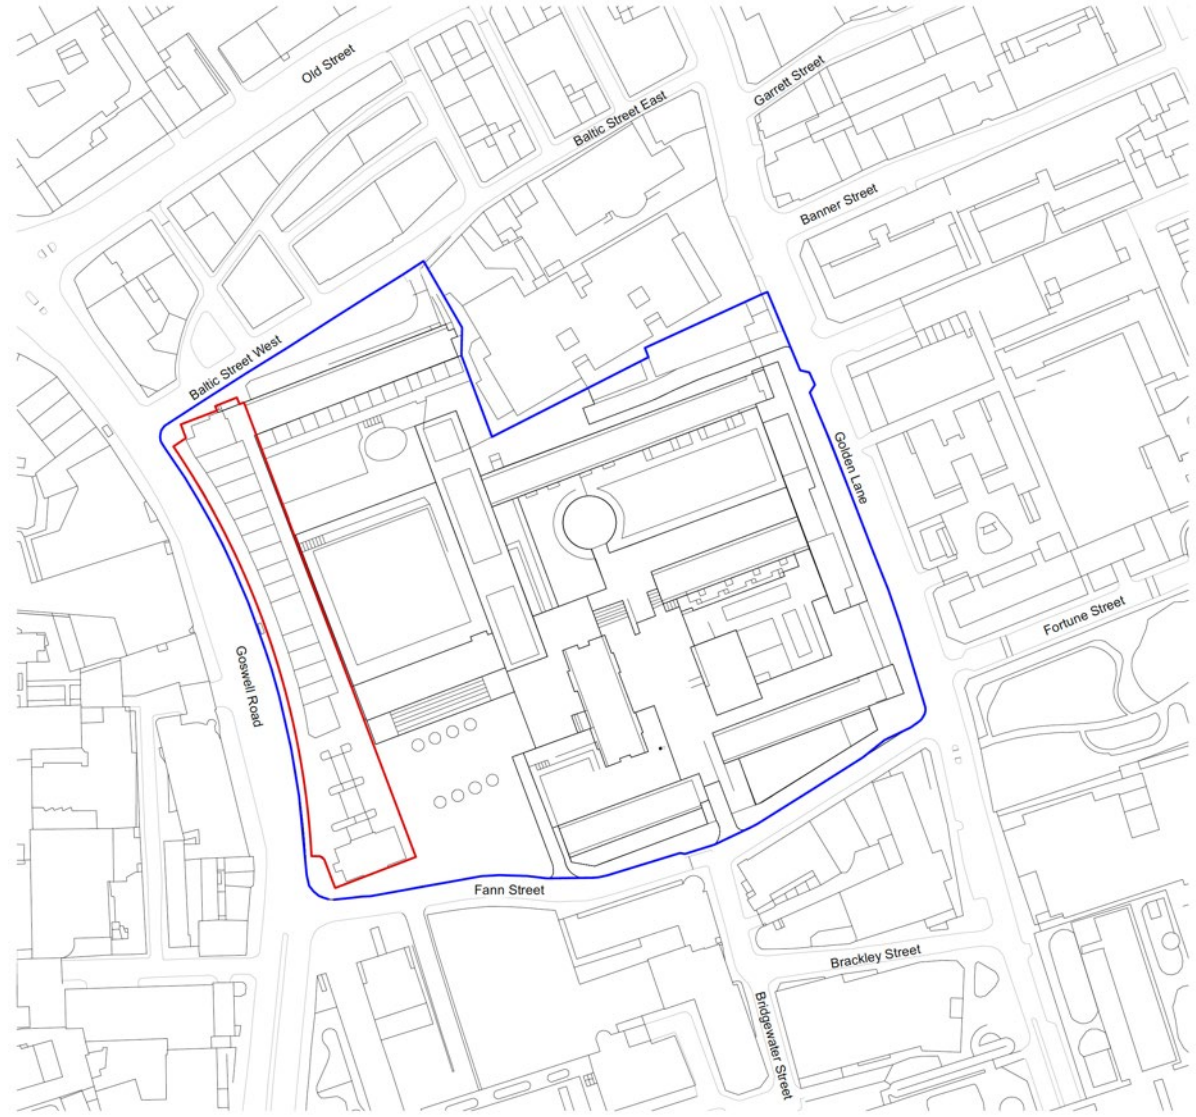
# Site Location Plan

Area pertaining to this application ————

Area within the ownership of the applicant but not part of this application ————

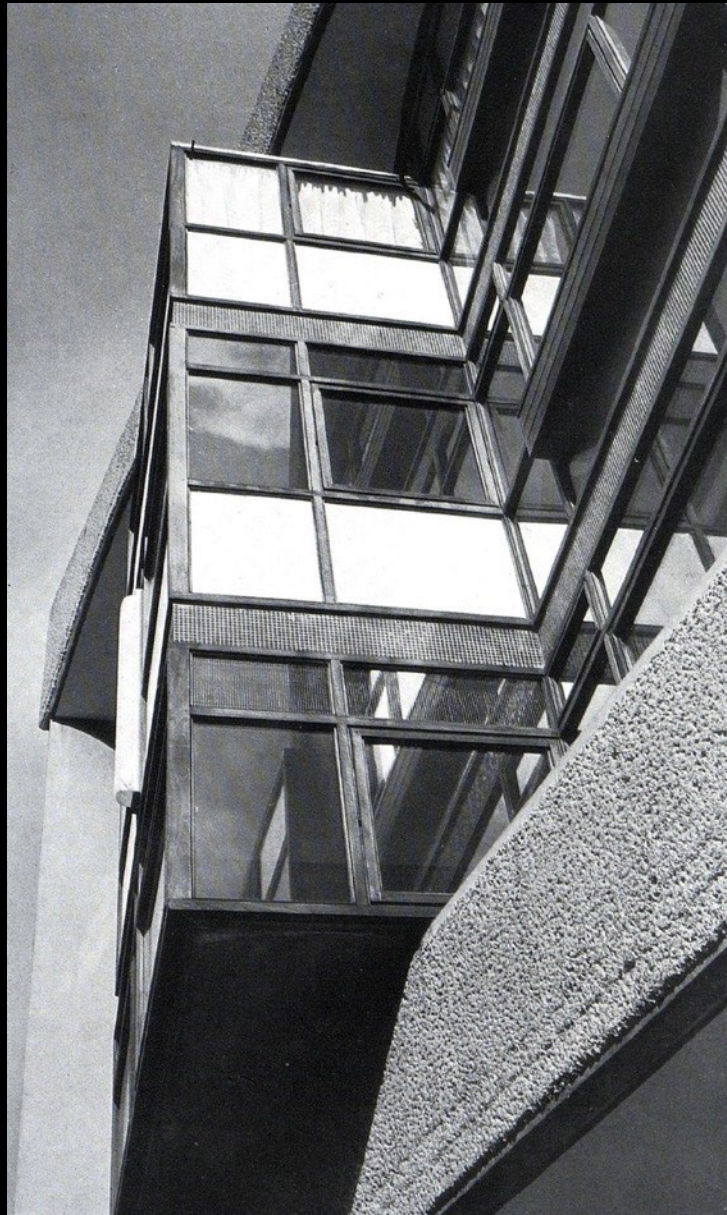
**Typical window – 1962**

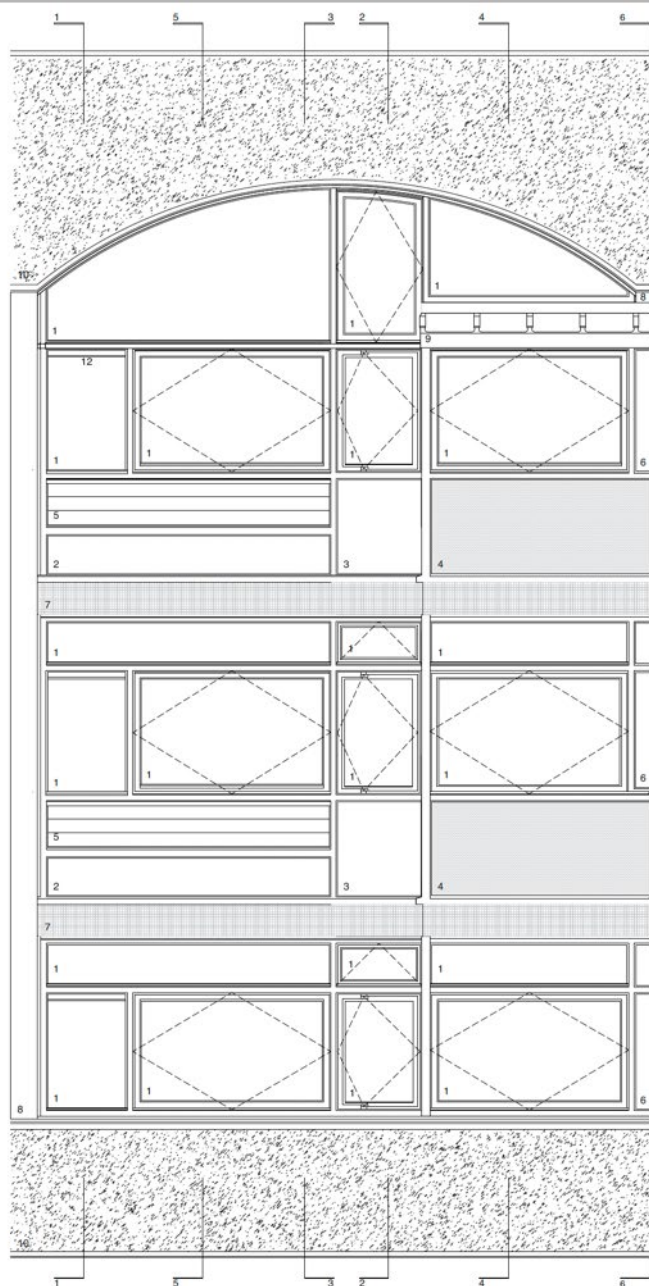
External Elevation

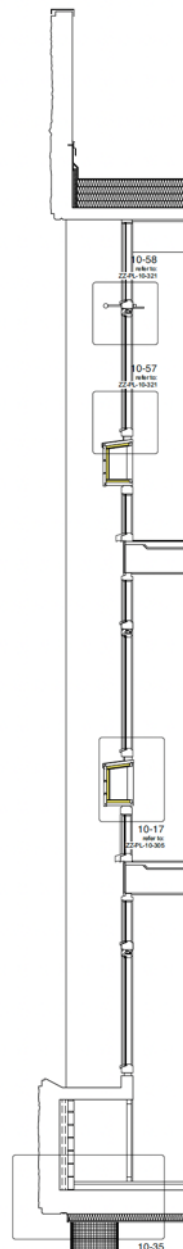
Section 1

## Key Proposals:

Repair existing window frames – retaining as much original fabric as possible.

Replace existing single glazing with new Vacuum Insulated Glass (VIG)

Addition of insulation to projecting bookshelf

Replace existing roof covering and add additional thermal insulation

Add rendered insulation to first floor soffit

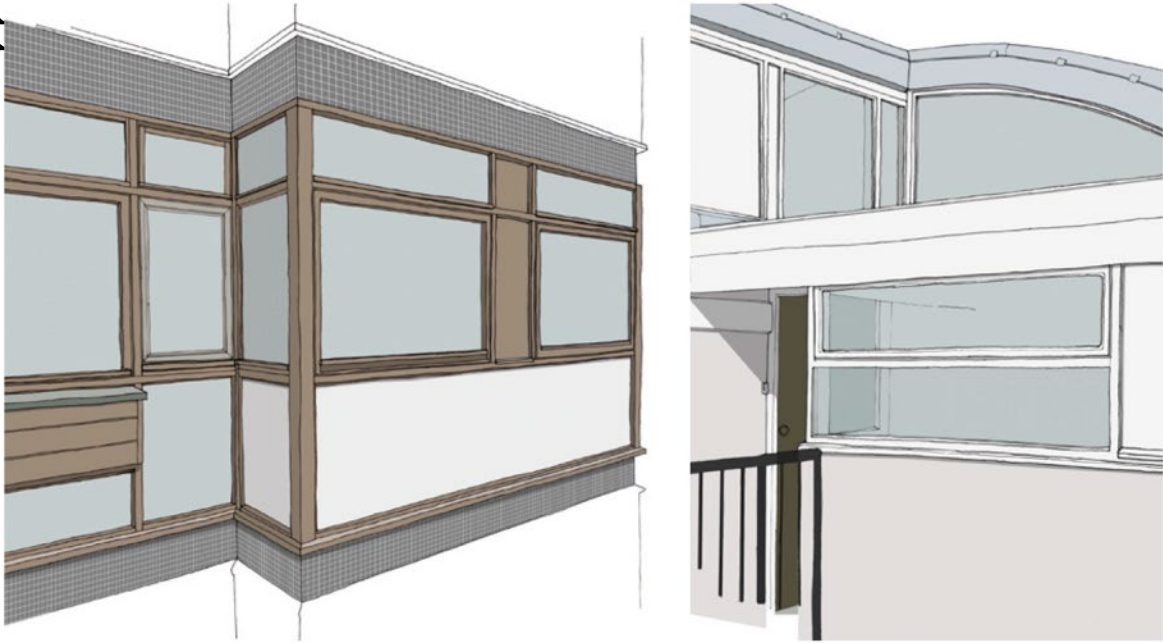
**Repair of Window Frames**

## Types of Window Repairs & Refurbishments

- ① Damaged or decayed wood
- ② Stained/dirty surfaces
- ③ Damage/failure of mosaics
- ④ Historic repairs
- ⑤ Failure of opening casements
- ⑥ Damaged or missing ironmongery/hardware
- ⑦ Poor quality paintwork

All existing frames will be stripped of paint and stains to allow the condition of the timber to be assessed.

There are three main types of repair proposed, depending on the extent to which the timber is degraded, damaged or missing. Details of these three methods are shown on the right. For further detail refer to NBS Specifications WR-C51 and WR-Z10.

Each type of repair is applicable to both sapele and softwood window frames.

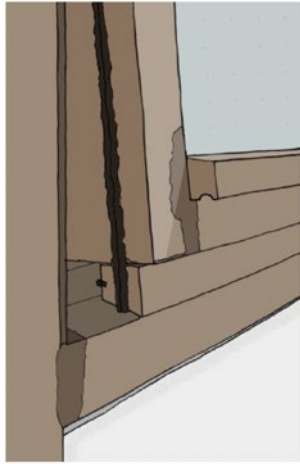
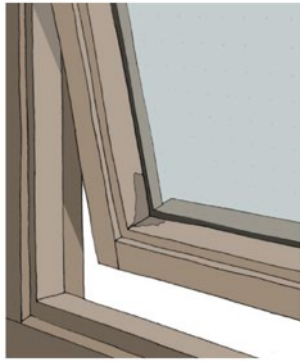
① **Minor Repairs**  
Small areas of degradation will be repaired using two-part resin to infill the damaged area.

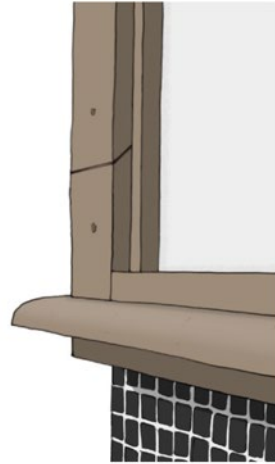
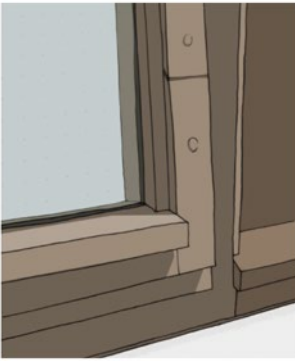
② **Small Sections**  
Where there are short sections of degraded timber, a new section of timber will be spliced in.

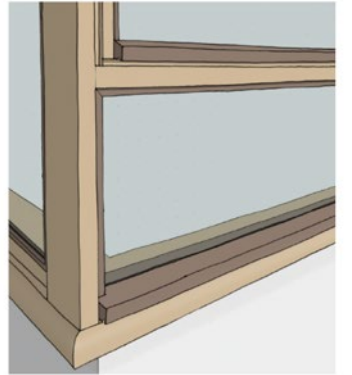
③ **Extensive Repairs**  
Where the degradation extends along a significant portion of the timber, the whole length will be replaced with a new section of timber. This also applies where a section of timber is missing. Where frames/casements are degraded to such an extent that they cannot be repaired effectively, they will be replaced with a like-for-like replacement.

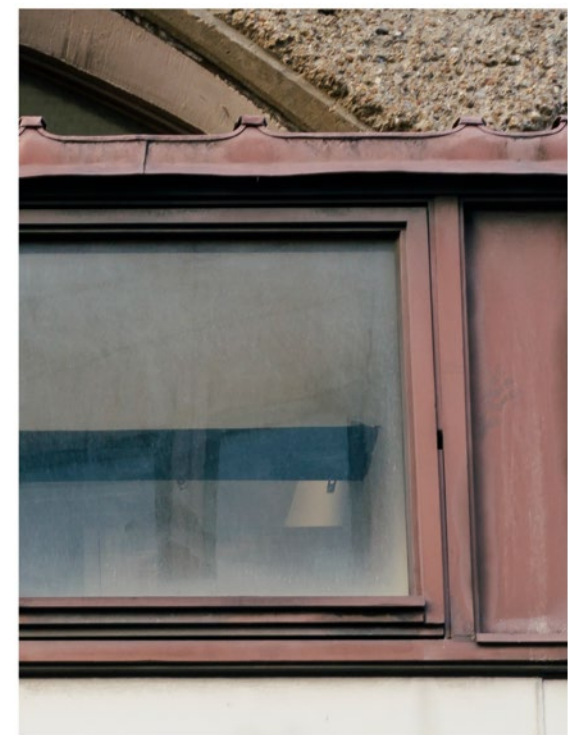
Original Window –  
no obvious rot

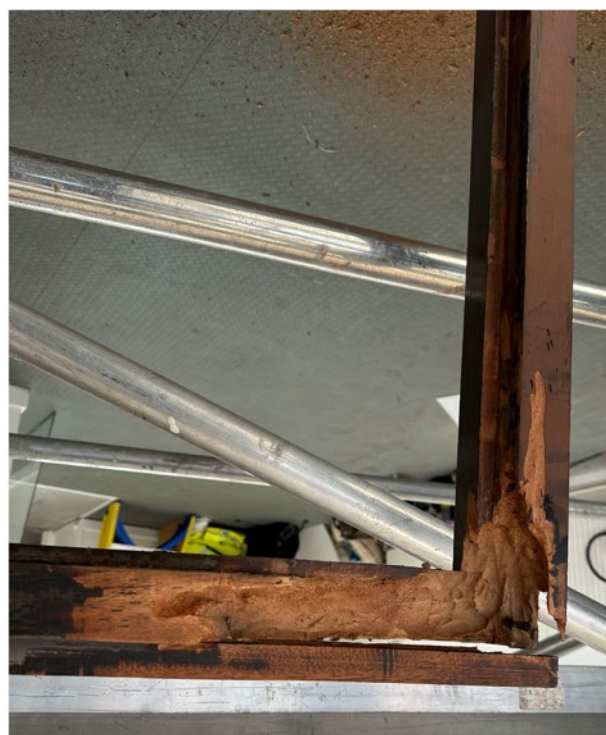
Window removed  
from frame and rot  
discovered

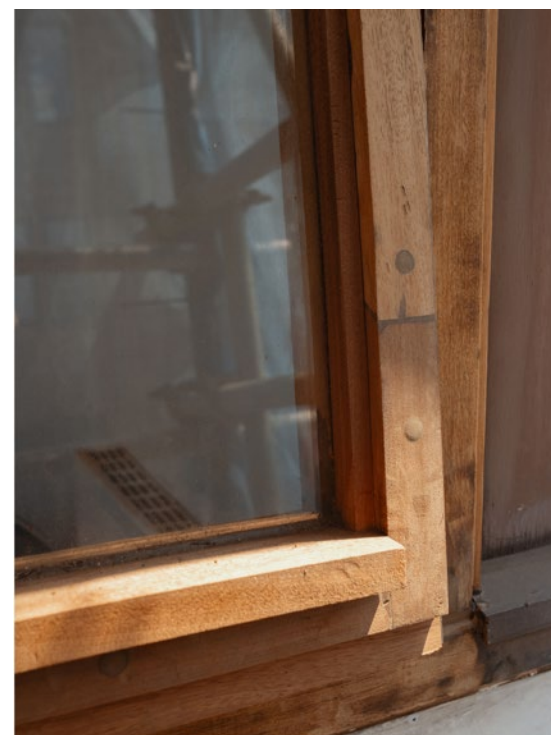
Window repaired  
with new sapele  
spliced into frame

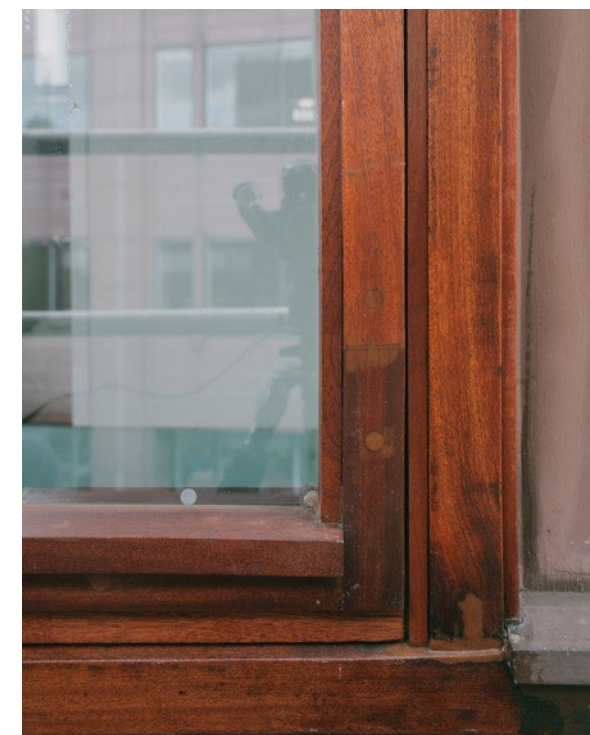
**Window Repair – repair process**

Completed repair,  
window reinstalled  
and oil finish applied

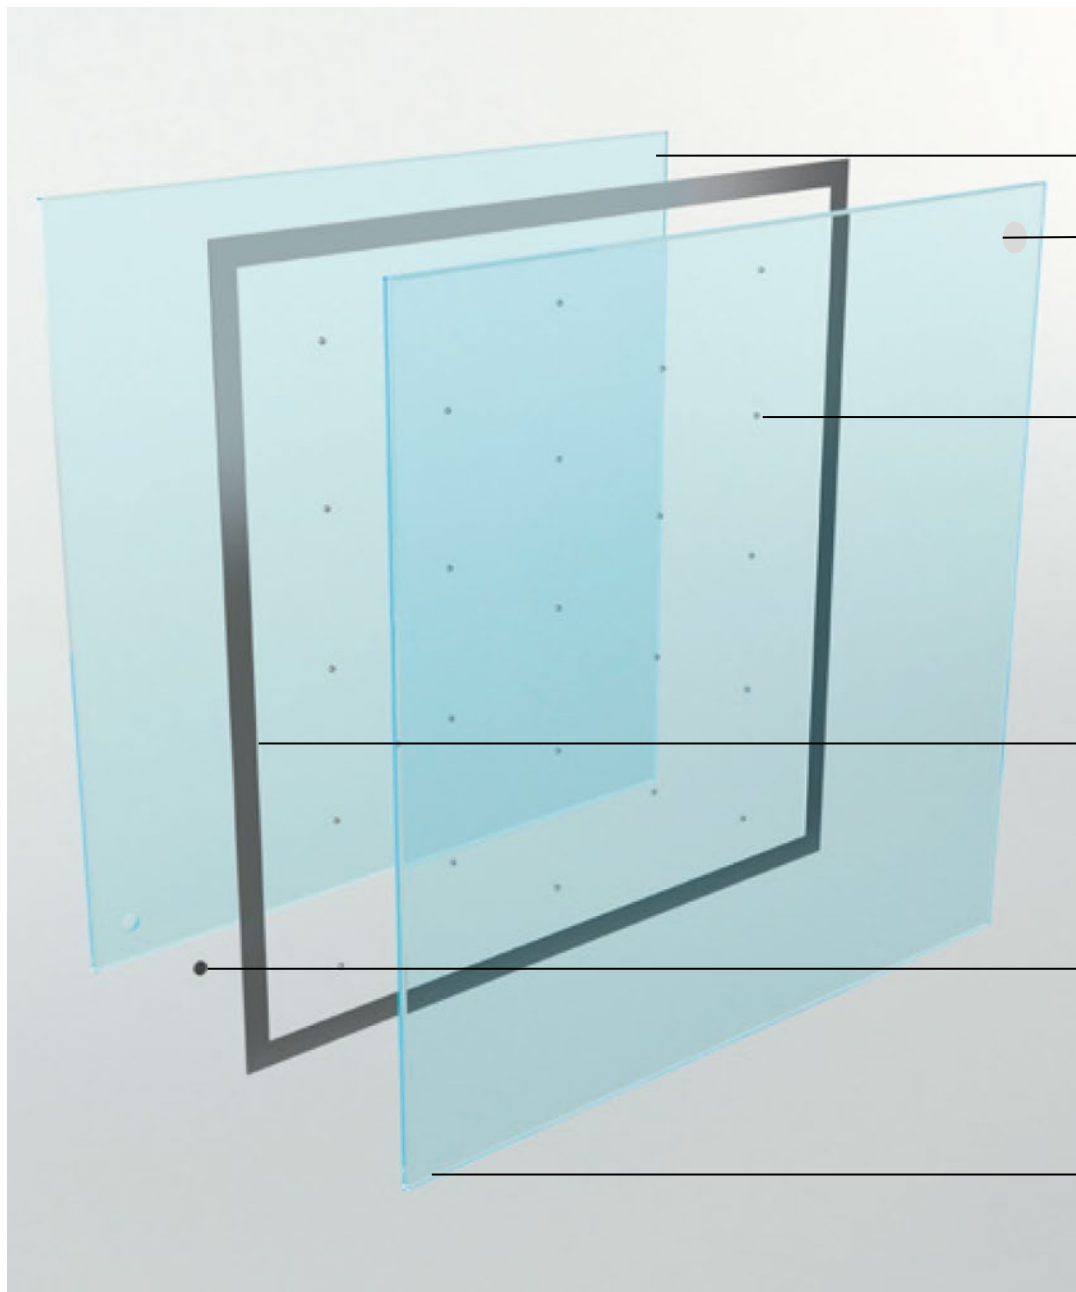
**Glass Replacement – Vacuum Insulated Glass**

4mm glass (toughened)

Getter (number dependent on sheet size)

Micro support pillar

Edge seal (0.3mm)

Evacuation port

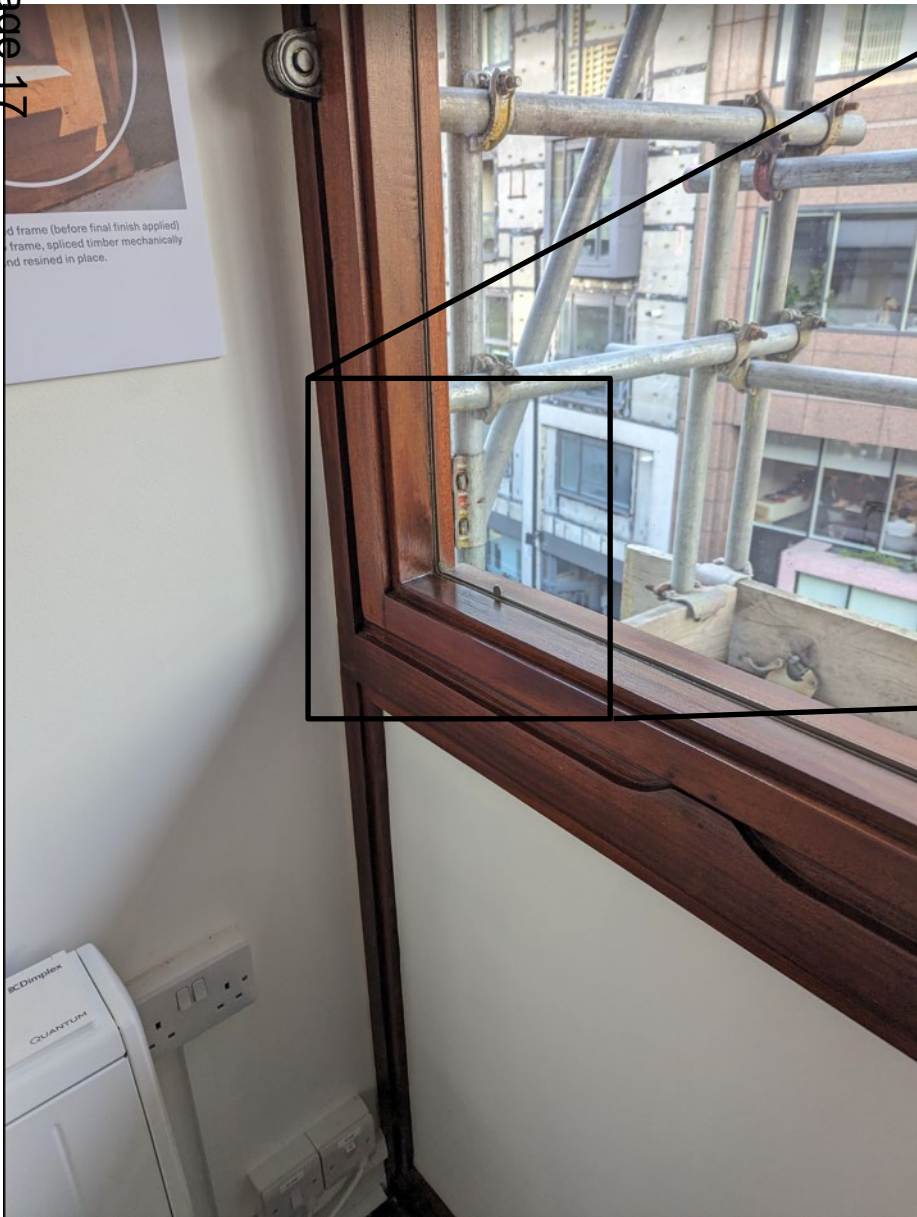
...d frame (before final finish applied)  
... frame, spliced timber mechanically  
... and resined in place.

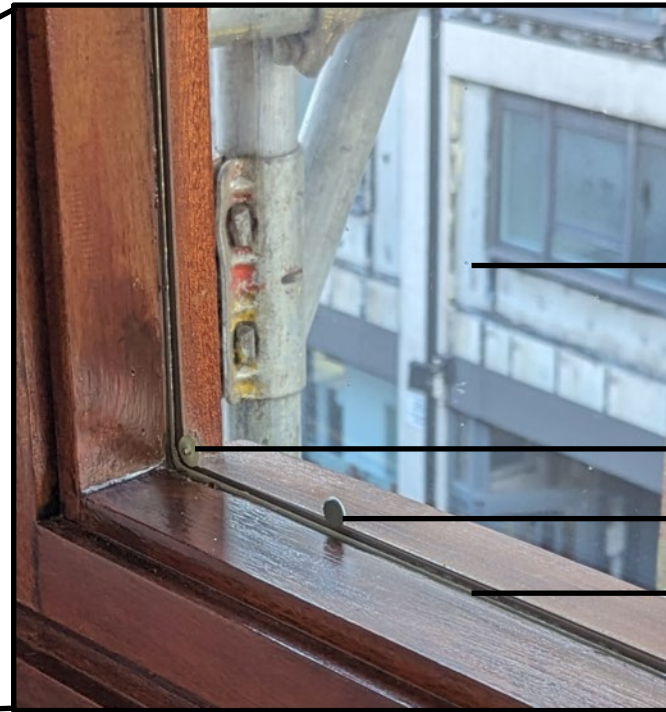
**Vacuum Insulated Glass - Installed**

Micro support pillar

Evacuation port

Getter

Edge seal

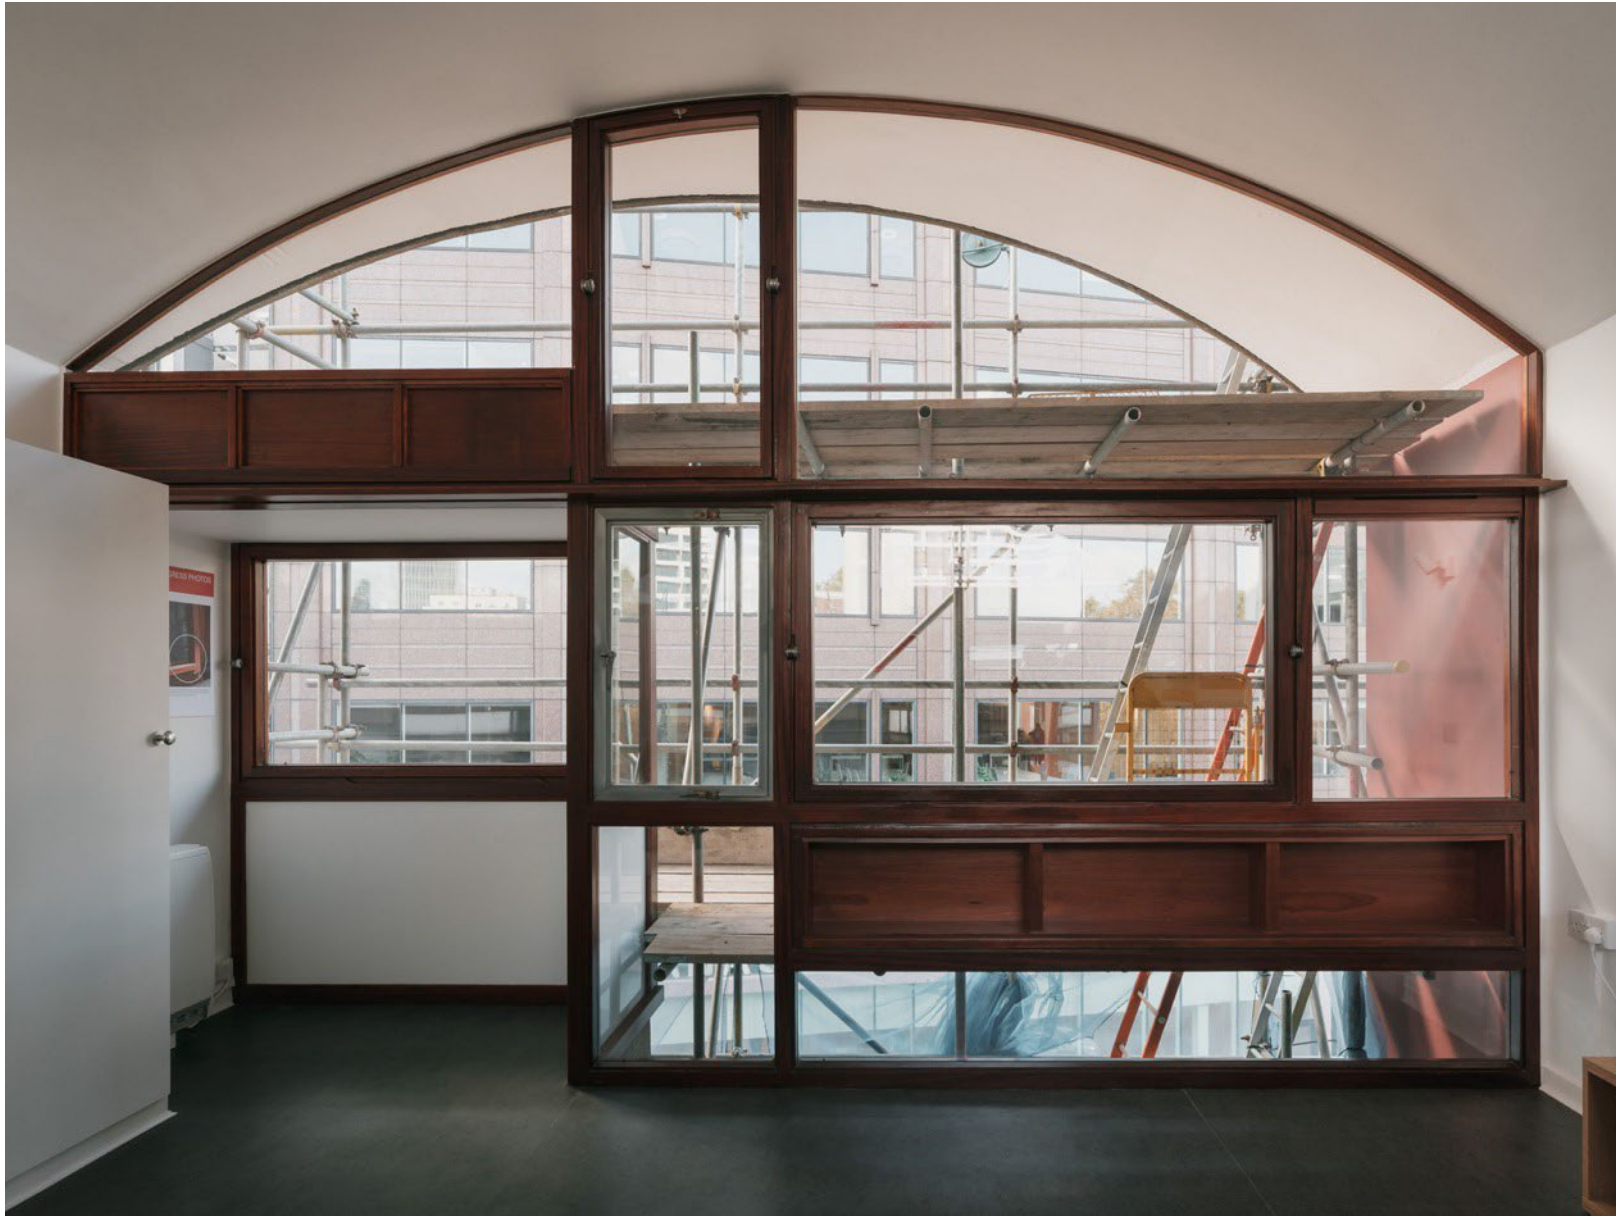
## Vacuum Insulated Glass - Benefits

Performance  
 U-value:  
 VIG: 0.47 W/m<sup>2</sup>K

Sound Reduction: 36dB (RW)

Context  
 Existing glass U-value 5.0 W/m<sup>2</sup>K

Reduction in heating energy demand:

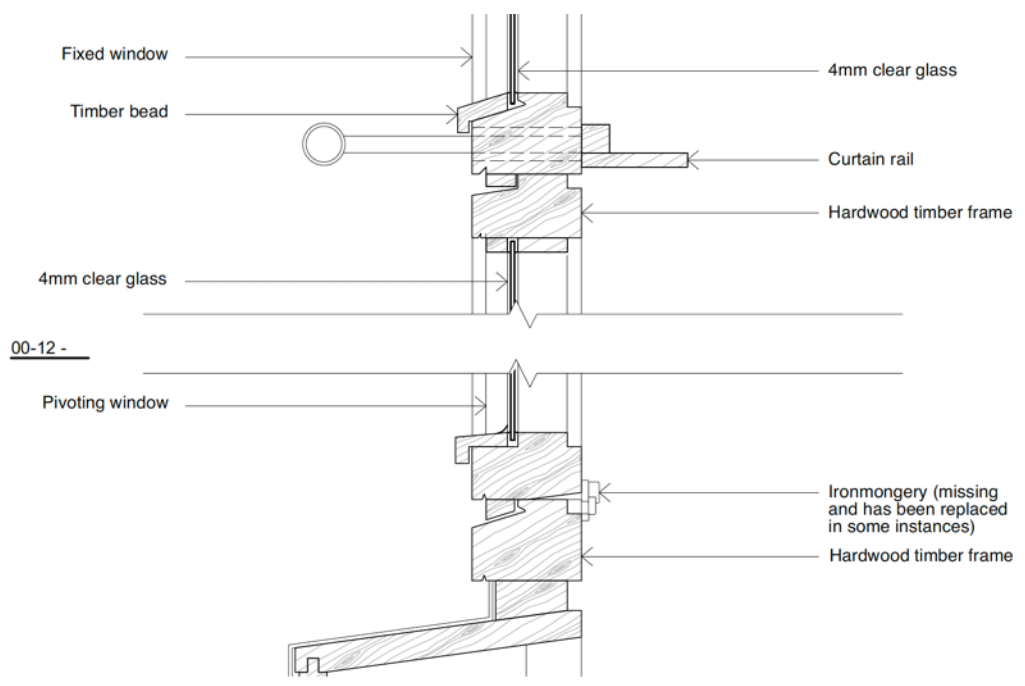
Existing window with single glazing

VIG can be installed into existing timber window with no adaptations required to the rebates in the window frames. Existing external sapele beads will be replaced with new sapele beads. Brush and compression seals will be installed into the opening window frames.

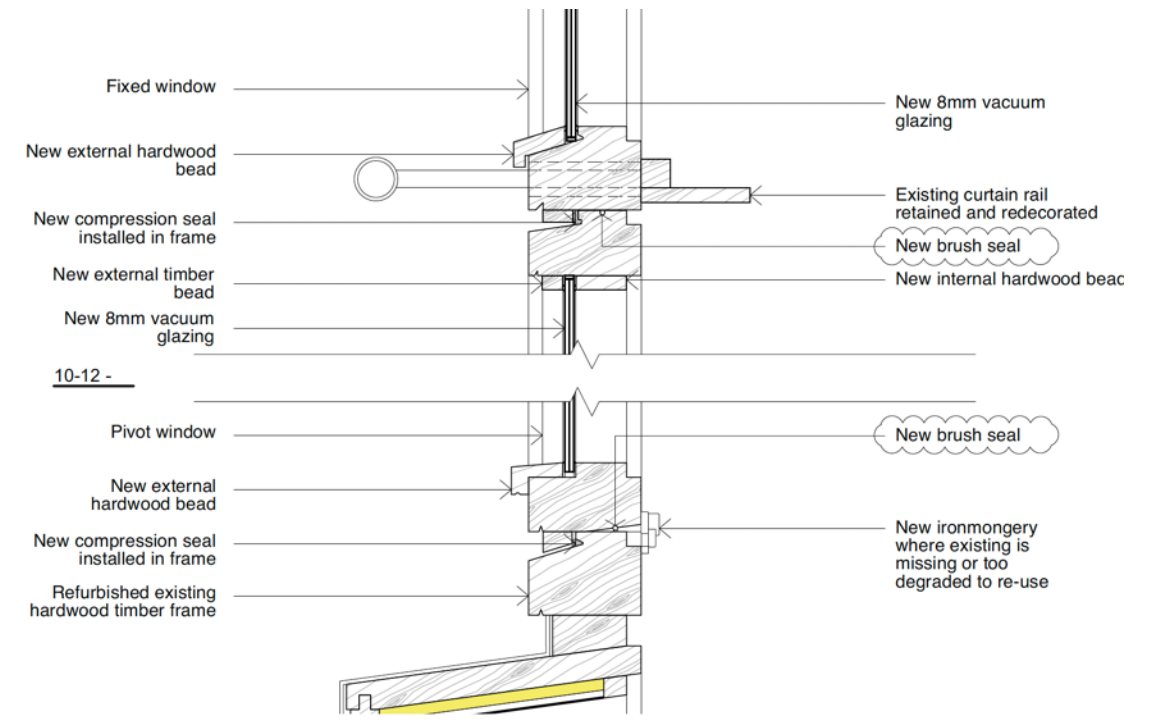
Proposed window with VIG

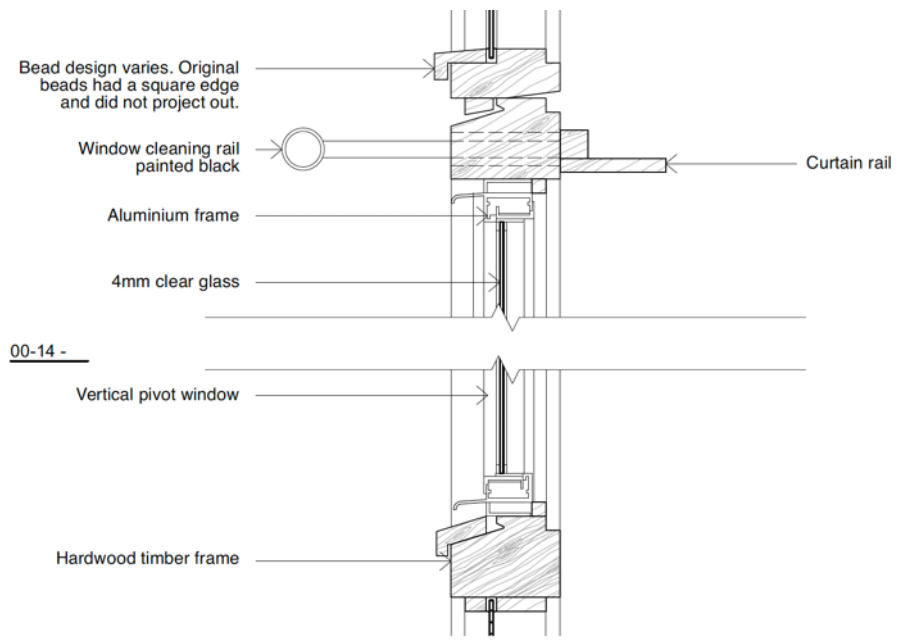
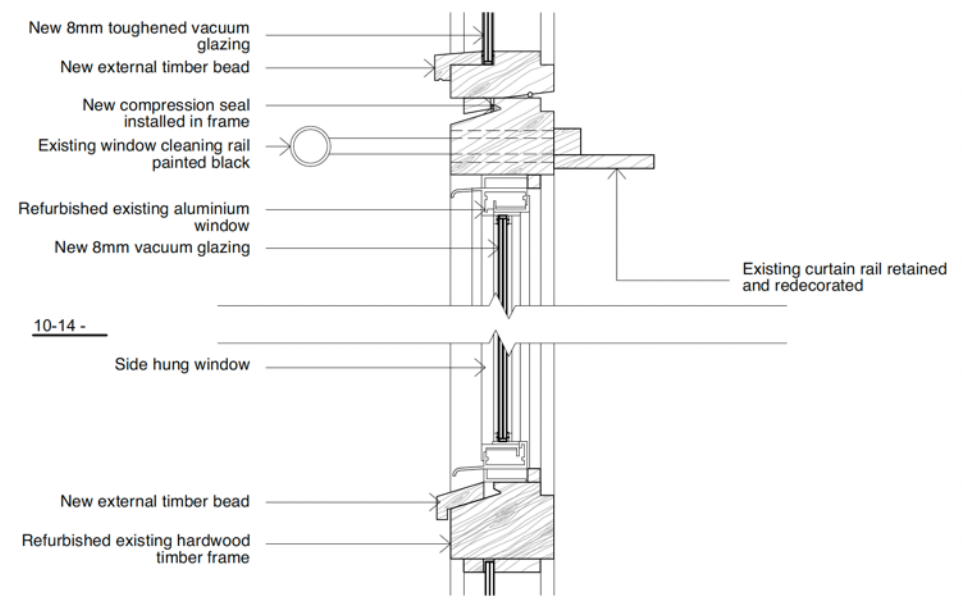
Existing window with single glazing

Existing window with VIG installed

VIG can be installed into the vertical pivot window with no adaption required to the frame.

The existing frame will be cleaned and re-anodized (the original finish).

New compression seals will be installed into the frame.

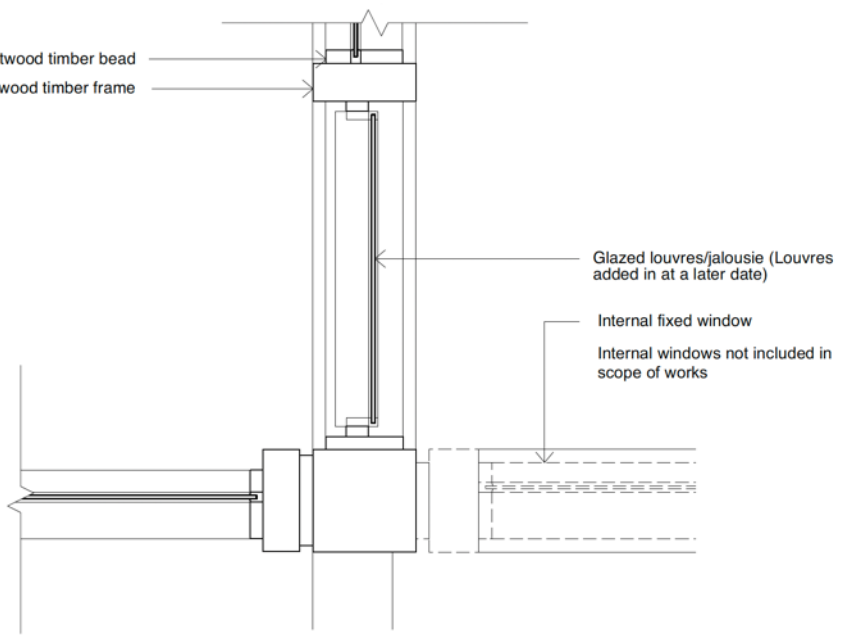
Existing jalousie window

The existing jalousie window is a significant route for heat loss in the home. It is proposed to remove and replace with a fixed panel of VIG.

The BRE testing data shows the air leakage through this window (when closed) accounts for 18% of the measured air leakage from the entire property.

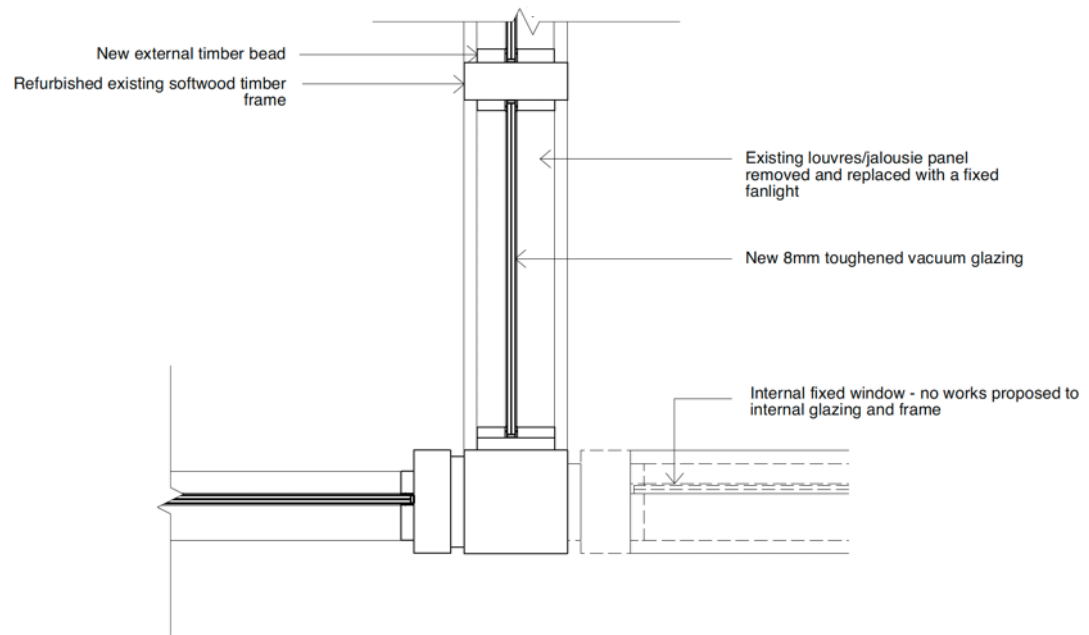
Proposed fixed light with VIG installed

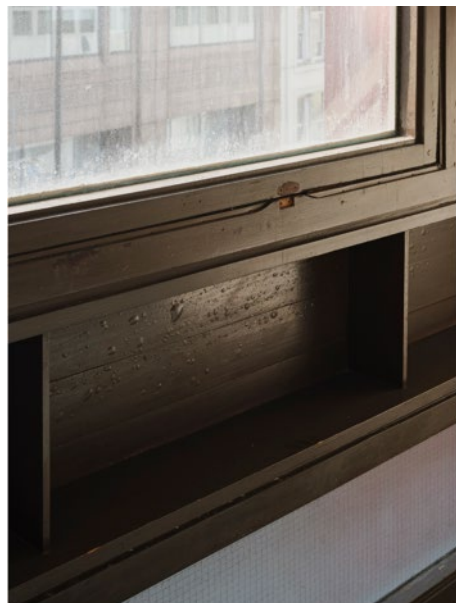
00-17 - Existing Detail Section of Bookshelf

### Existing

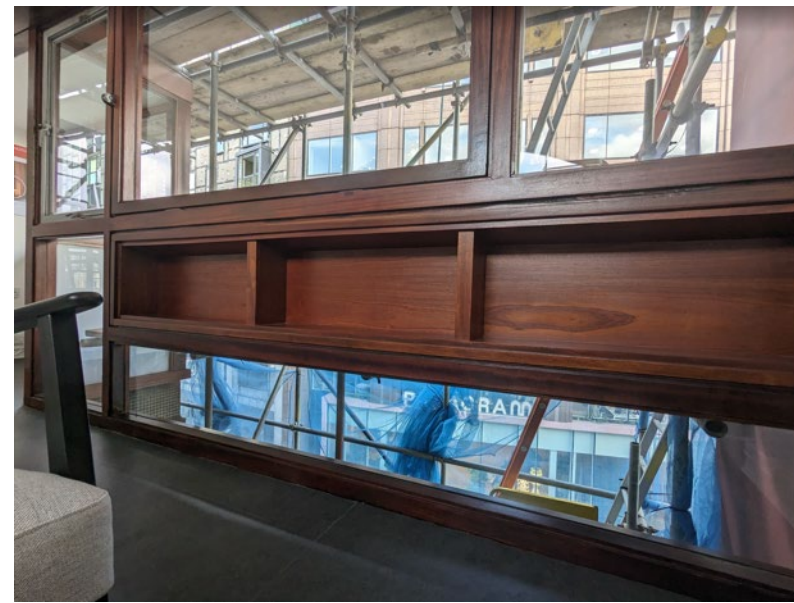
10-17 - Proposed Detail Section of Bookshelf

It is proposed to line the internal face of the bookshelf with a 10mm aerogel insulation, 6mm facing board, and a sapele veneer. The proposal aims to reduce the risk of condensation forming in the bookshelf.

### Proposed

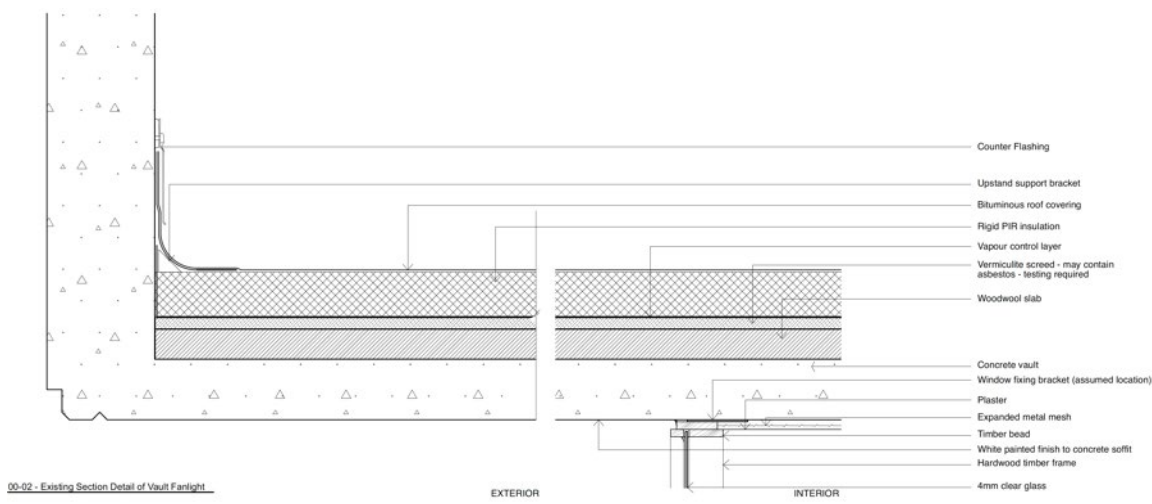
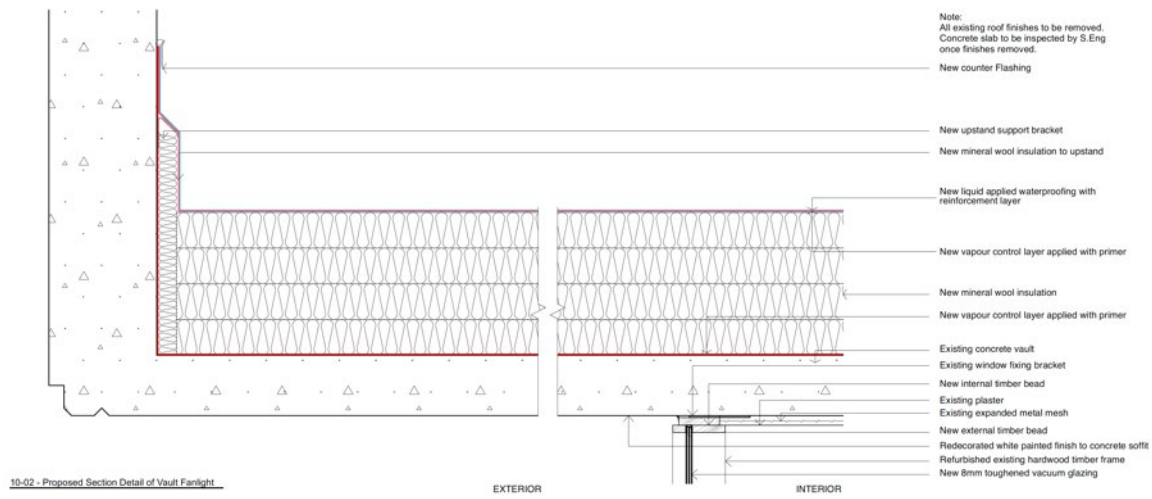
Existing Roof Build-up (U-value circa: 0.38W/m<sup>2</sup>K)

Proposed Roof Build-up (U-value: 0.17W/m<sup>2</sup>K)

Existing roof coverings to be removed.

Concrete slab to be inspected and any remedial works to concrete carried out.

New insulation and cold applied liquid waterproofing roof system added.

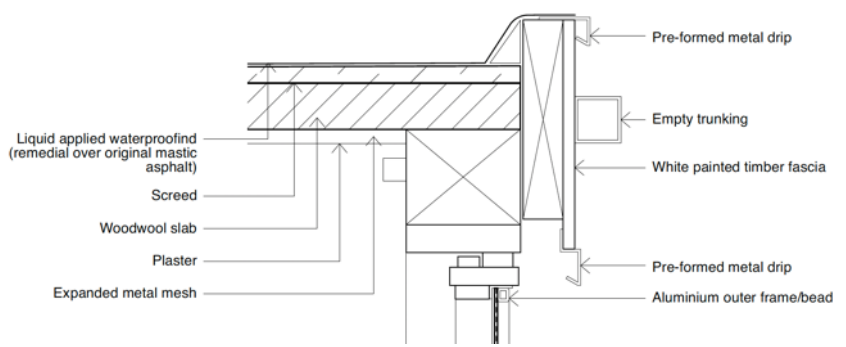
Existing Roof Build-up (U-value circa: 0.5W/m<sup>2</sup>K)

Existing roof coverings to be removed.

Woodwool decking to be inspected and any remedial works to concrete carried out.

New insulation and cold applied liquid waterproofing roof system added.

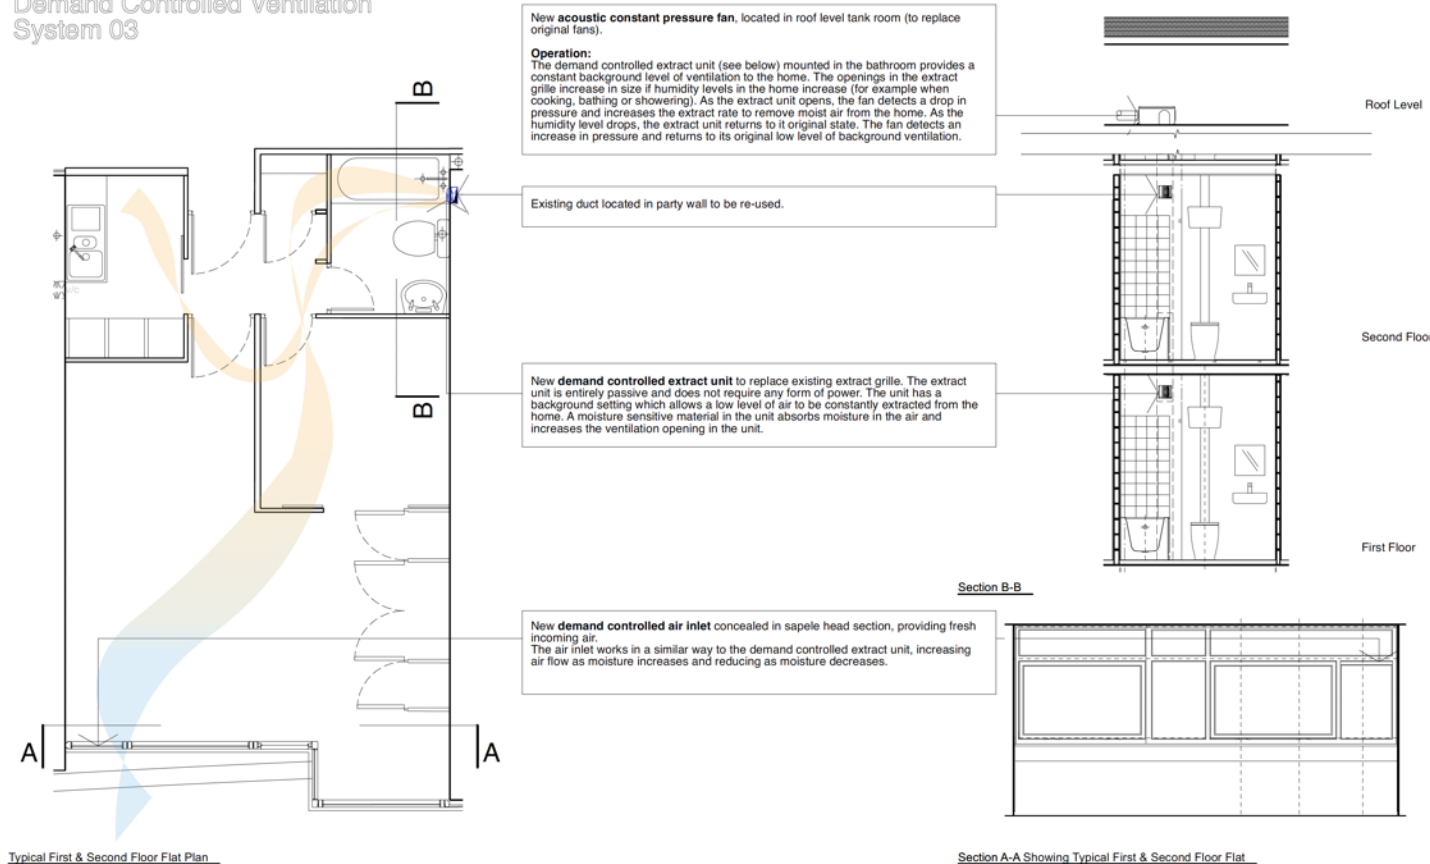
### Demand Controlled Ventilation System 03

Typical First & Second Floor Flat Plan

Section A-A Showing Typical First & Second Floor Flat

Ventilation System 03

As a result of the recognised link between improved thermal performance and the need for better, more controlled mechanical ventilation, new mechanical extract will be provided to all homes. This will take the form of adding a demand controlled ventilation system to each home.

Demand controlled ventilation adjusts ventilation extract rates based on the internal conditions in the home; as the moisture content of the air increases, extract rates increases to remove more air from the home.

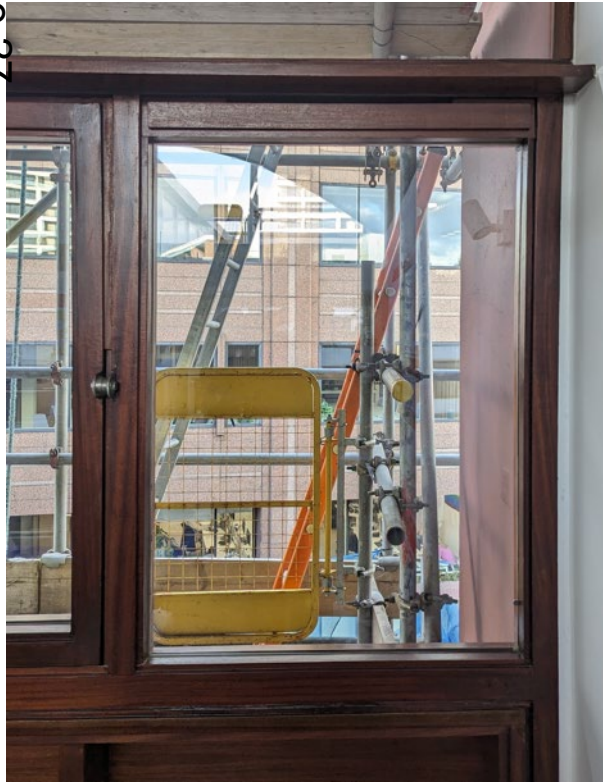
Internal view of trickle vent

The existing windows have non-controllable trickle vents incorporated into the jambs of the pivot windows. In the process of overhauling the windows these will be removed and new beads installed to close the gaps.

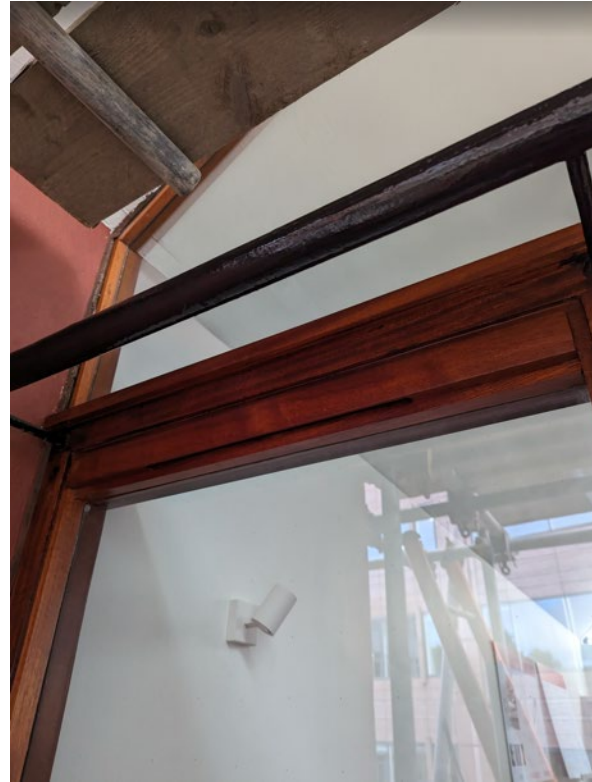
External view of trickle vent

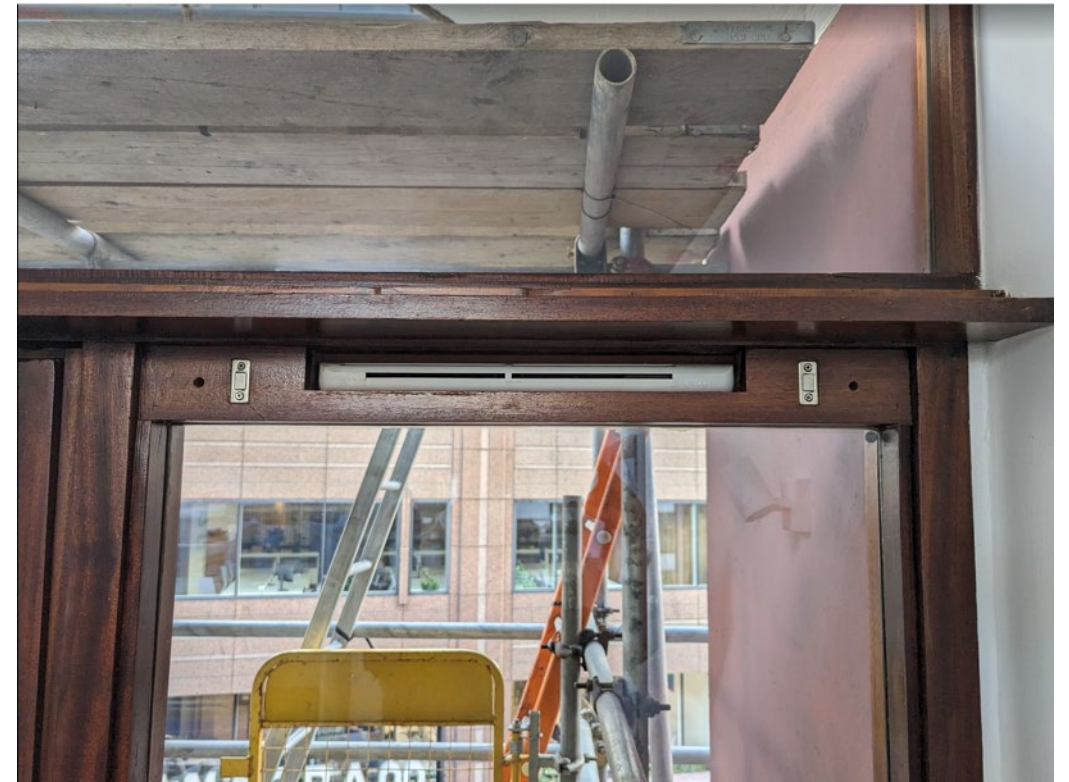
Trickle vent with sapele cover removed

A new head section is proposed to the frame of the fixed light above the bookshelf, to allow installation of a concealed demand controlled trickle vent, to provide background ventilation as part of the demand controlled ventilation system.
