# **Planning Applications Sub-Committee**

4. **CRESCENT HOUSE, GOLDEN LANE ESTATE, LONDON, EC1Y 0SL**  
Report of the Planning & Development Director.
5. **CRESCENT HOUSE GOLDEN LANE ESTATE LONDON EC1Y 0SL - LISTED BUILDING CONSENT**  
Report of the Planning & Development Director.

# **Crescent House**

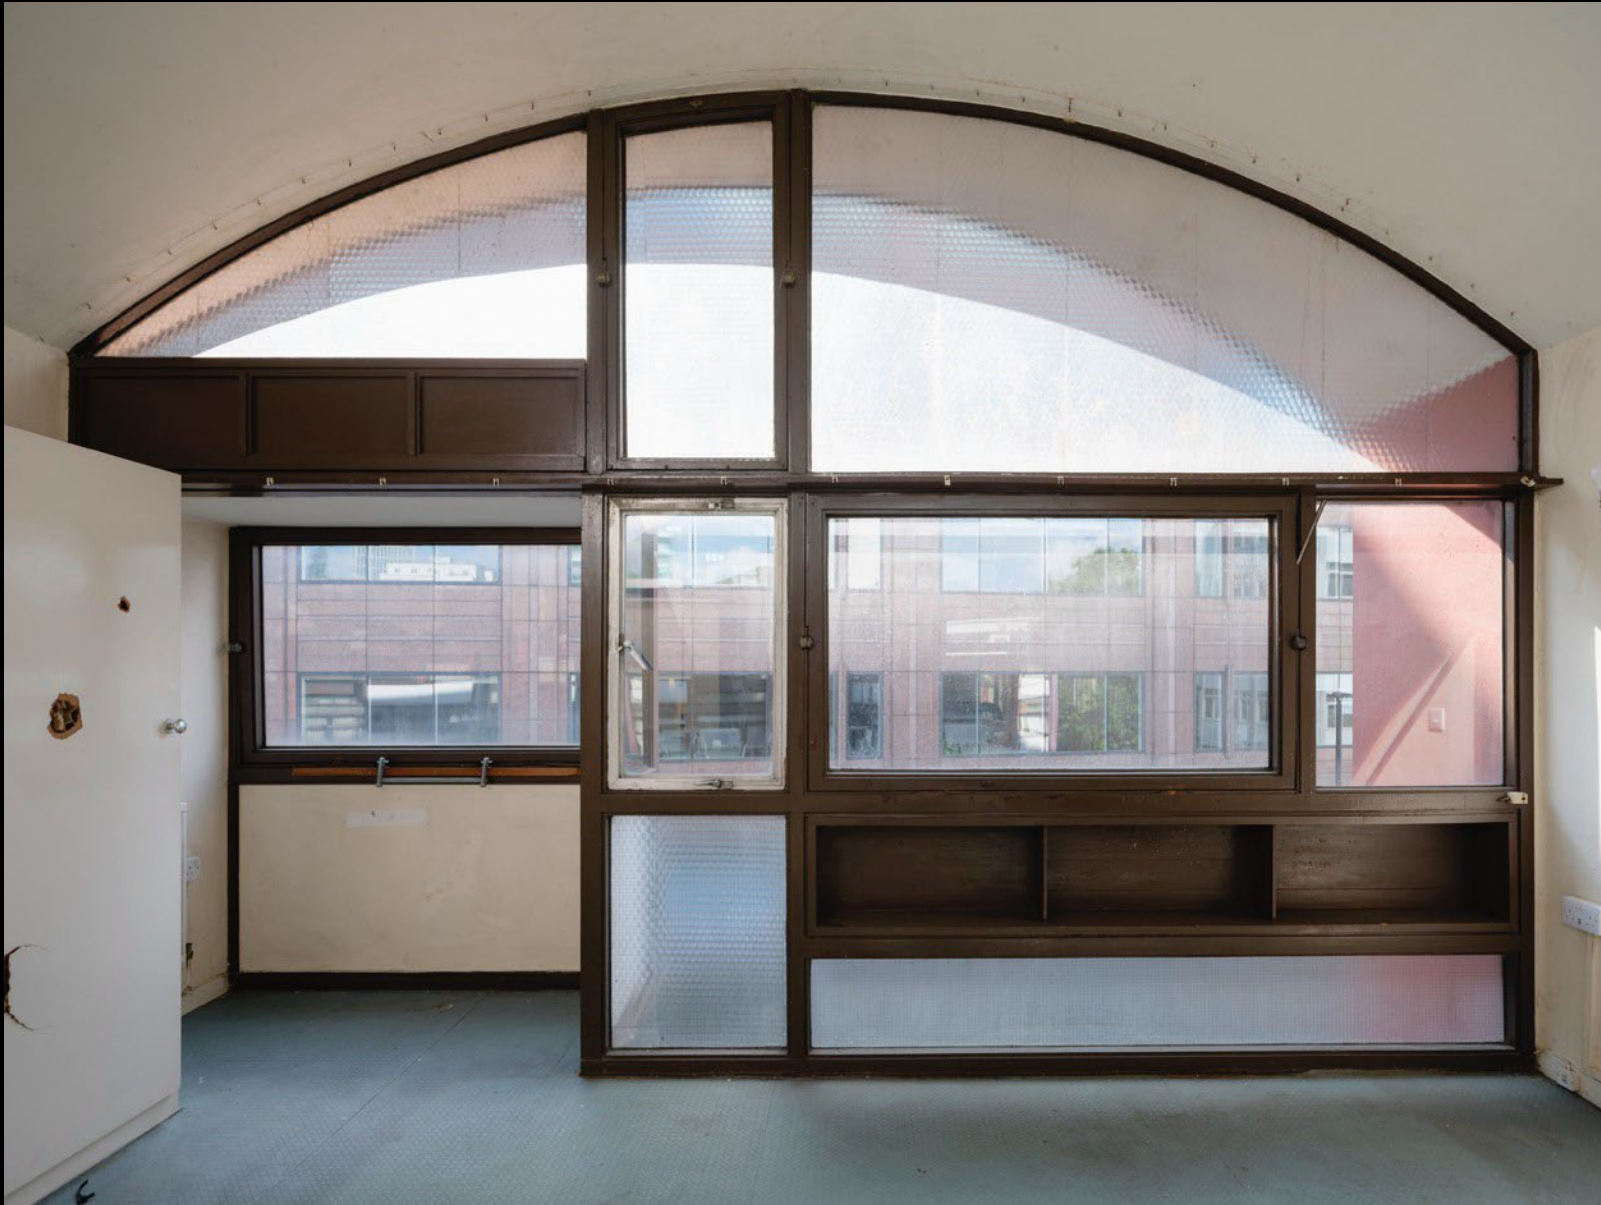
**347 Crescent House – Pilot Project**

A Pilot Project has been run to test a number of the proposals contained in the application. Work carried out:

Repair of window frames.  
Installation of VIG.  
Installation of demand controlled ventilation system.  
Installation of electric heating and hot water.

Interior of 347 Crescent House prior to Pilot Project starting.

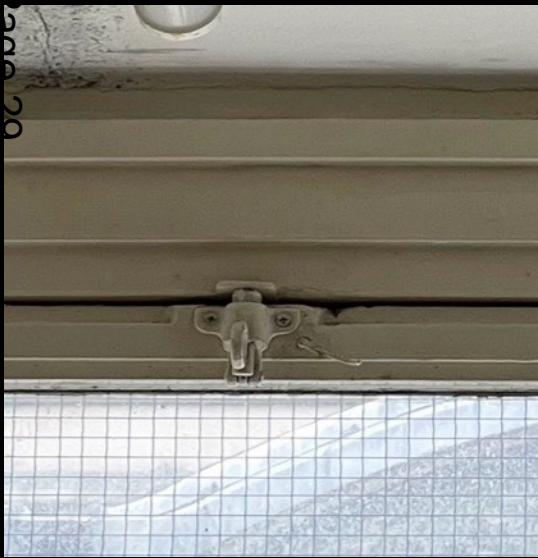
Original Naco pull handle

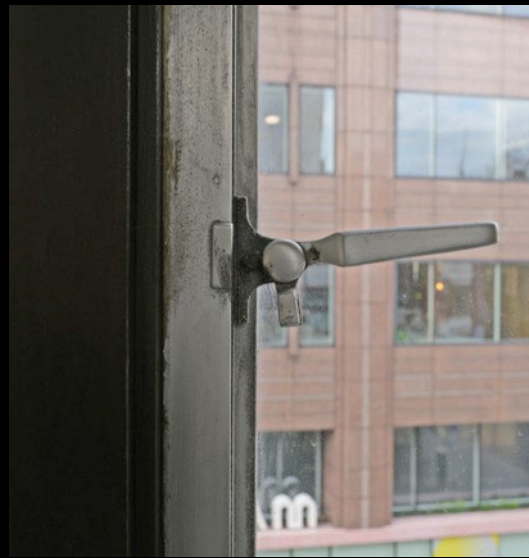
Original espagnolette handle

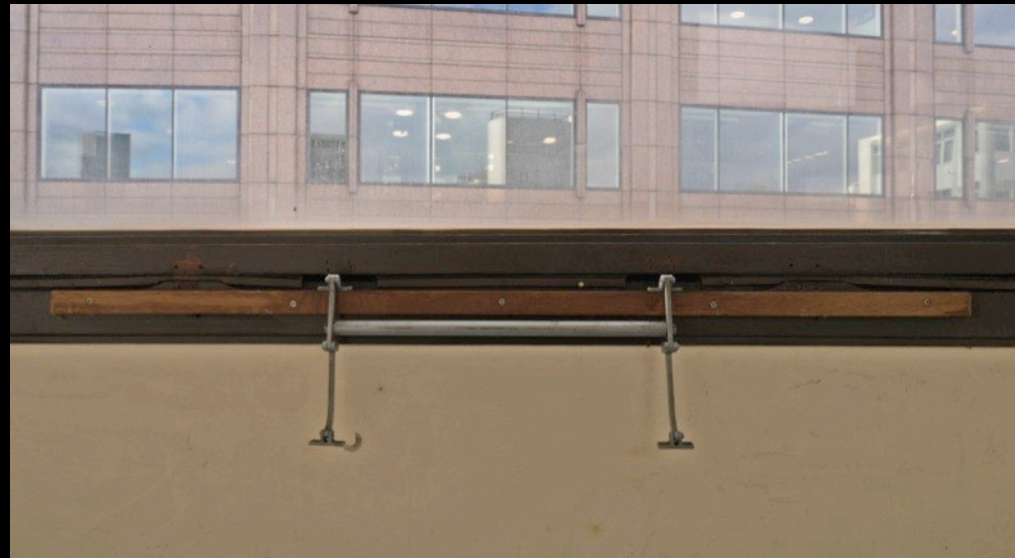
Replacement handle

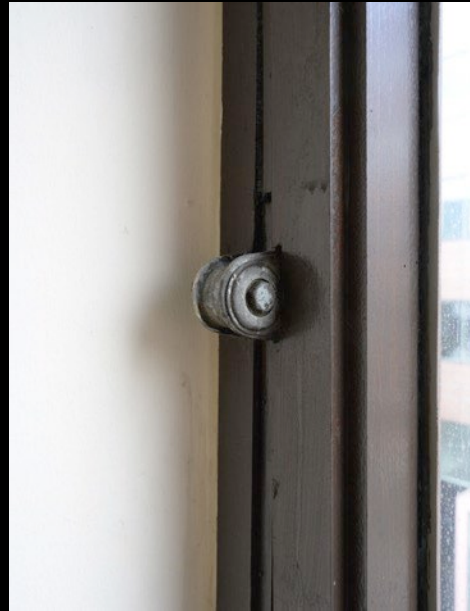
Original pivot hinges

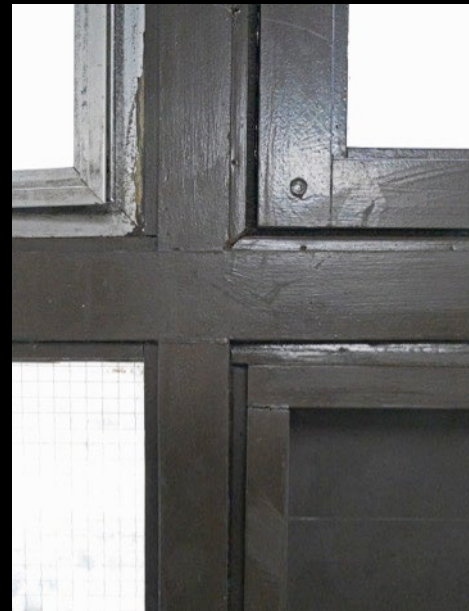
Shadow gap details

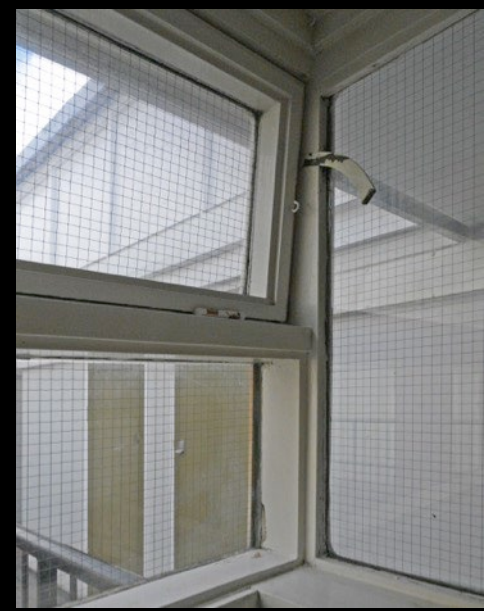
Kitchen window detail

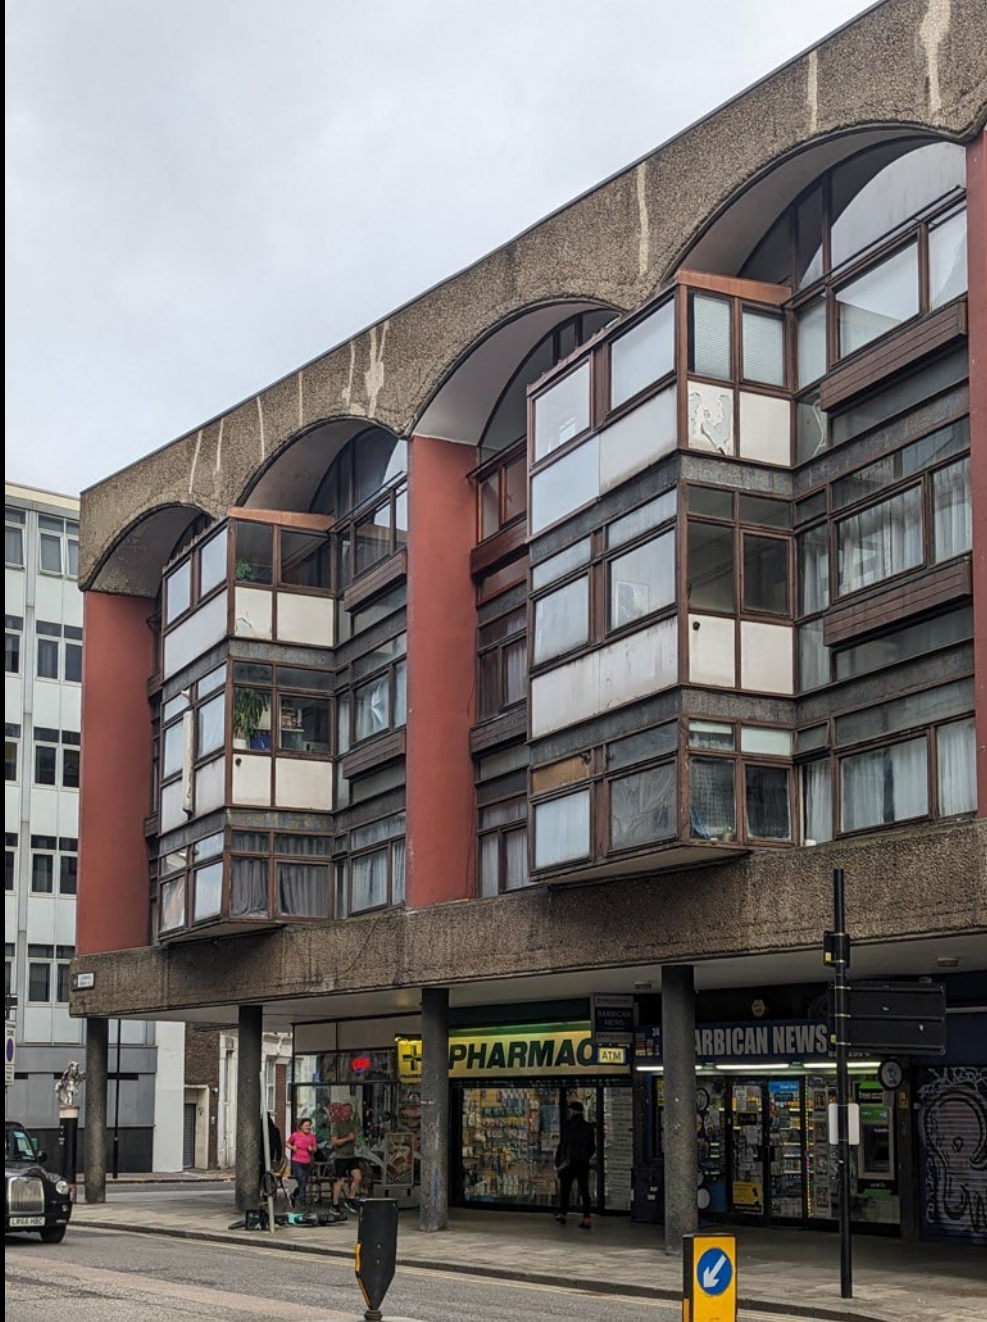
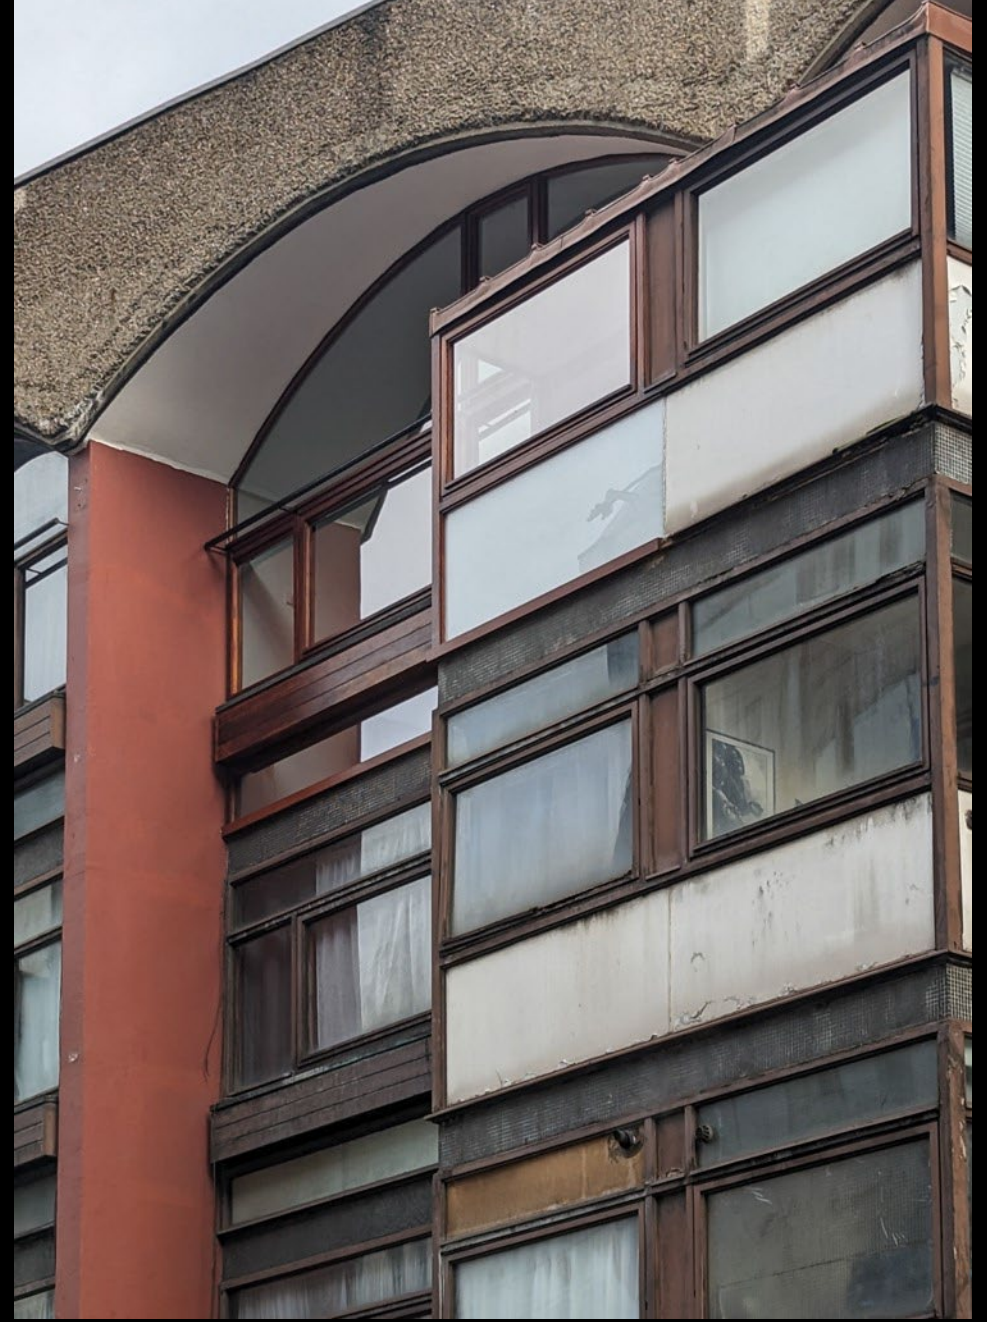
**347 Crescent House – Pilot Project**

347 Crescent House – Pilot Project
