# JULIAN HARRAP

THE MONUMENT TO THE GREAT FIRE OF LONDON

VOLUME I: CONSERVATION PLAN

MARCH 2025

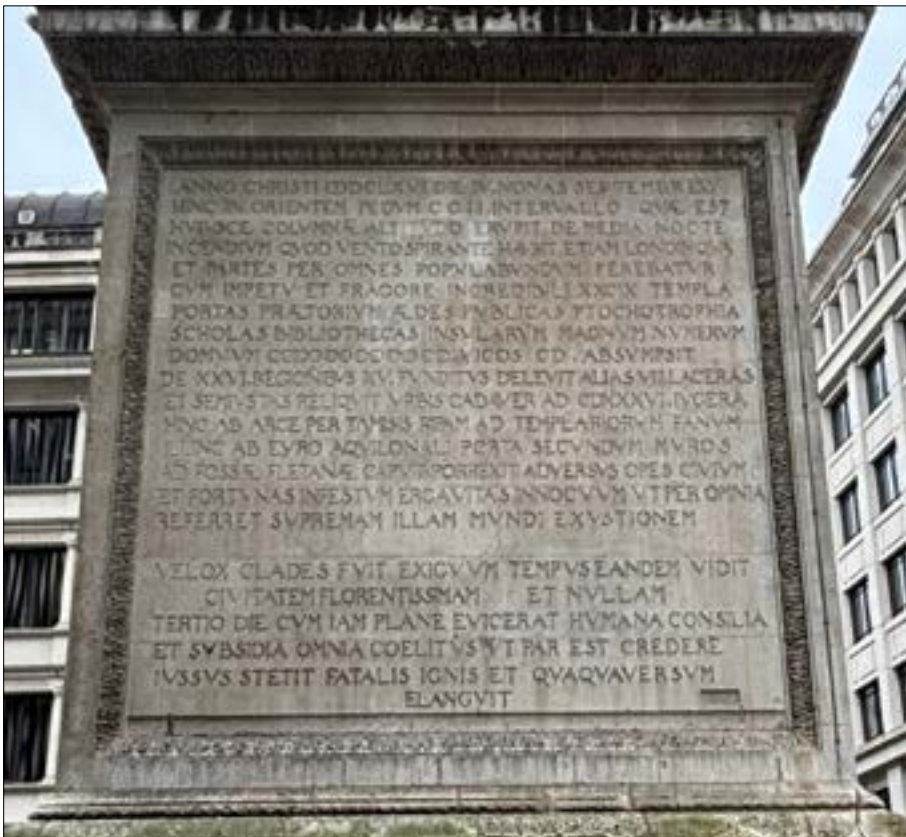
Fig. 7 North panel inscription, 2024

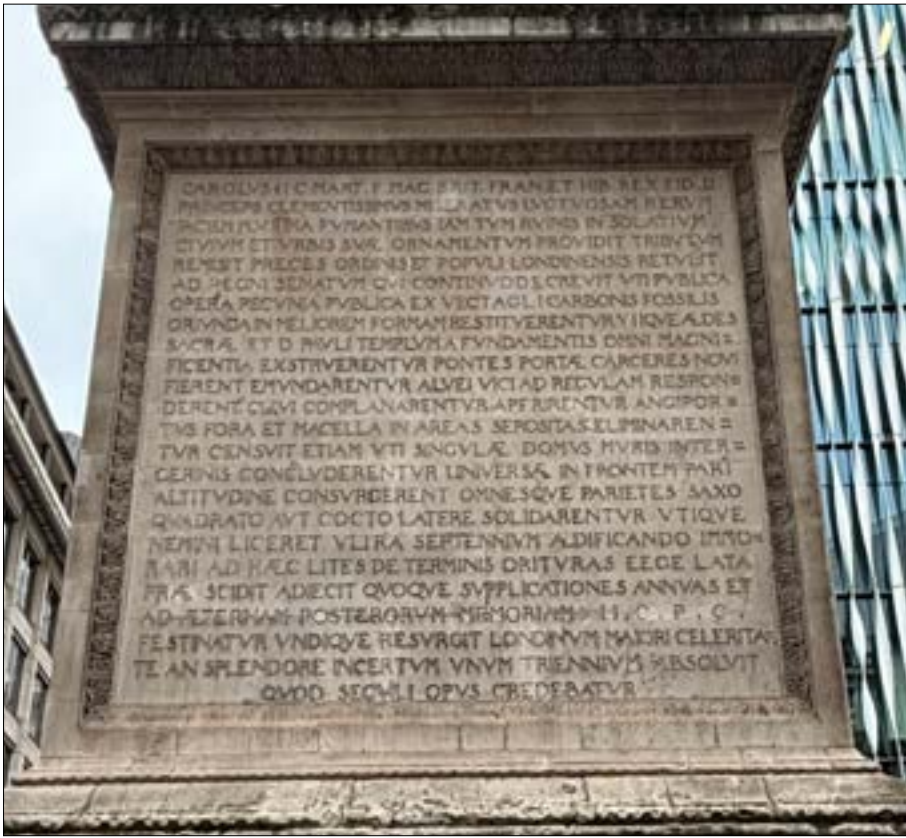
Fig. 8 South panel inscription, 2024

Charles the Second, son of Charles the Martyr, King of Great Britain, France and Ireland, defender of the faith, a most gracious prince, commiserating the deplorable state of things, whilst the ruins were yet smoking provided for the comfort of his citizens, and the ornament of his city; remitted their taxes, and referred the petitions of the magistrates and inhabitants of London to the Parliament; who immediately passed an Act, that public works should be restored to greater beauty, with public money, to be raised by an imposition on coals; that churches, and the cathedral of St. Paul’s, should be rebuilt from their foundations, with all magnificence; that the bridges, gates, and prisons should be new made, the sewers cleansed, the streets made straight and regular, such as were steep levelled and those too narrow made wider, markets and shambles removed to separate places. They also enacted, that every house should be built with party-walls,

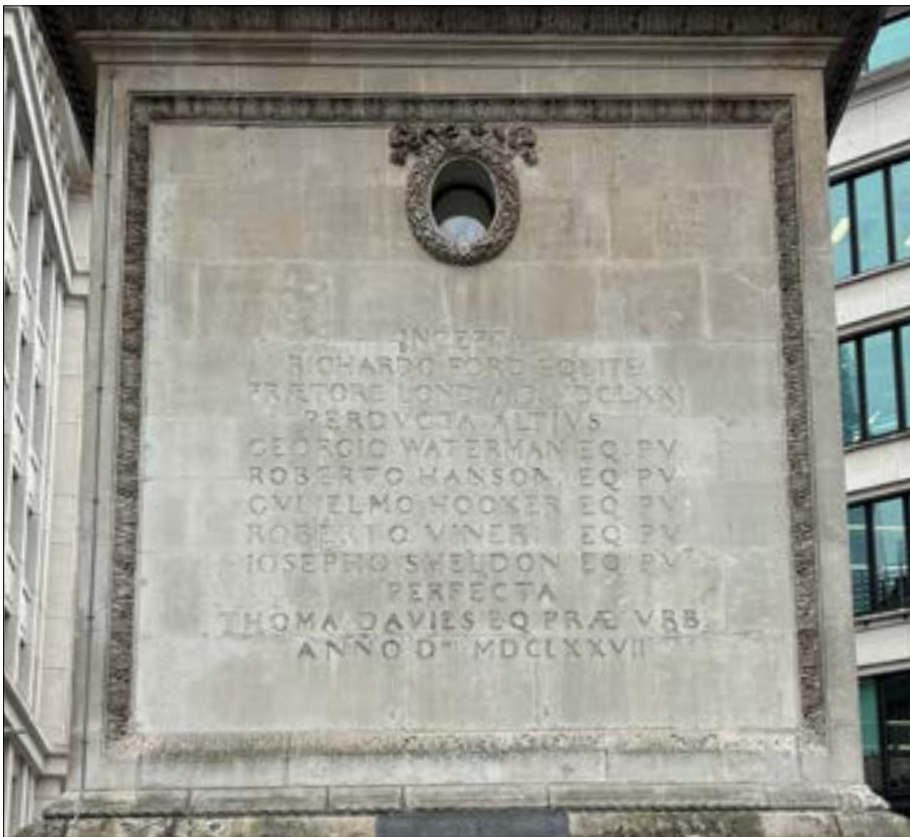
Fig. 9 East panel inscription, 2024

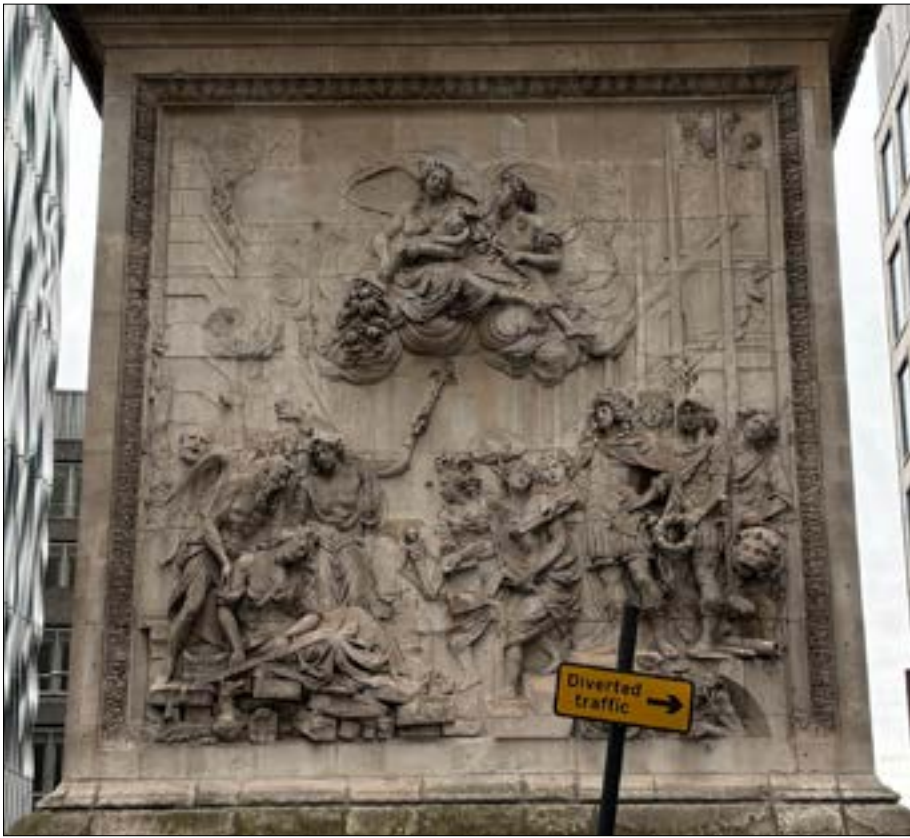
Fig. 10 West panel sculptural relief carving, 2024

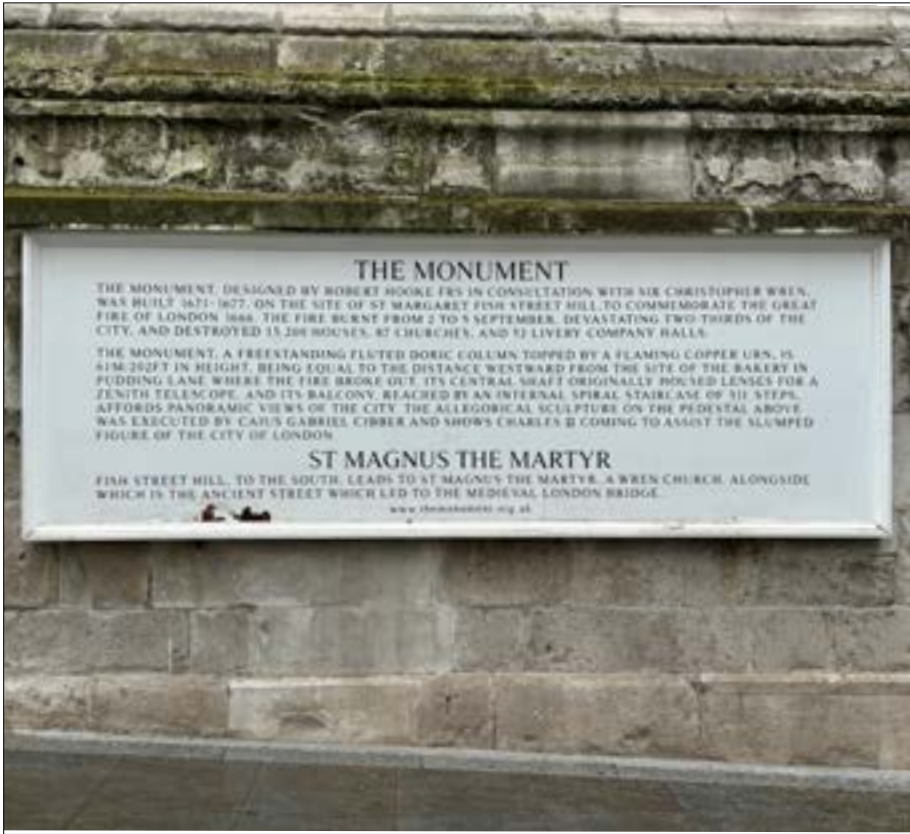
Fig. 11 Timber panel and inscription, 2024

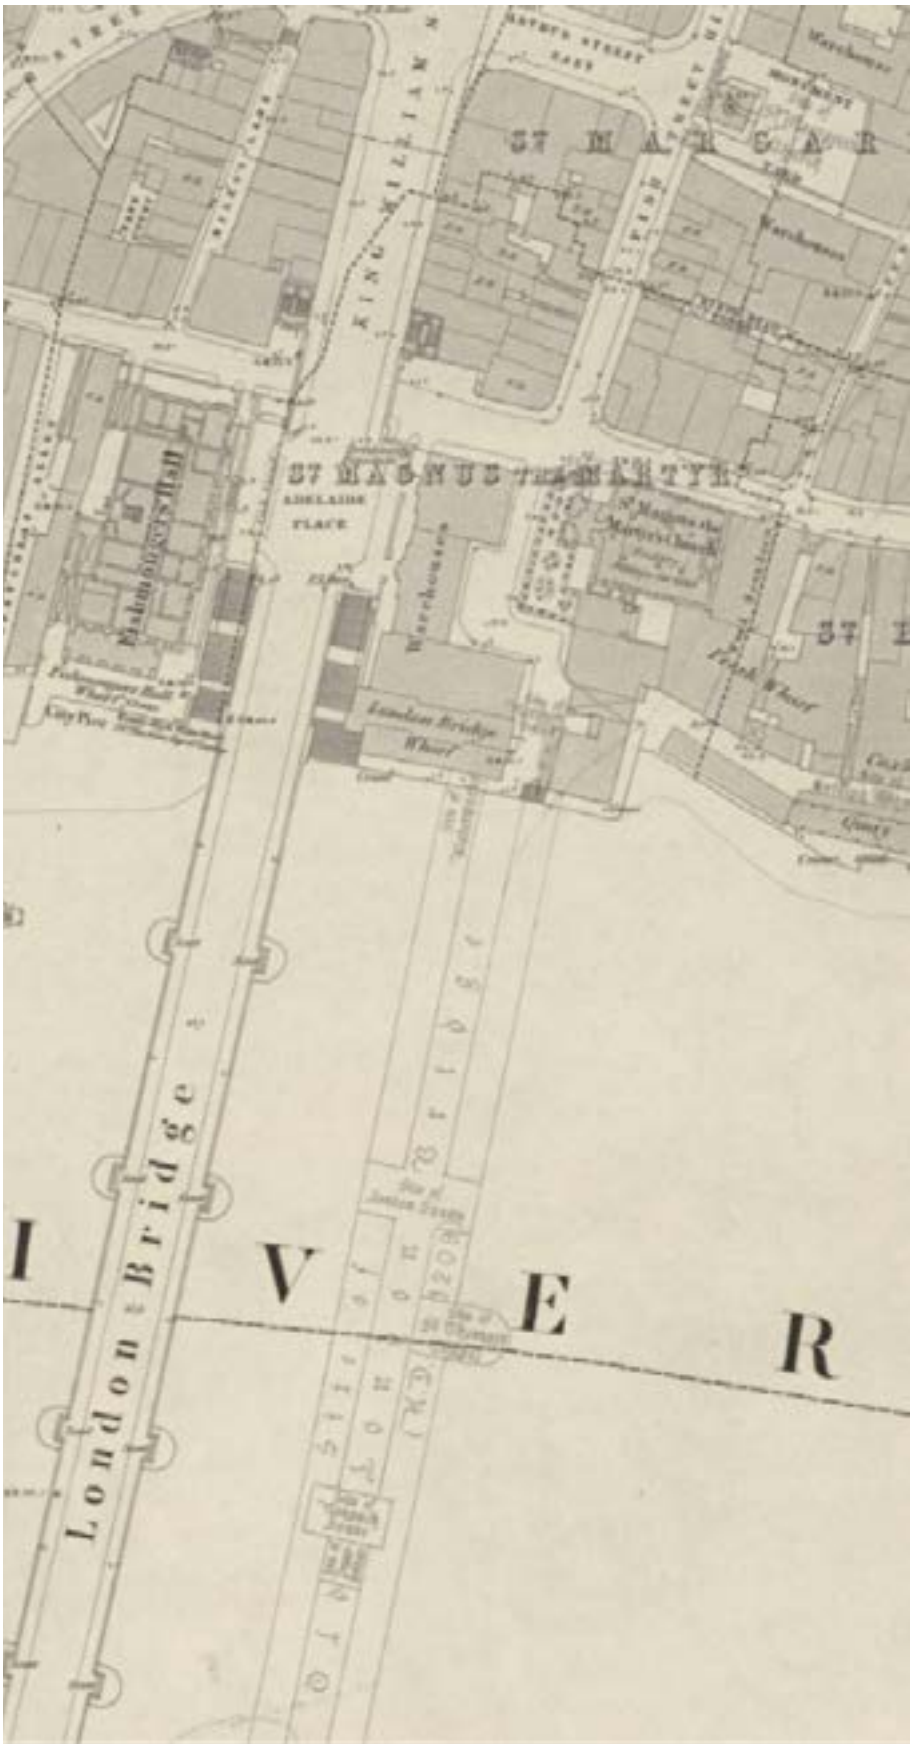
Fig. 12 1883 Ordnance survey map showing The Monument with the outline of Old London Bridge

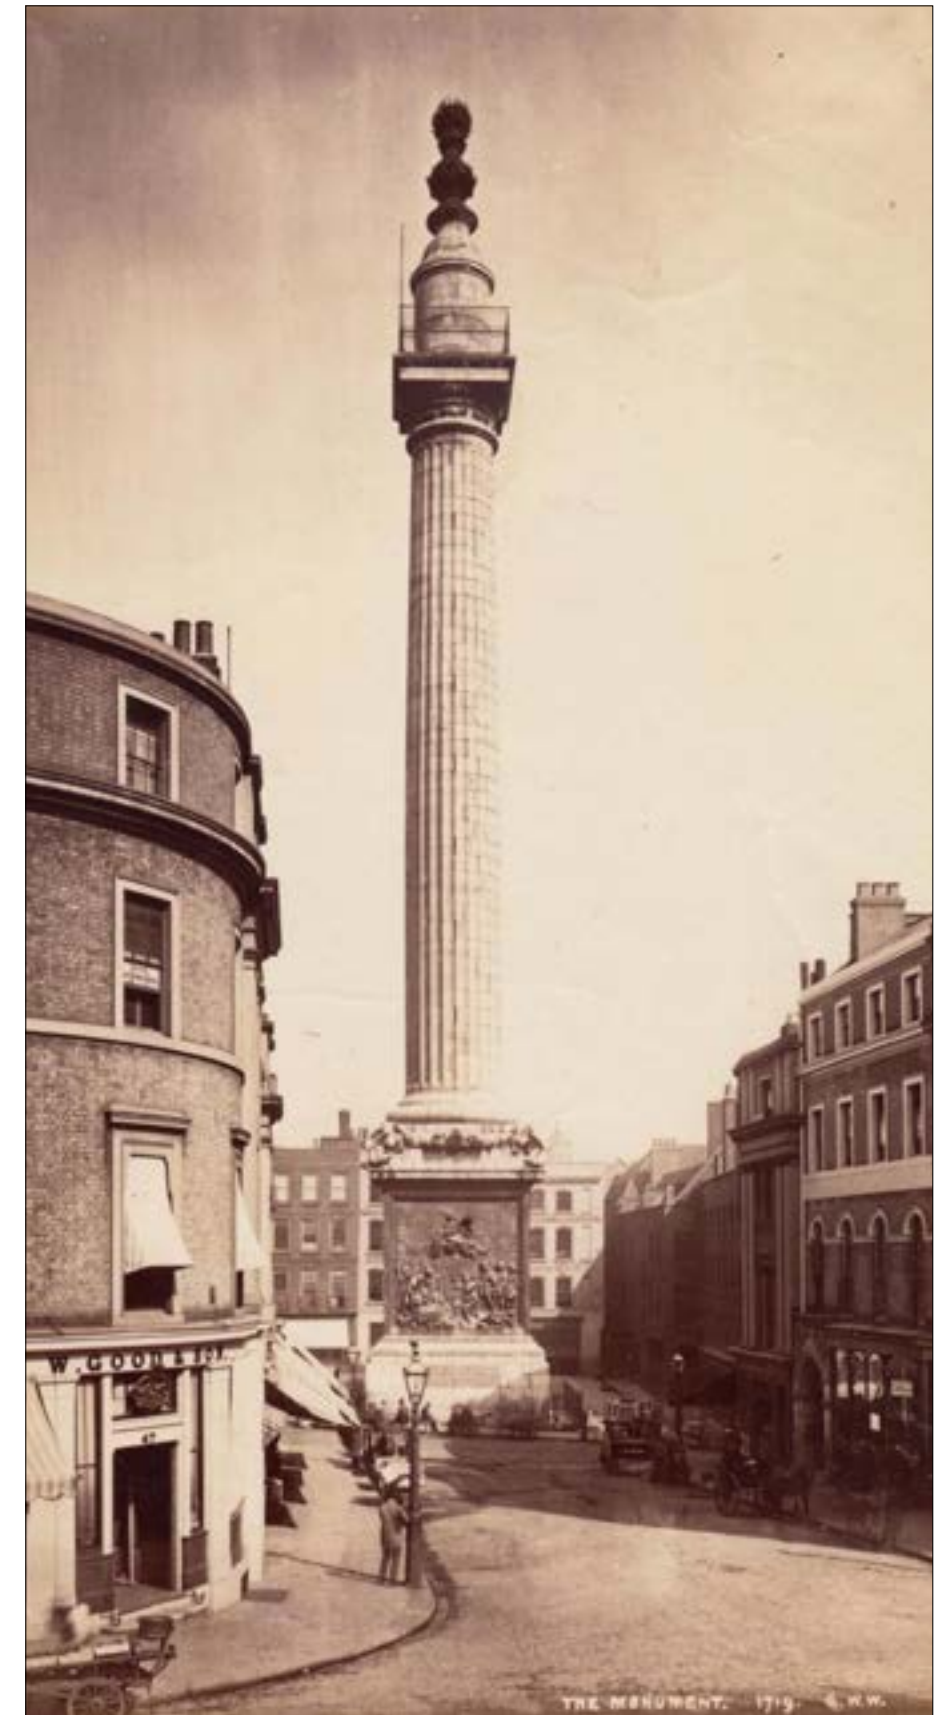
Fig. 17 Late 1870s photograph showing Monument Yard in its original form as a piazza, with surrounding buildings physically deferential to The Monument.

The late 1870s photograph (Fig. 17) shows Monument Yard in its original form as a piazza, with the surrounding buildings a variety of architectural styles, quite modest in aspiration and physically deferential to The Monument and not competing with it. All the buildings in the photograph of the east side (behind The Monument) look to be late 17th century. On the south side are more utilitarian type buildings, likely to be warehouses, and between the east side late 17th century buildings and warehouses on the south side is the original alley that went through to Pudding Lane (seen here as shadow between the two buildings).

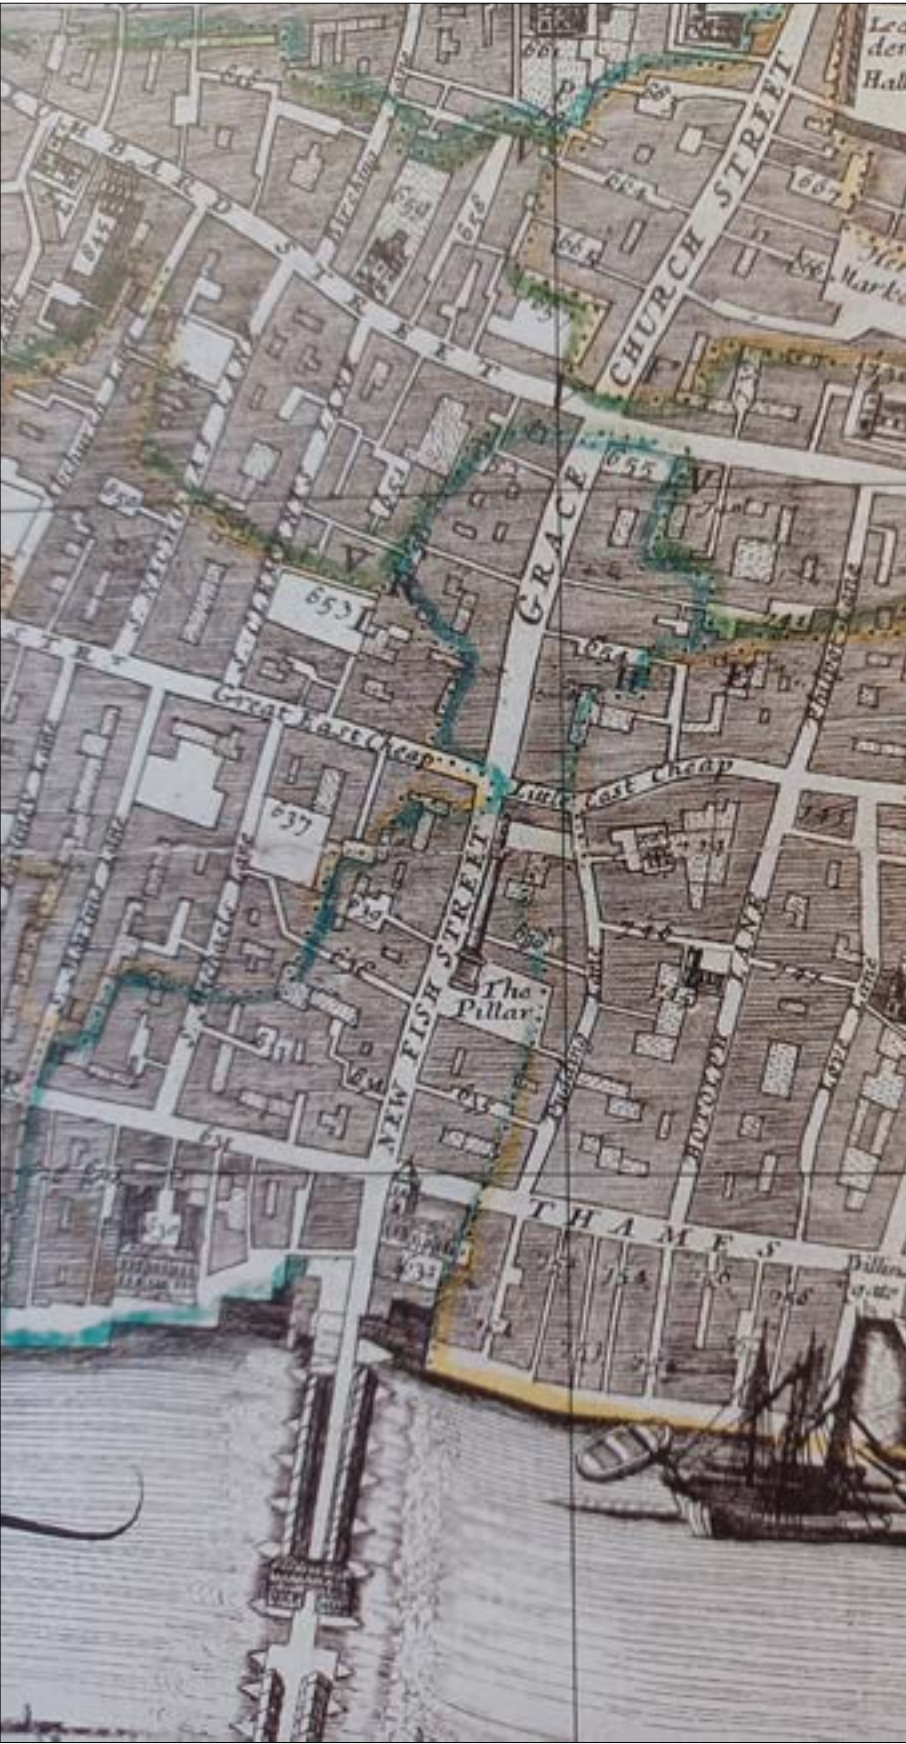
Fig. 20 1682 map showing 'The Pillar'. London &c. Actually Survey'd by William Morgan

- 1682: the Ogilby and Morgan map of 1682 shows that within ten years of the Great Fire the whole of the Pudding Lane area had been redeveloped. The Monument, built in 1671-77, and its square is shown (Fig. 20).

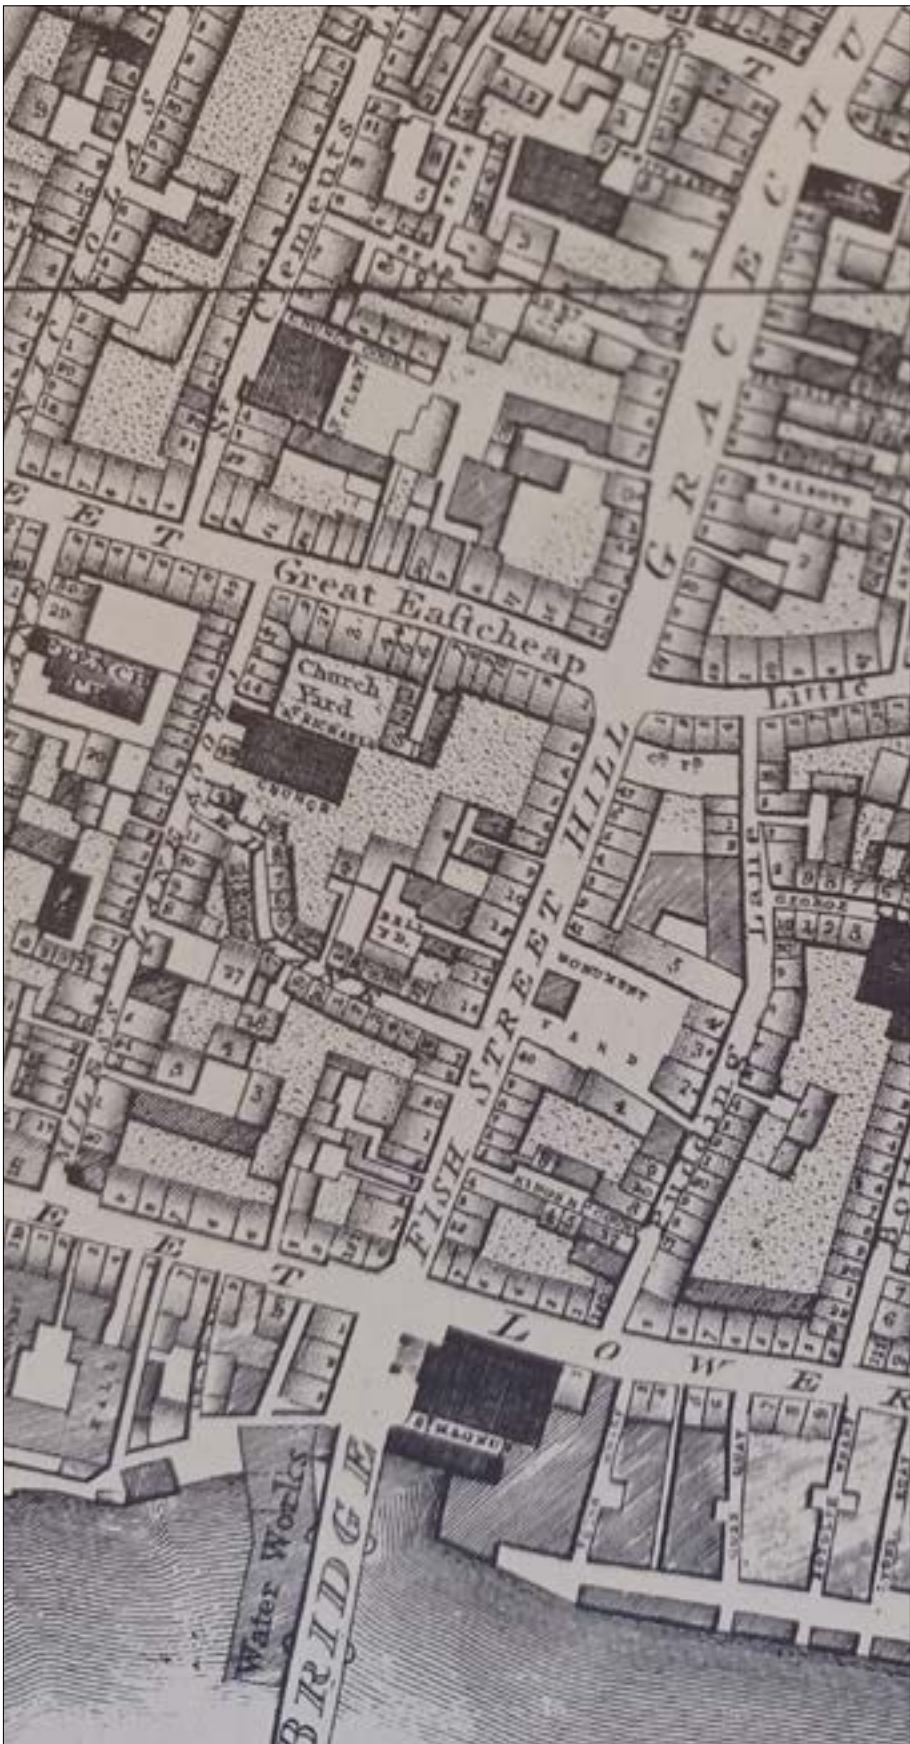
Fig. 22 Richard Horwood's map of 1792-99 and updated by William Faden in 1813 – useful for showing the individual buildings in Monument Yard

- 1746: Rocque's map of 1746 showing a similar pattern (Fig. 21).
- 1799: The Horwood map of 1799 shows the property numbers indicating the buildings were addressed as Monument Yard (Fig. 22).

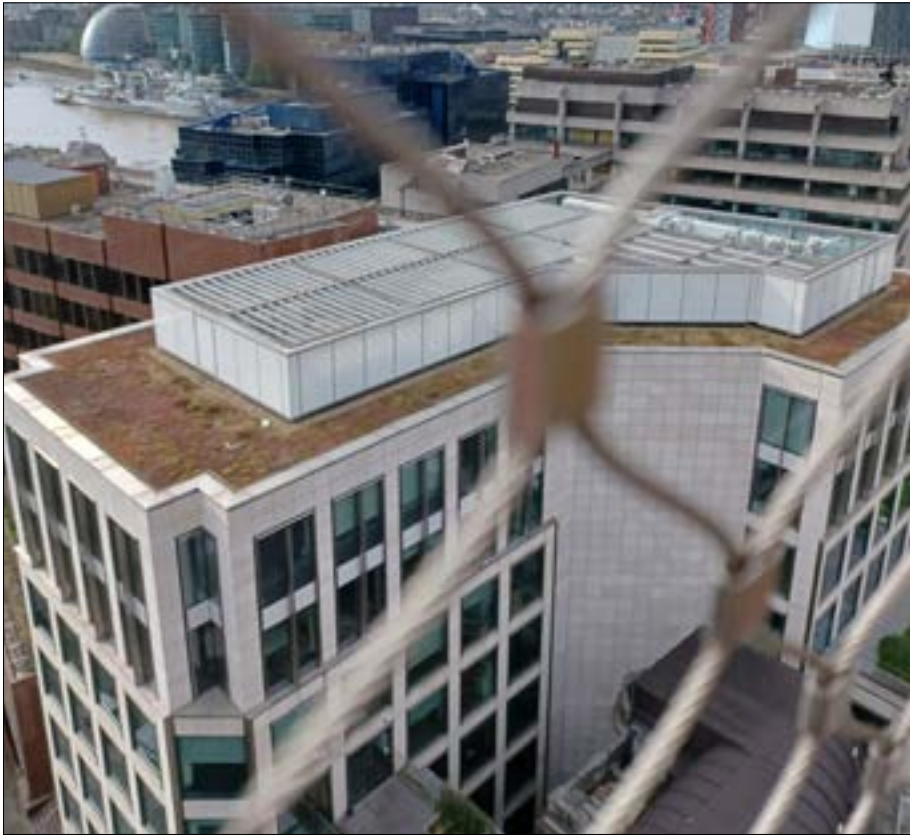
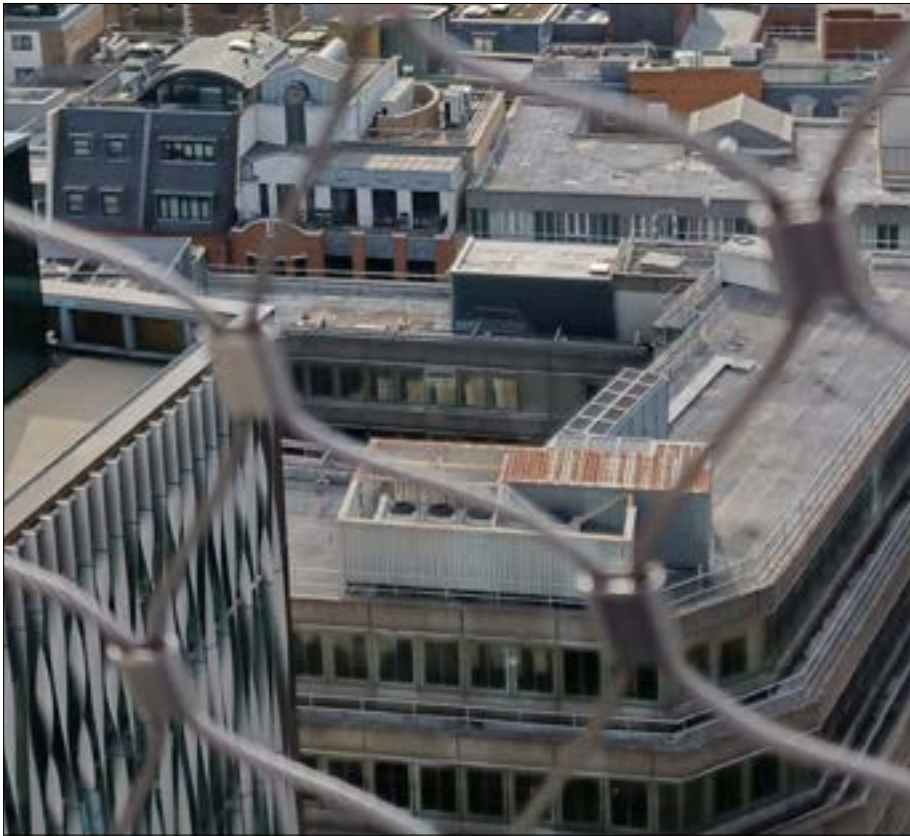
Fig. 41 From the Viewing Platform: rooftop services & plant, 2024

Fig. 42 From the Viewing Platform: rooftop services & plant, 2024

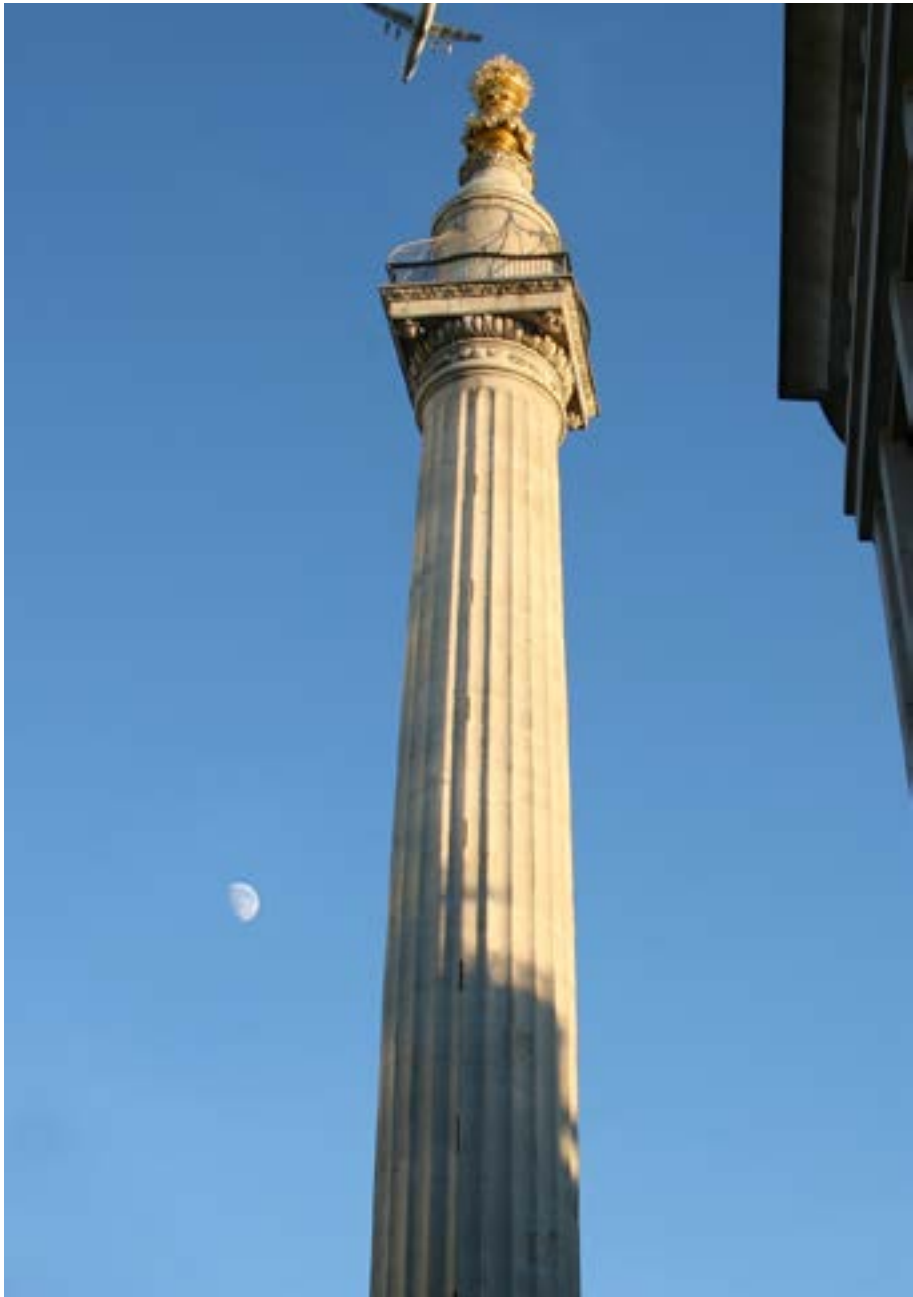
Fig. 45 Exterior of The Monument, 2009

The column shaft is 99 feet in height with 24 convex flutes. The raised flat ridge between two flutes is a fillet and, on The Monument, the central fillet on each face of the column is pierced with 8 no. narrow slit lights which light the internal staircase. The column base comprises a torus moulding on a square base,

which is decorated on each of the four sides by a carved garland with a shield and scroll and a carved dragon at each corner, representing the City of London.

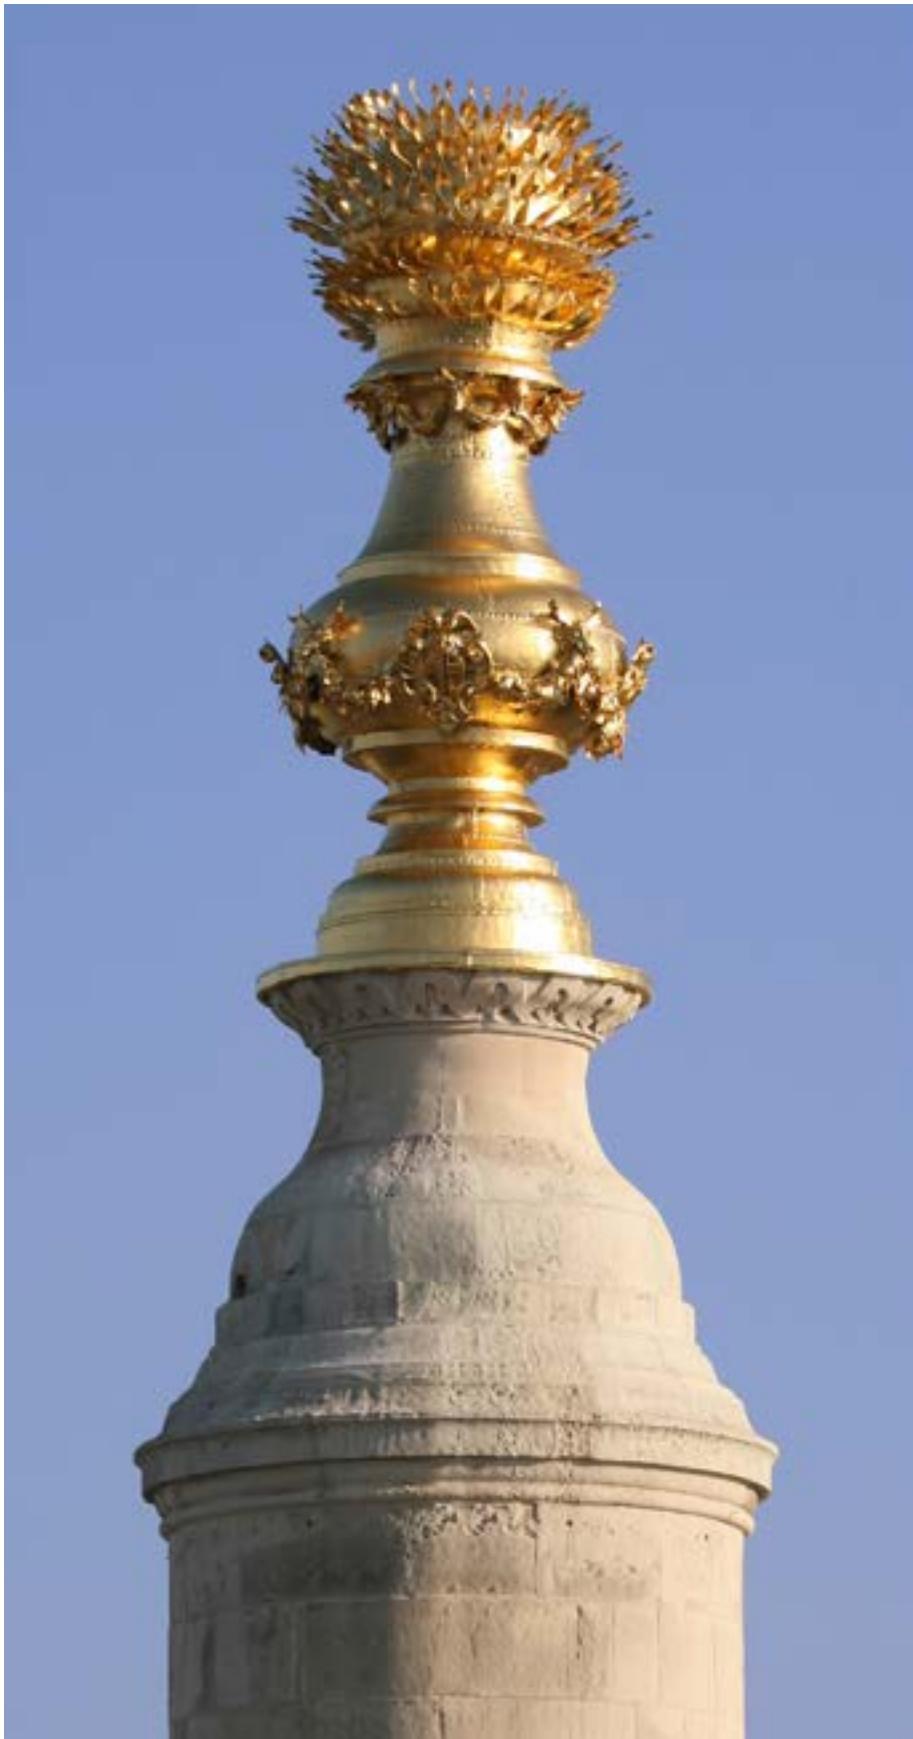
Fig. 47 The gilded copper flaming orb on the stone dome and drum 2009

The form of the flaming orb is a massive urn with a bowl at the very top constructed from deep bands of sheet copper, 1/8 inch thick, riveted together. The urn is decorated externally with copper garlands and the bowl with many twisted strips of copper, all fixed with rivets. The copperwork is externally gilded with sheets of gold leaf. The effect is a bowl of dazzling gold flames atop a golden urn.

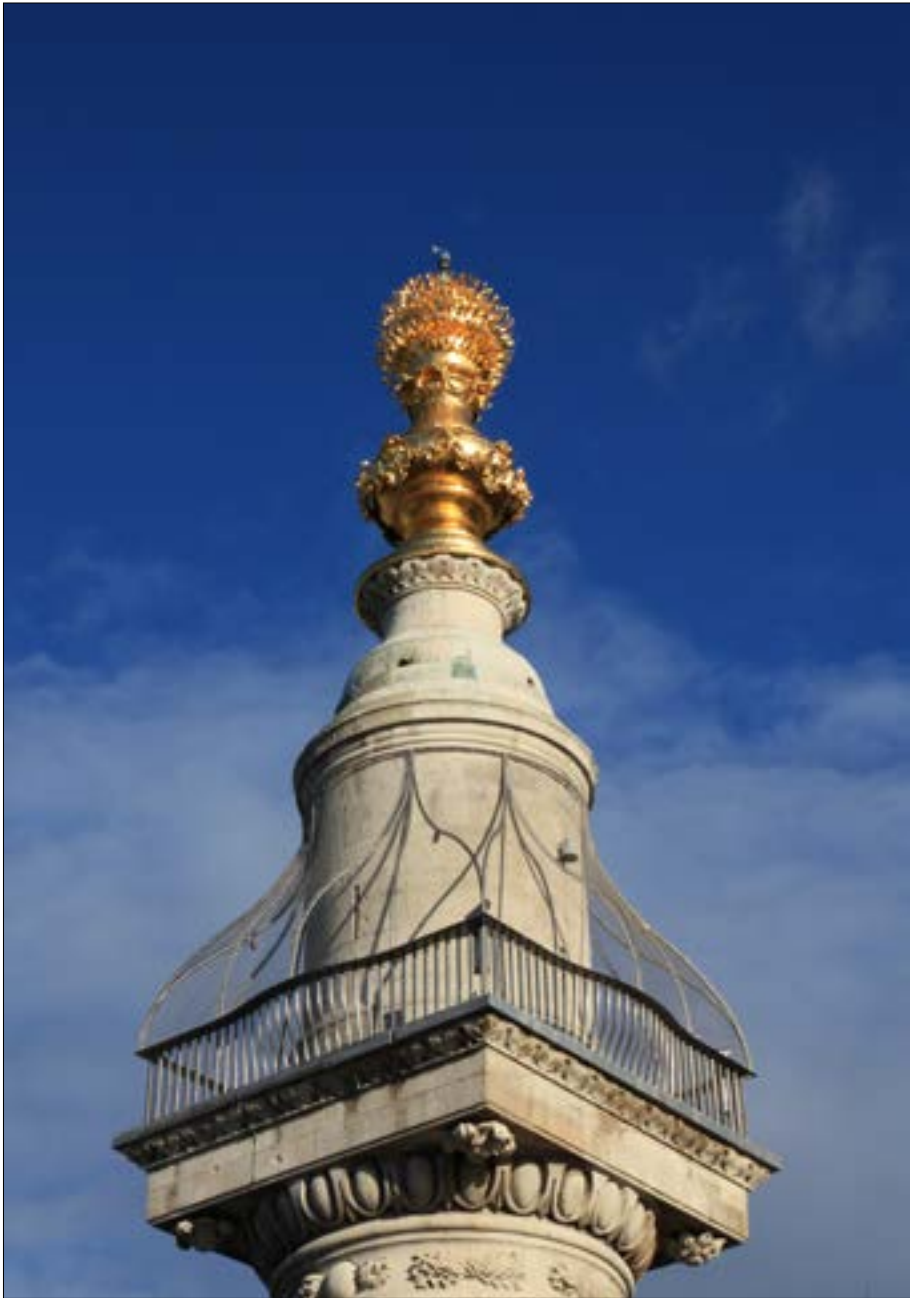
Fig. 50 Viewing platform new cage & balustrade in 2009.

At the time of its construction, the viewing platform was surmounted by a wrought-iron balustrade to dado height, with each widely spaced square baluster, appearing to be lead-caulked into the stone platform. Archive records describe the balustrade being extensively repaired and strengthened towards the end of the 18th century and in 1842, an iron cage added to prevent people throwing themselves from the platform. The balustrade and cage were renewed in 1954 with painted cast iron framing and balusters.

In 2009 the balustrade and cage were replaced with the current curved stainless-steel balustrade. Only alternate balusters are actually structurally embedded in the viewing platform to reduce the risk of inducing cracking along the edge of the black limestone.

Fig. 78 Viewing platform stainless-steel cage & balustrade, 2009

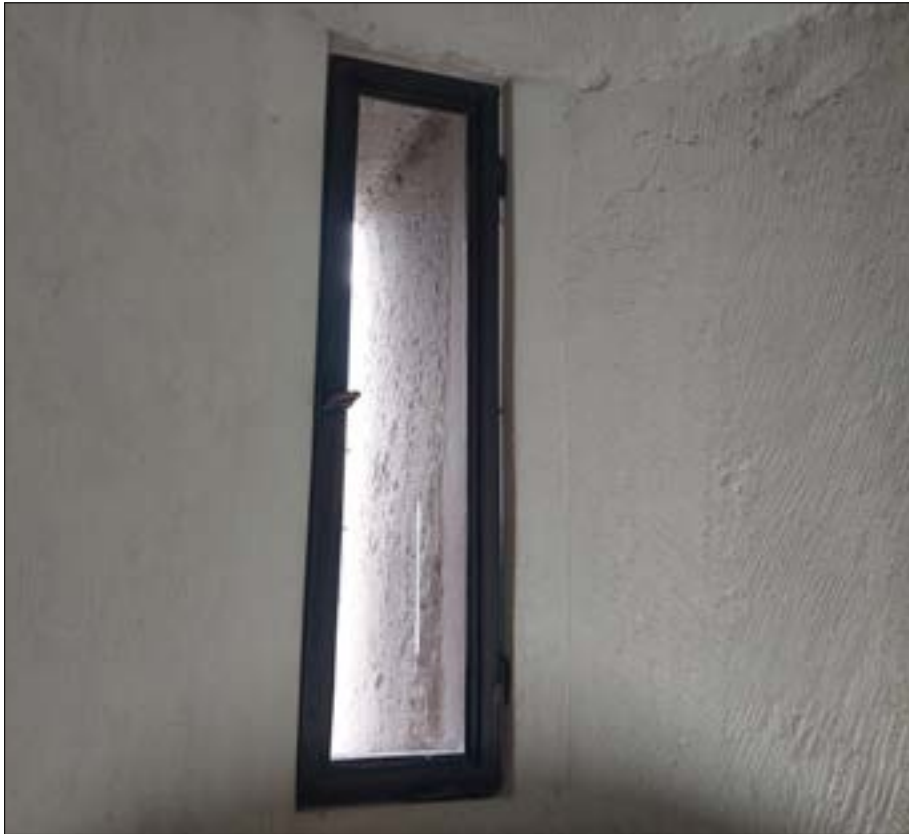
Fig. 51 Bronze casement window flush with stone wall, 2024

Each face of the column shaft has 8 no. narrow slit window openings. Internally the windows are within a niched recesses of varying sizes. The windows within the column shaft were nearly all replaced in 2009 with slim bronze casement windows, or fixed glass panes within bronze frames where the openings in the stonework are very narrow. An early iron framed window in the Drum was used as a prototype. Immediately above the entrance on the east side there is an oval window. The window is an iron framed centre hung pivot window.

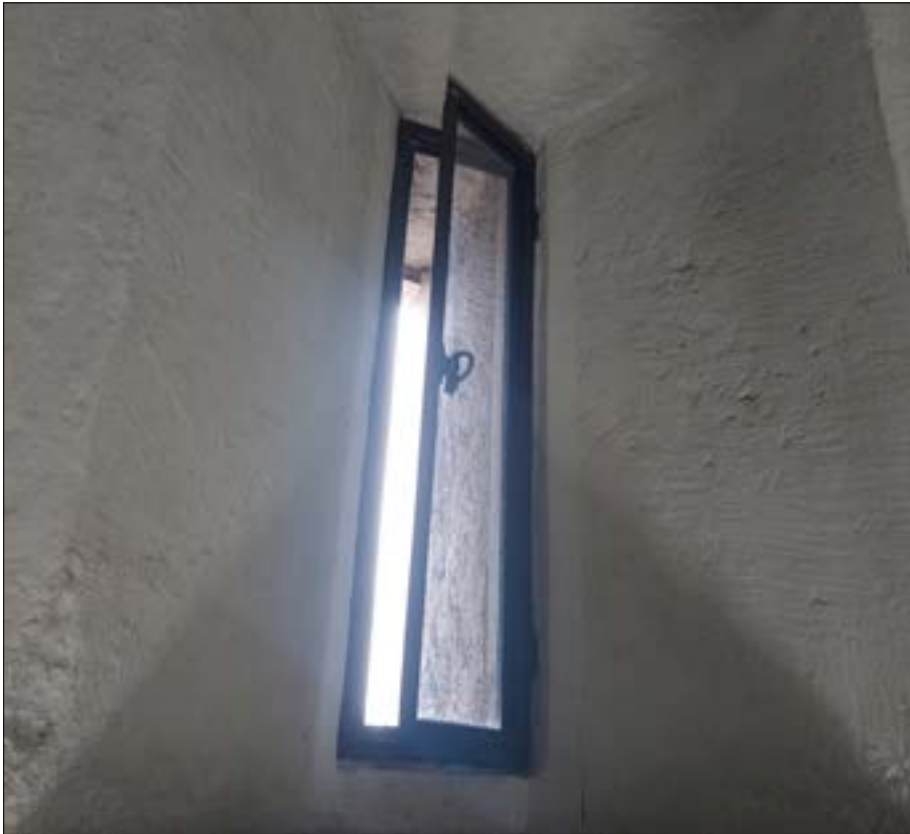
Fig. 52 Bronze casement opened, 2024

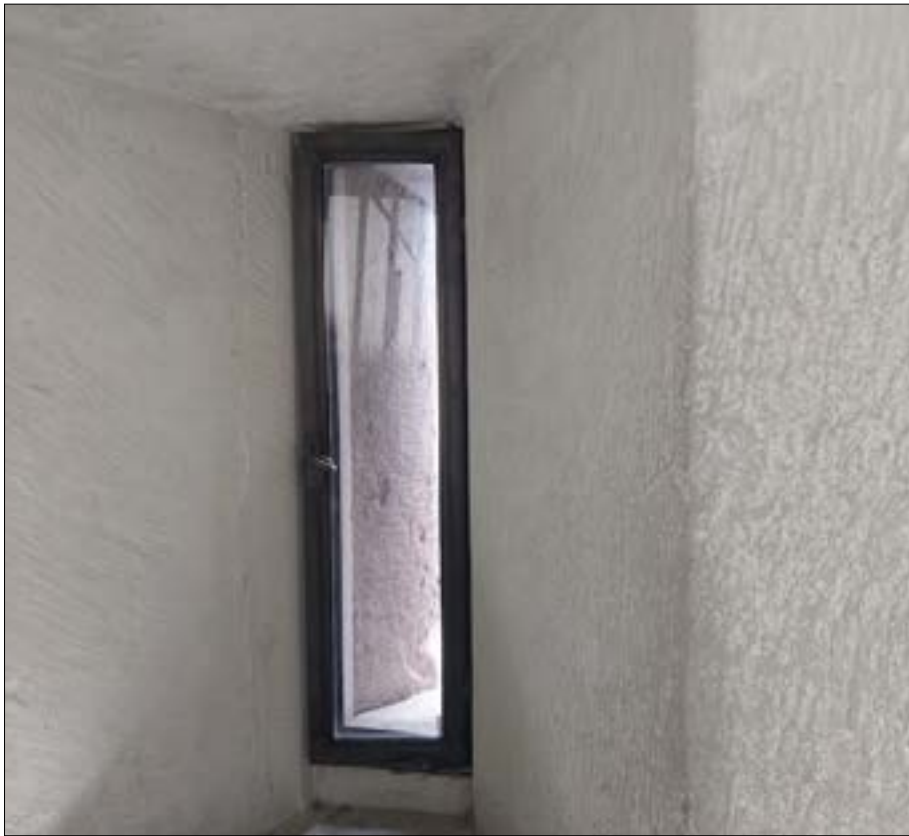
Fig. 53 Bronze casement in recessed alcove, 2024

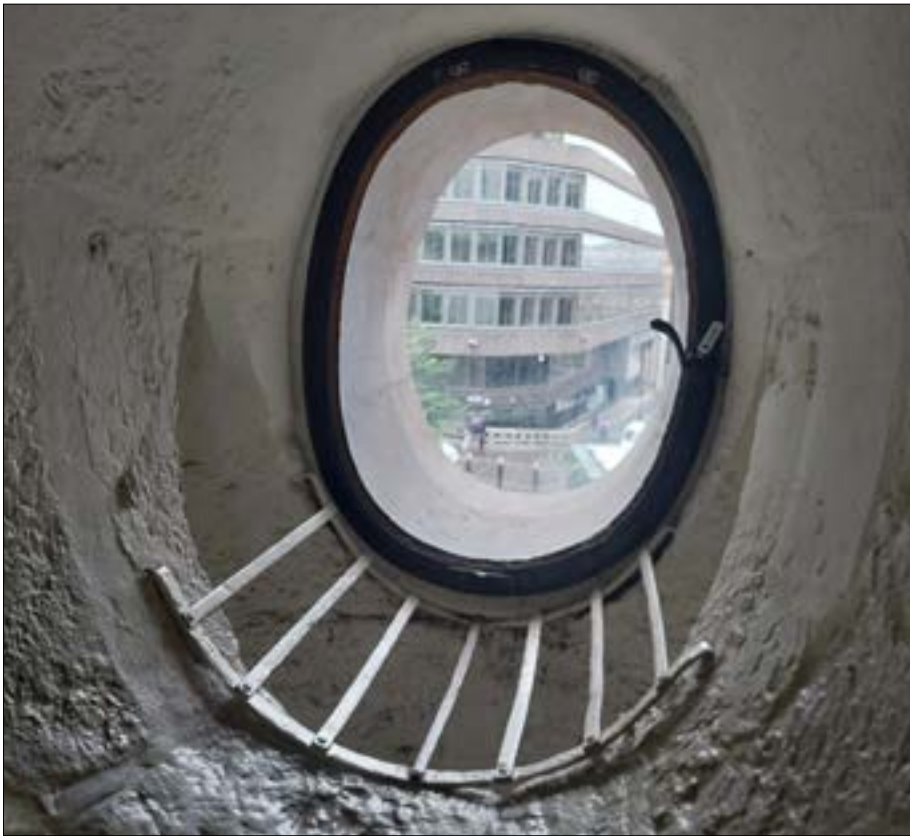
Fig. 54 Iron oval casement window, 2024

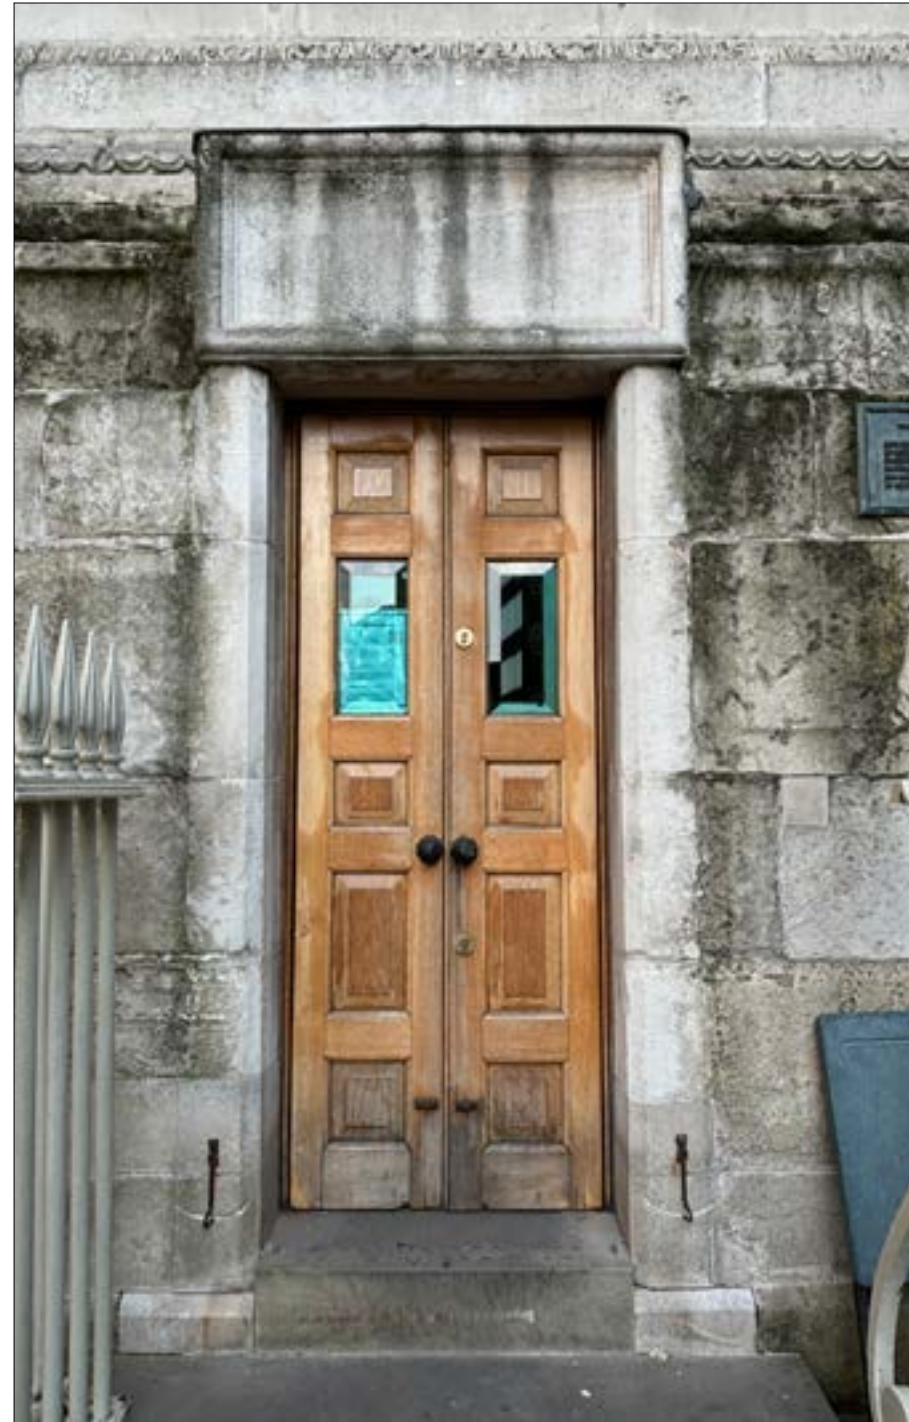
Fig. 55 Pair of glazed oak entrance doors, installed 2009, 2024.

The entrance doors are a pair of substantial four panel doors, held open within the stone reveals of the doorway by a pair of heavy iron hooks. The doors are of solid oak, glazed within their upper two panels and are set within an oak frame, all constructed in 2009.

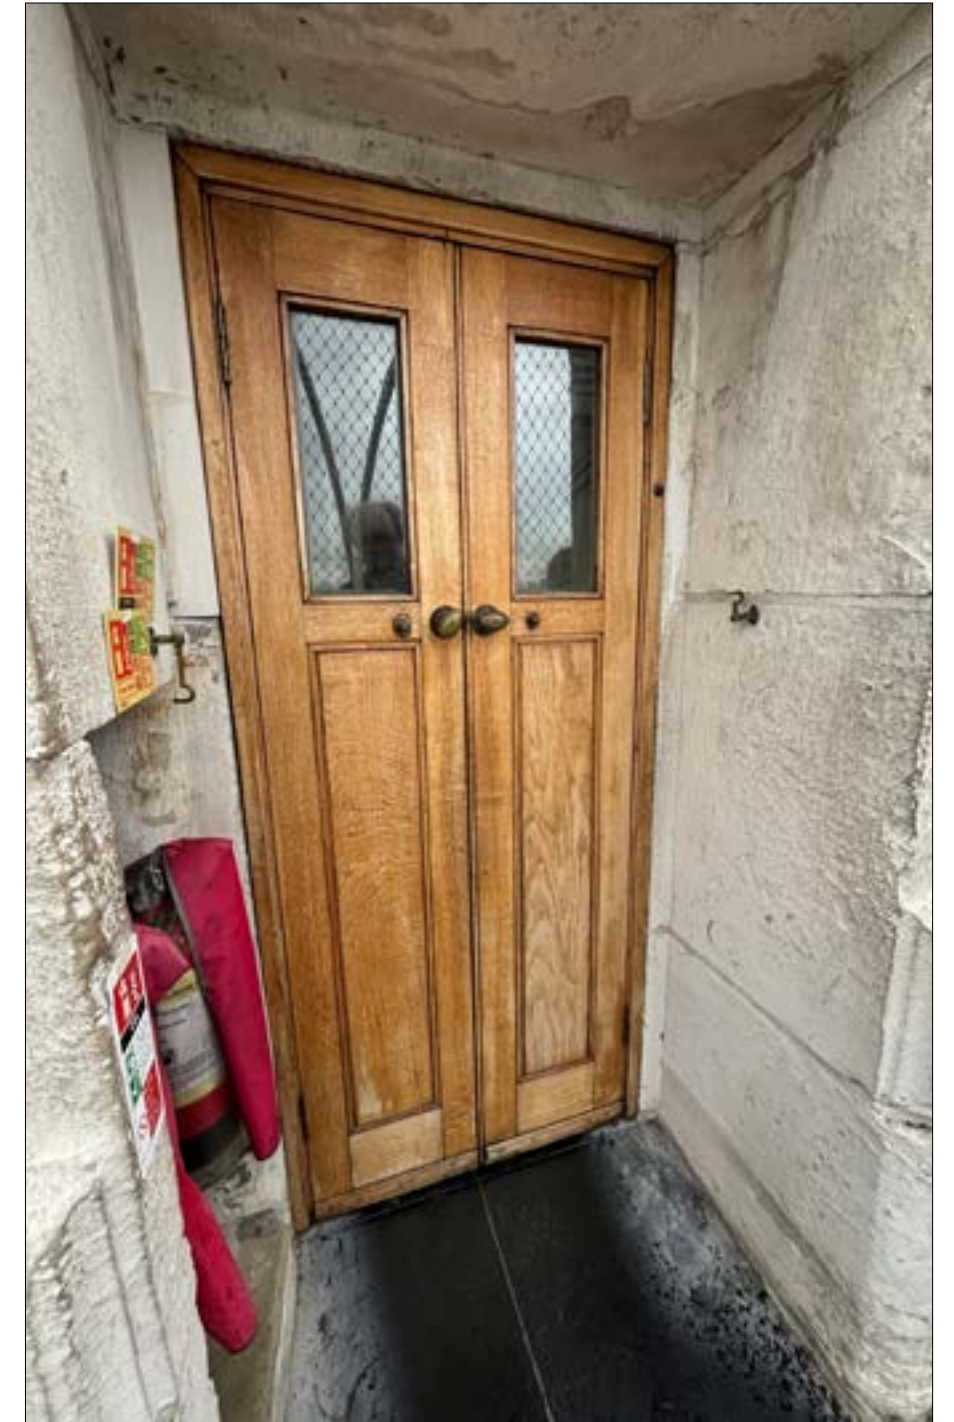
Fig. 56 Pair of glazed oak doors onto viewing platform, 2024.

The pair of oak glazed doors at high level, leading onto the viewing platform, are stained and varnished, with brass door furniture and appear to be 1950s.
