# JULIAN HARRAP

THE MONUMENT TO THE GREAT FIRE OF LONDON

VOLUME I: CONSERVATION PLAN

MARCH 2025

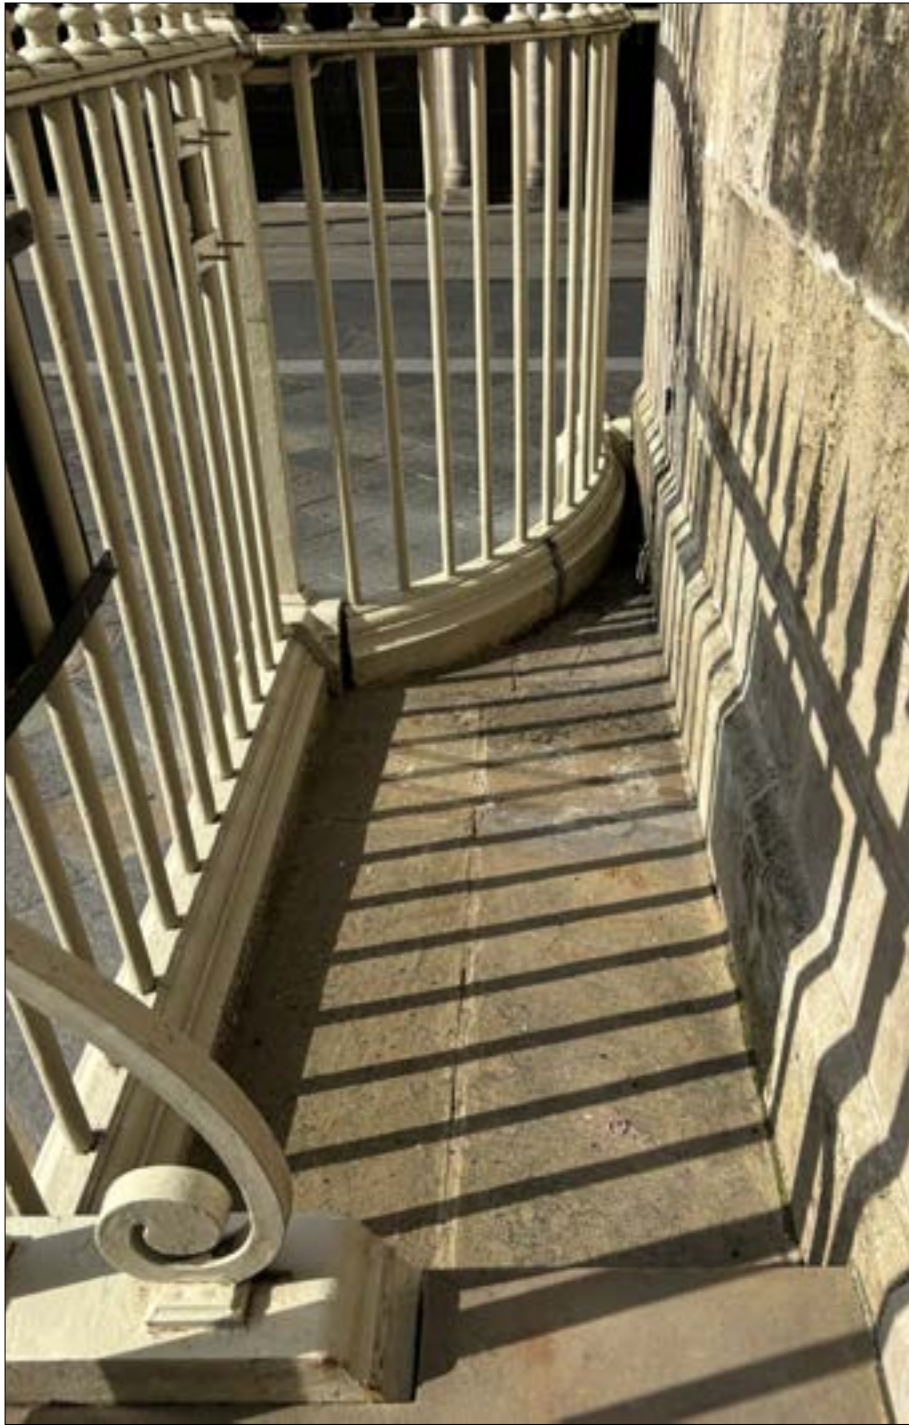
Fig. 57 Paved area within the cast iron railings on the east elevation, south side, 2024.

The Monument Yard was re-paved by the City Corporation as part of The Monument Street Scene Enhancement Scheme prior to 2007. The paving abuts the base of The Monument and is scribed to the cast iron plinth of the railings. The paving is 75mm Yorkstone on 25mm lime paving mortar on 100mm Type 1 sub-base. Yorkstone steps lead up to the entrance door. Railings around the base of The Monument were probably first installed towards the end of the 18th century, but the present cast iron railings, limited to the area around the entrance on the east facade, date from the late 19th century.

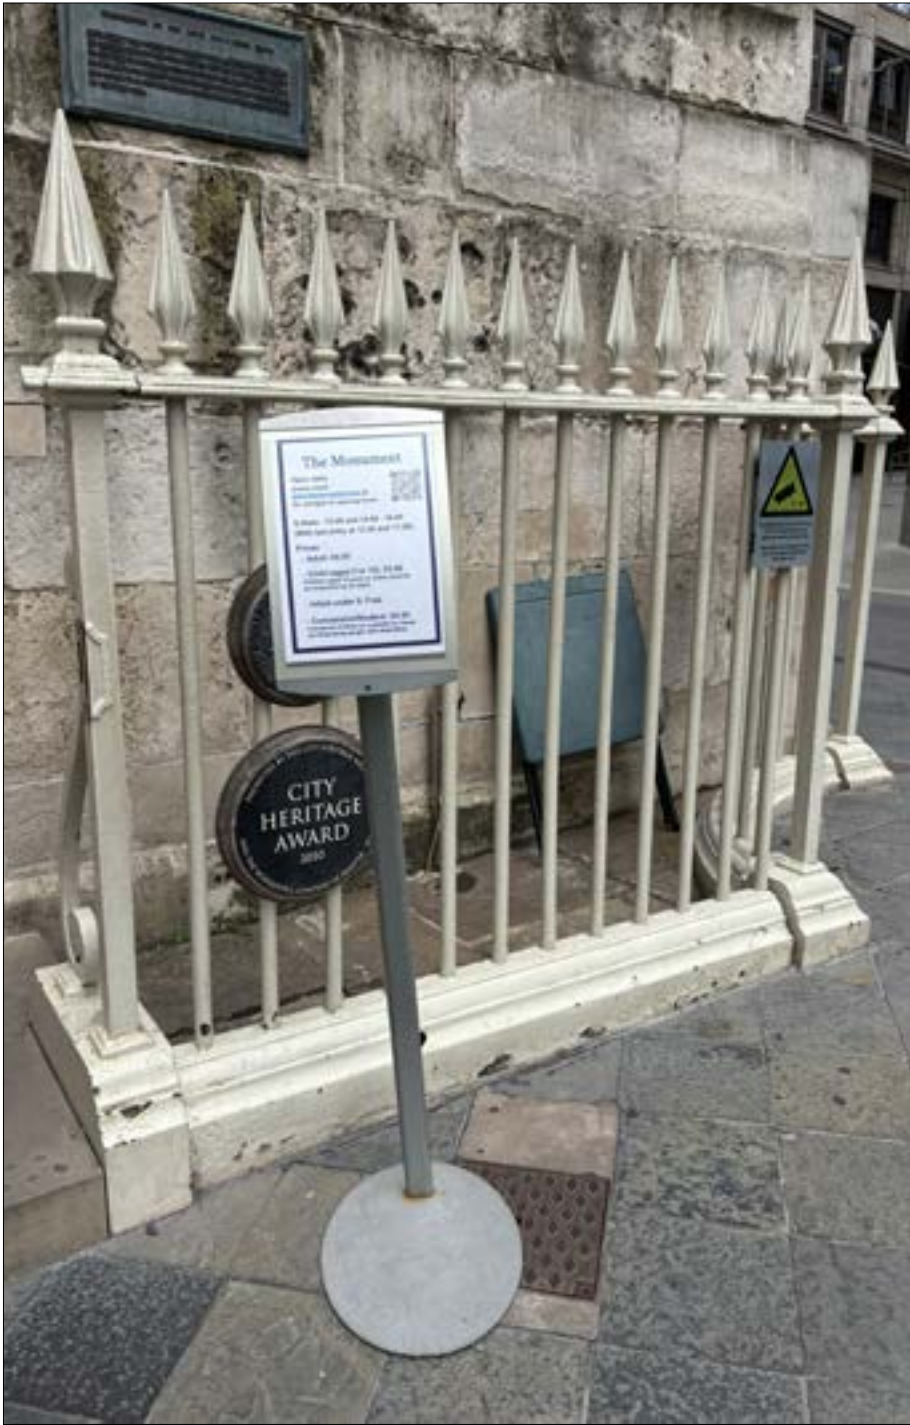
Fig. 58 Cast iron railings and plinth on the east elevation, north side, 2024

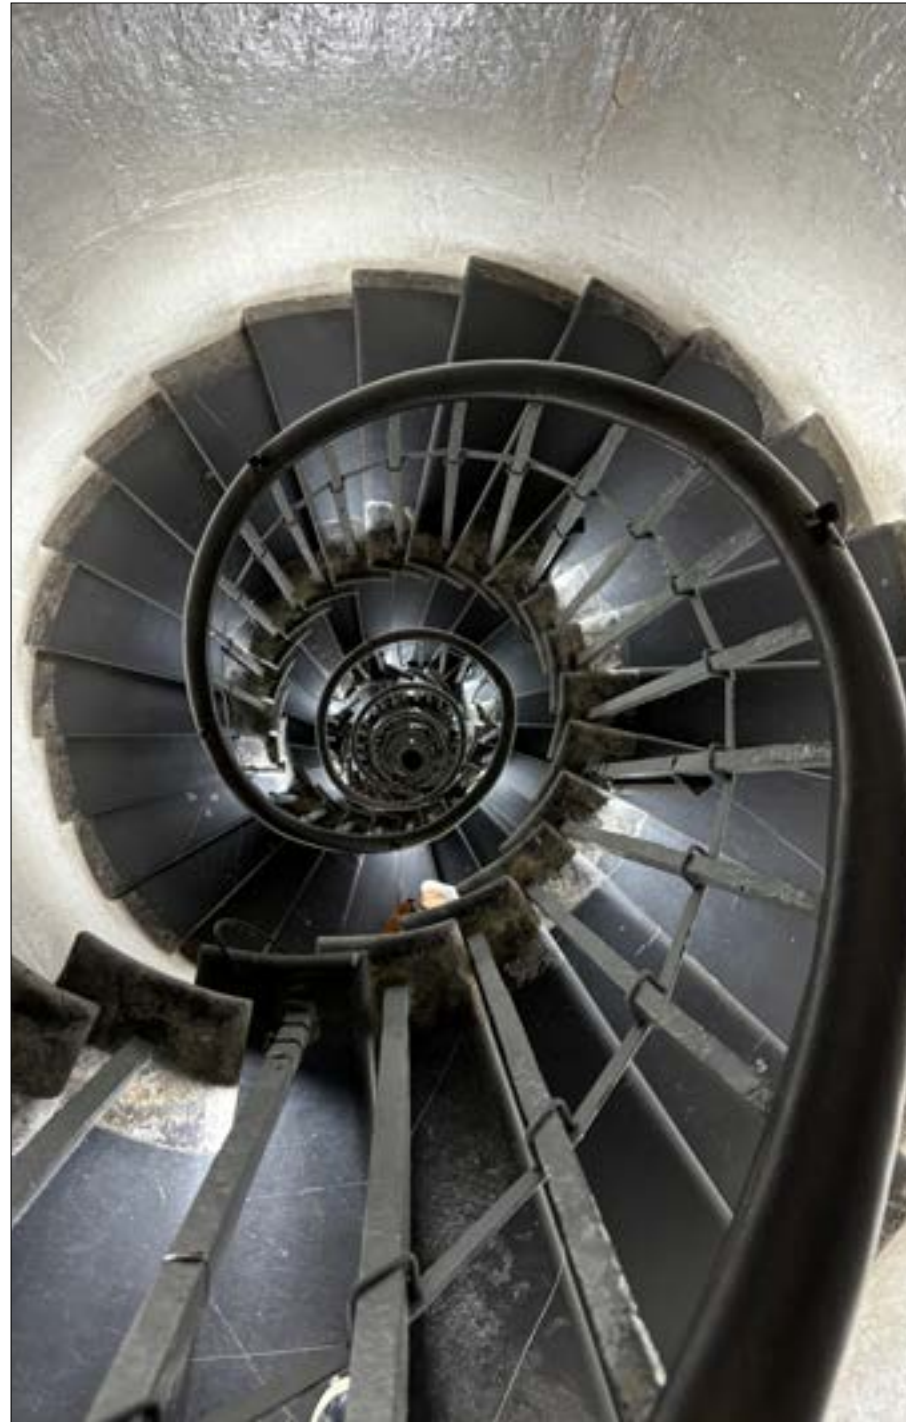
Fig. 59 Looking down the helical staircase showing stone insert repairs to all historic stair treads, 2024

The original black limestone spiral staircase was extensively structurally repaired during the 2009 contract using Fischer resin and stainless-steel reinforcement rods. Repairs to the steps were undertaken using black limestone from the Pooil Vaaish quarry on the Isle of Man, believed to be the original source of the stone.

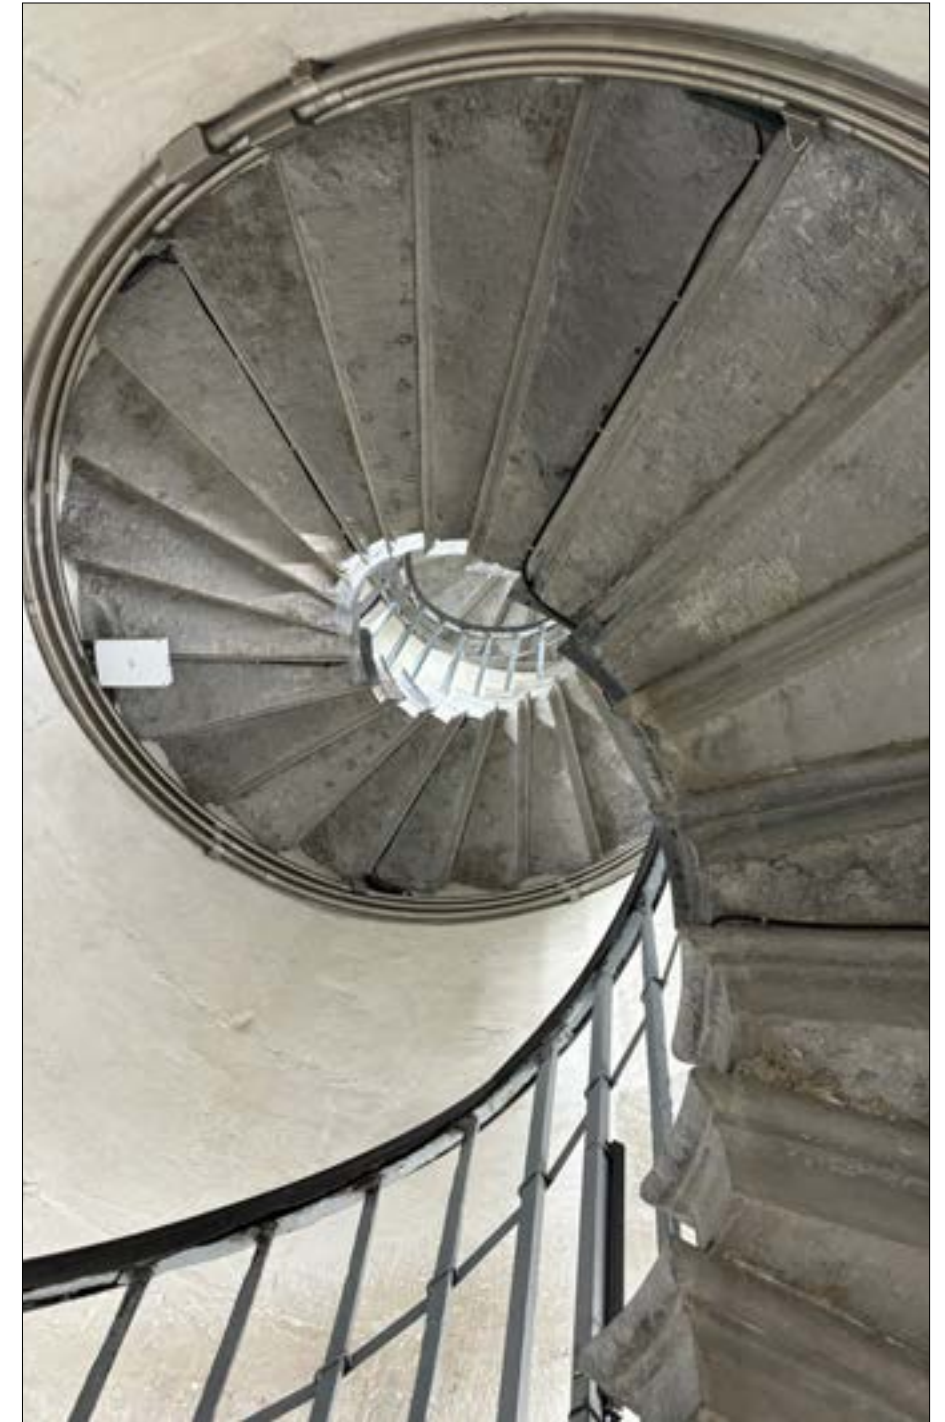
Fig. 60 Looking up at the underside of the stair treads at the original black limestone, 2024

‘a fine grained, dark grey and irregularly laminated limestone, a Bituminous Stromstolitic Pelmicrite. The general appearance, lithology and preservation are typical of many limestones from lower carboniferous strata of Britain, and north-western Europe’.

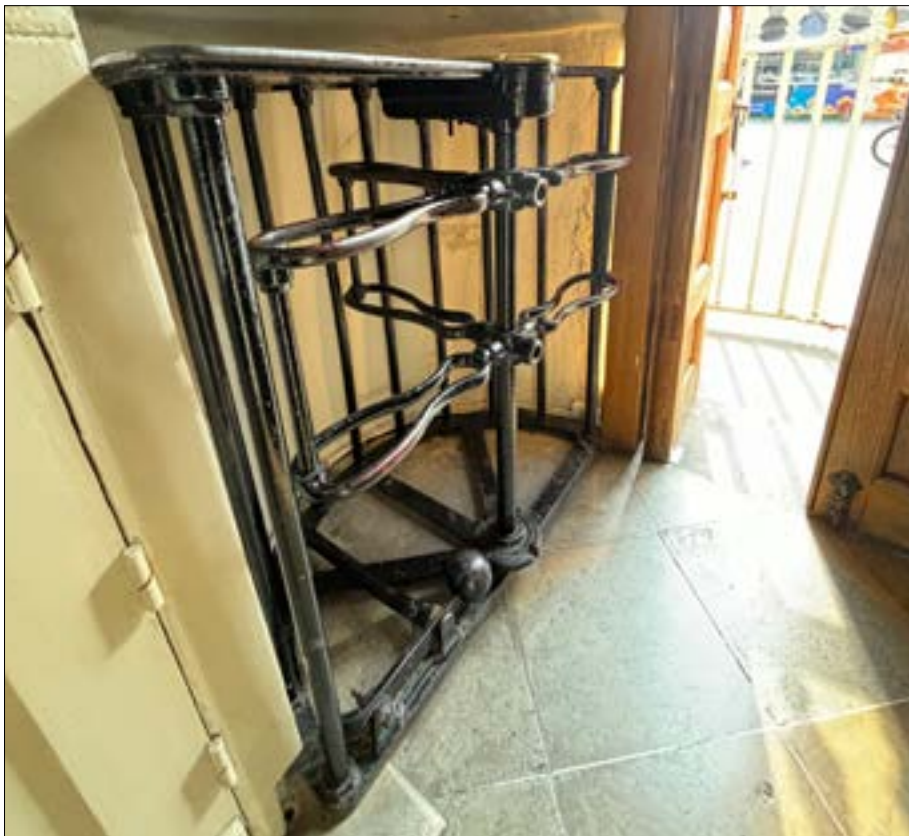
Fig. 63 c.1891 turnstile with the projecting ‘arms’ and the central rail temporarily removed (north side), 2024.

The mechanism was in good working order until the central barrier and the projecting arms of the gates were temporarily removed c.2010 to reduce the restricted access for visitors. This makes it more difficult for the attendants to count visitors in and out of the building and therefore to know how visitors are in the building at any one time.

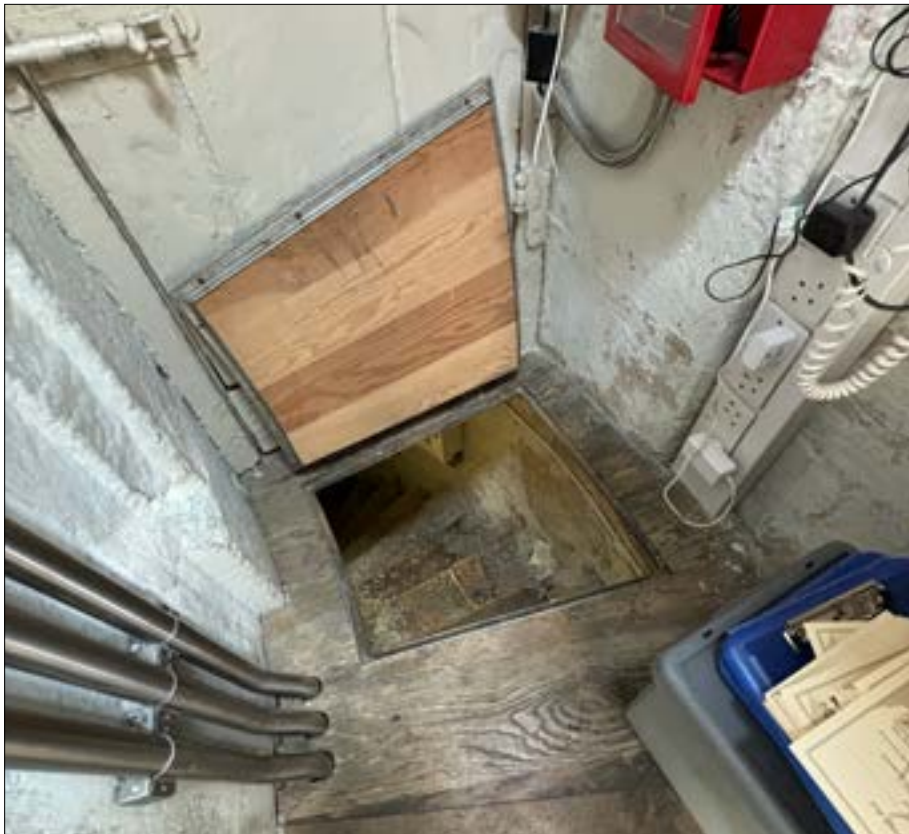
Fig. 65 Ground floor access hatch to the basement, 2024.

The floor hatch in the attendants’ recess leads, via a series of radiating stone steps, to a circular chamber 2.14 metres (7 feet) in diameter with a semi-circular domed Portland stone ceiling. The chamber lies directly beneath the stairwell. The walls are constructed of coursed rubble Portland stone blocks and red clay brickwork. The floor to the chamber is made up of a compacted lime screed.

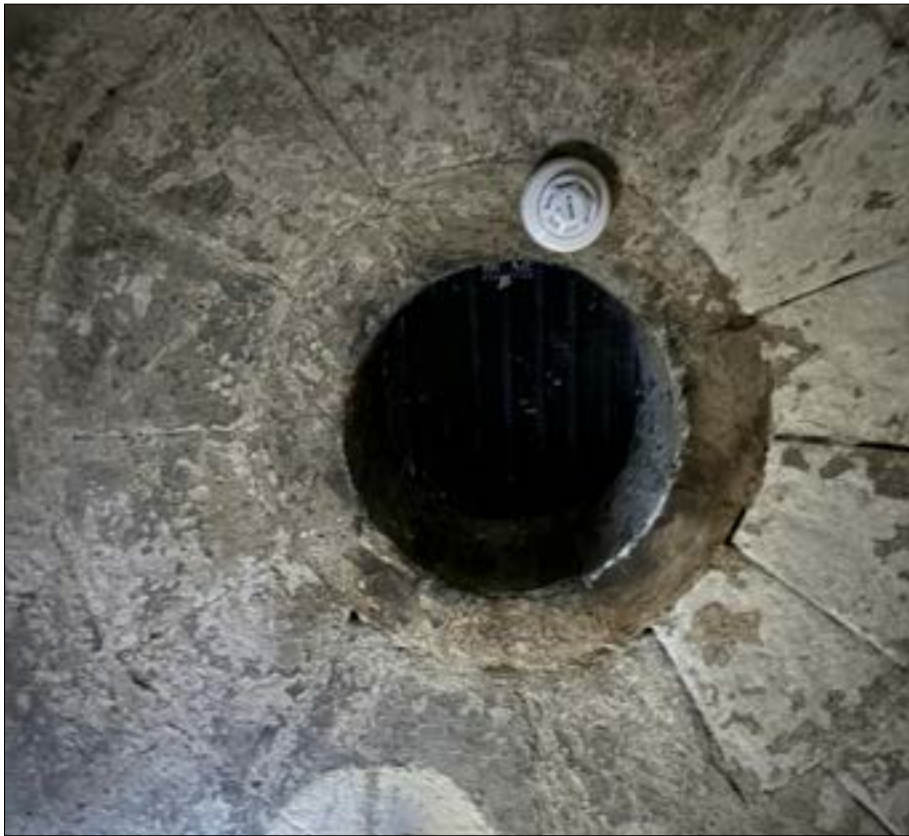
Fig. 67 Central circular basement room, looking up at the (blocked-up) oculus in the stone domed soffit, 2024

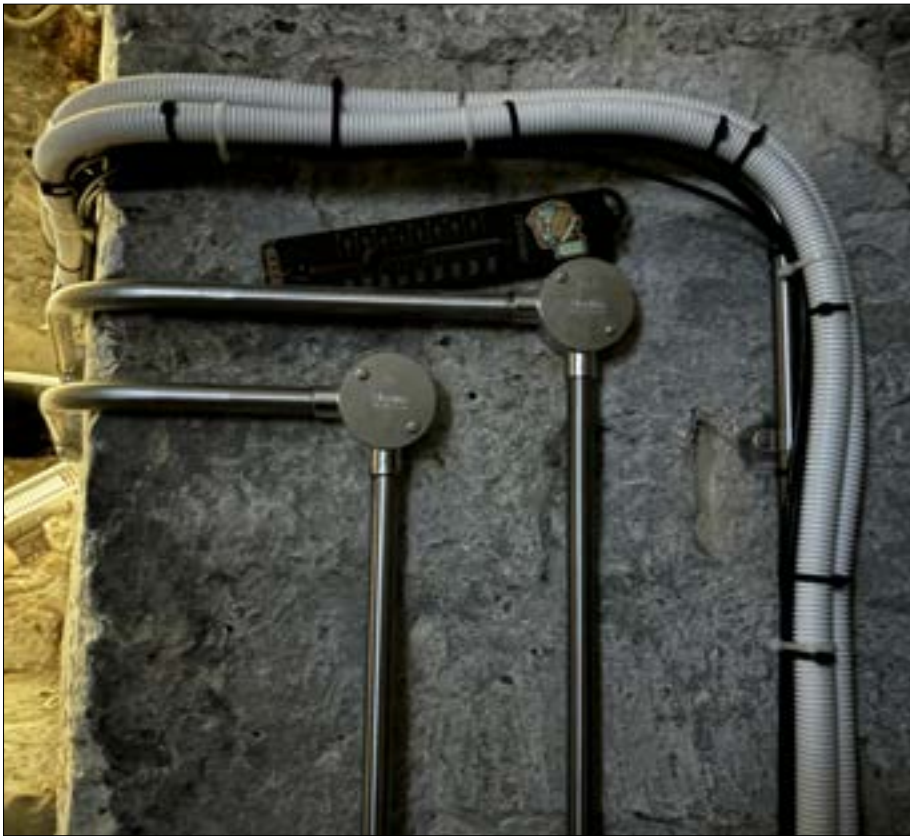
Fig. 68 Neat stainless-steel conduits & junction boxes, and temporary Cat6 cables to basement computer (for redundant Panoramic camera installation), 2024

Electrical services were renewed and upgraded in the 2007-2009 Major Repairs contract. All the cables, electrical & data, were brought up the stairwell in spiral stainless-steel conduits, each shaped-on site to fit the diminishing circumference of the stairwell. The viewing platform cage structure, of stainless-steel tubes, are also conduits for electrical cables.

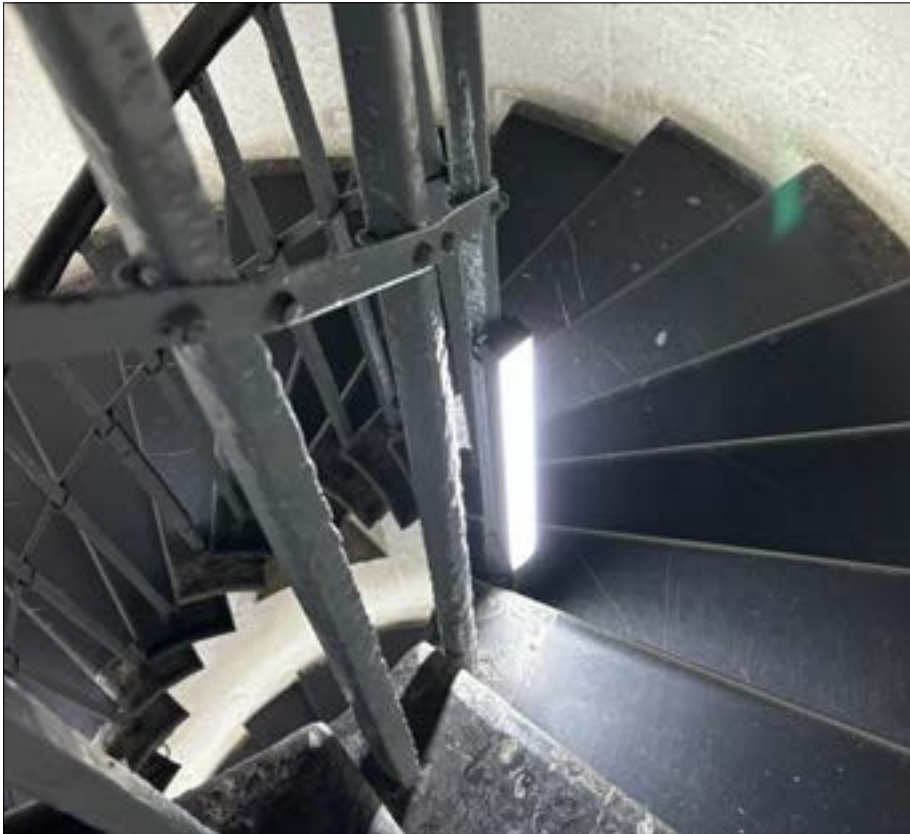
Fig. 70 Replacement stairwell lighting, 2024

The 2009 stairwell lighting was innovative slim LED light strips fixed to the 1” square stair balusters, the colour of the light fittings matching the dark grey iron balusters and softly lighting the treads of the spiral staircase. Several of the baluster lights had battery back-up as emergency lights, which were indistinguishable from the standard fittings. All baluster light fittings below viewing platform level have been replaced since 2009 with wider light strips, with a harsh bright light, and new transformers. The new baluster lights are in black housings which contrast with the balusters now painted pale grey. Emergency lights independent of the baluster lights have been introduced into the stairwell.

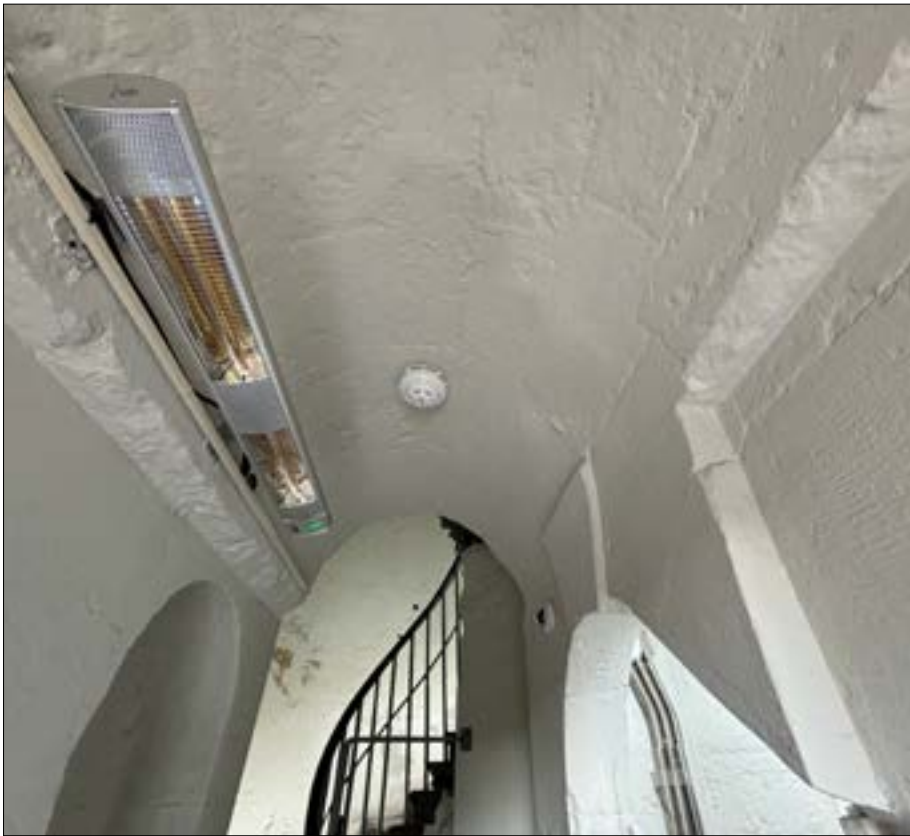
Fig. 72 Entrance foyer showing heater, redundant strip-uplighter, smoke detector, CCTV camera, stainless-steel conduits, 2024.

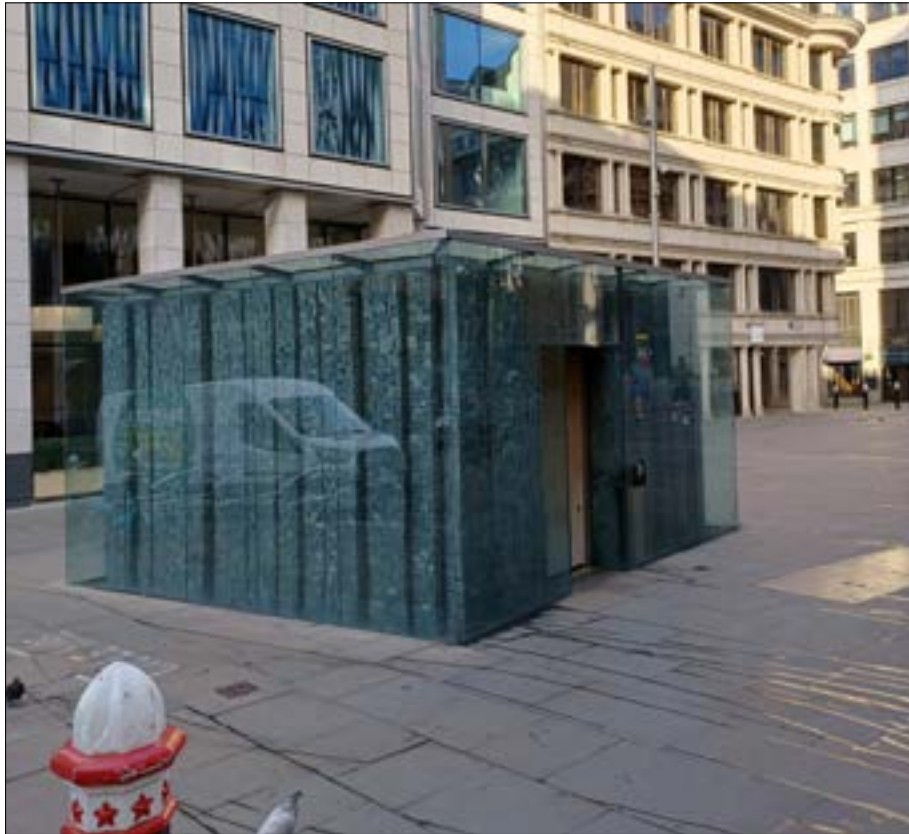
Fig. 73 The Pavilion in Monument Yard, from the north-west, 2024

The material chosen for the pavilion was Caithness Stone, the same dark stone that was chosen for paving Monument Square. The stones are within gabions which are enclosed with an outer skin of glass. The orientation of the Pavilion was rotated by 10 degrees to ensure that it will not directly face The Monument plinth, and a pallet of materials was used intended to compliment the setting of The Monument. The roof is covered in 100 small, inclined glass panels which reflect images of the Golden Orb on the top of The Monument when viewed from the viewing gallery.

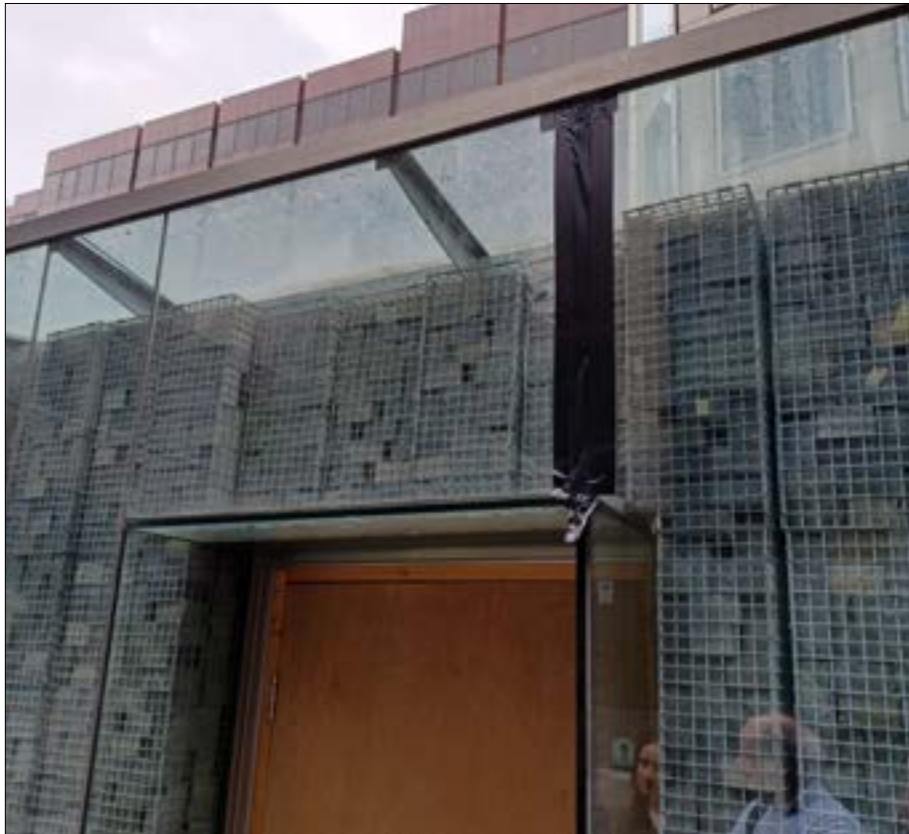
Fig. 74 Detail of the glazing & gabions, 2024

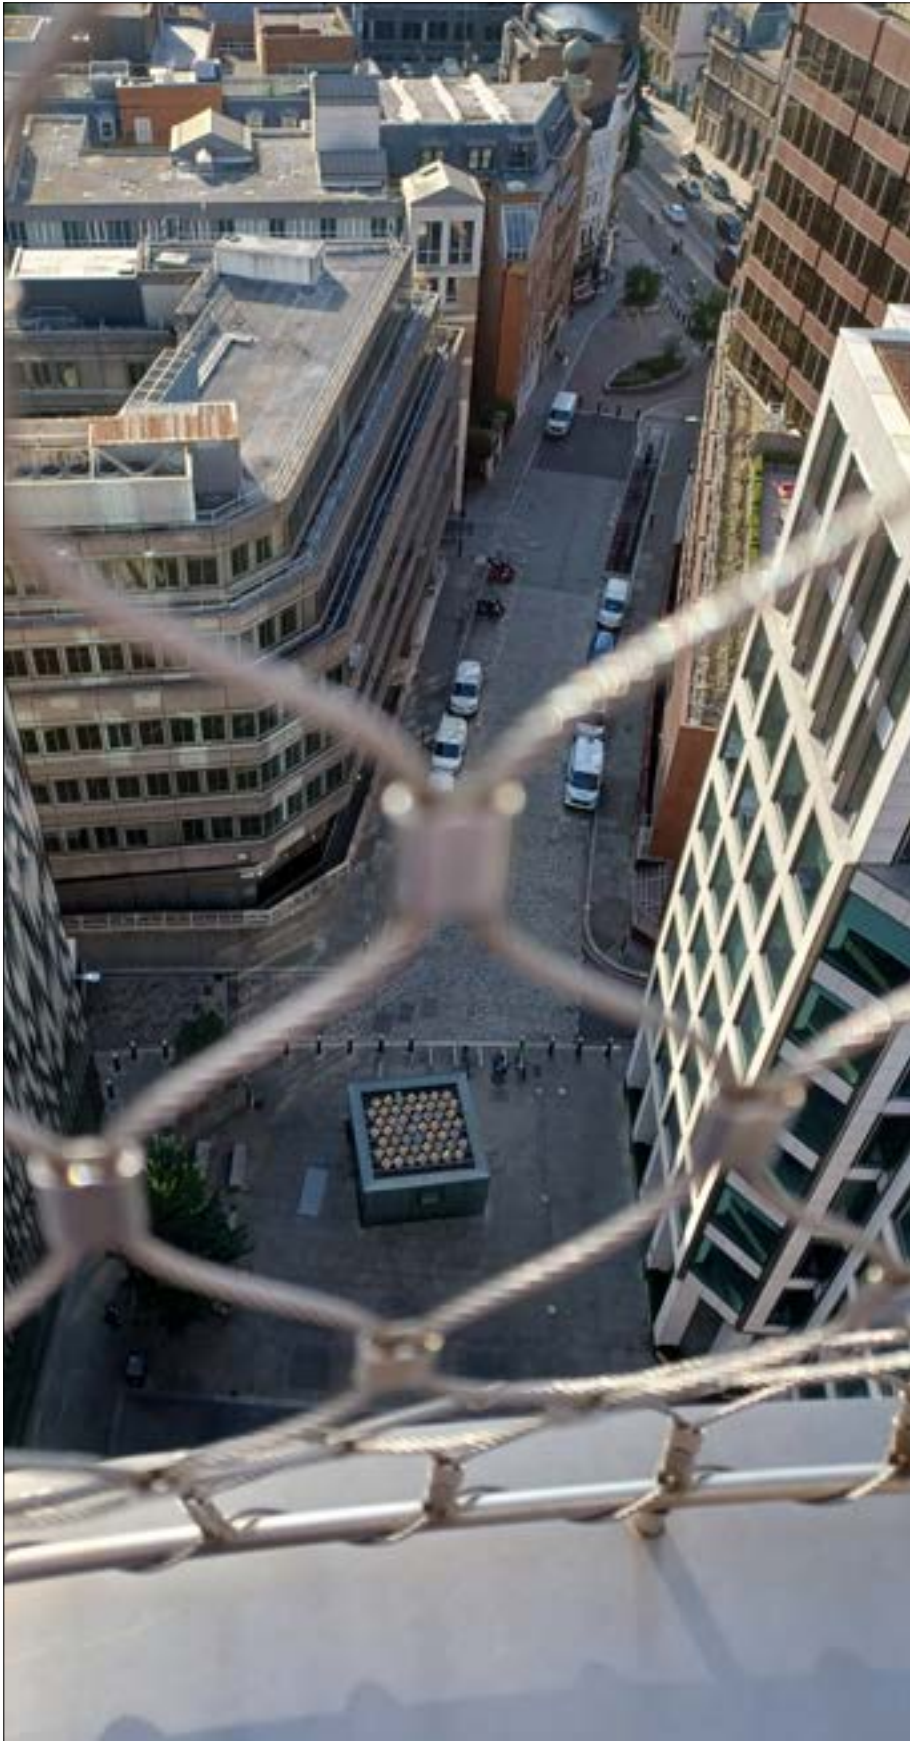
Fig. 75 View of the pavilion roof covered in 100 small, inclined glass panels when seen from the viewing gallery of The Monument, 2024

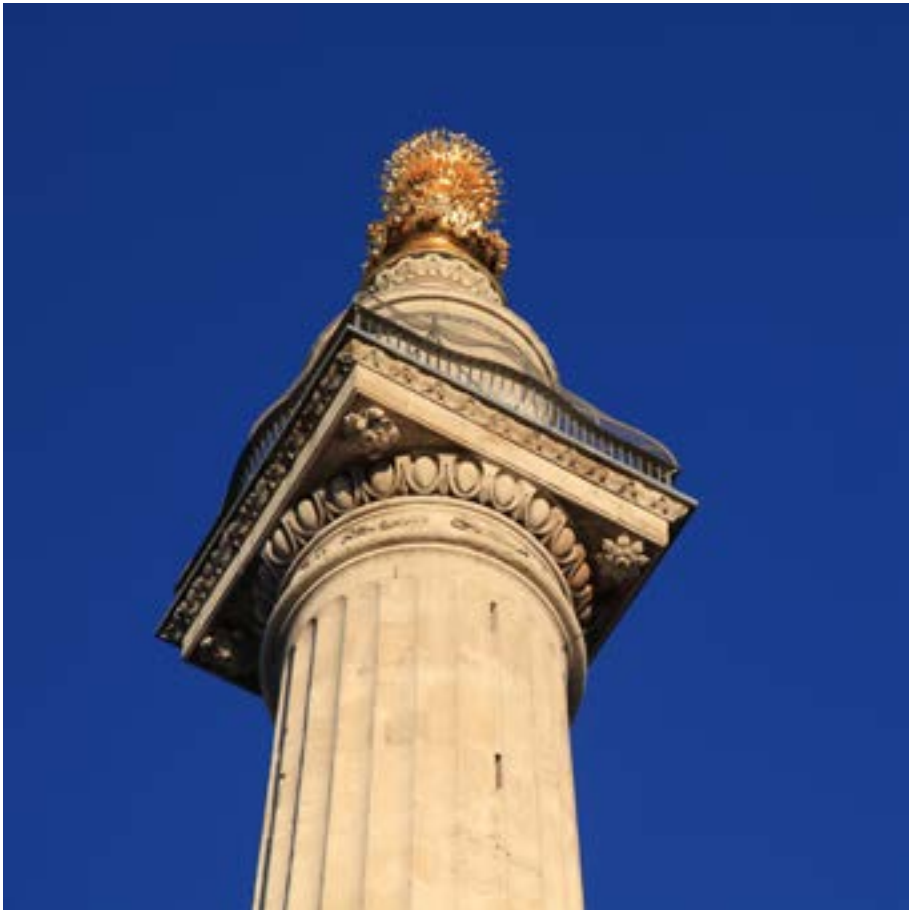
Fig. 76 Carved stone paterae on the underside of the column abacus, 2009

EXTERIOR		
ELEMENT	CONTRIBUTION TO SIGNIFICANCE	REASON
Exterior stonework	HIGH	Most of the original Portland stonework survives and is plain, fluted, incised and carved; repairs and replacement carved paterae are of high quality. The original black limestone viewing platform survives with archaeological remains of earlier balustrades
The Flaming Orb	HIGH	The gilded flaming orb is the dazzling showpiece at the top of the column, representing the flames of the Great Fire. Nearly all original fabric remains; some copper flames and leaves have been replaced and the orb has been re-gilded several times.
Viewing Platform Balustrade and Cage	MEDIUM	The balustrade is an important feature of the historic Monument. The bespoke design of the existing balustrade c.2009 reflects the original design; the lightweight mesh enclosure above provides security, the steel tubes are conduits for electrical & data services, both balustrade & cage are part of the lightning protection system. Intervention into the historic stonework is minimal.

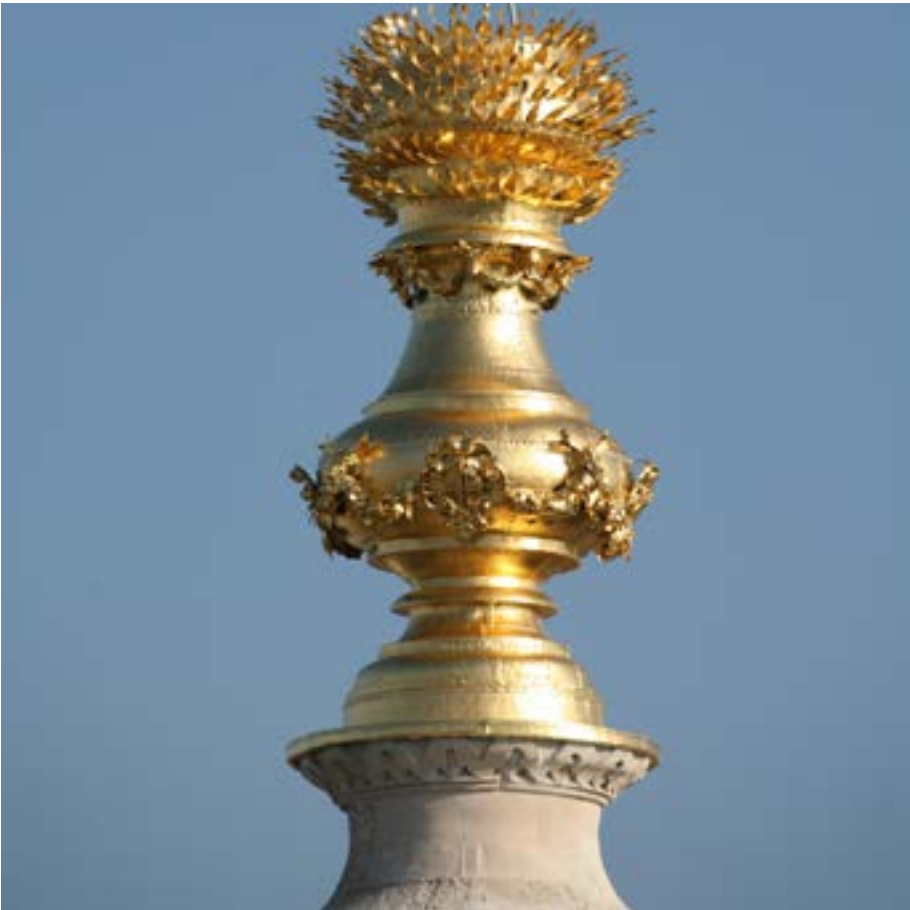
Fig. 77 The gilded Flaming Orb, 2009

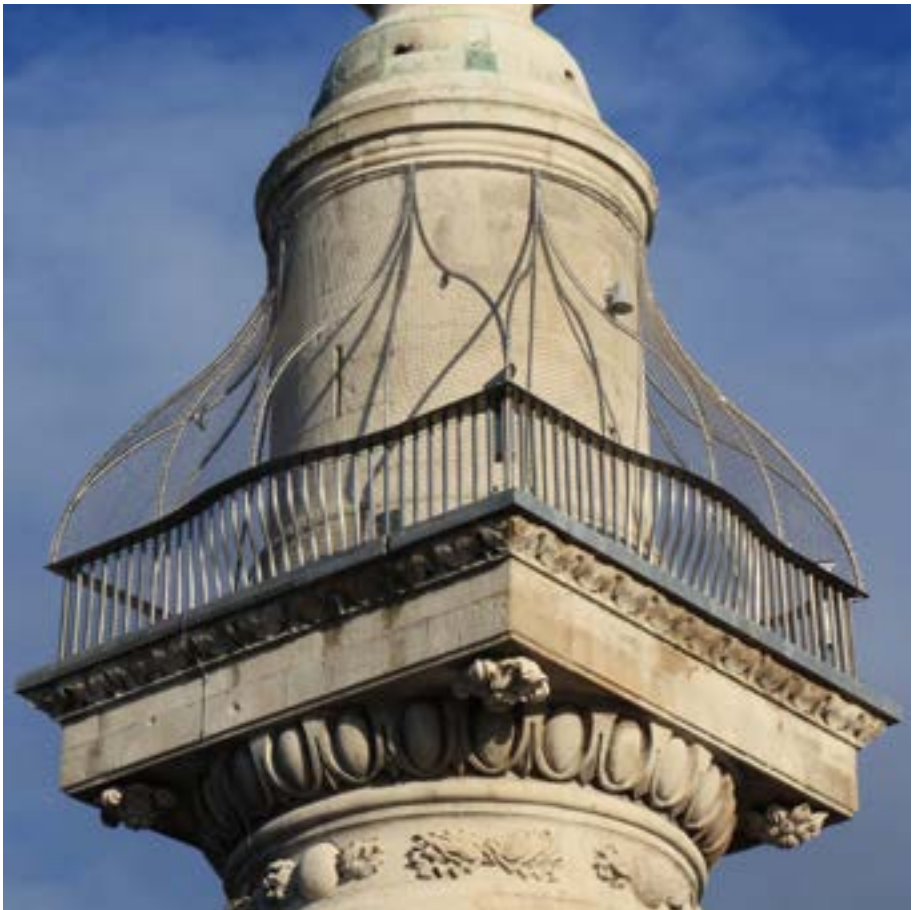
Fig. 78 Viewing platform stainless-steel cage & balustrade, 2009

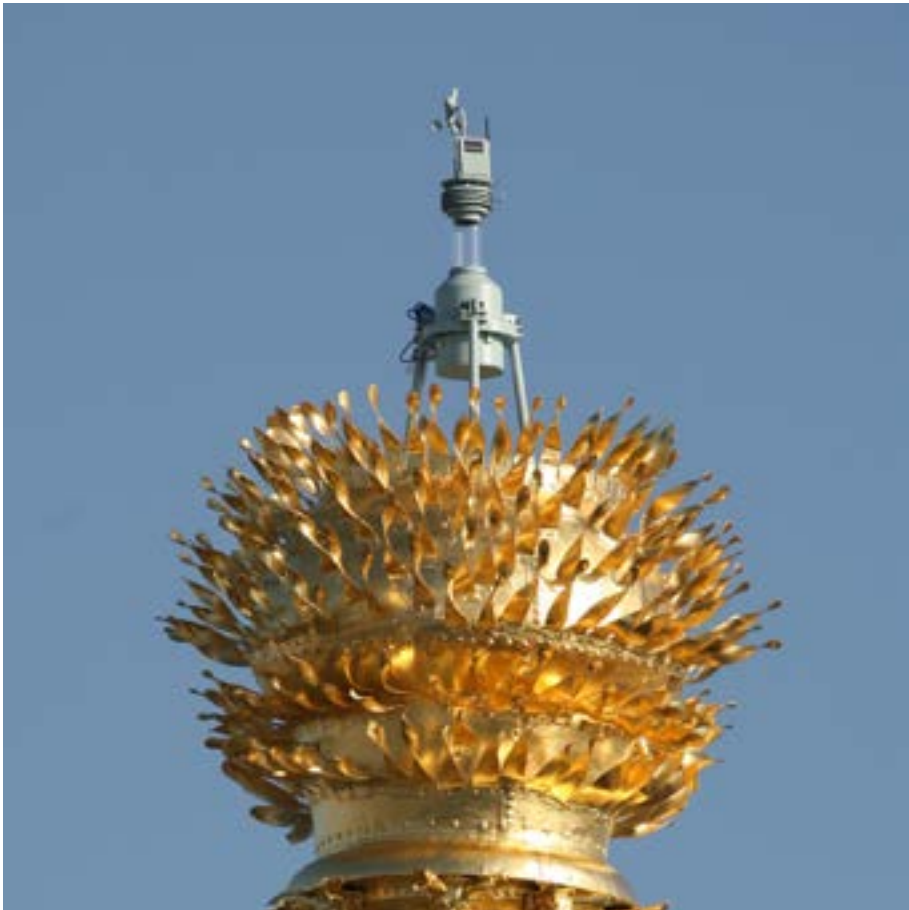
Fig. 79 Redundant panoramic camera & weather station installation at the top of the flaming orb, 2009

EXTERIOR			
ELEMENT	CONTRIBUTION TO SIGNIFICANCE	REASON	
Flaming Orb Camera & Stand	DETRIMENTAL	The panoramic camera system was intended as only a three-year project and ceased operating in 2011. The camera, weather station and bespoke stand are visible above the flaming orb and detract from the historic silhouette of The Monument.	
External Lightning Conductors	NEUTRAL	Essential for protection of the building, but obviously not contributing to historic exterior, the lightning protection system is carefully designed, integrating the existing iron & steel elements of The Monument as conductors, and using stone coloured down conductors.	
External Fixed Signage	NEUTRAL	A well designed addition to the historic monument for public information.

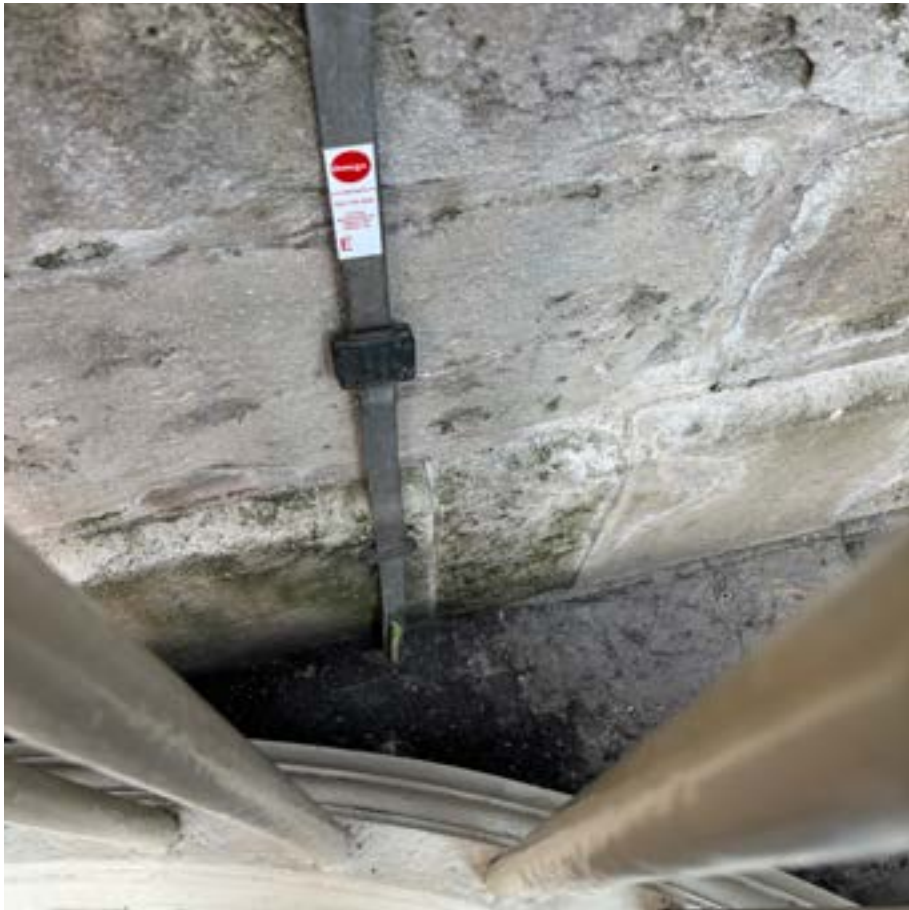
Fig. 80 Exterior lightning protection tape, 2024

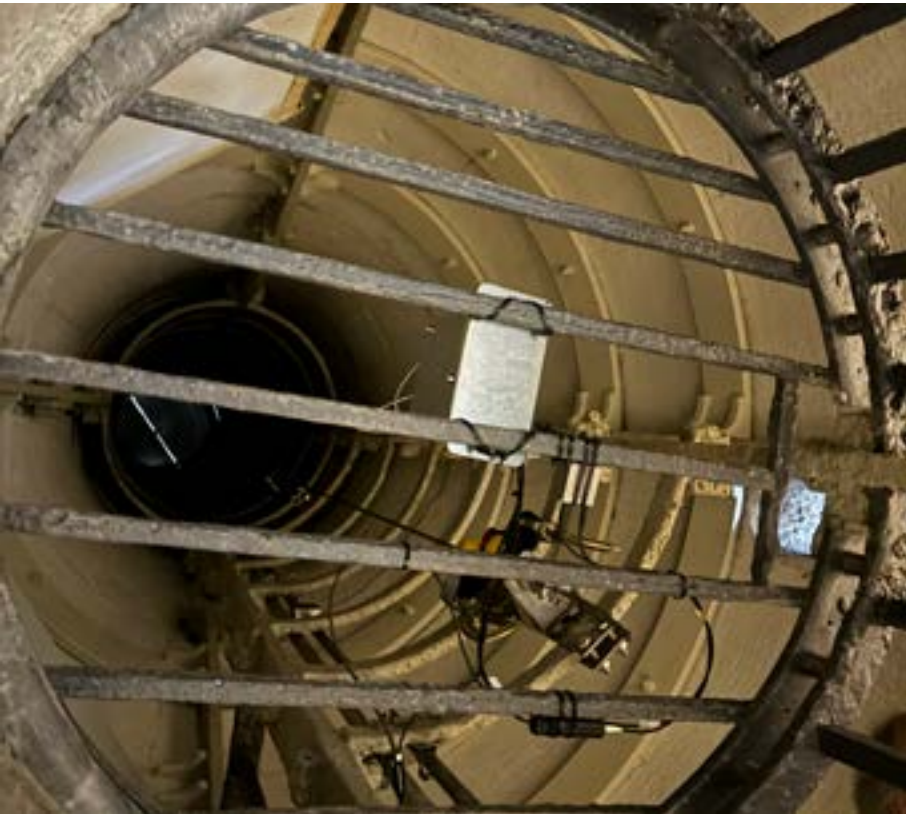
Fig. 82 Circular wrought iron grille at the base of the flaming orb armature, 2024

INTERIOR: IRONWORK		
ELEMENT	CONTRIBUTION TO SIGNIFICANCE	REASON
Supporting Iron Armature Supporting Flaming Orb	LOW	The copper construction of the flaming orb is fixed down onto the stonework of the dome with the original wrought iron armature, which is also a circular ladder giving access to the very top of the copper bowl.
Staircase Balustrade	MEDIUM	Many surviving wrought iron balusters supporting the curved oak handrail, although recent repainting ironwork in light grey detracts from original unpainted colour.
Drum Iron Grille	LOW	Historic iron grille too fragile to safely serve its original function; it remains in situ supplemented by pure iron reinforcement c.2009.
Oval Window Iron Grille	LOW	Simple historic wrought iron bars, (recent replacement bar is not a good match to the historic).
Ground Floor Iron Grille to Hooke’s Workshop	NEUTRAL	A modern iron grille based on historic precedent.

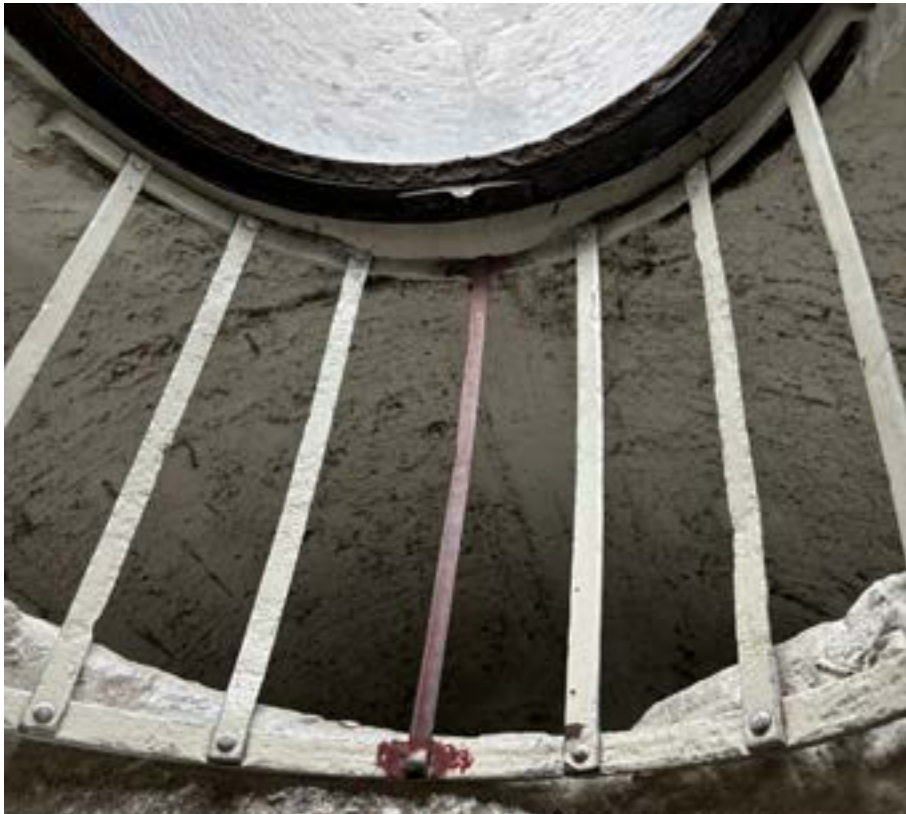
Fig. 83 Flat iron bars rivetted across a ventilation opening beneath the east oval window, 2024

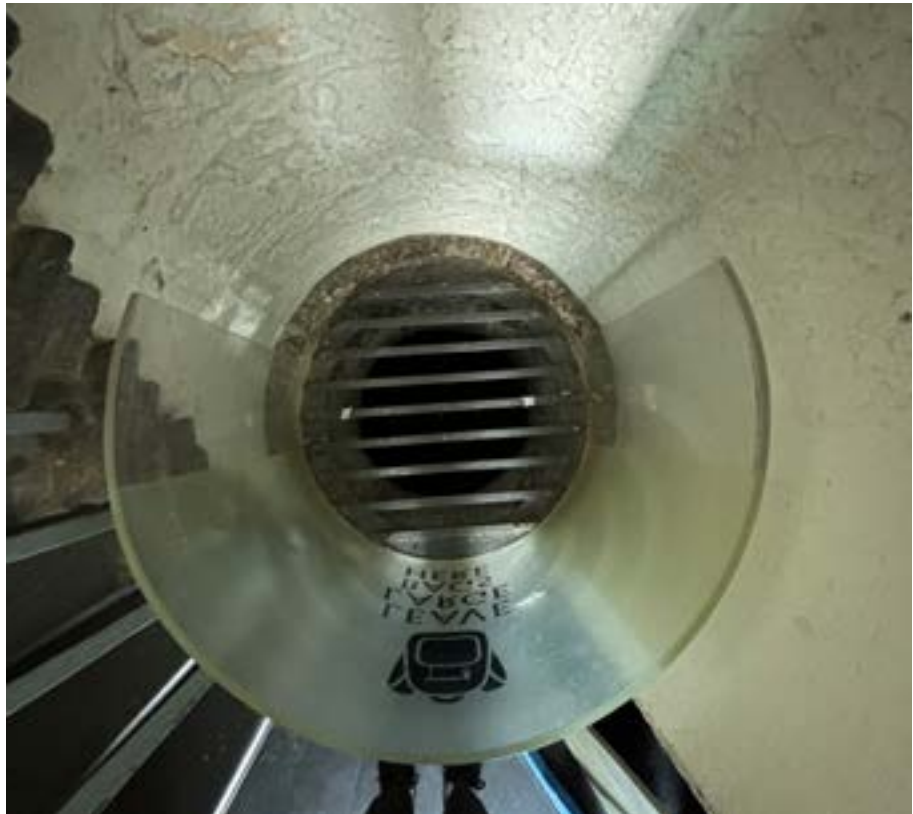
Fig. 84 Circular wrought iron grille at the basement dome oculus/base of helicar stair, 2024

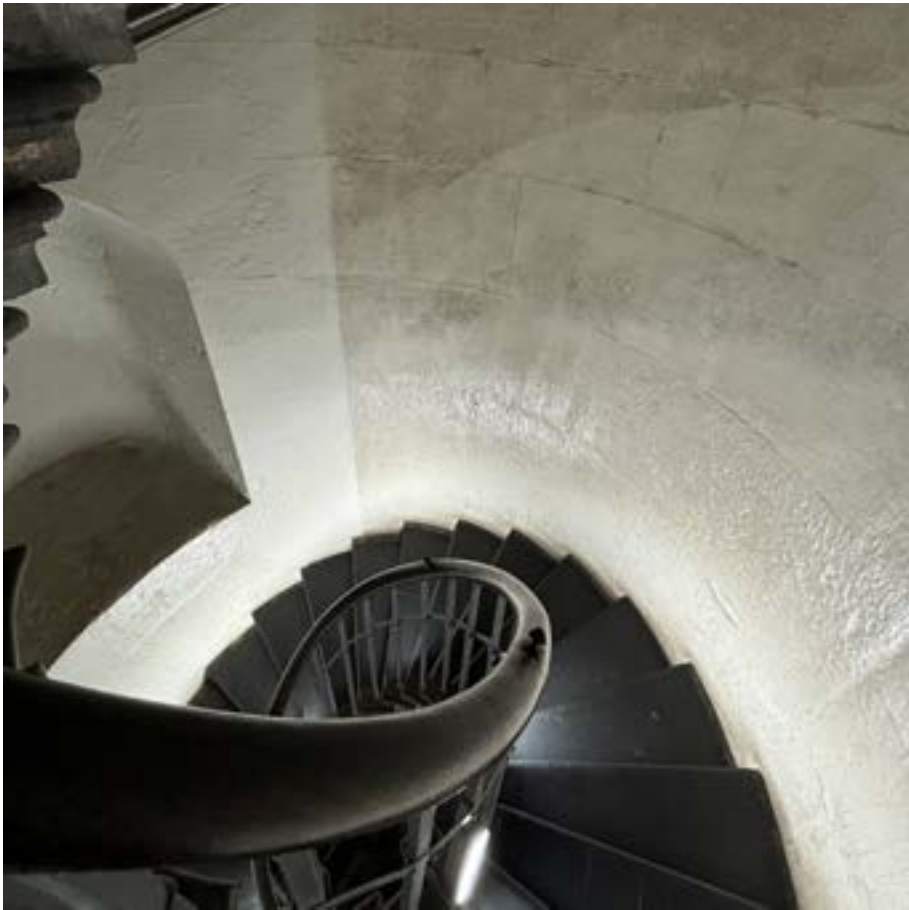
Fig. 85 Staircase balustrade curved oak handrail, 2024

INTERIOR: JOINERY			
ELEMENT	CONTRIBUTION TO SIGNIFICANCE	REASON	
High-level Timber Enclosure	LOW	A simple (non-original) boarded enclosure with the patina of age.	
Staircase Balustrade Handrail	MEDIUM	Curved oak balustrade handrail with many original steamed-timber sections, but later replacement sections of poorer quality workmanship reduce the potential significance.	
Entrance Lobby Historic Joinery	LOW	The joinery appears to be of differing ages, maybe both eighteenth and nineteenth century designed to suit the locations. The attendants' door and rear cupboard with an interesting build-up of paint layers, appears older than the wall cupboards.	
Entrance Lobby C21 Joinery	DETRIMENTAL	The joinery is no longer fit for purpose and chipboard shelves have been added.
