# JULIAN HARRAP

THE MONUMENT TO THE GREAT FIRE OF LONDON

VOLUME I: CONSERVATION PLAN

MARCH 2025

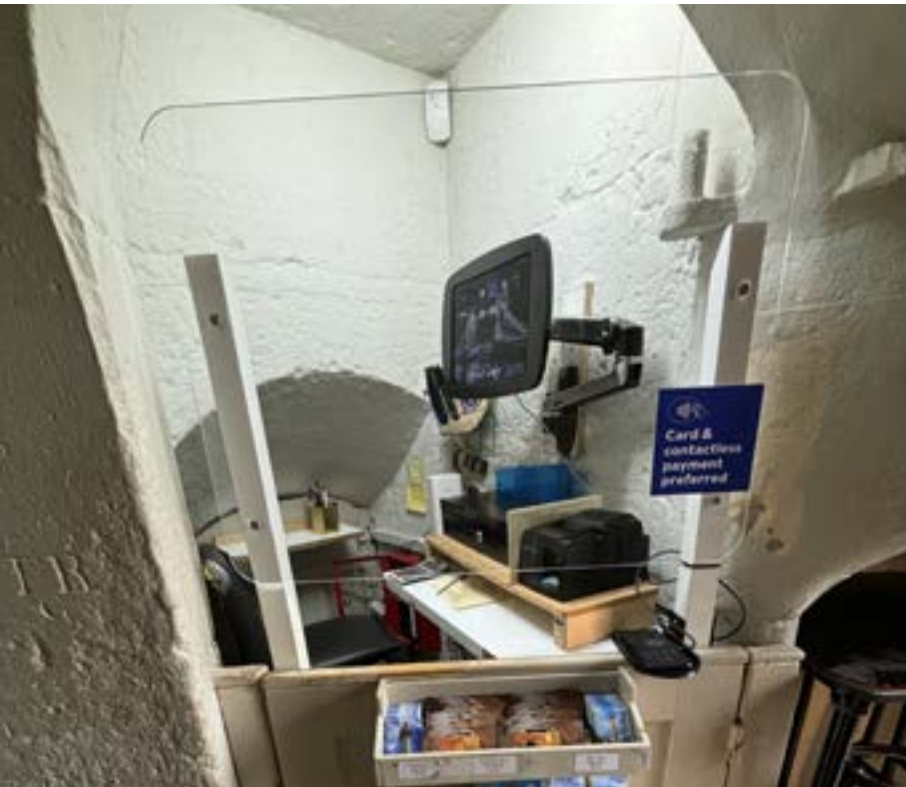
Fig. 88 Perspex screen across attendants' recess, 2024

ENTRANCE LOBBY: FIXTURES, FITTINGS & SIGNAGE		
ELEMENT	CONTRIBUTION TO SIGNIFICANCE	REASON
Entrance lobby folding chair	NEUTRAL	Bespoke discreet seat and seat-back designed for this location, late twentieth century and of its time.
Perspex screen	DETRIMENTAL	One of several modern fixtures/fittings /signs introduced into the Entrance Foyer, which are not high quality in terms of design, materials or workmanship, and together greatly detract from this small simple historic interior.
Curved perspex storage screen	DETRIMENTAL	Primary reason is that the Perspex screen obscures the circular floor opening (oculus), an feature of architectural, historic & scientific significance.
Signage: <ul style="list-style-type: none"><li>- Duplication of Statutory H&amp;S signage (fire extinguishers)</li><li>- Standard signage replaces hand-painted signage</li><li>- Dark blue standard payment signage stuck on Perspex screen</li><li>- Multiple signs advising 'CCTV in operation'</li><li>- Paper sign in plastic wallet Sellotaped to front door glazing</li><li>- Remains of fixings to removed signs: adhesive on joinery, rawl plugs into stonework</li></ul>	DETRIMENTAL	Many signs introduced into the Entrance Foyer, are not high quality in terms of design, materials or workmanship, and together detract from this small simple historic interior; some signs are duplicated and unsightly adhesive or rawl plugs are evident where signs have been removed.

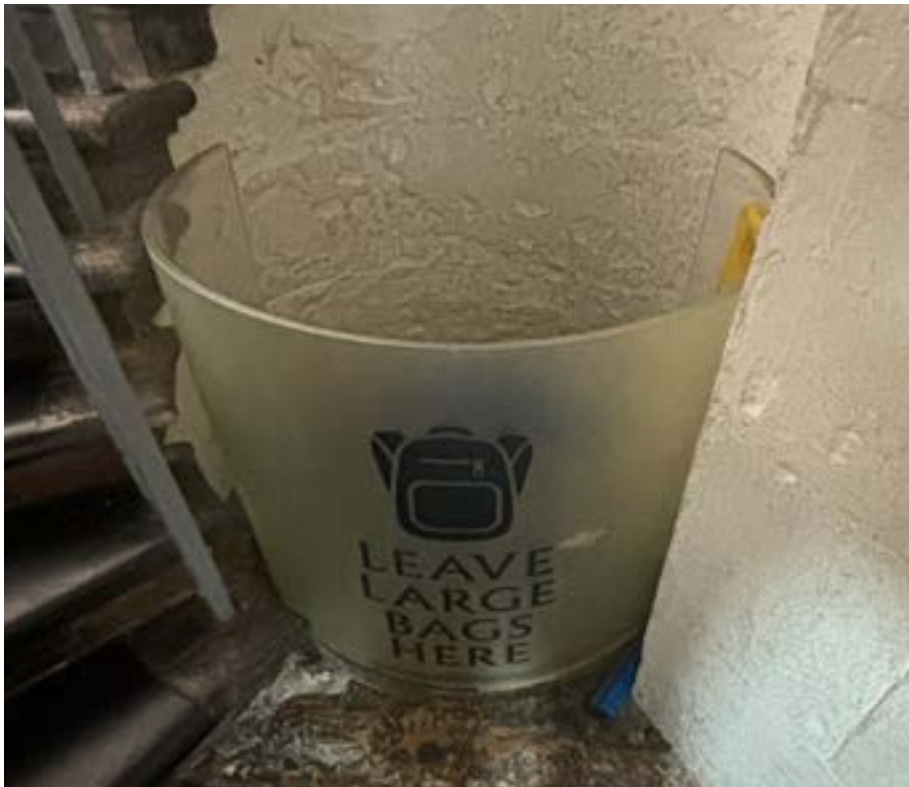
Fig. 89 Curved Perspex bag store screen, 2024

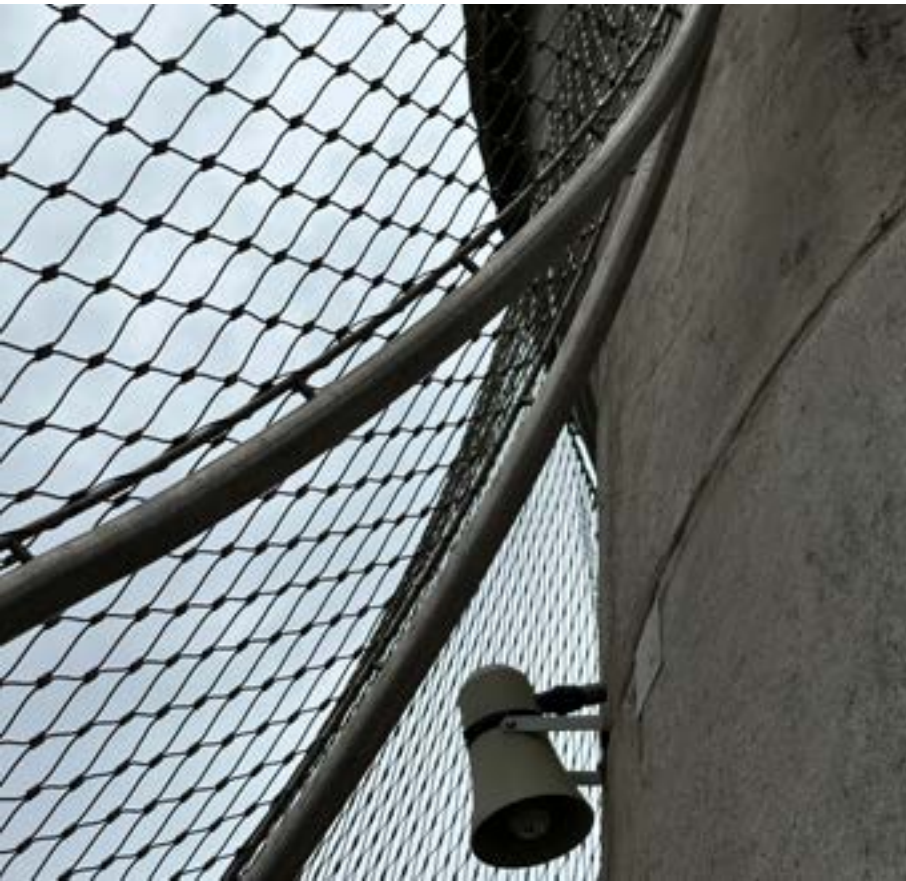
Fig. 91 Viewing platform speaker fixed to the stone Drum, 2024

EXTERIOR: VIEWING PLATFORM M&E SERVICES		
ELEMENT	CONTRIBUTION TO SIGNIFICANCE	REASON
Electrical & Data Conduits	NEUTRAL	The conduits are very discreet; the viewing platform cage structure of stainless-steel tubes, are also conduits for electrical cables.
Viewing Platform Speakers	NEUTRAL	Stone-coloured, unobtrusive, well-located, important for safety.
Viewing Platform CCTV Cameras	NEUTRAL	Important for safety, located on the C21 cage structure re-using the bespoke stainless-steel conduits, less appropriate than the stainless-steel smaller cameras they have replaced.
Viewing Platform Intercom	DETRACTS	The intercom is well designed and of quality materials, but as it needs to be highly visible to the public with large clear lettering, it is obtrusive and detrimental to the historic interior.
Viewing Platform Lighting	DETRACTS	LED ‘ropes’ fixed underneath the balustrade provide an unattractive strong and harsh down-light when viewed from below and appear to be an under designed temporary solution when seen from the viewing platform. The temporary uplighter fixed with cable ties to a corner of the balustrade is not an appropriate light fitting for an ancient monument and lights the flaming orb from one side only.

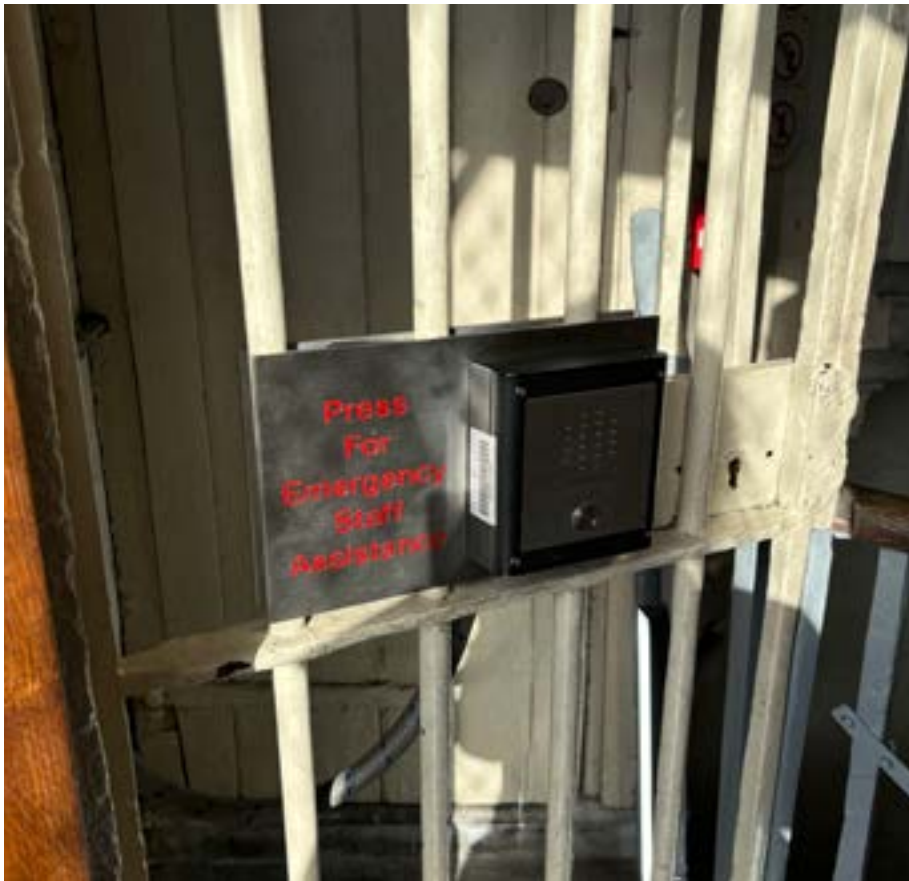
Fig. 92 Viewing platform intercom connecting to ground floor reception, 2024

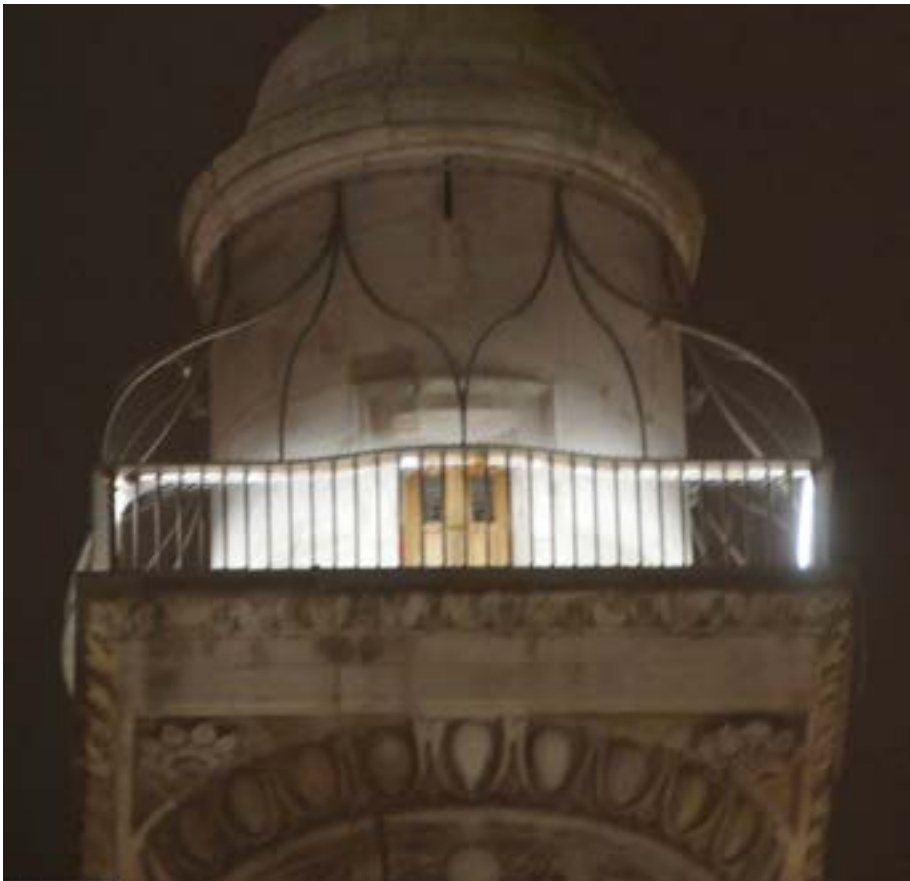
Fig. 93 LED lighting rope beneath viewing platform handrail, 2018

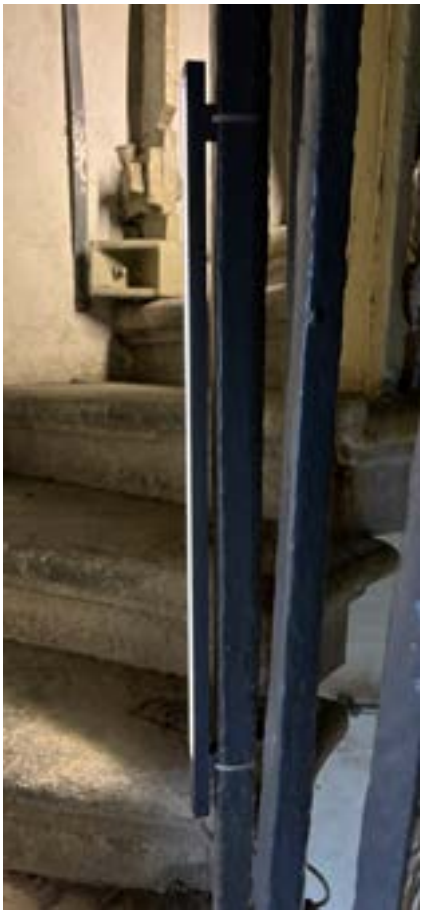
Fig. 96 2009 light strips

STAIRWELL ELECTRICAL SERVICES			
ELEMENT	CONTRIBUTION TO SIGNIFICANCE	REASON	
Electrical Cables in Upper Stairwell	DETRACTS	Electrical cables recently added at high level are not (all) in existing stainless-steel conduits or neatly tied to existing conduits and look a mess.	
Smoke Detector & Sounder	DETRACTS	Detrimental to a small historic interior, but important for safety and reasonably well-located.	
Staircase Lighting	DETRIMENTAL	Replacement baluster lights produce harsh cold light and are no longer directed onto stair treads but are twisted away from the tread to avoid glare for the visitor climbing the stairs. The replacement fittings are wider than the balusters and black, contrasting with the pale grey paint of the iron balusters.	
Emergency Lighting	DETRACTS	Emergency lights have been introduced into the stairwell replacing the previous emergency lighting, which was some of the existing baluster lights, with a battery back-up and therefore entirely unobtrusive within the stairwell.

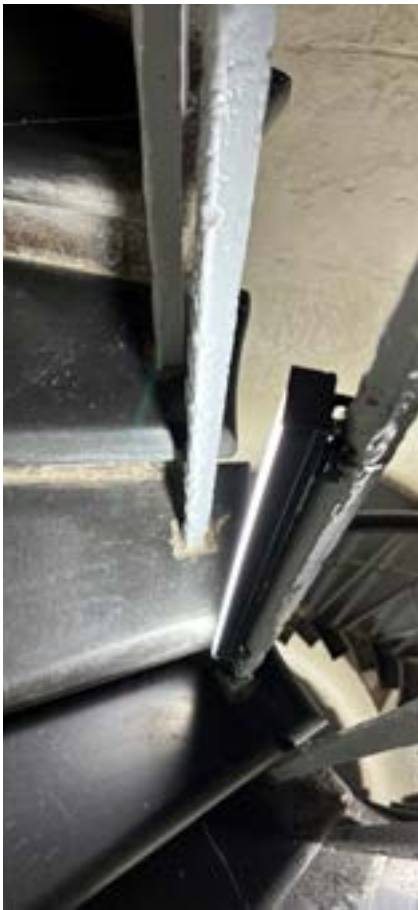
Fig. 97 Replacement light strips

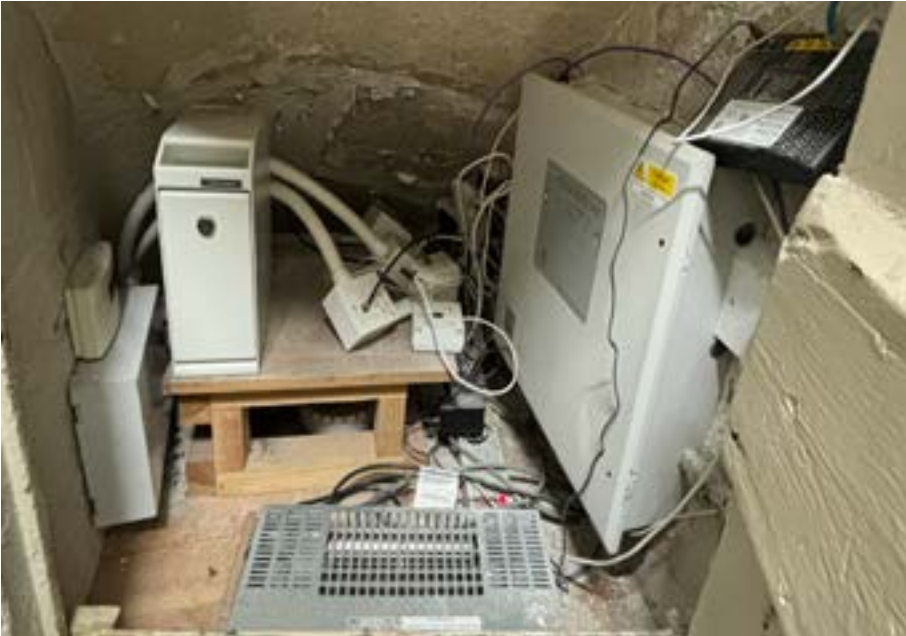
Fig. 99 Electrical services in cupboard at back of attendants' recess, 2024

ENTRANCE LOBBY: ELECTRICAL SERVICES		
ELEMENT	CONTRIBUTION TO SIGNIFICANCE	REASON
Overhead Radiant Heater	NEUTRAL (wiring detracts)	Quality stainless steel coloured, reversible, location along one side of the barrel vault, necessary in winter. Thick black visible cabling detracts.
Plinth Heater	NEUTRAL	Located in plinth of cupboard in attendants' recess, not visible to visitors and providing heat to attendants where it is needed.
Smoke Detector	DETRACTS	Detrimental to a small historic interior, but important for safety and reasonably well-located.
Lighting: Strip Luminaires located either side of Entrance Door within door architrave	LOW	Warm soft light back-lights historic turnstiles and enhances the entrance.
Lighting: Strip Luminaire located along the Barrel Vault, South-Side (assumed redundant)	DETRACTS	It is assumed that this light is not operational since the radiant heater was installed.
Lighting: LED Strip Light in Attendant's Recess

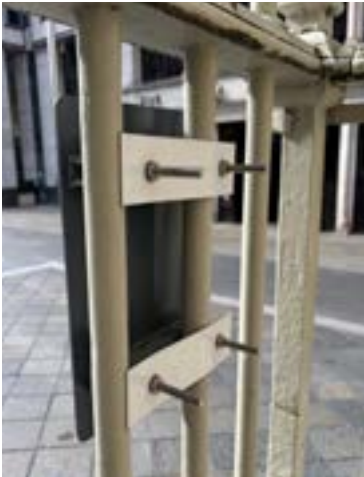
Fig. 108 Crude fixings to CoL sign, 2024

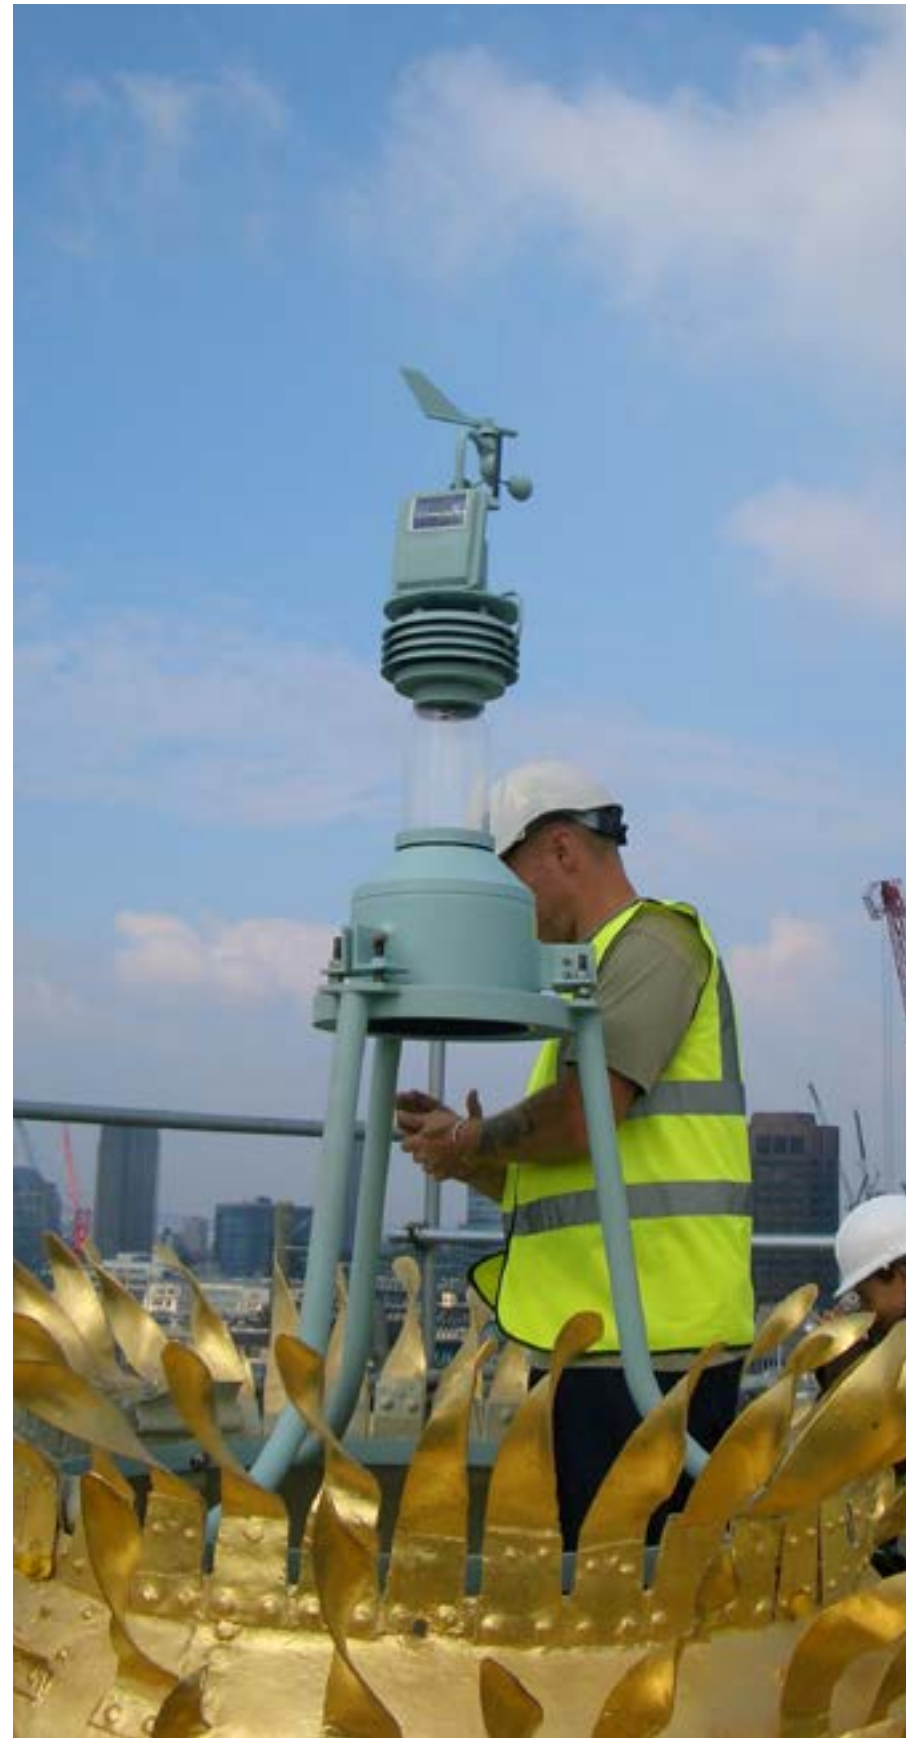
Fig. 112 Installation of the temporary camera, casing, weather station and steel support frame, 2008

PA37. The City Corporation will explore solutions for the disused panoramic camera and weather station and associated equipment and consider providing a simpler and less obtrusive system.

- Fig. 110. 19th century boundary marker (City Corporation 2024).
- Fig. 111. Seating in Monument Yard (© Google July 2022).
- Fig. 112. Installation of the temporary camera, casing, weather station and steel support frame, 2008 (© Christopher Meigh-Andrews 2008).

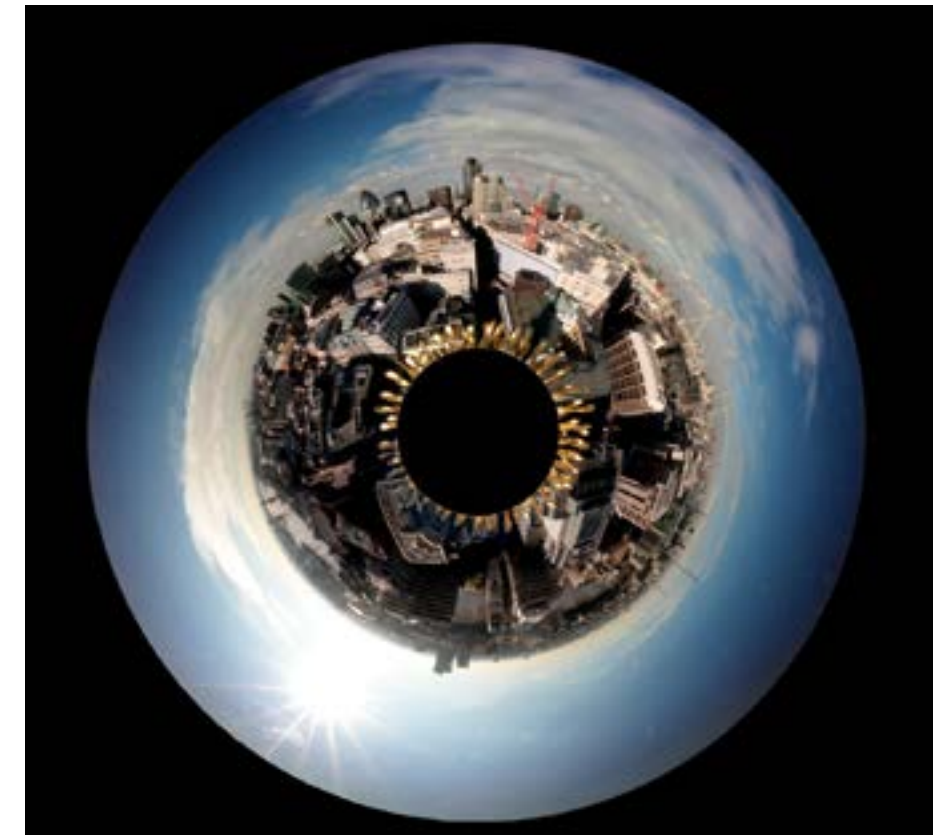
Fig. 113 Camera image through conical lens 2008

- Fig. 113. Camera image through conical lens 2008 (© Christopher Meigh-Andrews 2008).
- Fig. 114. Computer equipment & Cat 6 cables in the circular basement (Julian Harrap Architects LLP 2024).

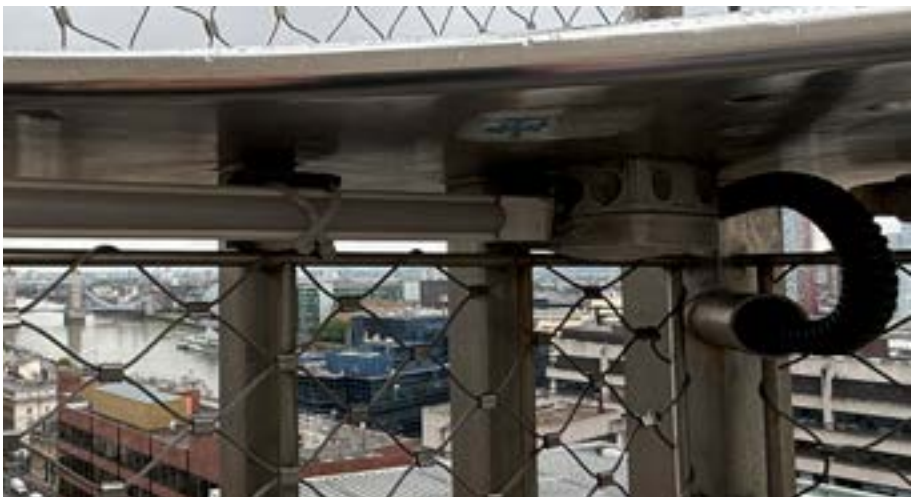
Fig. 115 Viewing platform LED rope light, 2024

- Fig. 115. Viewing platform LED rope light, 2024 (© Julian Harrap Architects LLP 2024).
- Fig. 116. Viewing platform temporary spotlight, 2024 (© Julian Harrap Architects LLP 2024).

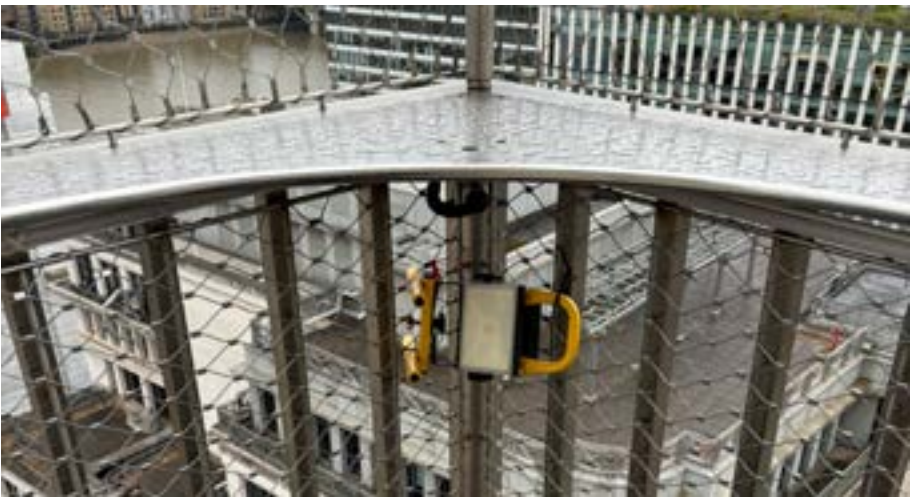
Fig. 116 Viewing platform temporary spotlight, 2024

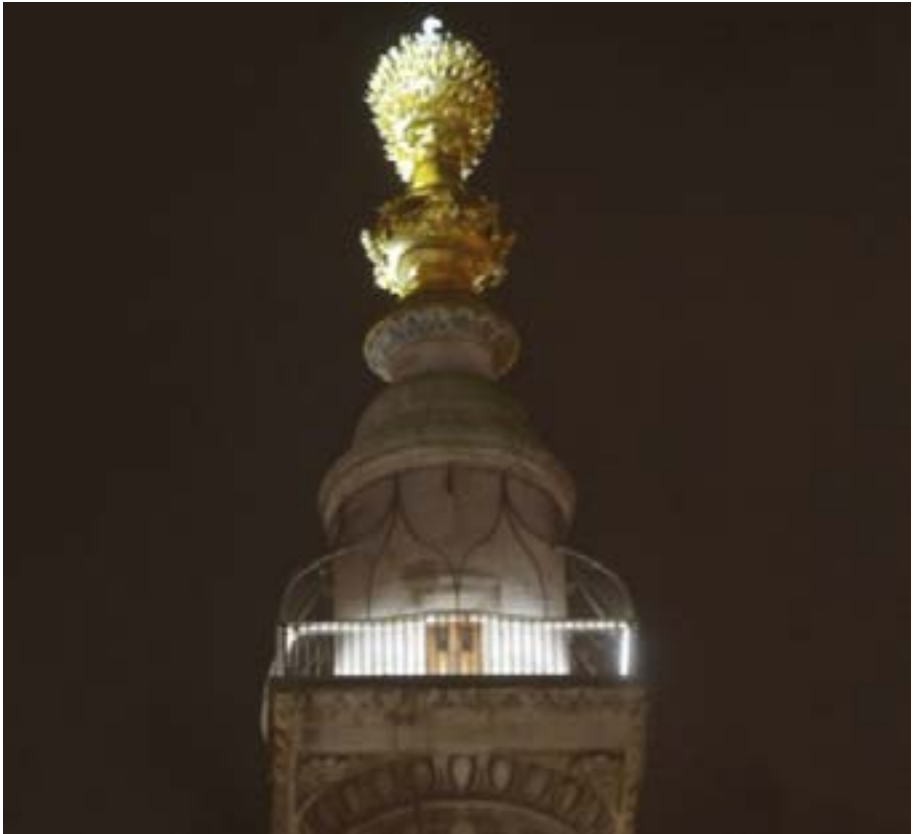
Fig. 117 LED rope to underside of balustrade handrail, 2018

- Fig. 117. LED rope to underside of balustrade handrail, 2018 (© Julian Harrap Architects LLP 2018).
- Fig. 118. Light Bureau's lighting design image, 2009 (Light Bureau 2009)

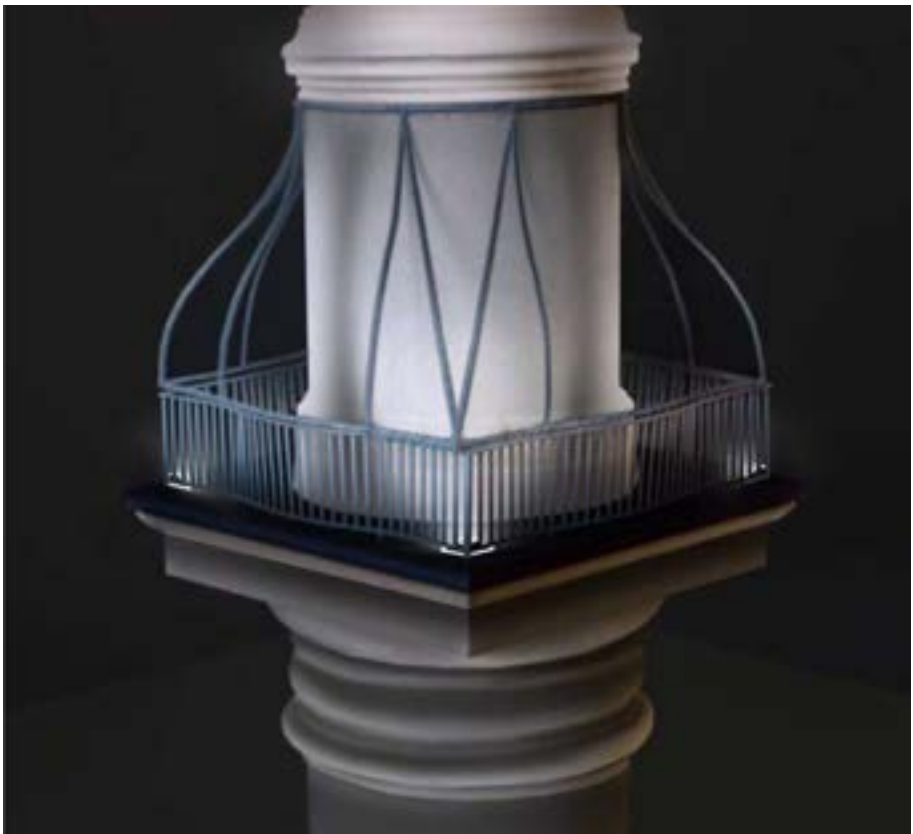
Fig. 118 Light Bureau's lighting design image, 2009

In the 2007-2009 repair contract, power supplies were installed to each external corner of the viewing platform to supply future low-level external light fittings in each corner. Light Bureau in collaboration with Mike Stoane, lighting designer, prepared preliminary designs for light fittings. Issues are protection of lights from accidental damage and vandalism. The City of London Planning Department have advised that external light on the viewing platform would require planning consent.
