THE MONUMENT TO THE GREAT FIRE OF LONDON

VOLUME IV: APPENDICES

MARCH 2025

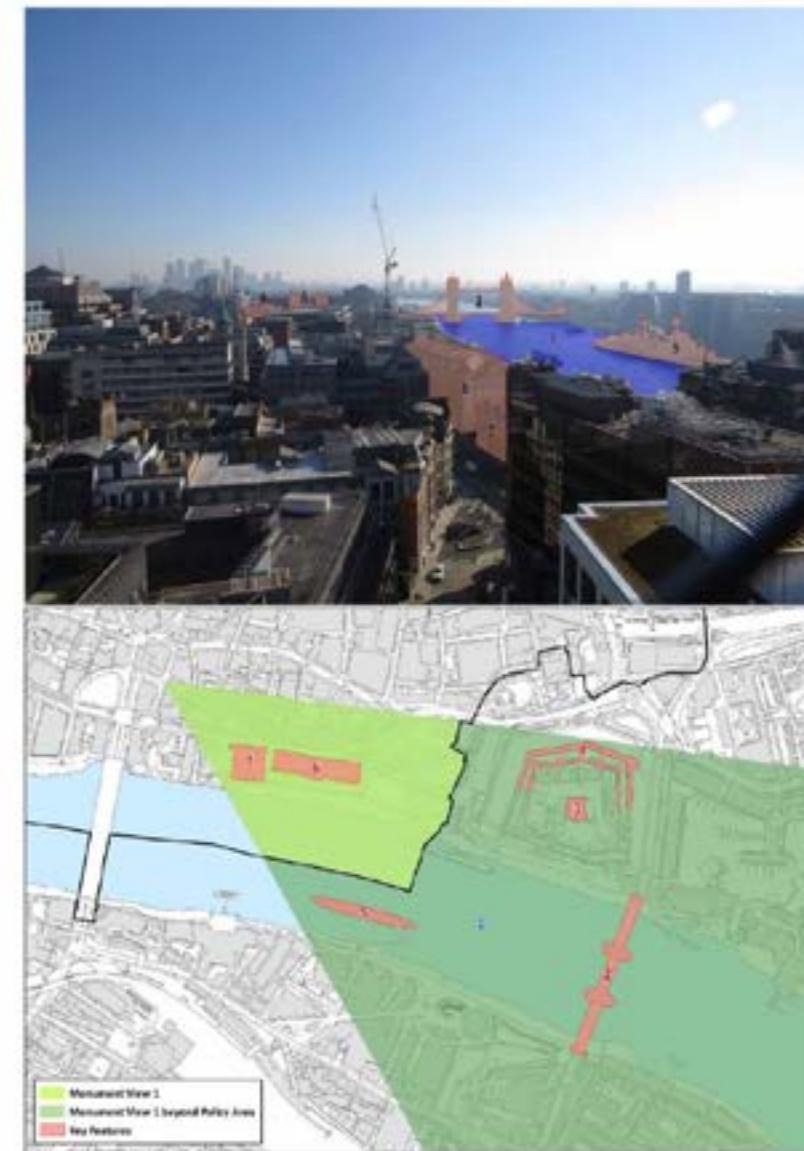
Figure 3: View One Photograph and Map (highlighting key features)

River Thames (1); Tower Bridge (2); Tower of London World Heritage Site (3) – White Tower, (4) – Northern Battlements; HMS Belfast (5); Custom House (6); Old Billingsgate (7)

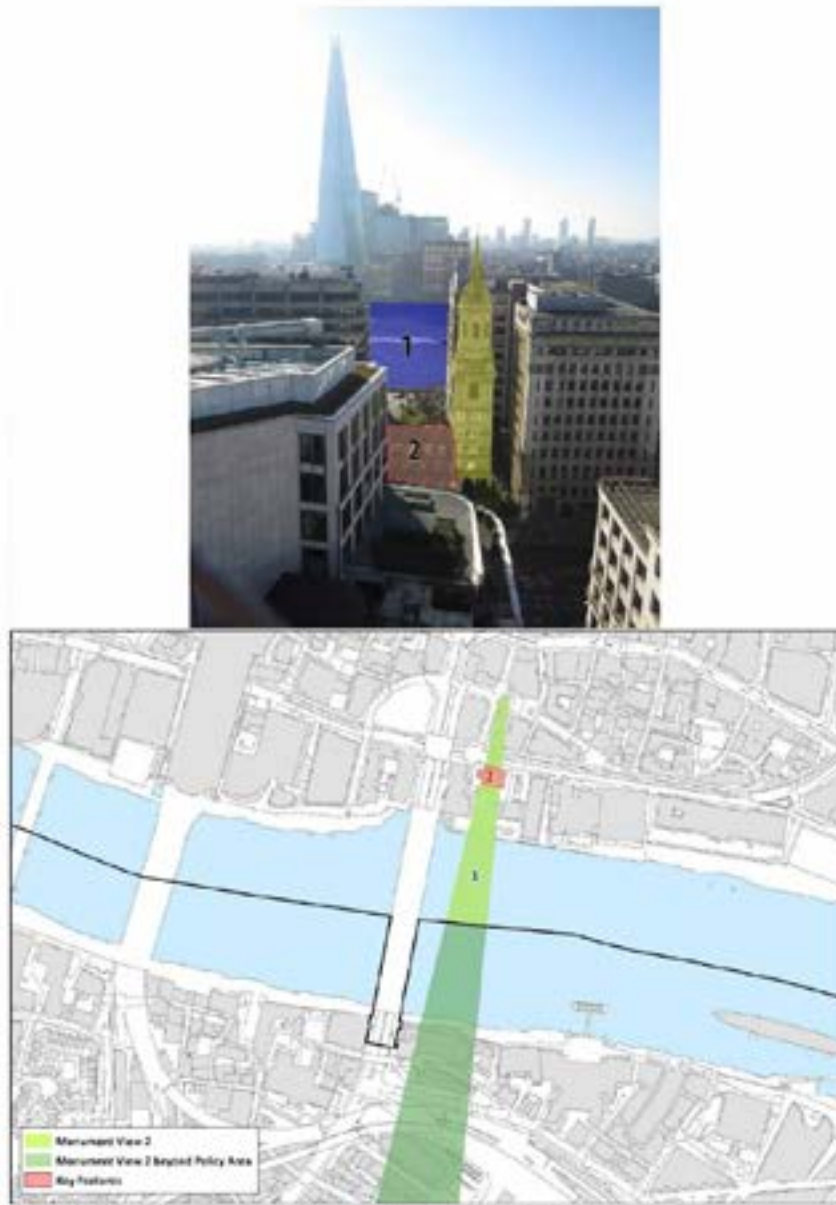
Figure 4: View Two Photograph and Map (highlighting key features)

River Thames (1); St Magnus the Martyr Church tower (2) (partly outside policy area - yellow). Other features in the view include the London Bridge tall building cluster in the background.

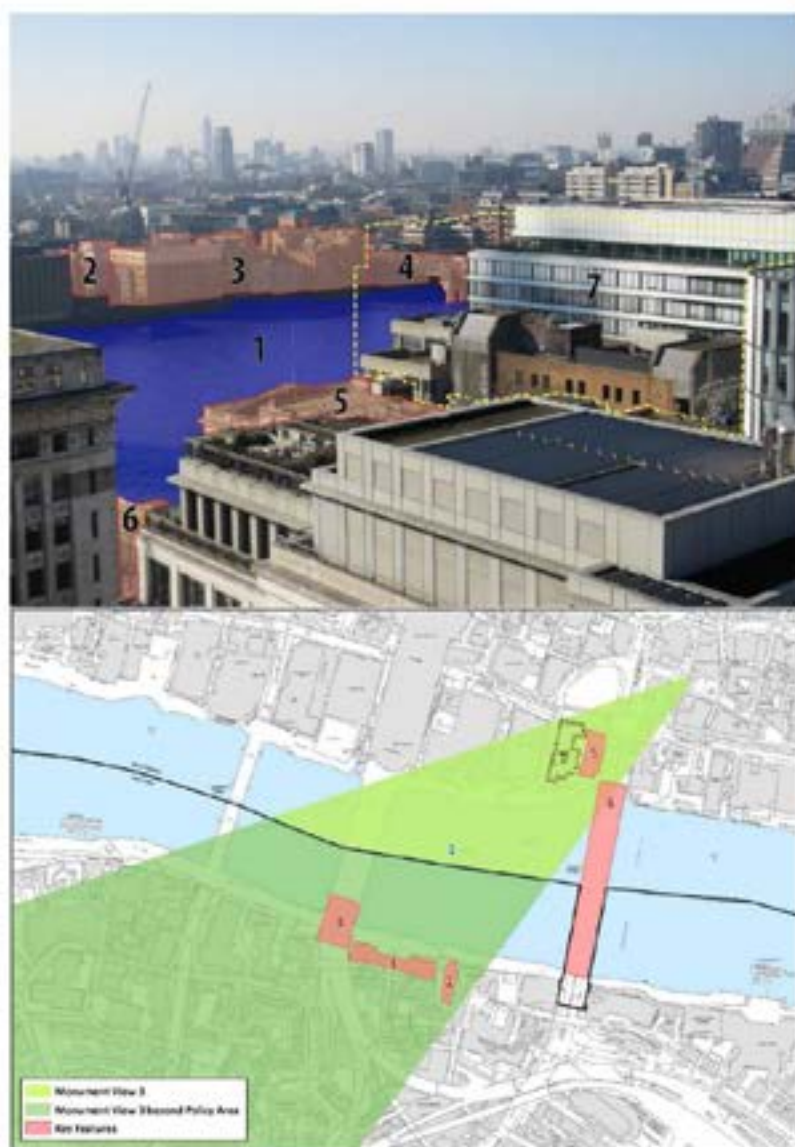
Figure 5: View Three Photograph and Map (highlighting key features)

River Thames (1); Golden Hinde Galleon (2); Pickford's, Winchester, New British and Clink Wharves (3); Cannon Street Railway Bridge (4); Fishmongers' Hall (5); part of London Bridge (6). The Seal House redevelopment (7) proposal is shown outlined in yellow.

- (7) Redevelopment (18/01178/FULMAJ) at **Seal House** was agreed by Planning and Transportation Committee on 18 March 2019 subject to signing of Section 106 Agreement. The agreed proposal obscures a part of the river and Cannon Street Railway Bridge in views from the Monument viewing gallery (building outline dashed in yellow in Figure 5), which represents a departure from policy. It was considered that the proposed scheme offered significant wider and inclusive public benefits which outweigh the less than substantial harm to the view from the Monument. In particular, the provision of a large free to access public roof garden with generous opening hours offering exceptional views of London in a high quality economically and socially inclusive space was considered to represent a valuable and unique new asset for the City of London as a whole, for its workers, residents and visitors.

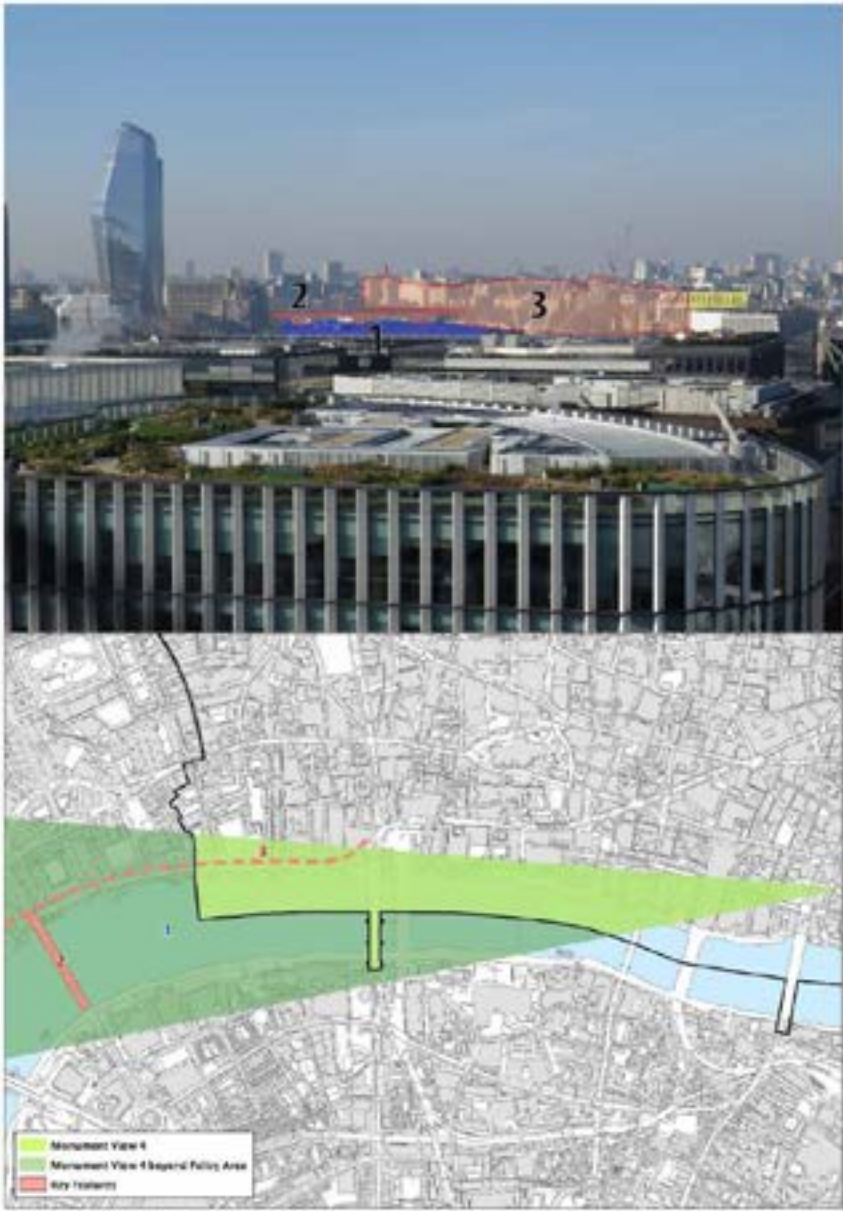
Figure 6c: View Four Photograph and Map (highlighting key features)

Key Features: (See Figure 6).
River Thames (1), Waterloo Bridge (2), Victoria Embankment Buildings (3) partly outside policy area - yellow).
