## Appendix 3

### Air Quality

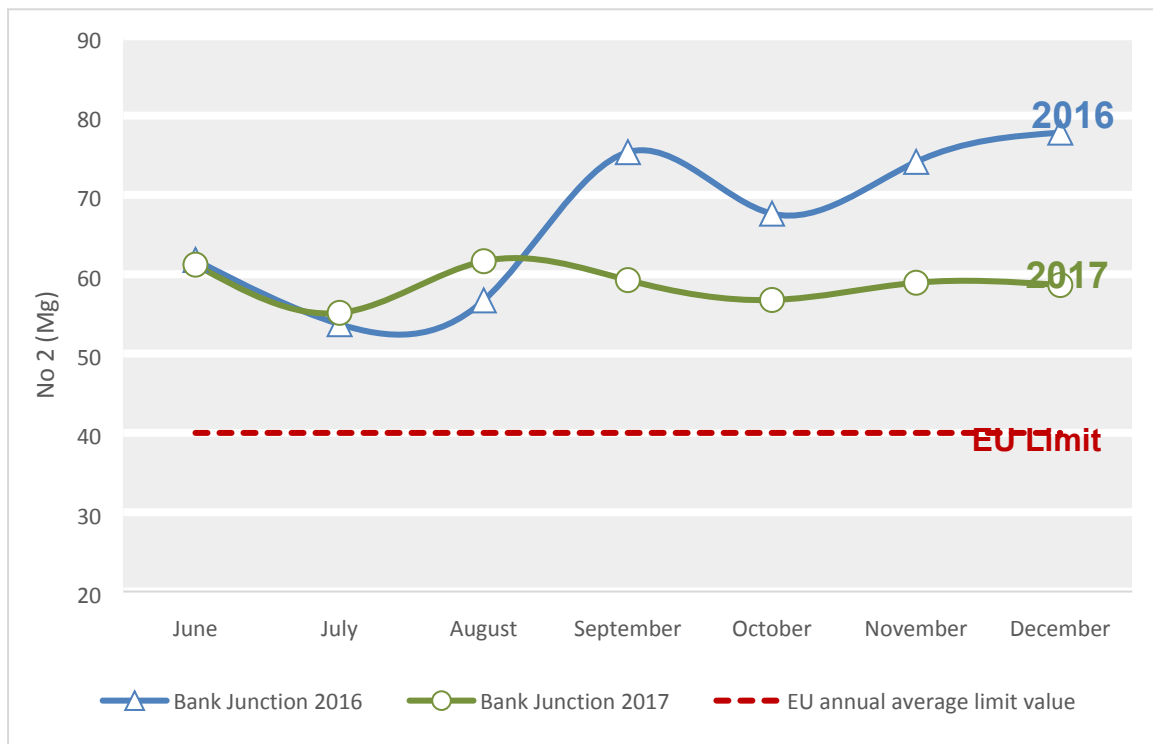
**Figure 3 (in main report): Changes in No<sub>2</sub> between 2016 and 2017 at Bank Junction**

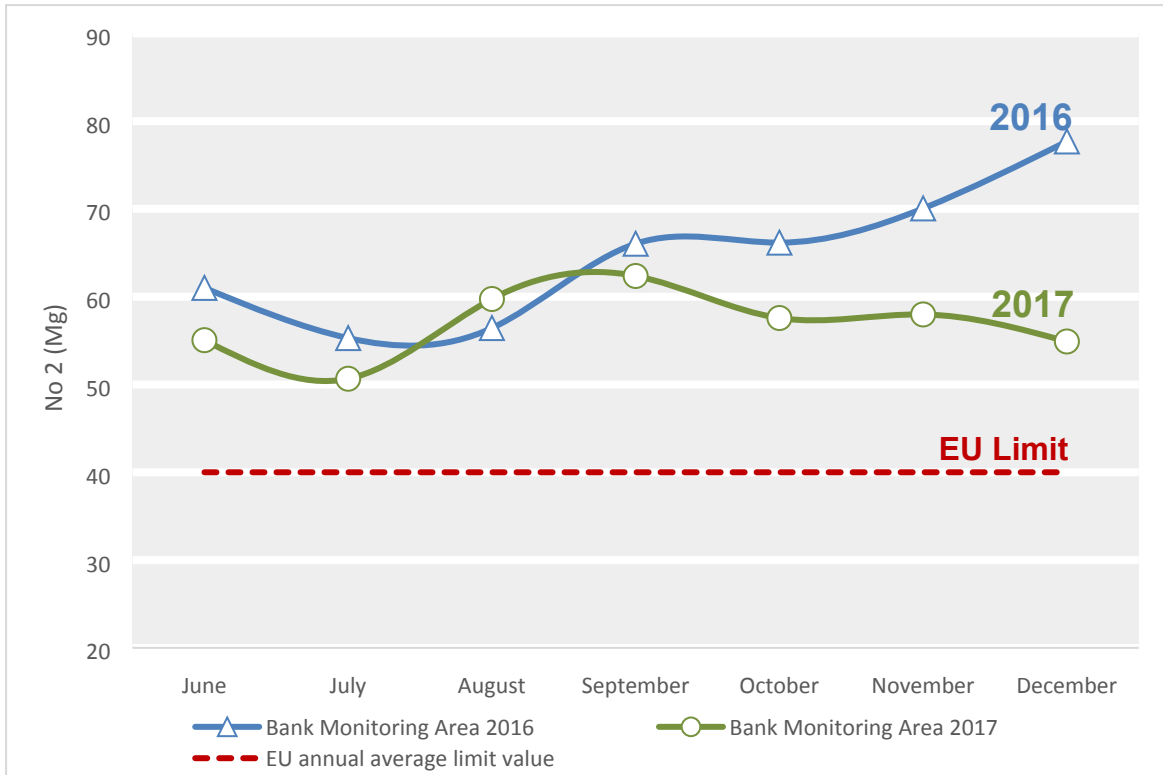
**Figure 9:  
changes in No<sub>2</sub> between 2016 and 2017 in the Bank Monitoring Area**

Figures 8 – 11 below compare 2017 post-scheme data to 2016 data for the same months (June to December). Emerging data appears to indicate that there has been an improvement in air quality at Bank Junction and in the surrounding area since the introduction of the Bank on Safety scheme. Diffusion tube locations are shown in Figure 9.

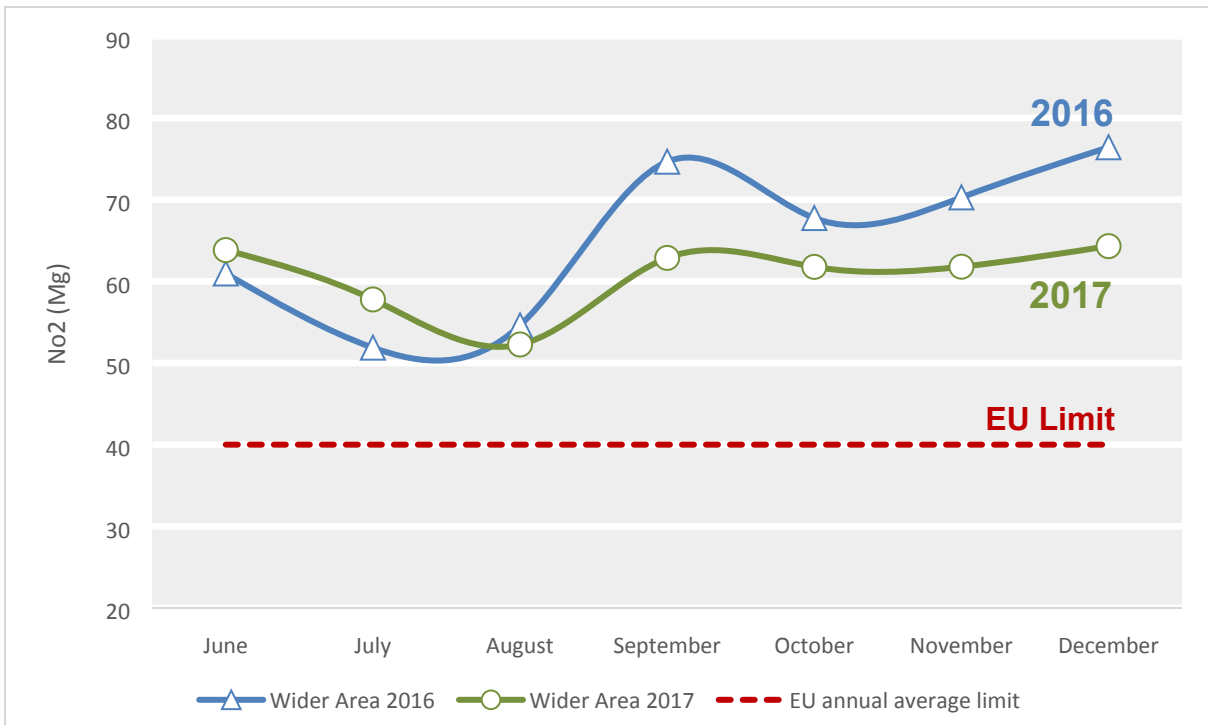
**Figure 10**  
changes in No<sub>2</sub> between 2016 and 2017 in the Wider Area

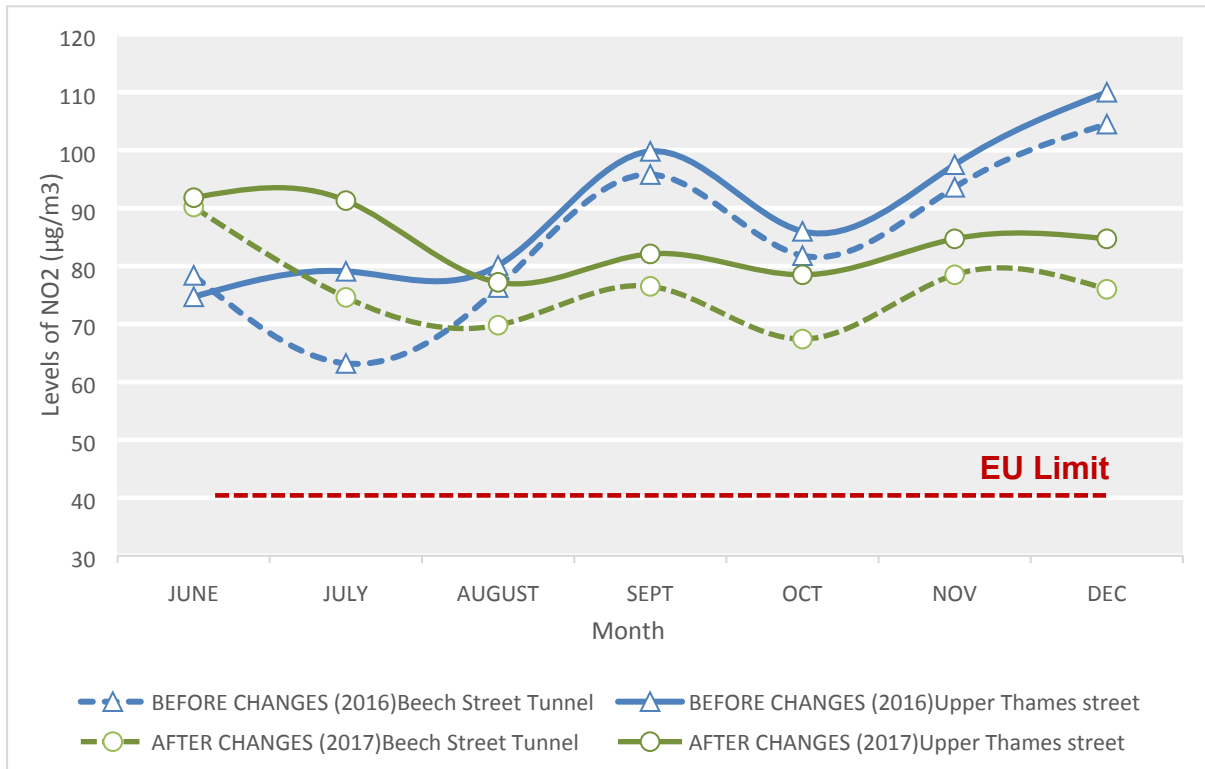
**Figure 11**

**Changes in No2 between 2016 and 2017 at City of London continuous monitoring locations (locations not shown in Figure 8)**
