OPT-OUT OF THE COMMUNAL HEATING AND HOT WATER SYSTEM
Report of the Executive Director, Community and Children's Services

Feasibility Study and Report on The Heating And Hot Water Services

Due to the numerous failures and age of the existing plant and equipment at the Middlesex Street Estate, London, we were asked to visit site to review the plant equipment condition and provide a feasibility report with recommendations on replacement or upgrading of the existing equipment and services.

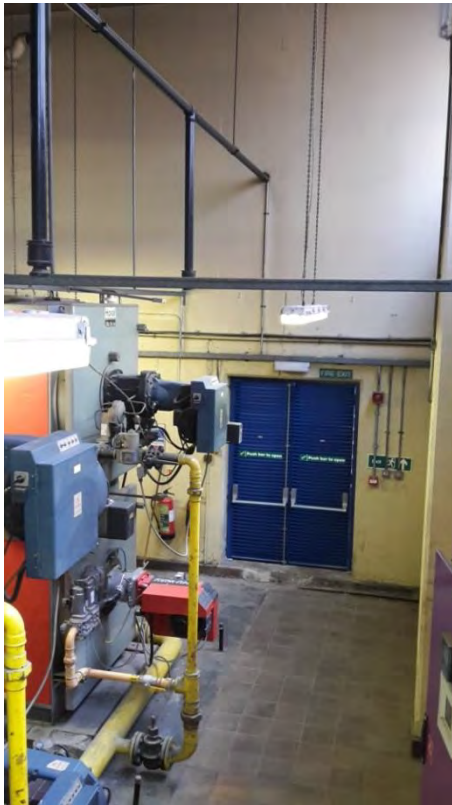
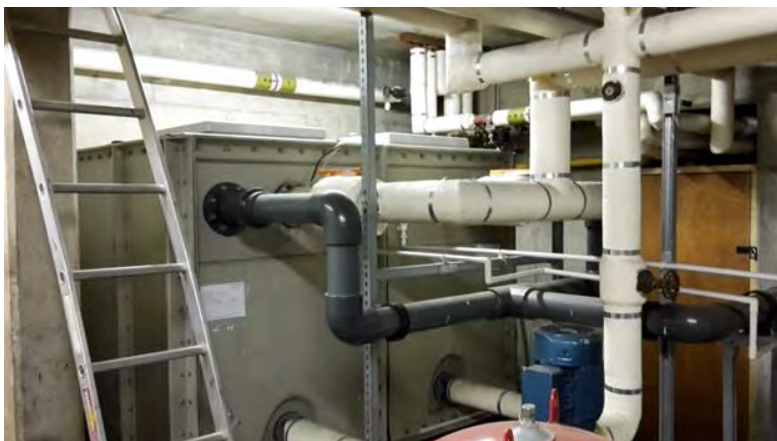
Lighting is inadequate with poor lighting levels and there are units which are non-functioning.

There are signs of leakage within the plant room mainly around valve glands.

Signage's within the plant rooms are poor and mostly outdated.

Condition Rating: Code 3

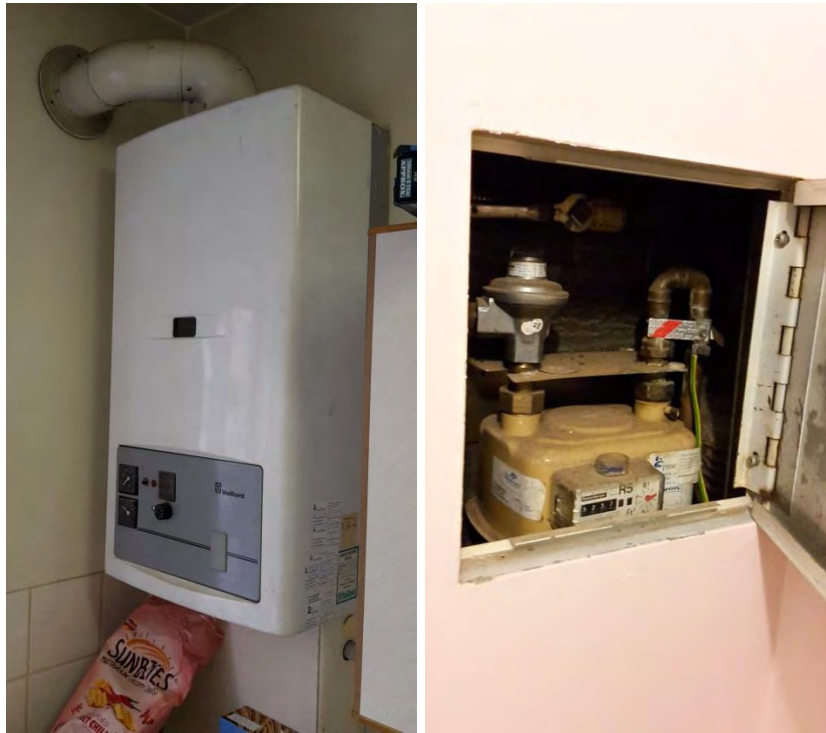
The domestic boilers surveyed were mainly 15 years+ of age and in fair to poor condition.

It is noted that the gas run supplying the domestic boilers externally has been run in copper pipe which has no identification label or colour coded. This requires rectifying ASAP as it does not conform to GSUIR 1998

Condition Rating: Code 3

These should be renewed and the systems brought into line with current regulations.

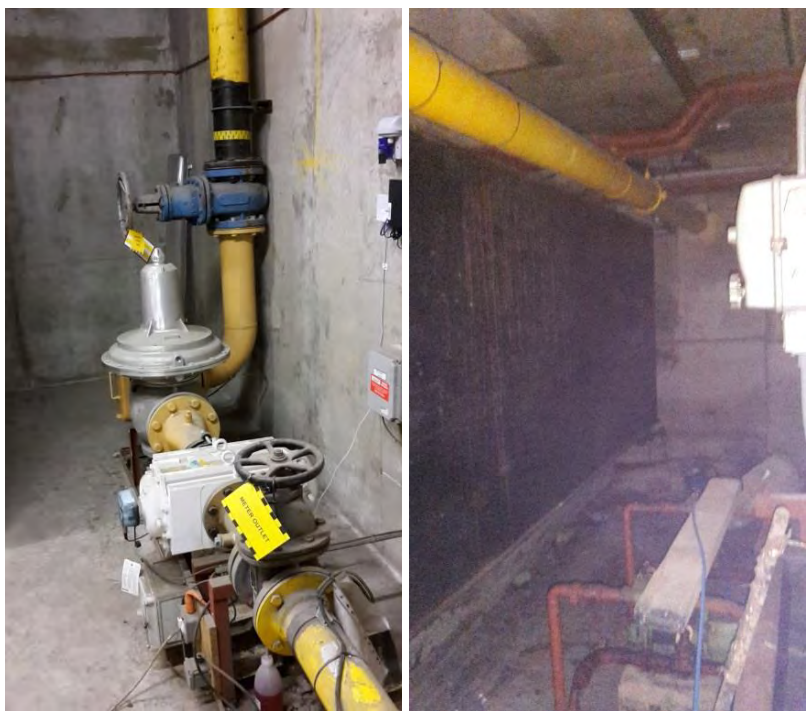
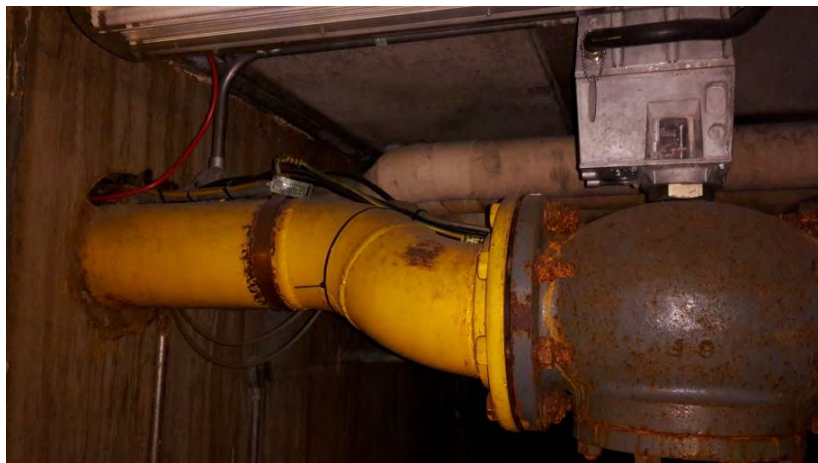
GAS SUPPLY

The gas meter room is located within the basement area below the nearby dental surgery. The access door is next the Artizan Library entrance.

There is 1 x 150mm electronic gas safety valve in the oil tank room. This is a major cause for concern and will need to be assessed under the DSEAR 2002 regulations to clarify level of risk and remedial actions required.

It is not known whether the redundant oil storage tanks plant and associated pipe work have been degassed and rendered safe in accordance with the HSE guidelines.

Condition Rating: Code 2

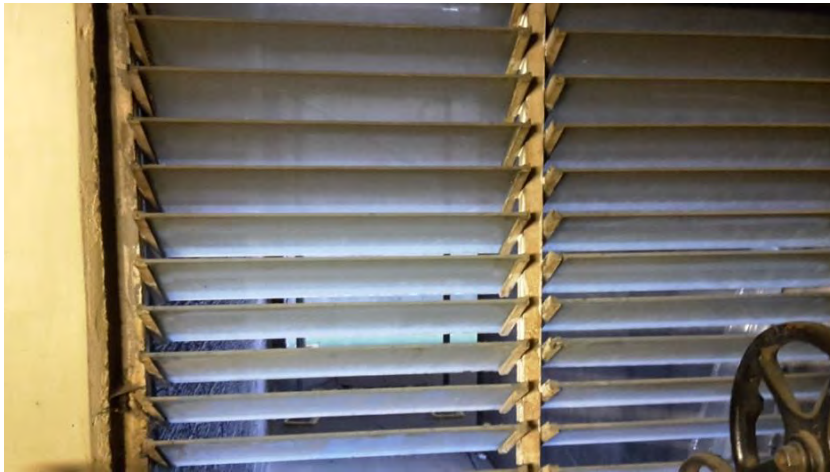
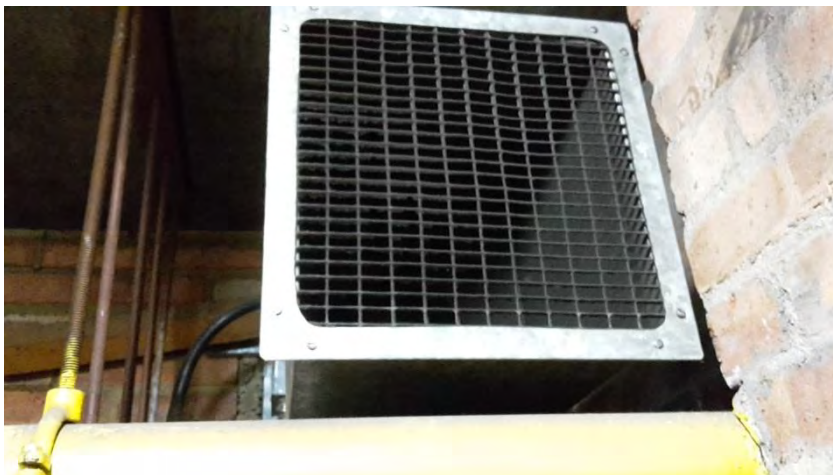
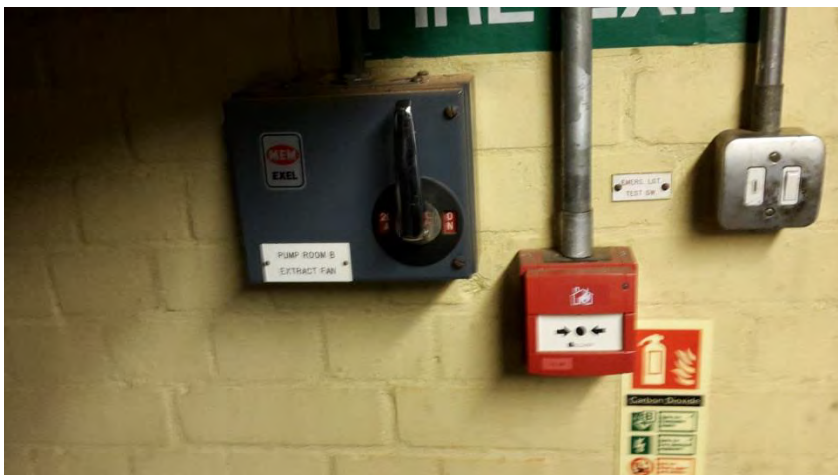
VENTILATION

The plant room is ventilated via combined high and low level grilles direct to outside. These are located above the windows and on the fire escape double louvred door.

There is also a Vent Axia inlet fan in one of the adjoining heating zone pump areas at high level above the pipe work at the back of the boiler plant room.

Condition Rating: Code 3

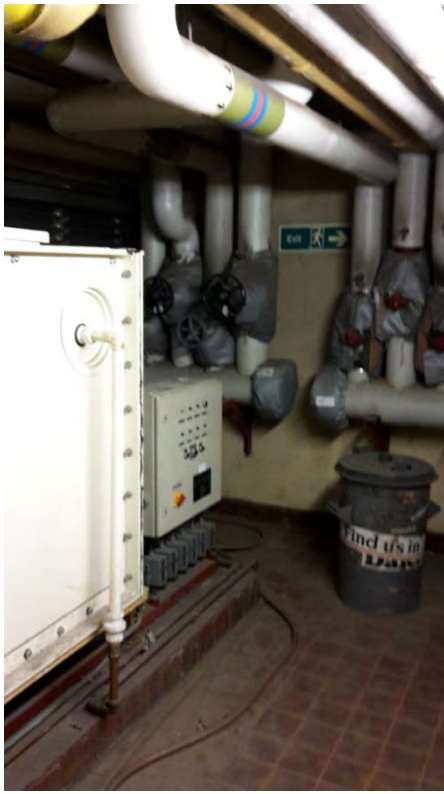
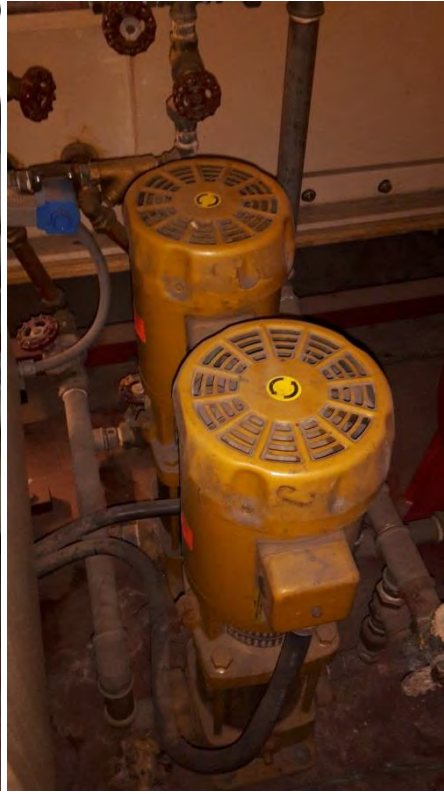
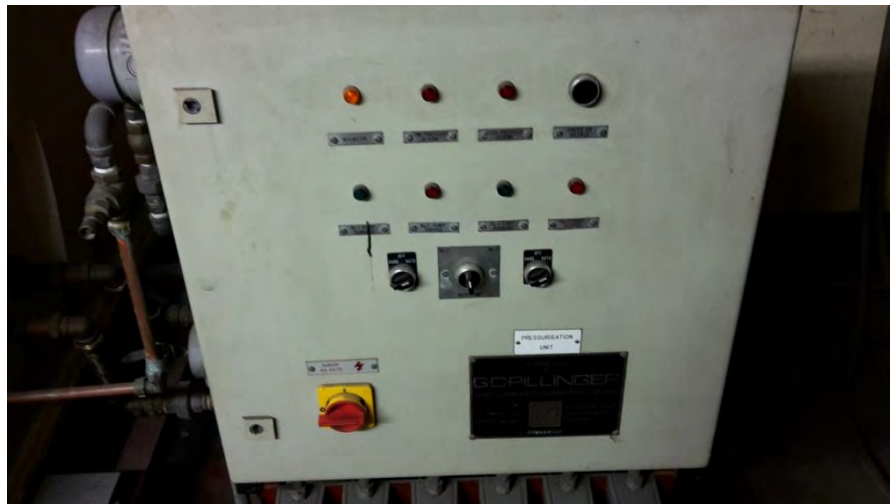
PRESSURISATION UNIT

The system is pressurised via a Pillenger Unit incorporating 2 x multi-stage pumps, 1000 litre break tank and a 100 litre expansion vessel. Approx. 15 years old and in poor condition.

Condition Rating: Code 2

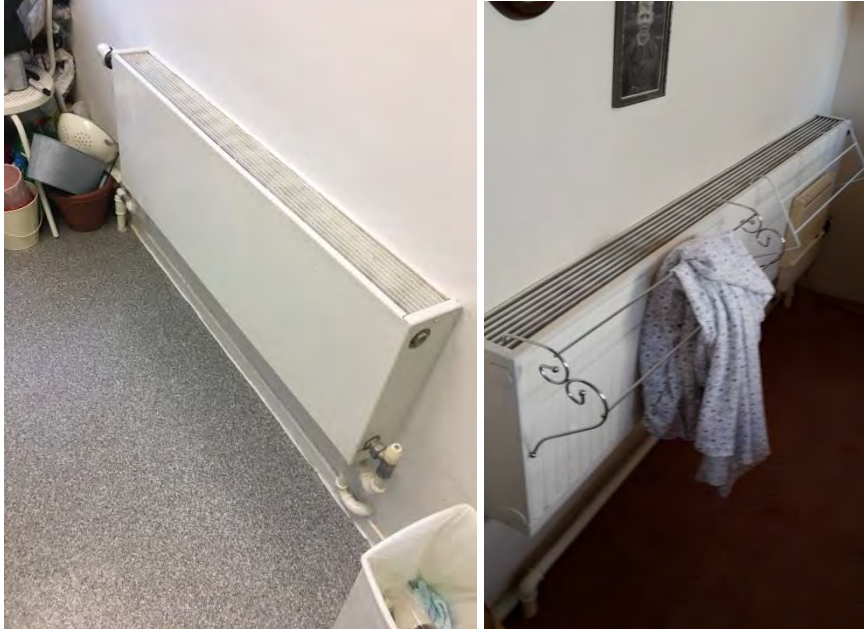
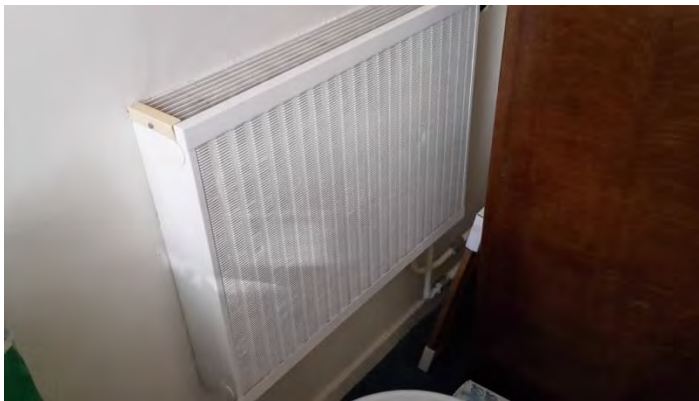
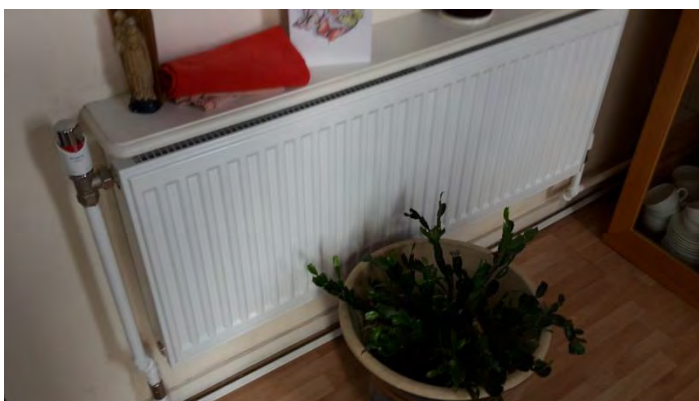
HEAT EMITTERS

In dwelling pipe work installation is fair. It is run mainly within the screed floor or through ceilings.

Does not conform to current Building Regulations L1 of the approved document, with missing radiator thermostatic controls valves, room thermostats or programmers.

Condition Rating: Code 3

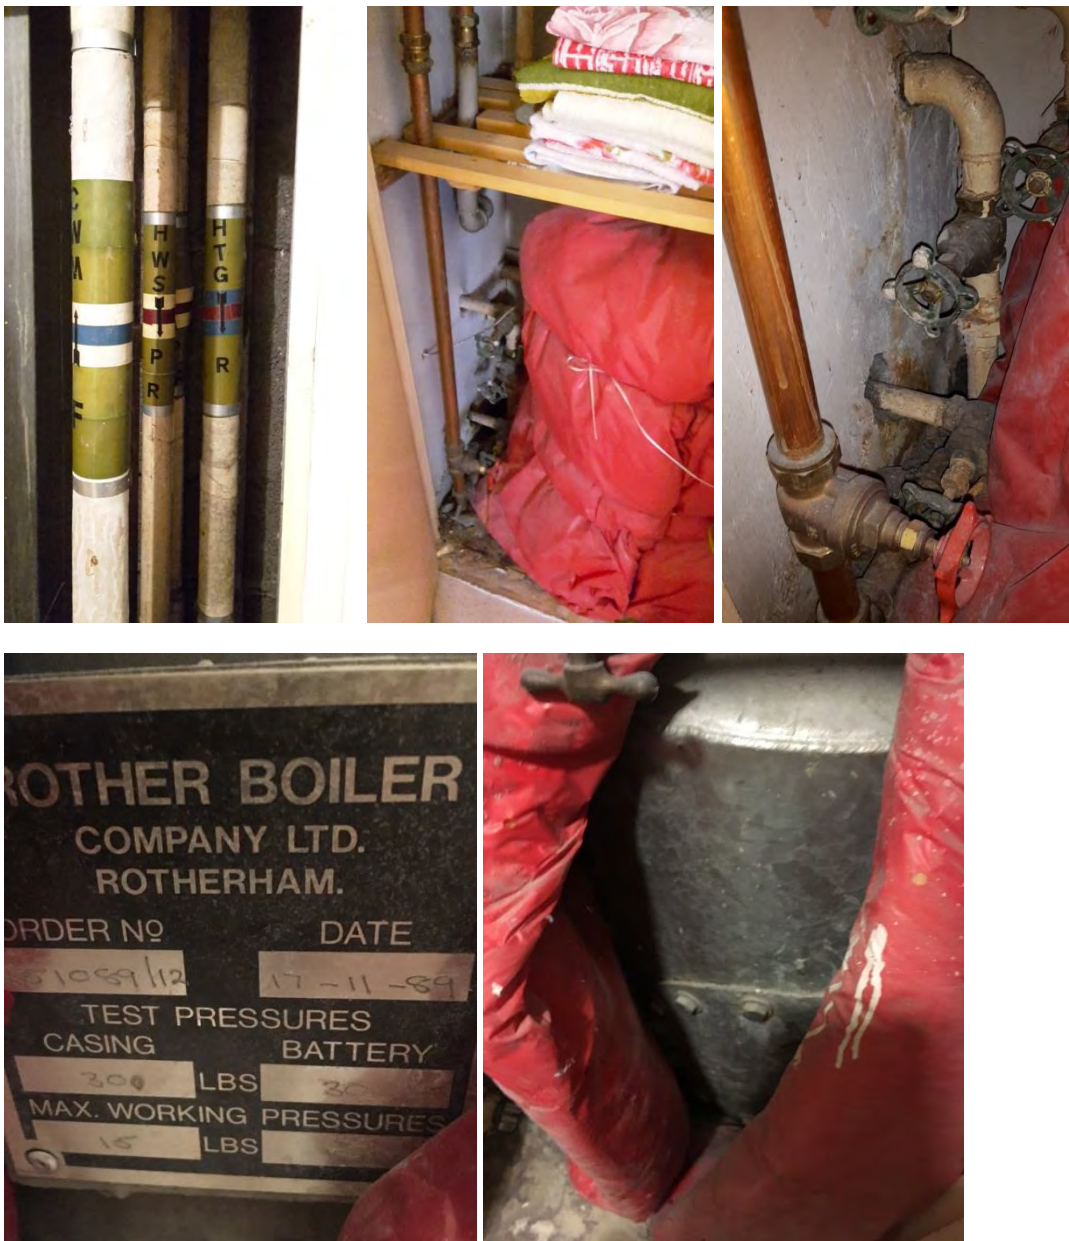
HOT WATER CYLINDERS (WITHIN DWELLINGS)

Of the 10% dwellings surveyed the pipe work installation is original and past its economic life expectancy, with missing insulation or inadequate sleeving, The pipe work rises through a central service duct then is run mainly within screed floor or through ceilings within the dwellings.

Hot water cylinders do not conform to current Building Regulations L1 of the approved document, with missing basic controls such as cylinder stats, regulating valves, insulation jacket and either damaged, missing or beyond economic life expectancy.

Condition Rating: Code 2

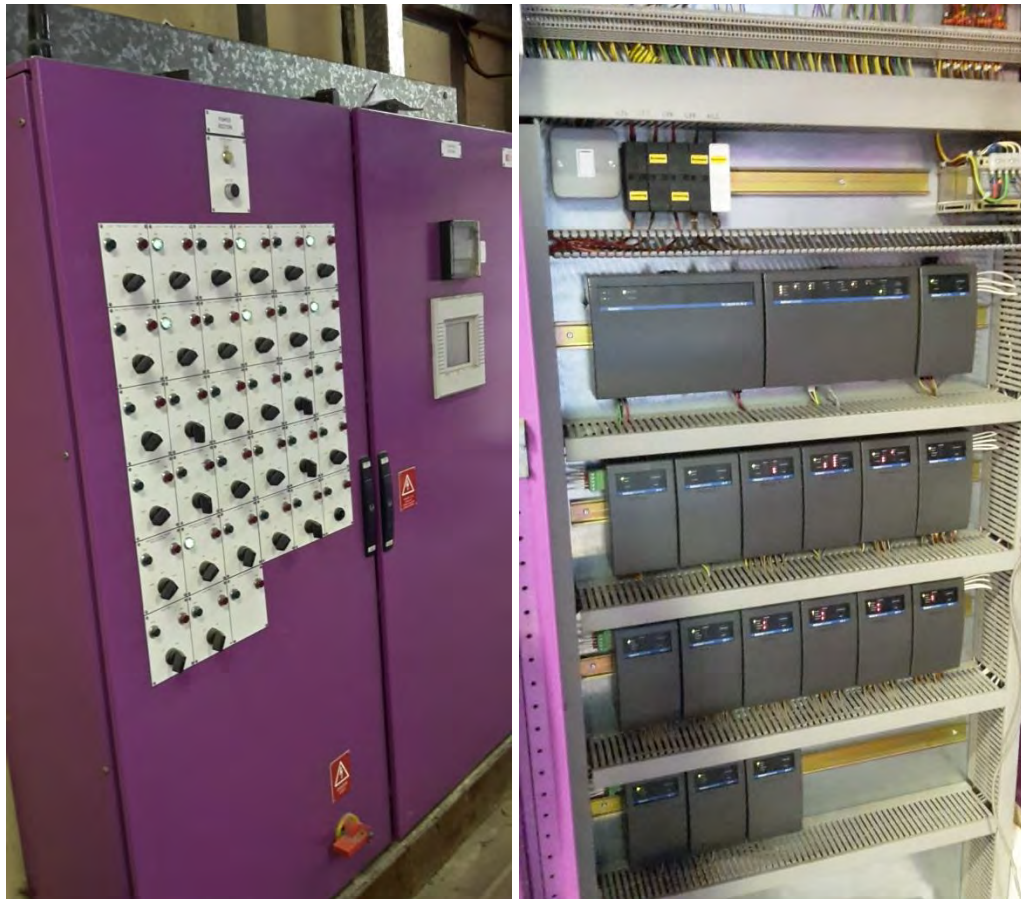
CONTROL PANEL AND CONTROLS

The controls panel and existing controls visibly are in fair condition.

The Landis Gyr three port motorised valves are showing signs of slight leakage

Condition Rating: Code 2

Generally all controls require renewal, as they are inefficient for today's standards and will not meet current Building Regulations of the approved documents.

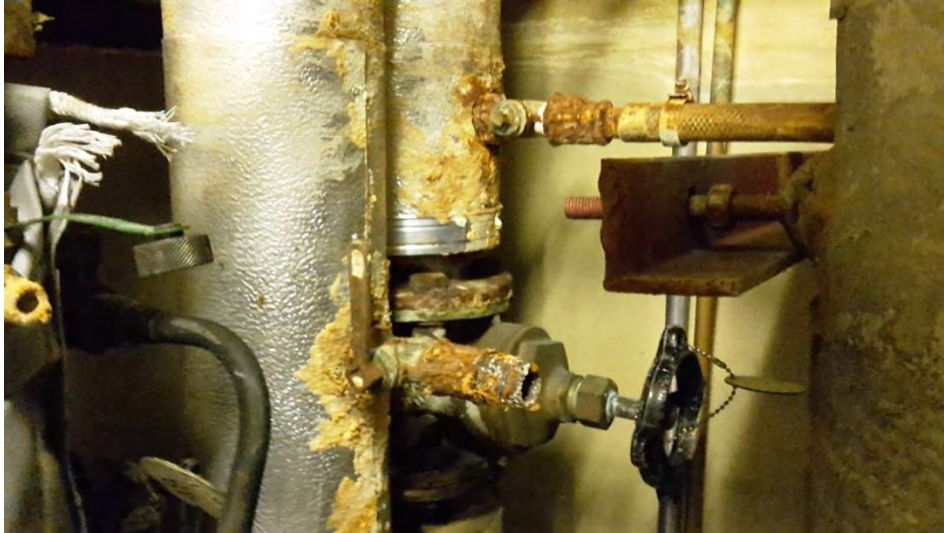
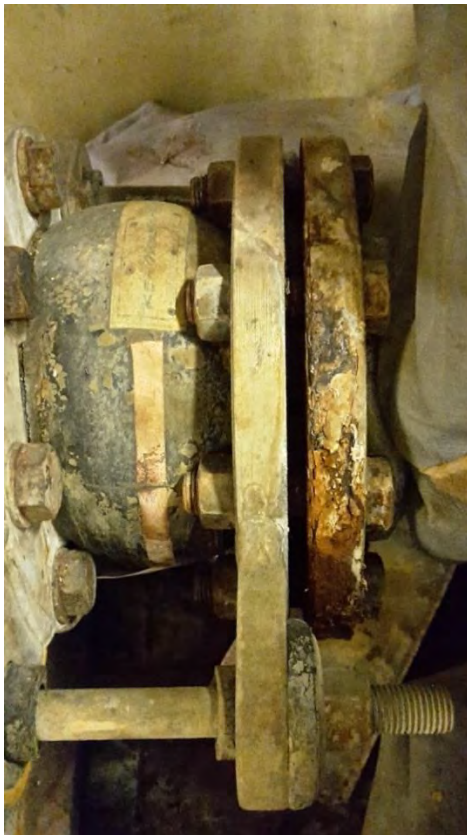
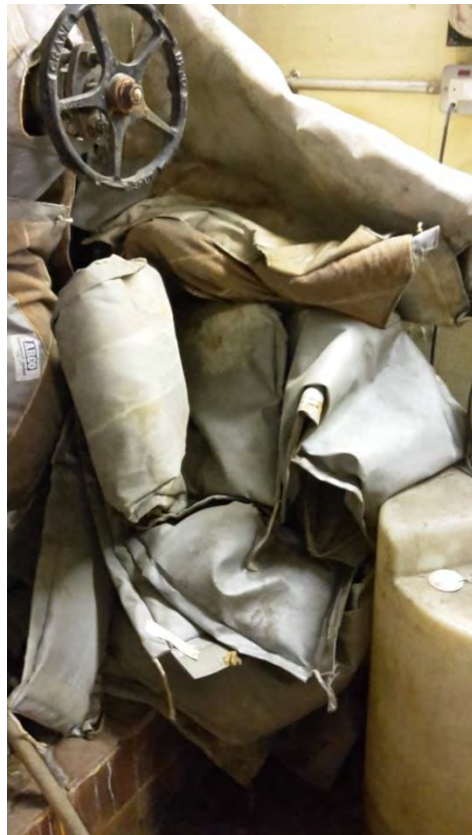
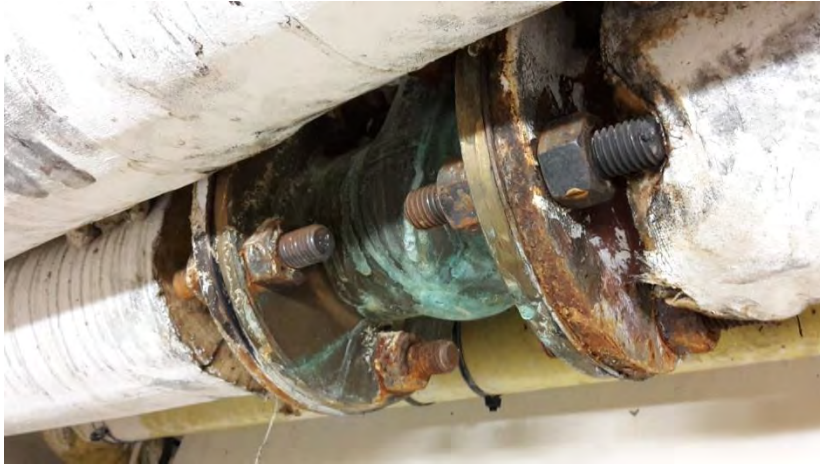
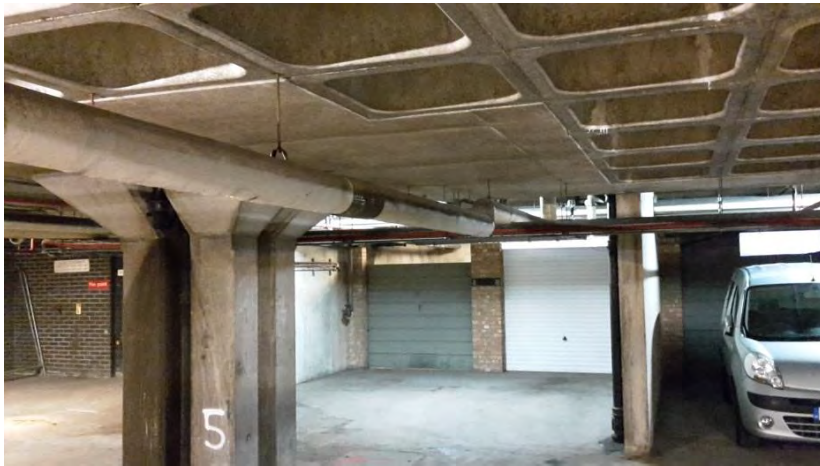
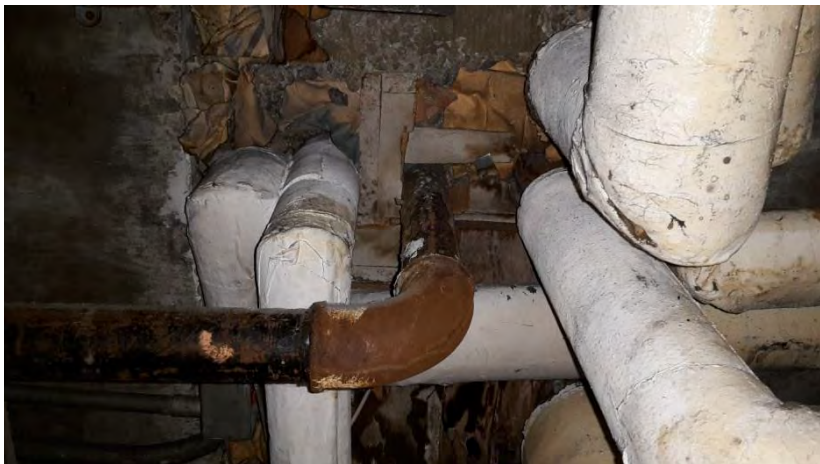
The valves generally are in fair/poor condition. There appears to be a lack of maintenance and signs of leakage. Some valves have been left open ended.

Pipework generally is in fair/poor condition, with signs of leakage. Valve wraps are either missing or not refitted.

Several sections of insulation is missing/damaged on main distribution pipe work externally

Pipe work within various areas is insulated in suspected asbestos material. No information available on site.

Condition Rating: Code 1

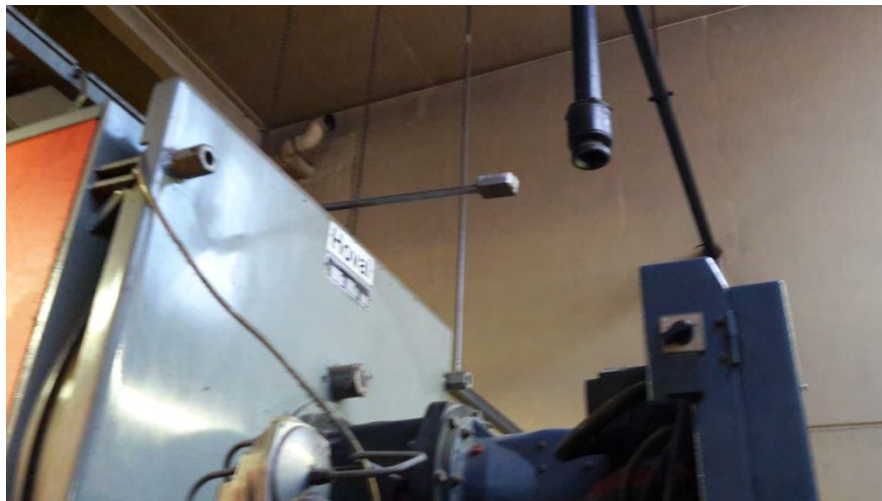
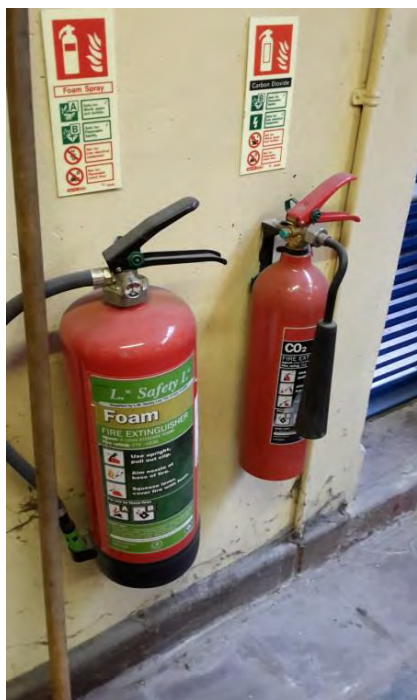
FIRE SAFETY DEVICES

Thermal links on boilers.

No Gas leak detector in boiler room and gas meter room.

No fire proofing in shared riser ducts in all blocks

Condition Rating: Code 3

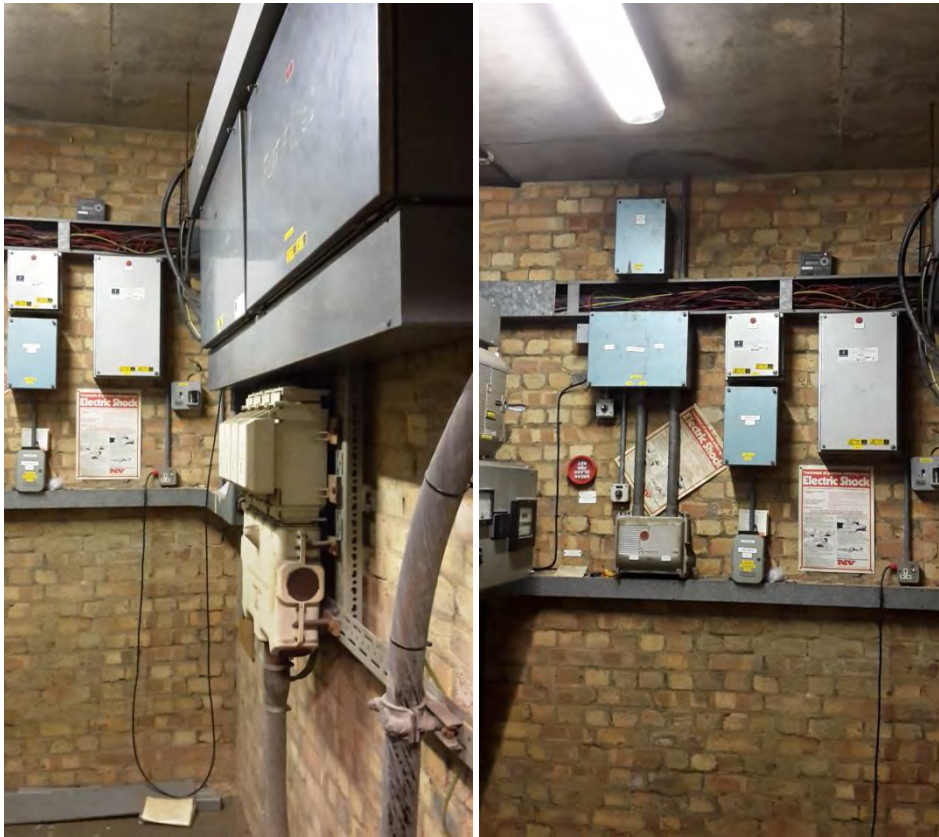
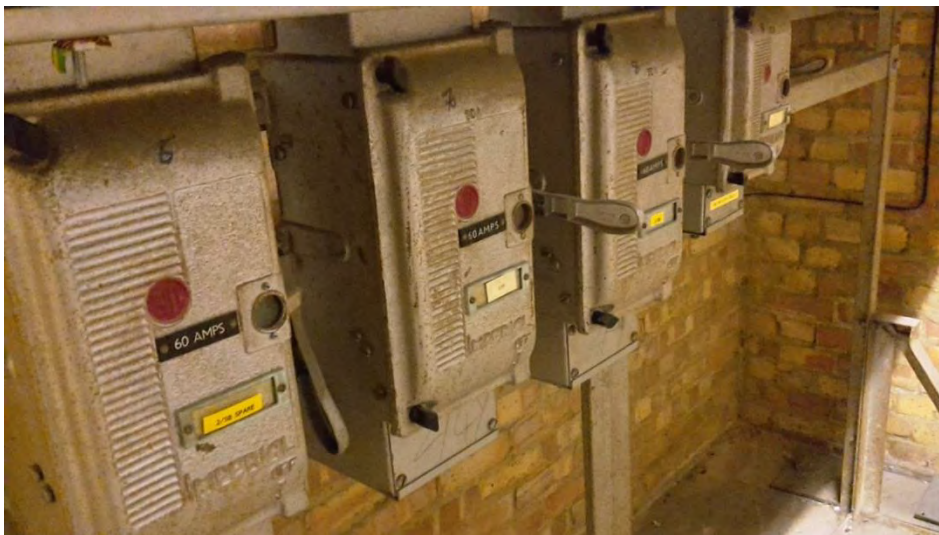
GENERAL WIRING AND CONTAINMENT

Wiring is visually mostly in a fair/poor condition, and original 30 years of age.

Condition Rating: Code 2

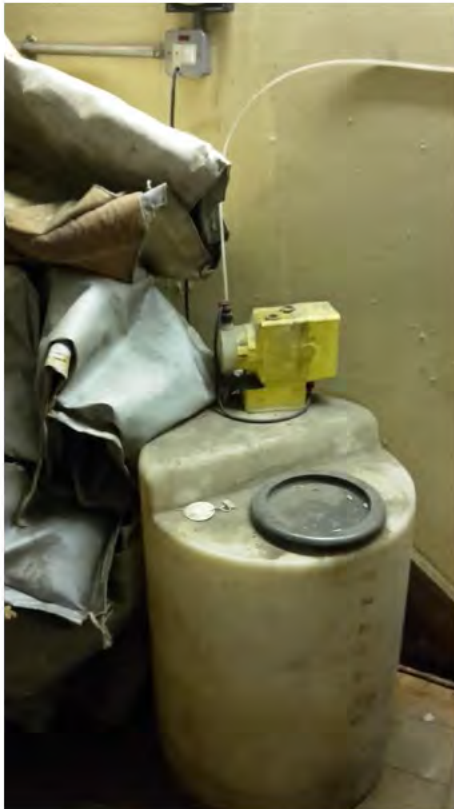
WATER TREATMENT/DOSING

Dosing pot in fair condition but not connected to the system.

Condition Rating: Code 3

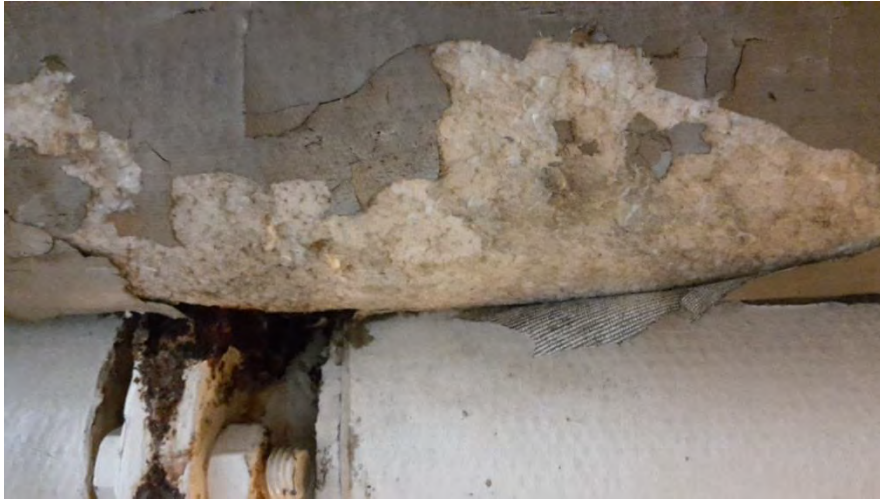
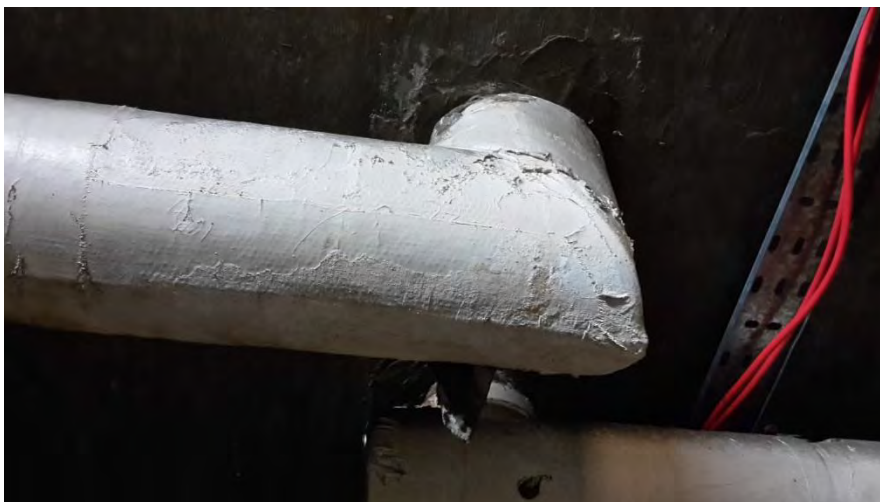
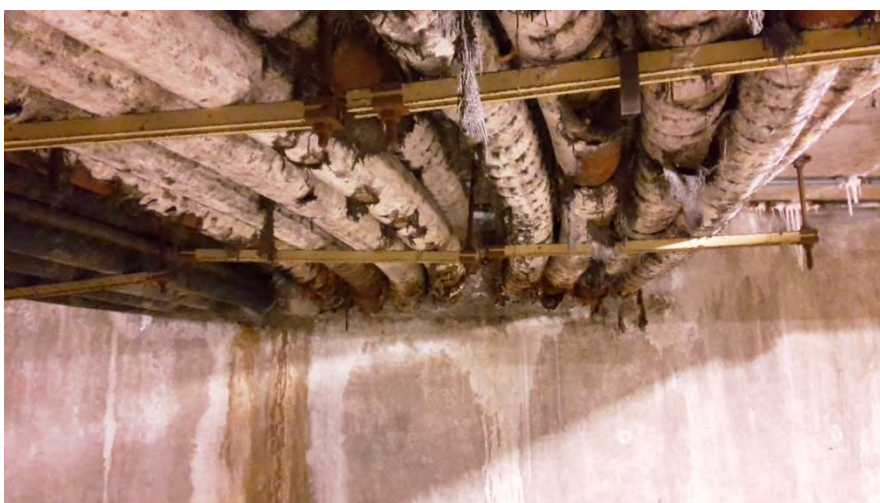
No asbestos information was available on site. However asbestos suspected material is likely to be in all areas. An assessment should take place. Insulation on pipe work should take priority as this is damaged and if asbestos content is confirmed then area is highly hazardous and requires urgent attention.

Condition Rating: Code 1

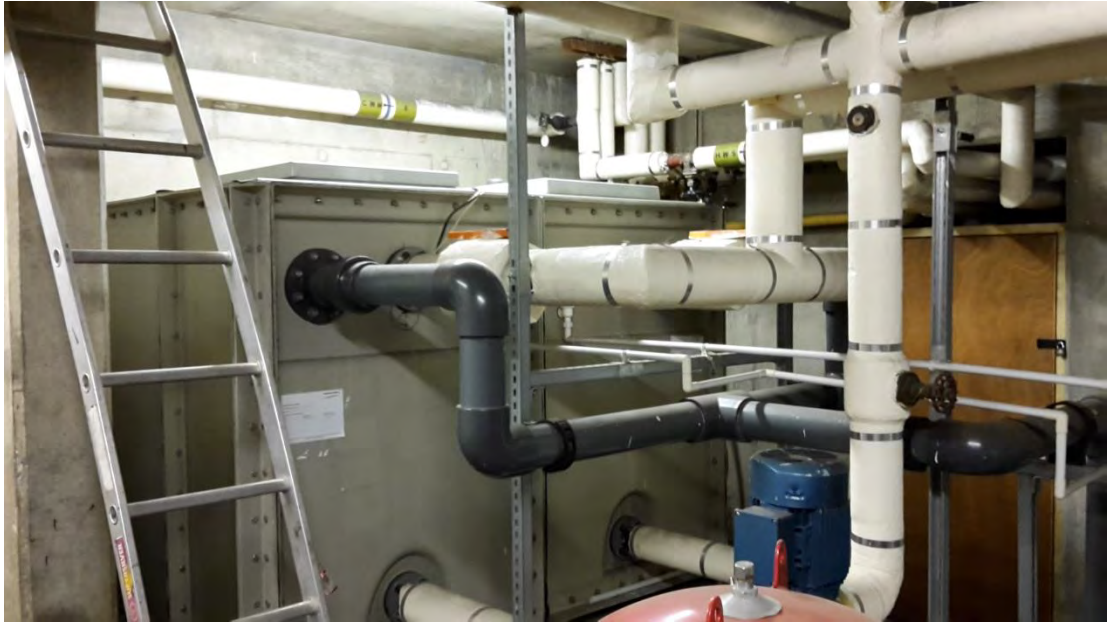
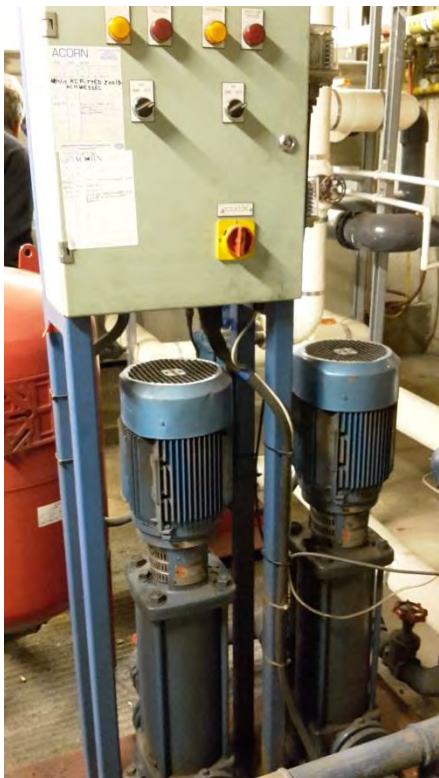
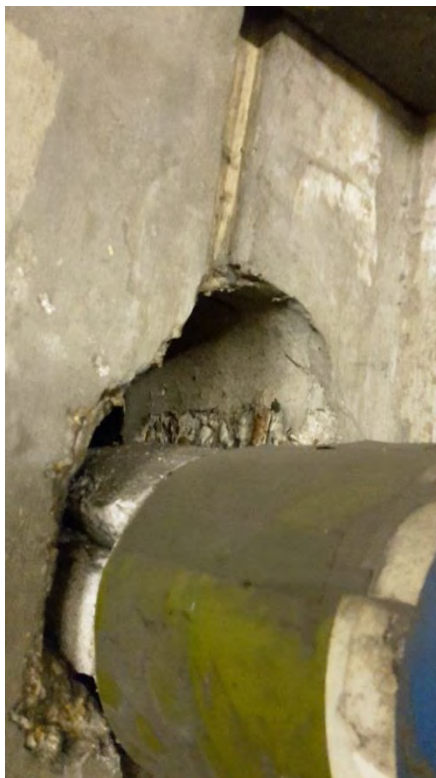
COLD WATER BOOSTER SETS

There is a central plant room in the basement area containing a cold water storage tank and duty and standby booster pumps set. Approx. 15 years old.

Plant rooms require a general tidy up and there is suspected asbestos material on pipework and fire proofing is required to some areas.

Condition Rating: Code 1

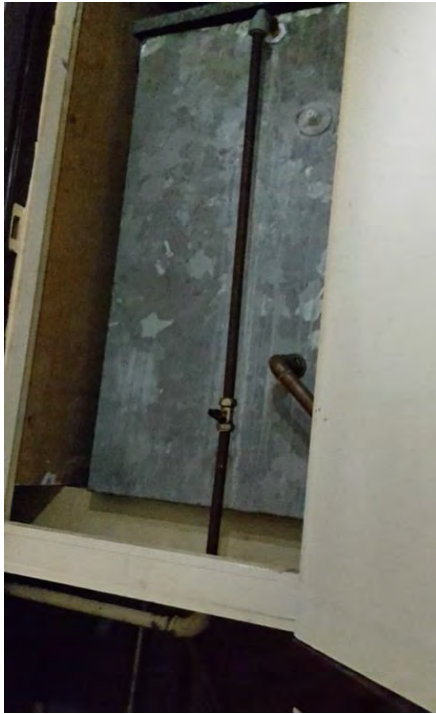
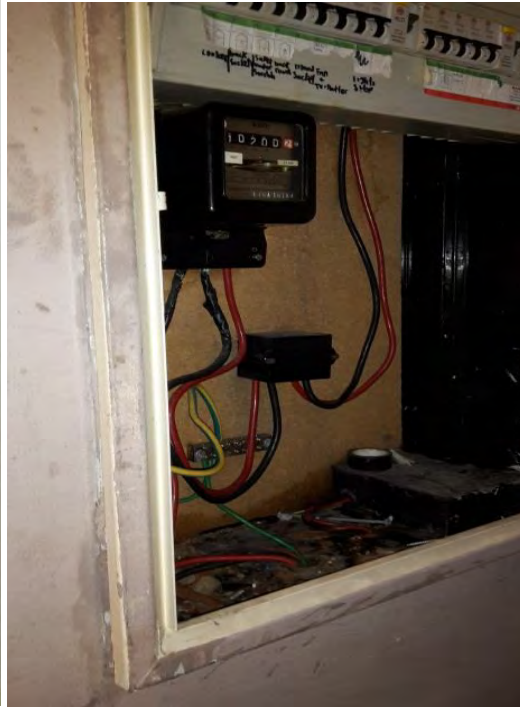
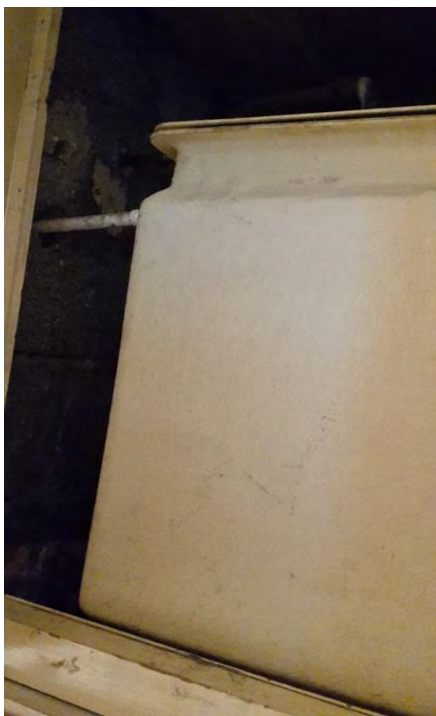
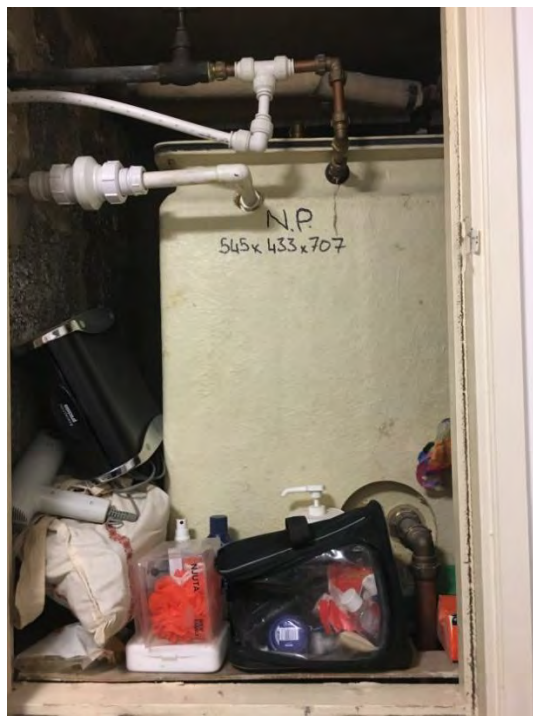
COLD WATER STORAGE TANKS

These are mainly GRP cisterns but galvanised also present in some locations, are located within each dwelling and are supplied via mains water or the booster plant.

Particular concern was the galvanised tank located within the "Tiffin Box" Restaurant which was badly leaking into the electrical fuse board. The Owner stated that this had already been reported to the Corporation of London. This requires urgent attention.

Condition Rating: Code 1 (Tiffin Box)

Condition Rating: Code 3 (generally)

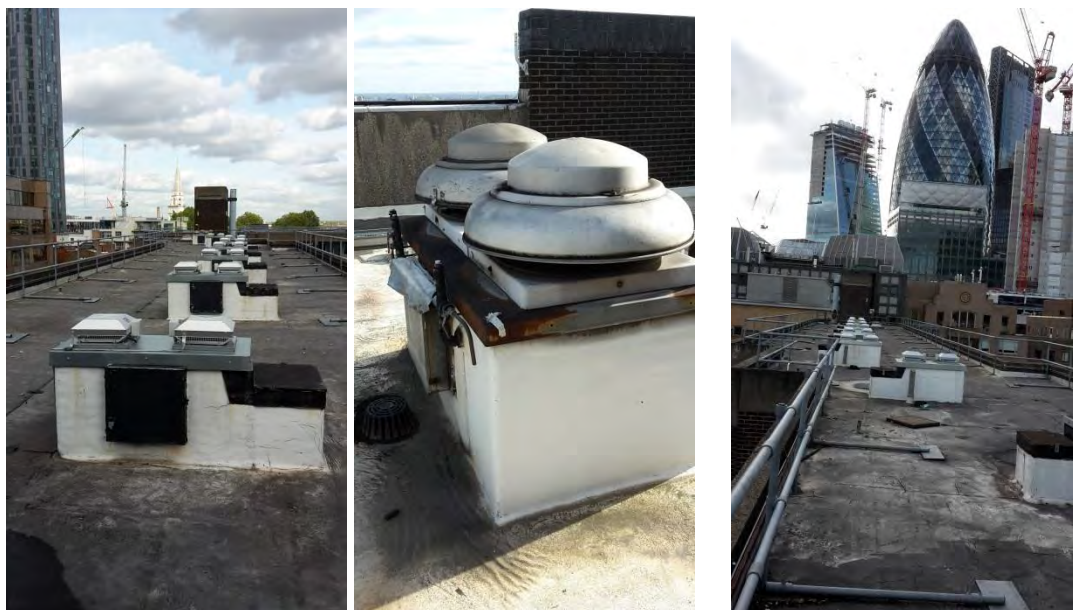
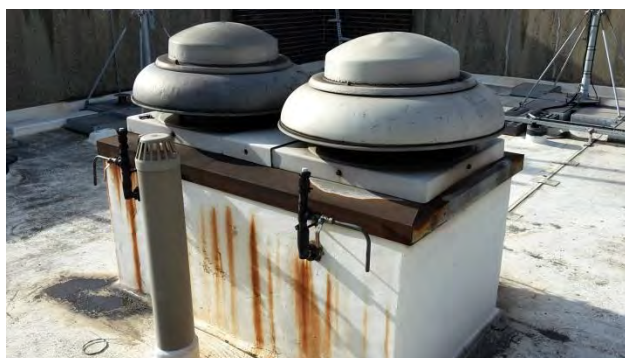
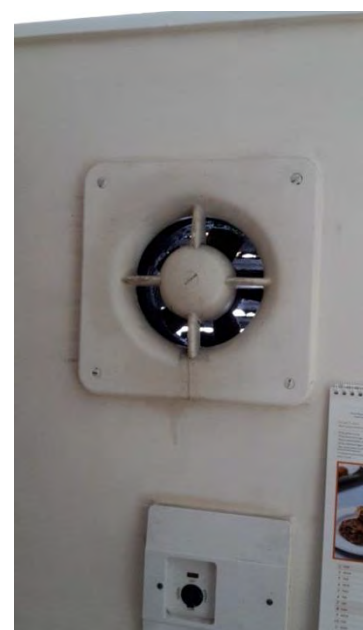
COMMUNAL FANS

There are Helios RDW 225/2 communal fans on the flat roofs of each block. The ductwork drops down each column of two flats in the service riser duct providing extraction for bathrooms.

The communal fans are in fair condition,

Condition Rating: Code 2

Where individual fans have been installed in kitchen areas these can either remain, be cleaned or replaced, depending on condition. Where none have been installed, new fans will be installed to comply with Part F of the approved document Building Regulations.
