## Queen's Park Joint Consultative Group

**For Discussion**  
(Pages 5 - 14)
5. **DRAFT QUEEN'S PARK CONSERVATION MANAGEMENT PLAN**  
A report of the Superintendent of Hampstead Heath (copy attached).

**APPENDIX E**  
**BUILDINGS CONDITION SURVEY**

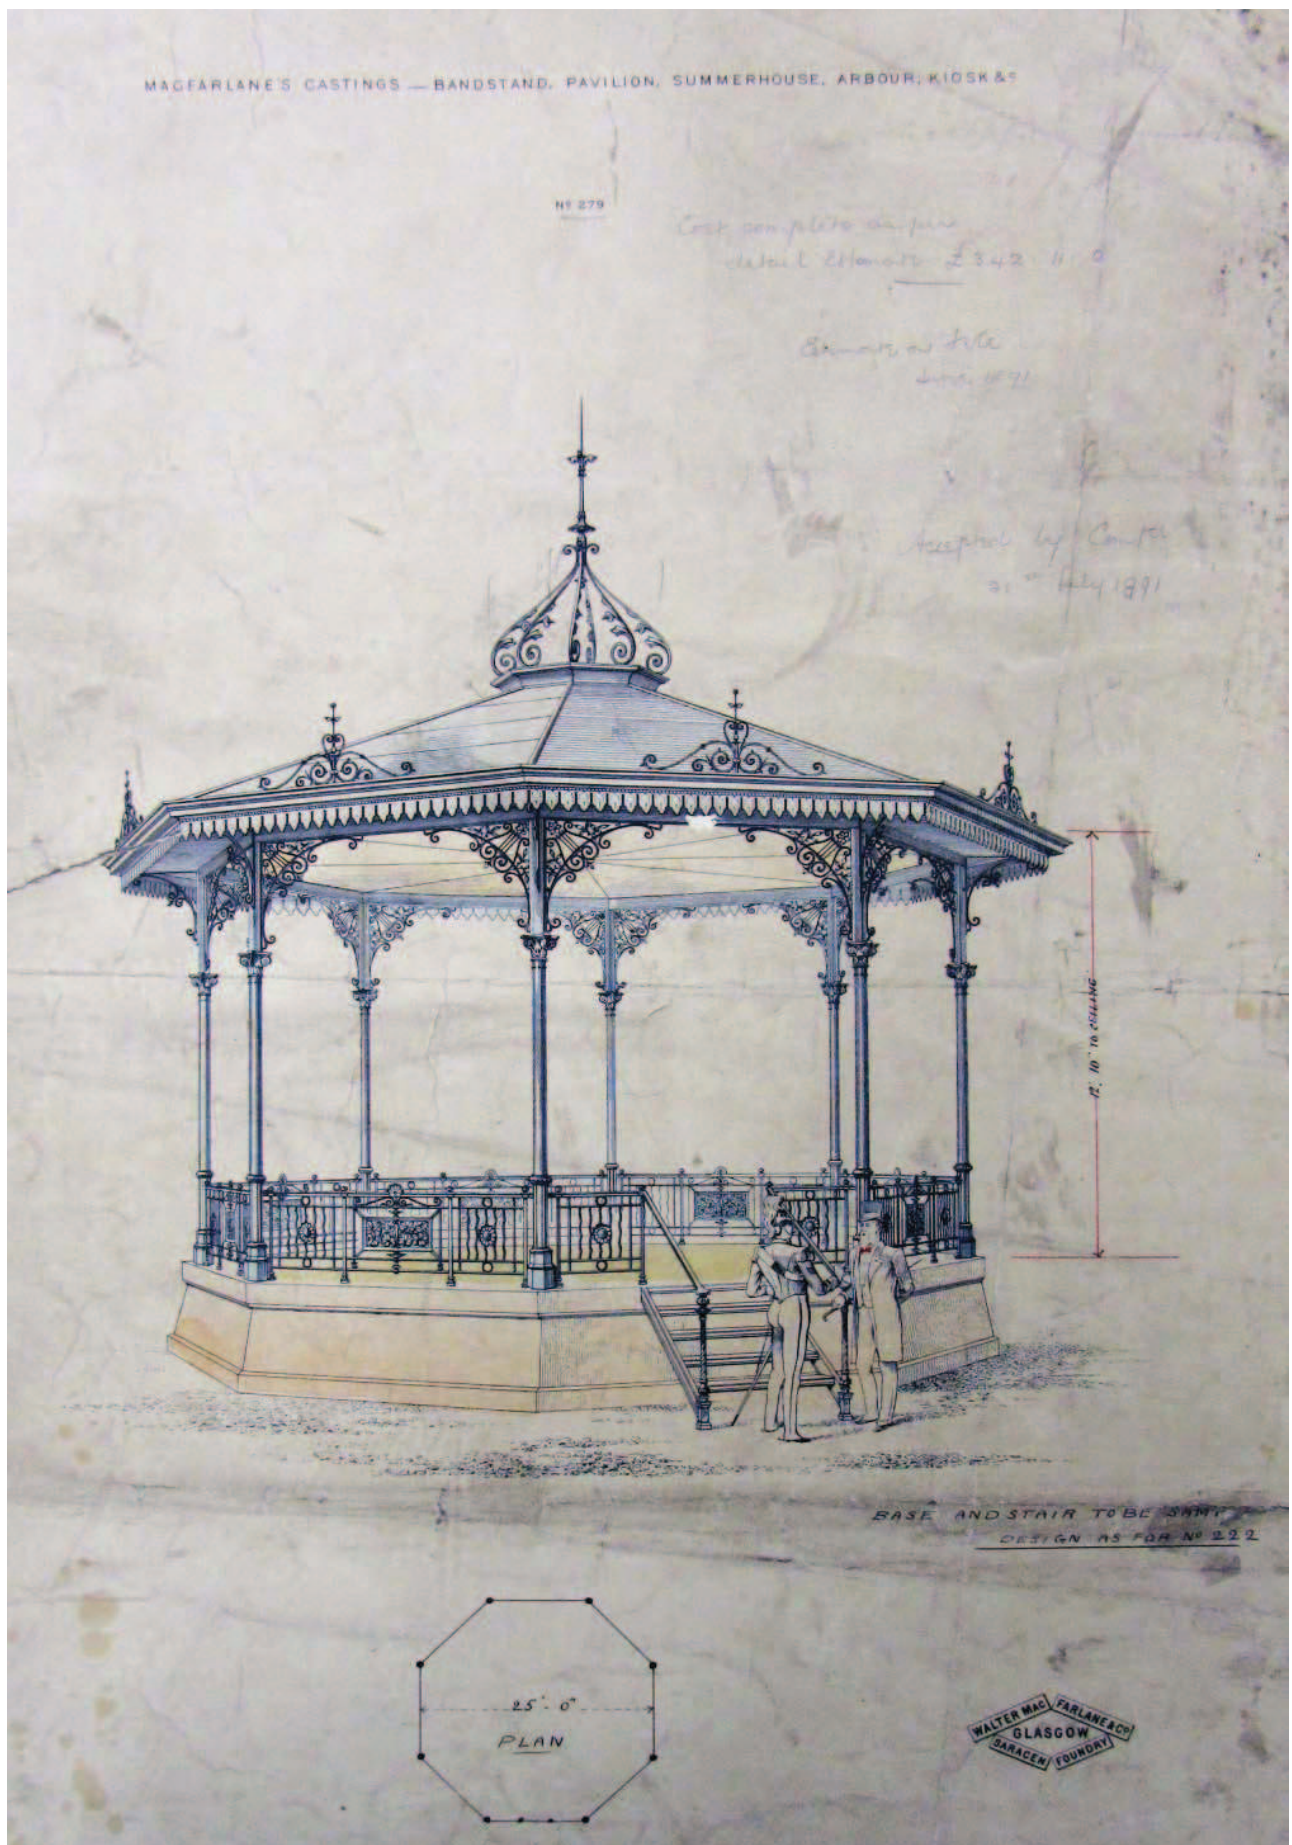
**Figure 21:** Drawing of the Proposed Bandstand from Walter MacFarlane & Co. dated July 1891. Has a note saying cost £342.11s

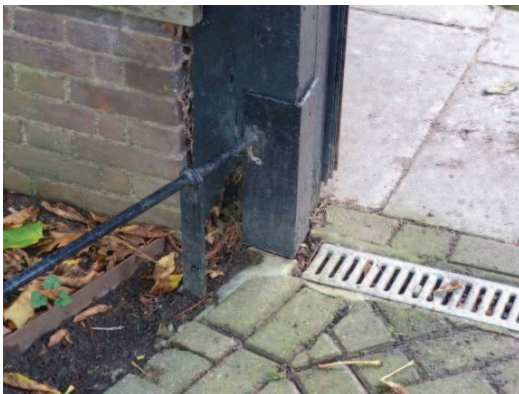
- 2.20 The northern elevation has suffered from movement which has distorted the frame and caused a number of the mortise and tenon joints to pull apart. This has possibly been caused by the rotting of the bases of the principal posts. These could not be in a more inappropriate location; buried in soil, at the foot of a slope and, in the case of one of the posts, at the termination of a drainage channel. There is also a channel drain across the base of the opening between the posts, which may well also terminate against the feet of the posts. This should be investigated further in order to improve the detail and to confirm the structural effectiveness of the current repairs.

Rotten oak post adjacent to drainage channels (2.20).  
Steel reinforcement bolted to brickwork(2.21)

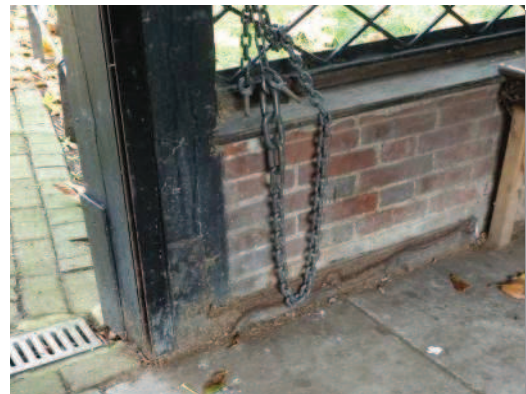
- 2.21 The rotten bases of the posts are reinforced with steel angles. Unfortunately the steelwork appears to be bolted only to the adjacent brickwork panels. It is unclear whether this is effective in structural terms and it seems possible that settlement is still occurring. It is recommended that structural advice is obtained.
- 2.22 A galvanised steel roller shutter has been set across the head of the opening on the north side, presumably to enable the Lychgate to be secured at night. The considerable weight of the shutter is likely to contribute to any settlement and distortion of the frame.

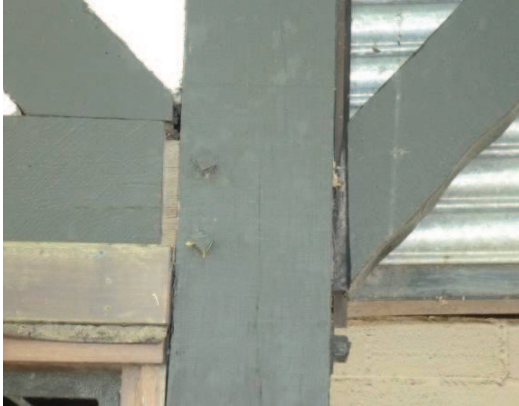
Dislocation of frame (2.20)

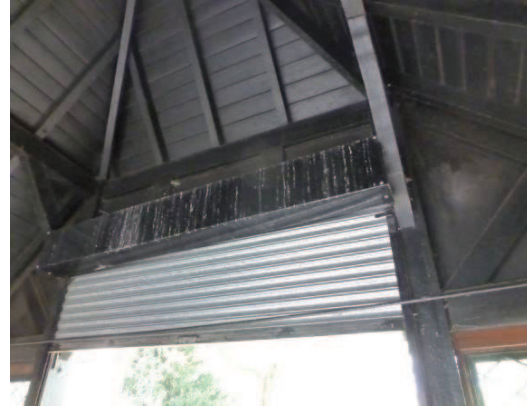
Roller shutter (2.22)

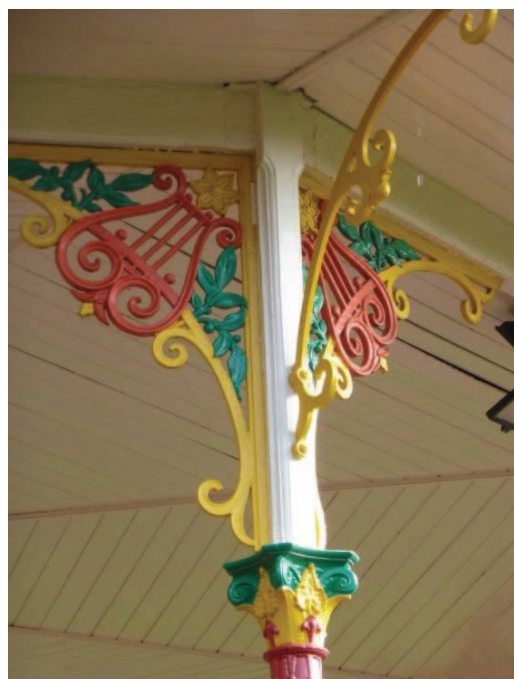
Detail of column bracketry

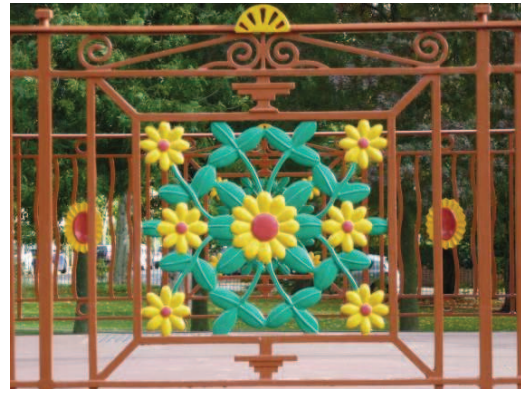
Detail of balustrade

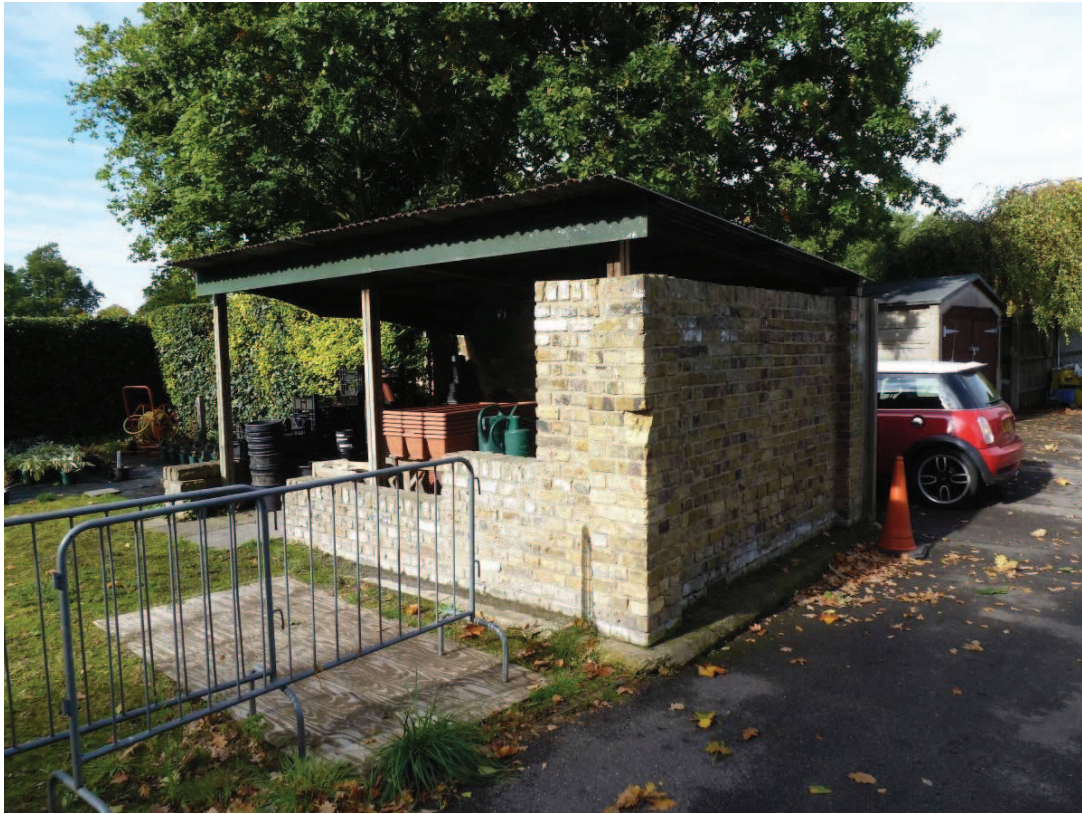
## Storage Lean-To

- 4.6 A simple, ad-hoc structure, apparently built from salvaged materials. Consists of a yellow stock brick wall on two sides and dwarf brick walls on the remaining two sides, constructed over a concrete base which is possibly older than the brickwork. The roof structure is a mixture of treated timber and steel supported on timber posts at the high end, and from the brick wall at the low end. The roof is finished in what appears to be a re-used steel roller shutter. The floor within is finished in York stone pavings.

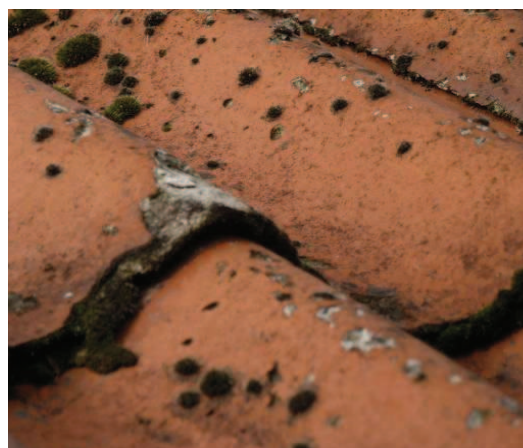
Friable roof surface (4.14)
