Barbican Estate
Barbican Residential Blocks
Andrewes House - Fire Strategy
Report

Rev C | 7 September 2022

Job number 279095-00

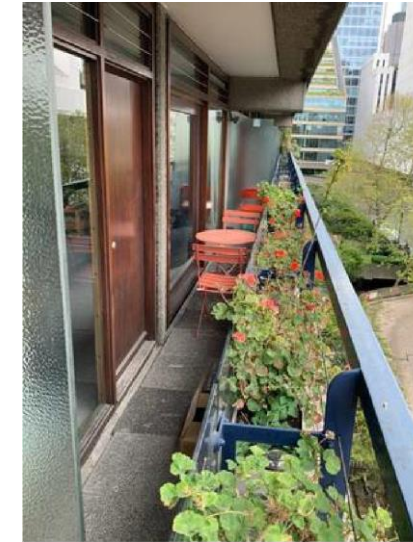
Figure 5: Furniture along the South balcony

In addition to the above, it was identified during the site visit, that furniture is located along the South balcony as shown in Figure 5 below **Error! Reference source not found.** These should be removed so that the escape route remains unobstructed.

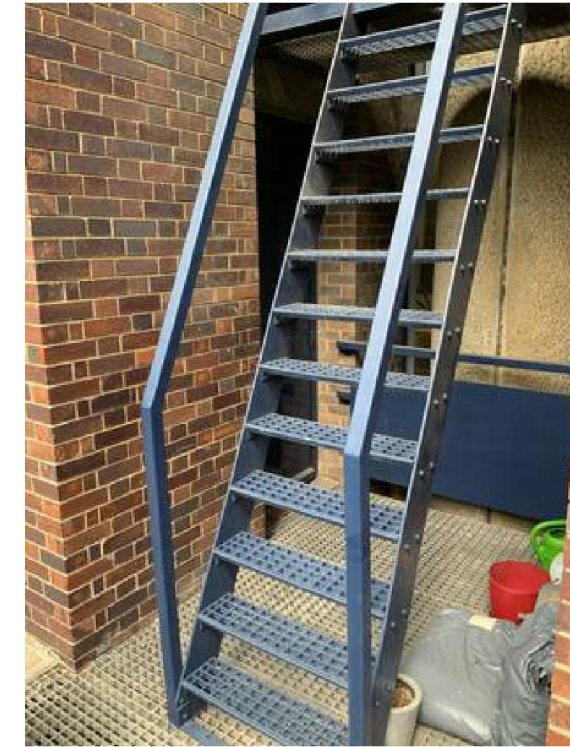
Figure 6: Ladder from L01 to L02 leading to Willoughby Carpark through L02 garden.

- Flat entrance – onto the same stair serving Level 1 to 7 above.
- Willoughby carpark via the gardens – all L02 flats each have a garden that is open to adjacent gardens. Occupants can evacuate through the gardens and travel to the Willoughby carpark to reach the final exit.
- There are also four L01 flats (SC49 end of Andrewes House) with external ladders leading down to L02 (refer to Figure 6). BS 9991 states that ladders should not form part of a means of escape route from any dwelling. Therefore, the ladder that connects L01 to L02 cannot be considered as an alternative means of escape.

The door that leads to the Willoughby carpark from the gardens is currently locked and can only be opened by a key. The lock should be changed so that it can be opened without the use of a key or other devices.

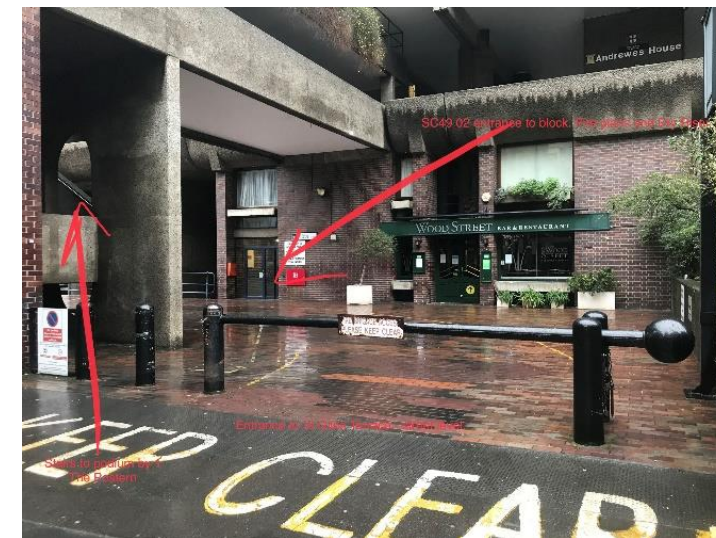
Figure 8: Final exit for firefighting shaft SC49 at St Giles Terrace

In the case of SC49, discharge is available at both Podium level and street level, adjacent to fire service vehicle access point. Refer to Figure 8 below.

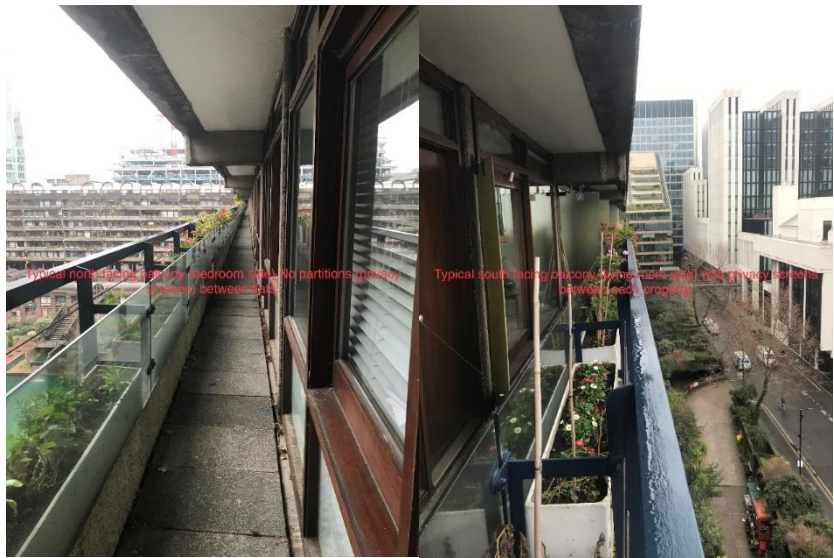
Figure 12: Photos of both South and North facing balconies

BE confirmed the distance from the balcony surface to top of the balustrade glazing is 960 mm and from the top of the balustrade glazing to the soffit is 1430 mm which is compliant as it is more than 50% of the vertical plane across the surface as shown in Figure 12.

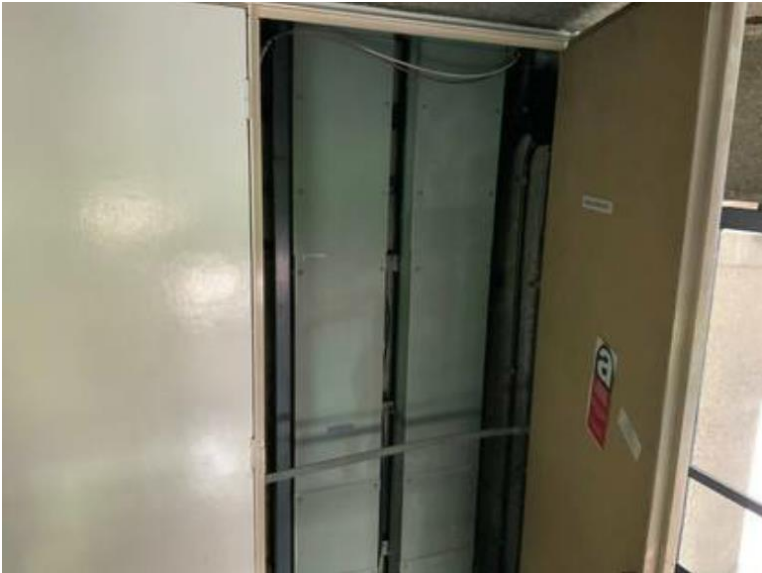
Figure 15: Service shaft door within one of the common stairs

During the site visit, the doors to services risers within the stairs were not labelled fire doors and were not being maintained properly to provide separation between the riser and the stairs. Figure 15 shows one of the doors for service risers.

After consultation with BE on 23/07/2021, BE have confirmed that City of London carries out monthly door inspections and London Fire Brigade does an inspection every 6 months.

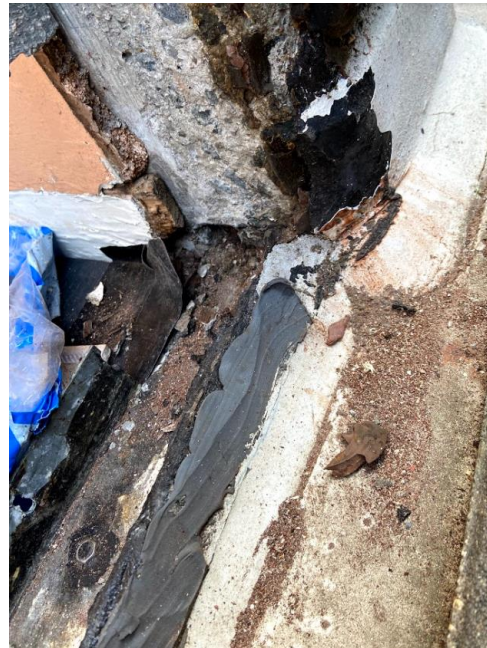
Figure 16: Aperture of a balcony door frame showing no cavity

the balconies. Figure 16 illustrates an aperture where a balcony door frame has been removed showing no cavity within the structure.

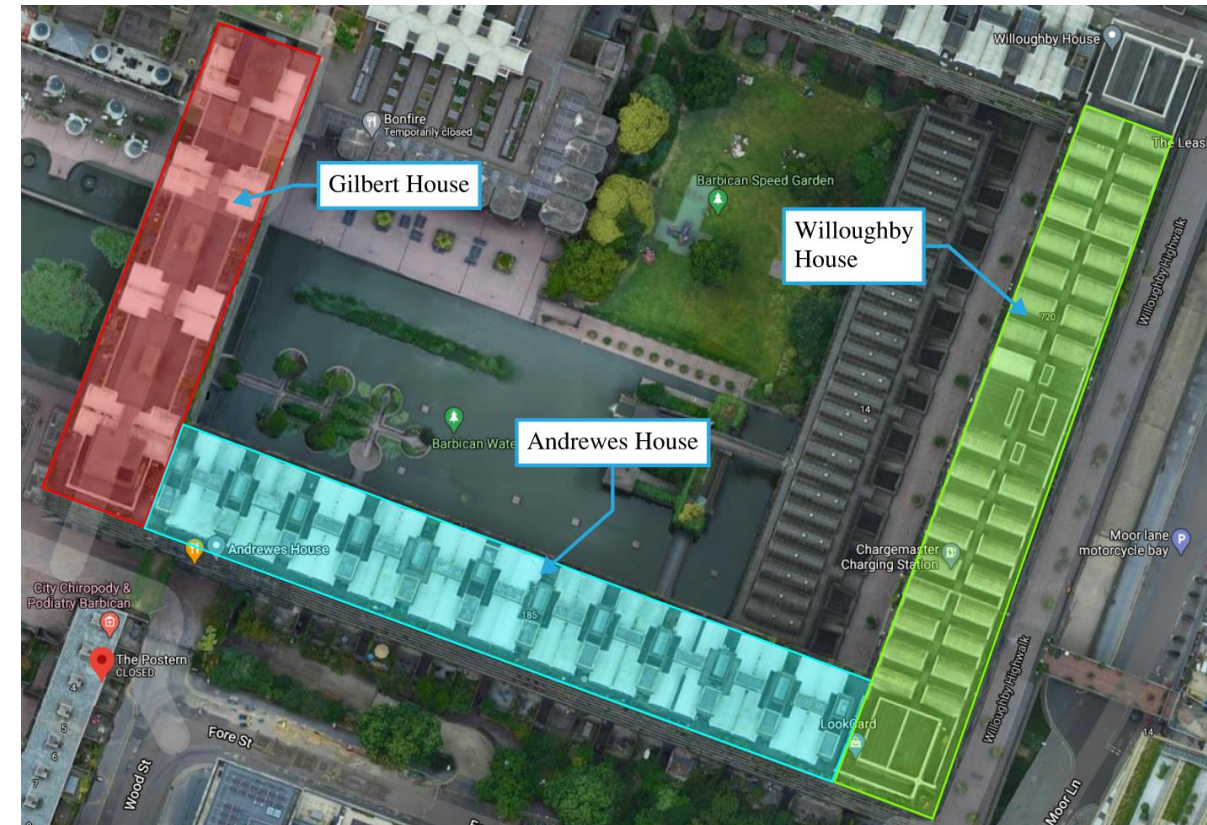
Figure 18: Existing roof arrangement for Andrewes House and adjacent blocks

BRE 187 states unprotected areas can be discounted where the boundary and the building are at an angle of more than 80° to each other. As shown in Figure 18 below, both Gilbert House and Willoughby House are at an angle of more than 80° from Andrewes House and therefore it is not required to consider external fire spread.

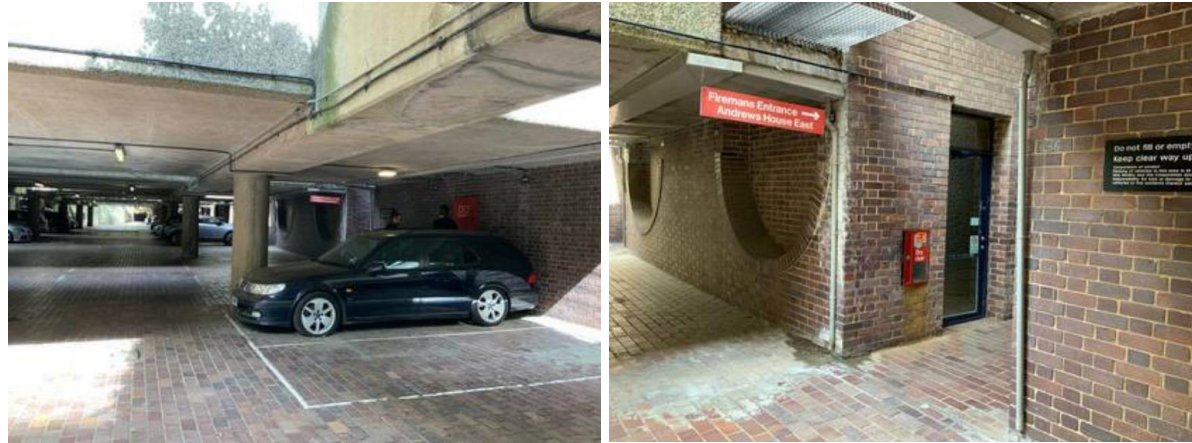
Figure 19: L03 Carpark level access to SC44

The carpark has large openings along the top and runs the entire length of Andrewes House, where fire service will be able to access the two firefighting shafts SC38 and SC44 as shown in Figure 19.

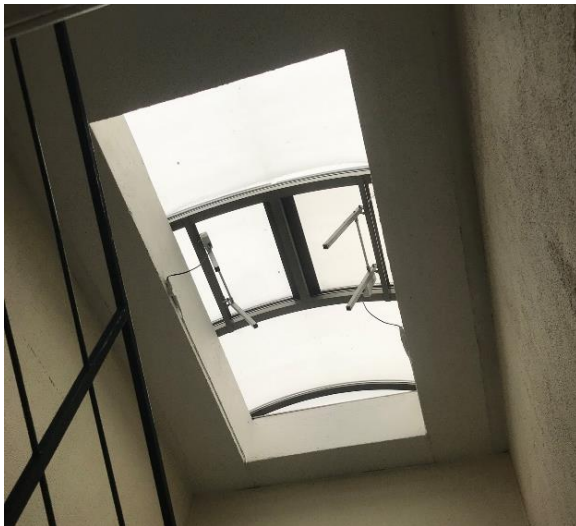
Figure 22: Staircase 49 opening vent

Existing provisions: all firefighting stairs are provided with automatically opening vents at the top of the stairs (see Figure 22 below). Each vent is operated by a switch located on the fire service access level, by the firemen's lift. During the site visit, the dimensions of the vents were measured to be approximately 1.1 m by 0.8 m, which is less than the required ventilation opening.
