CORPORATION OF LONDON

Feasibility Study and Report on The Heating And Hot Water Services

Middlesex Street Estate

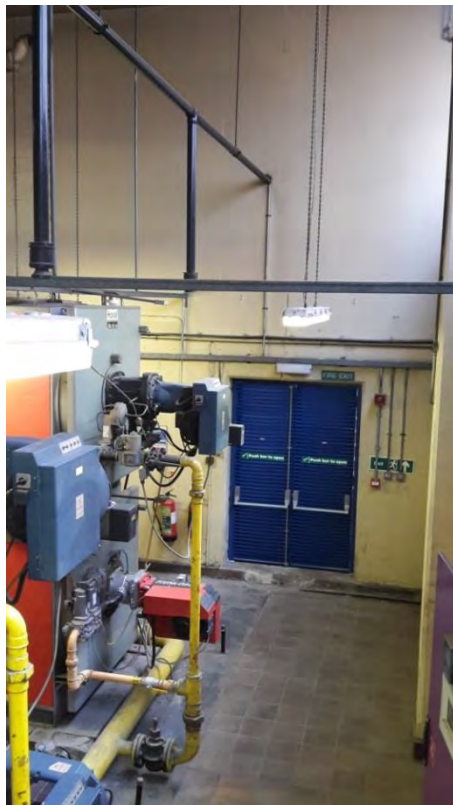
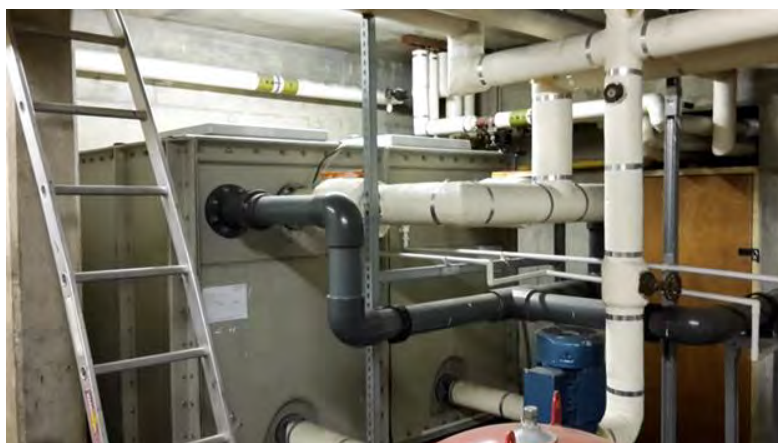
Lighting is inadequate with poor lighting levels and there are units which are non-functioning.

There are signs of leakage within the plant room mainly around valve glands.

Signage's within the plant rooms are poor and mostly outdated.

Condition Rating: Code 3

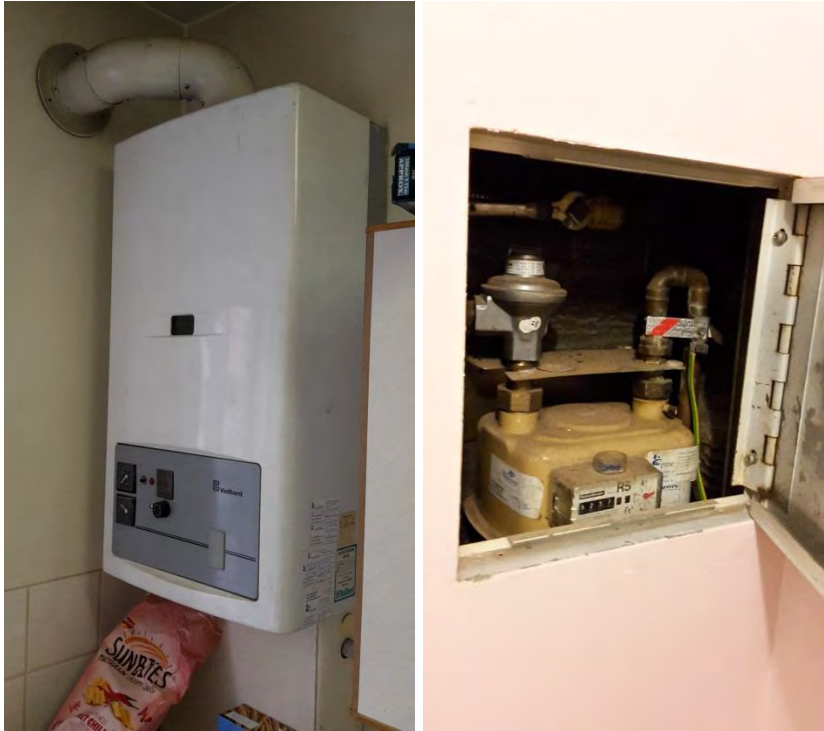
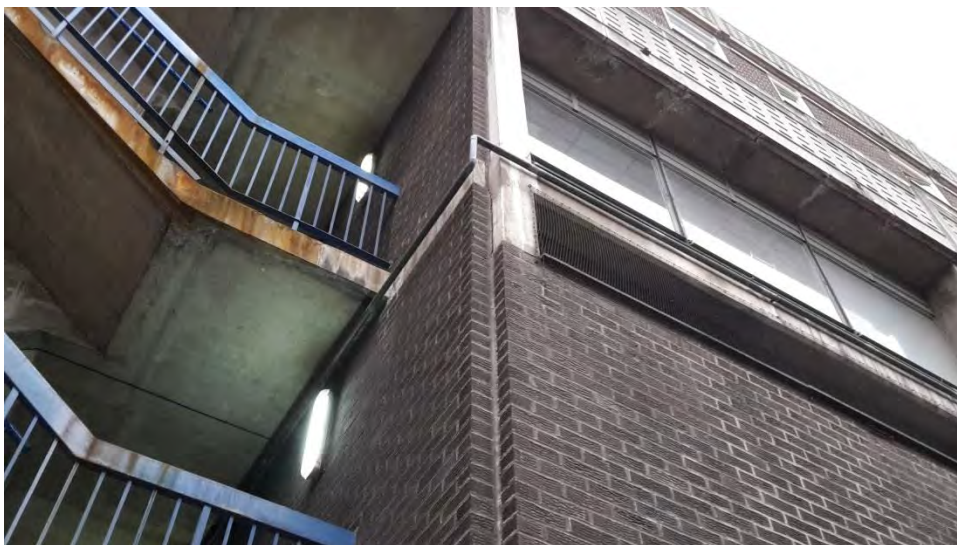
The domestic boilers surveyed were mainly 15 years+ of age and in fair to poor condition.

It is noted that the gas run supplying the domestic boilers externally has been run in copper pipe which has no identification label or colour coded. This requires rectifying ASAP as it does not conform to GSUIR 1998

Condition Rating: Code 3

These should be renewed and the systems brought into line with current regulations.

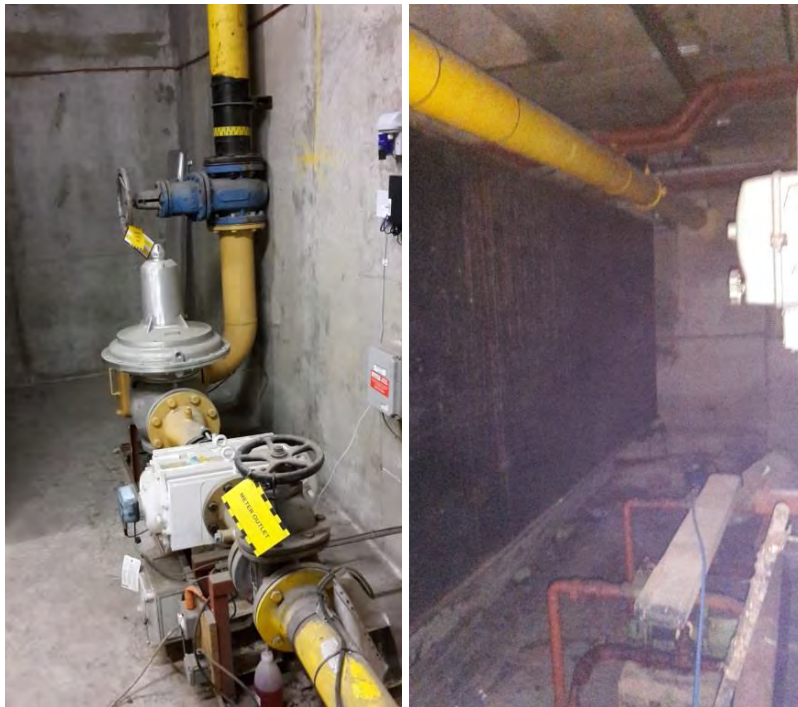
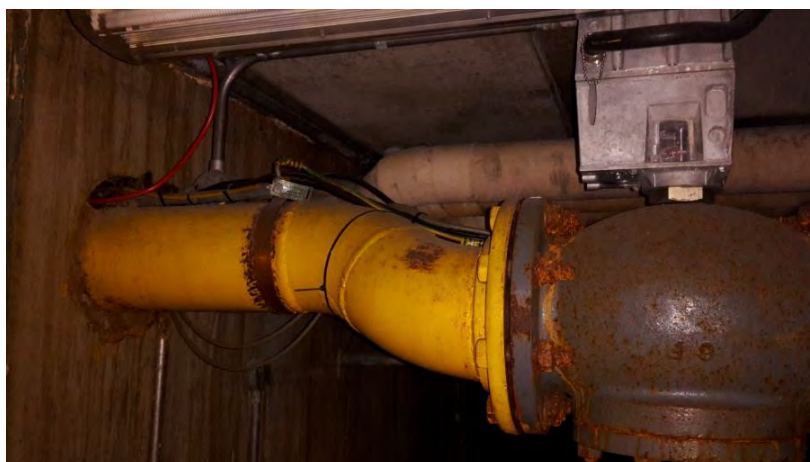
GAS SUPPLY

There is 1 x 150mm electronic gas safety valve in the oil tank room. This is a major cause for concern and will need to be assessed under the DSEAR 2002 regulations to clarify level of risk and remedial actions required.

It is not known whether the redundant oil storage tanks plant and associated pipe work have been degassed and rendered safe in accordance with the HSE guidelines.

Condition Rating: Code 2

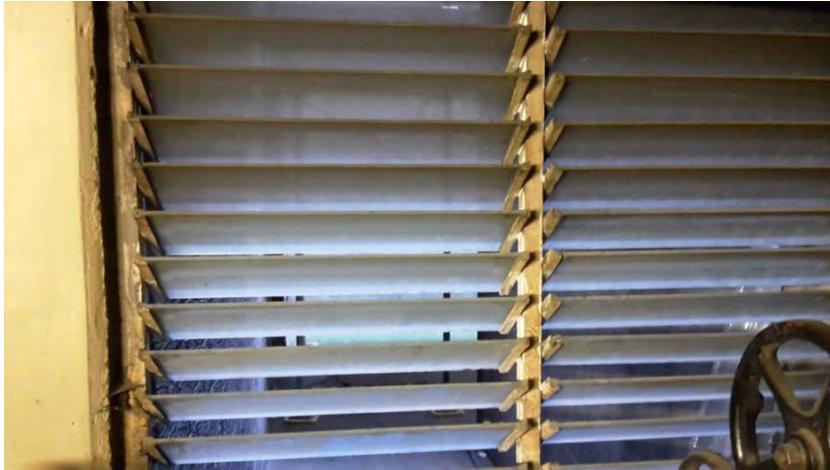
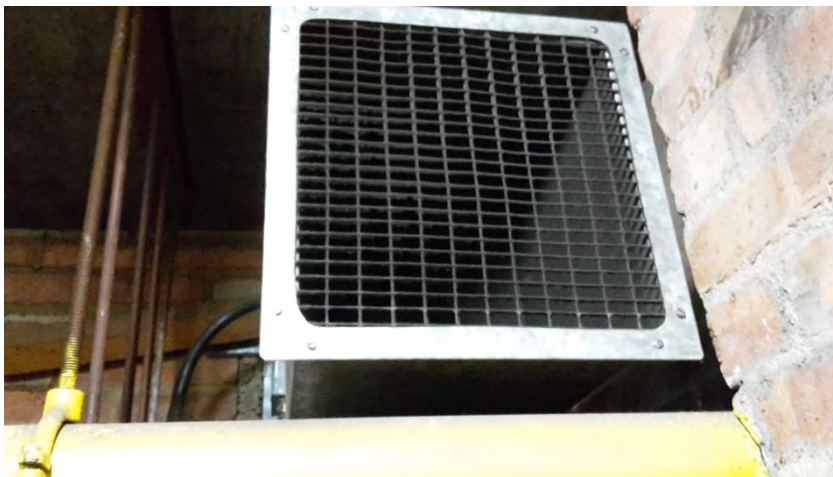
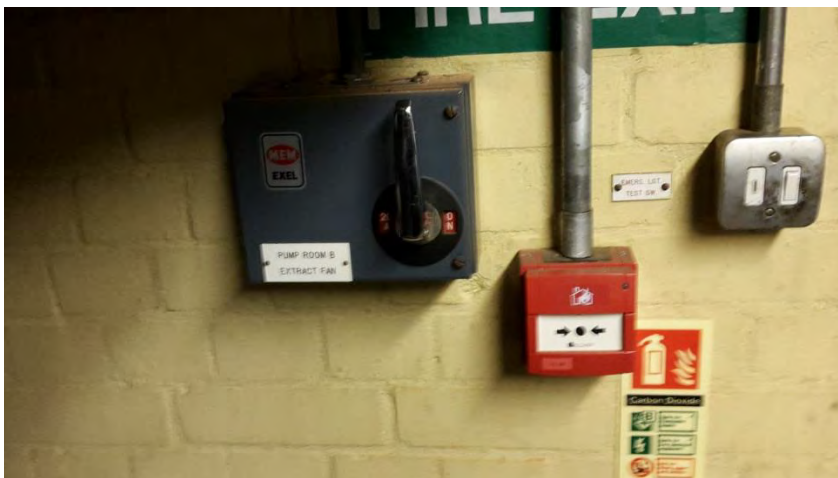
VENTILATION

The plant room is ventilated via combined high and low level grilles direct to outside. These are located above the windows and on the fire escape double louvred door.

There is also a Vent Axia inlet fan in one of the adjoining heating zone pump areas at high level above the pipe work at the back of the boiler plant room.

Condition Rating: Code 3

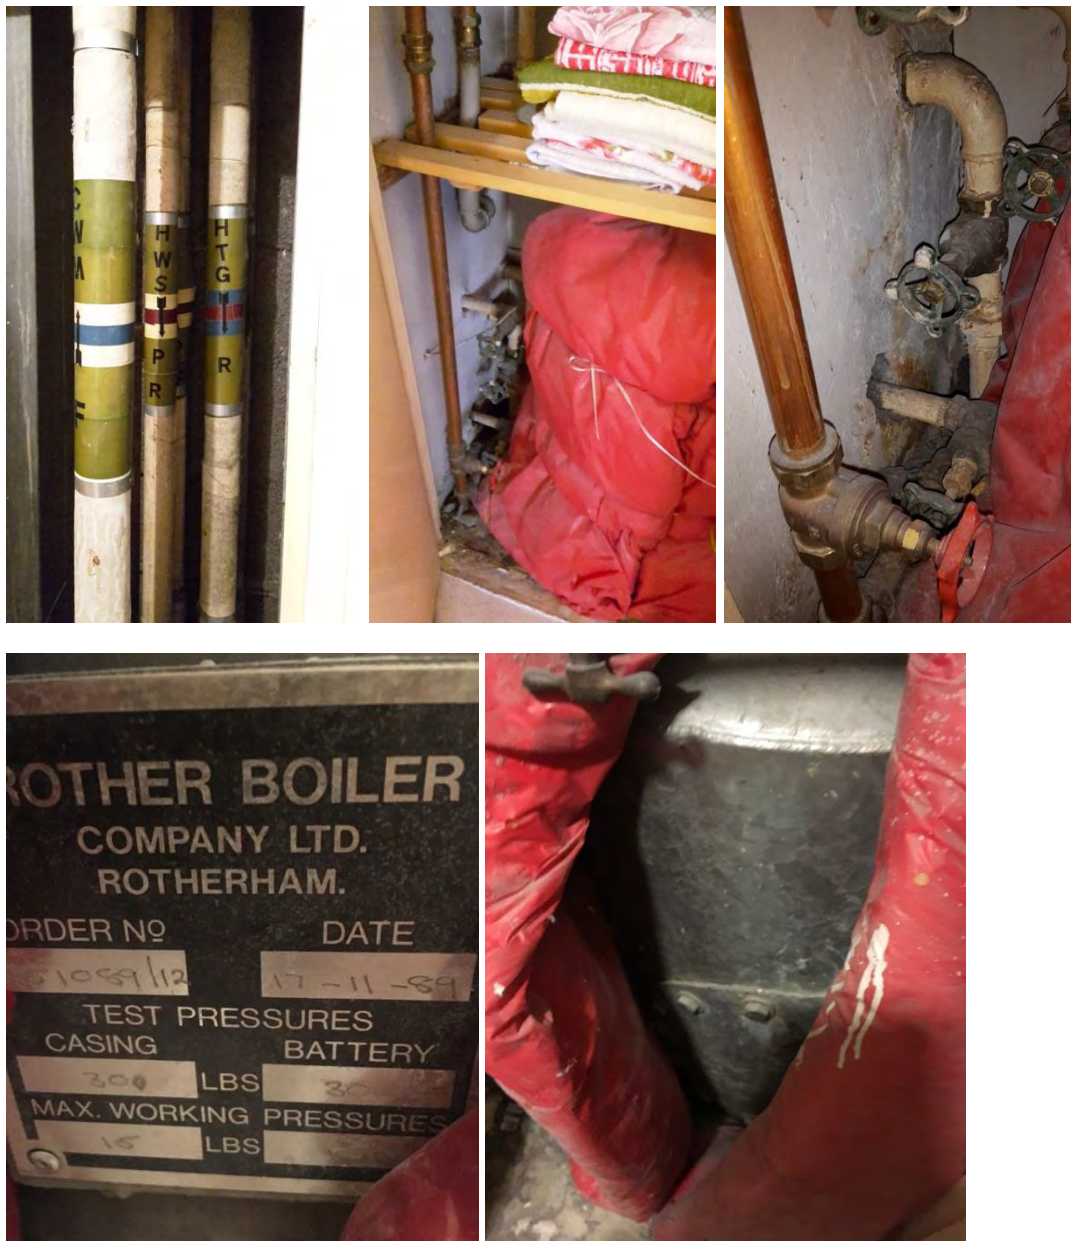
HOT WATER CYLINDERS (WITHIN DWELLINGS)

Of the 10% dwellings surveyed the pipe work installation is original and past its economic life expectancy, with missing insulation or inadequate sleeving, The pipe work rises through a central service duct then is run mainly within screed floor or through ceilings within the dwellings.

Hot water cylinders do not conform to current Building Regulations L1 of the approved document, with missing basic controls such as cylinder stats, regulating valves, insulation jacket and either damaged, missing or beyond economic life expectancy.

Condition Rating: Code 2

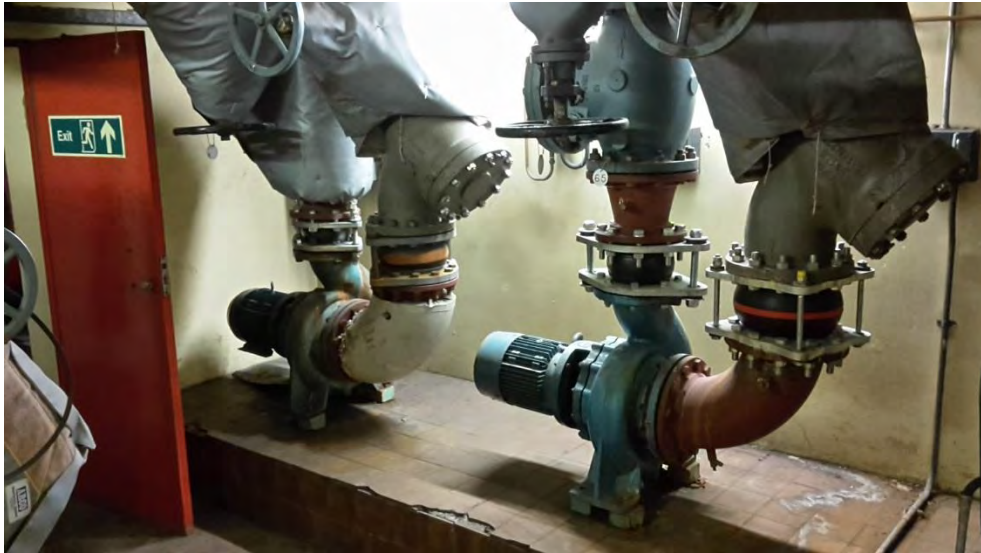
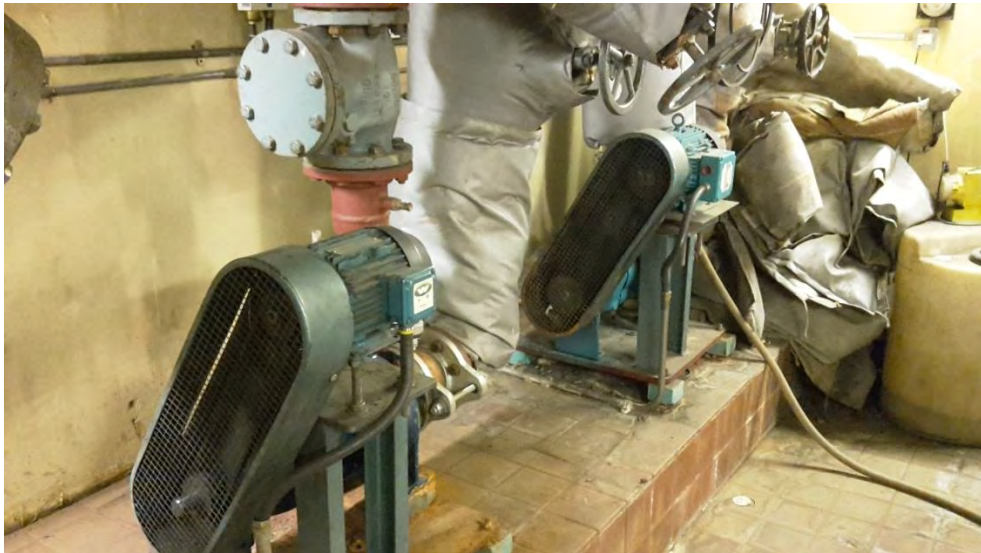
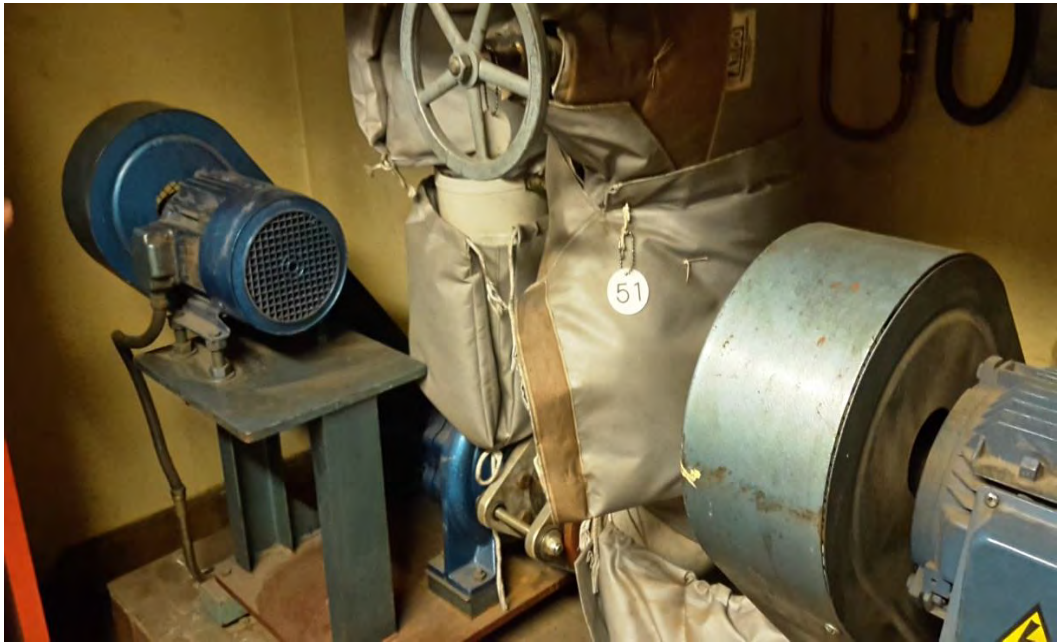
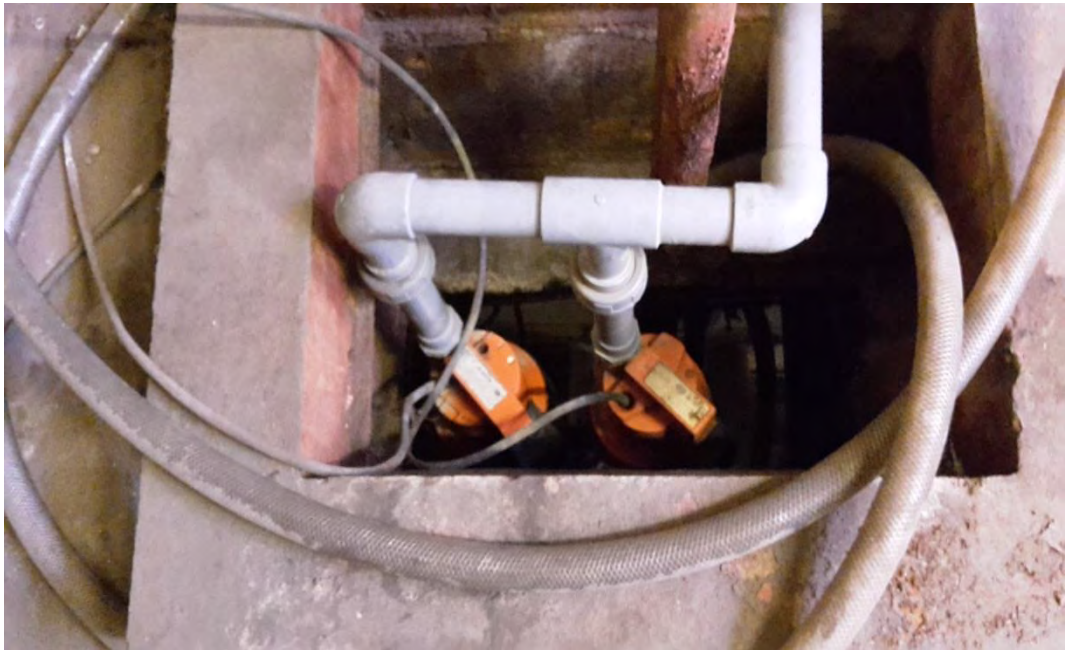
PUMPS

2 x Sump pumps

Condition Rating: Code 3

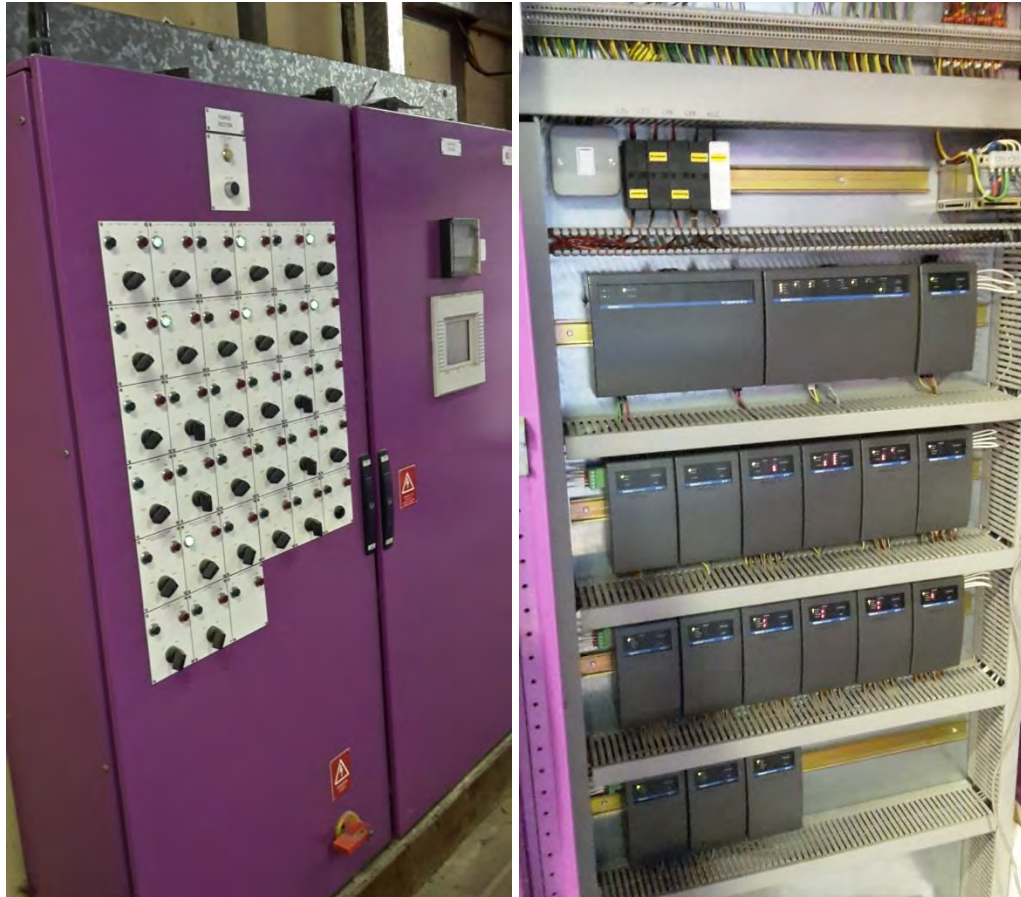
CONTROL PANEL AND CONTROLS

The controls panel and existing controls visibly are in fair condition.

The Landis Gyr three port motorised valves are showing signs of slight leakage

Condition Rating: Code 2

Generally all controls require renewal, as they are inefficient for today's standards and will not meet current Building Regulations of the approved documents.

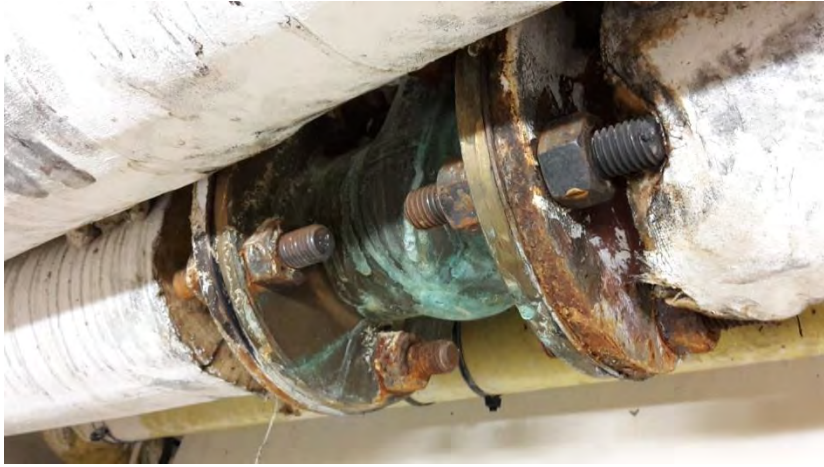
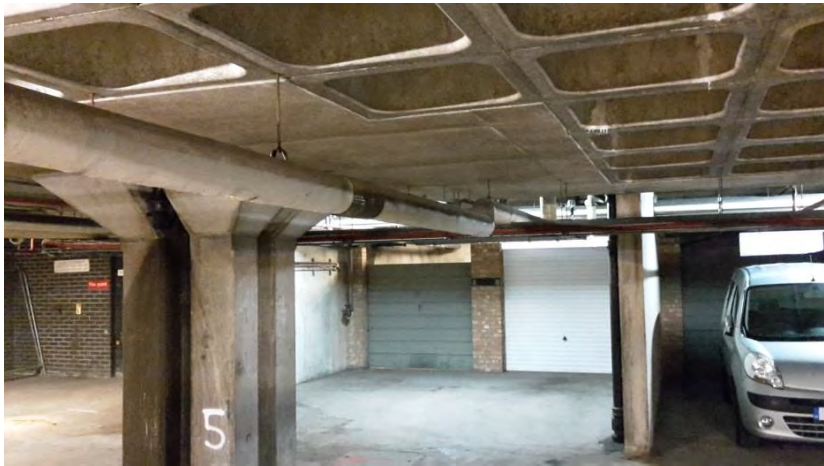
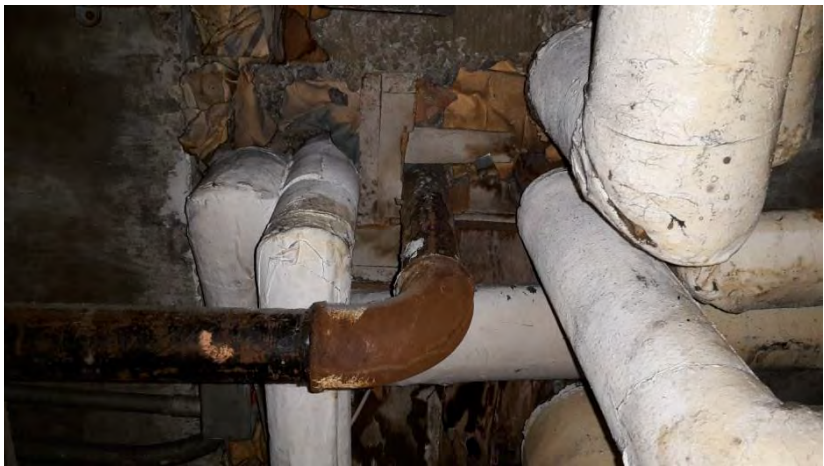
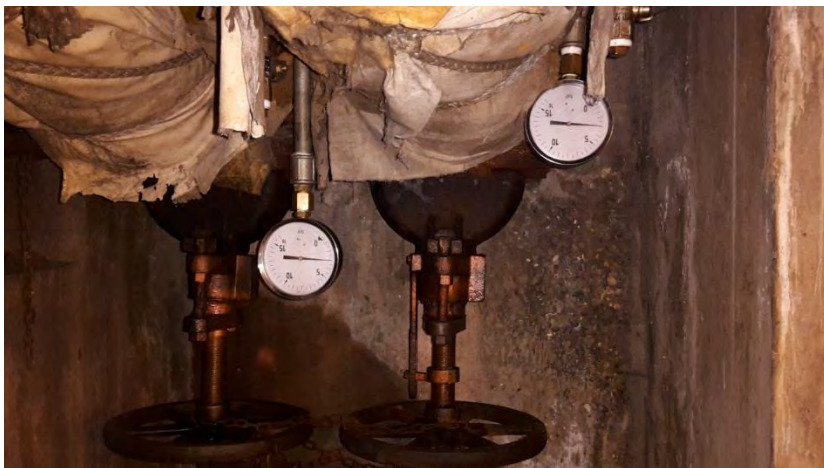
The valves generally are in fair/poor condition. There appears to be a lack of maintenance and signs of leakage. Some valves have been left open ended.

Pipework generally is in fair/poor condition, with signs of leakage. Valve wraps are either missing or not refitted.

Several sections of insulation is missing/damaged on main distribution pipe work externally

Pipe work within various areas is insulated in suspected asbestos material. No information available on site.

Condition Rating: Code 1

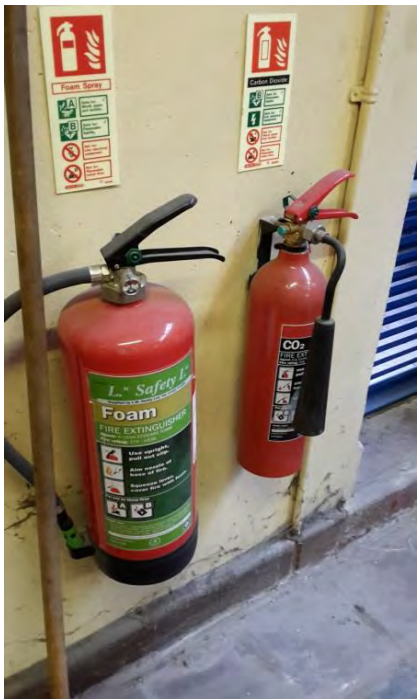
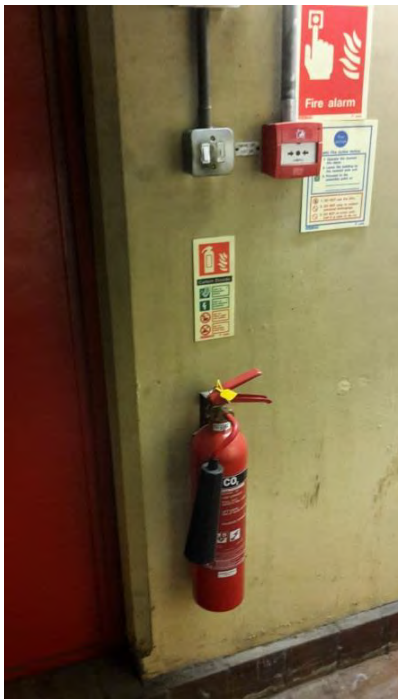
FIRE SAFETY DEVICES

Thermal links on boilers.

No Gas leak detector in boiler room and gas meter room.

No fire proofing in shared riser ducts in all blocks

Condition Rating: Code 3

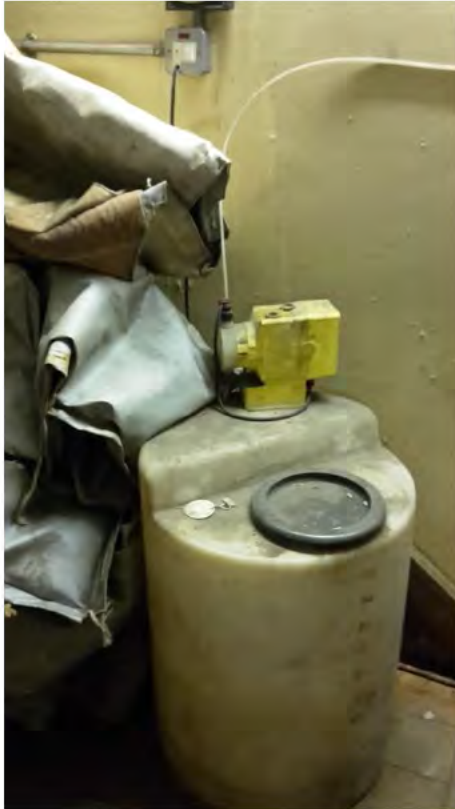
WATER TREATMENT/DOSING

Dosing pot in fair condition but not connected to the system.

Condition Rating: Code 3

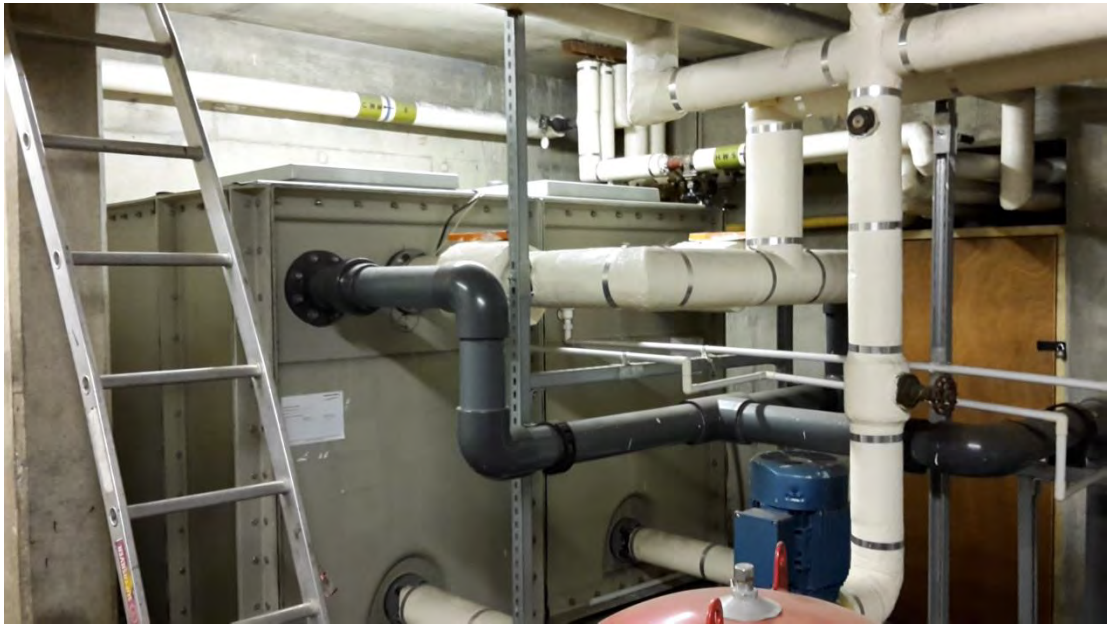
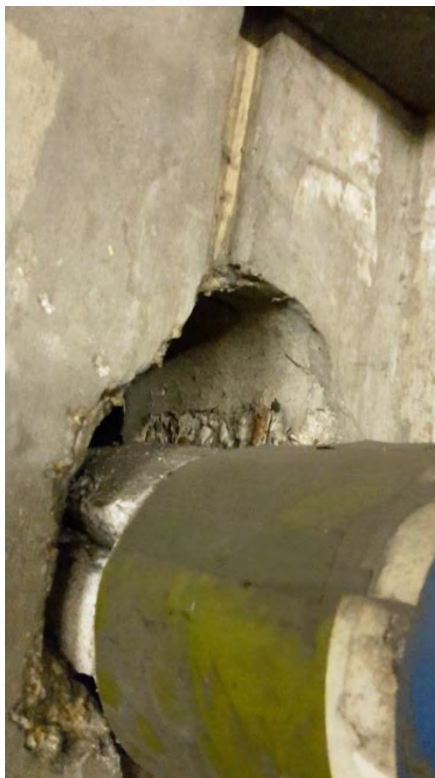
COLD WATER BOOSTER SETS

There is a central plant room in the basement area containing a cold water storage tank and duty and standby booster pumps set. Approx. 15 years old.

Plant rooms require a general tidy up and there is suspected asbestos material on pipework and fire proofing is required to some areas.

Condition Rating: Code 1

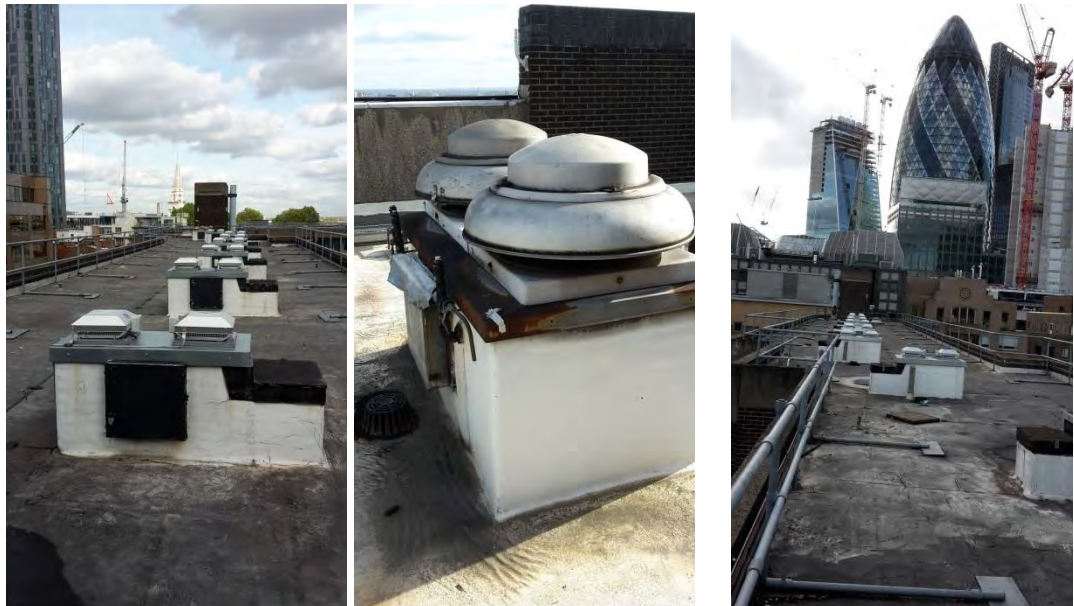
COMMUNAL FANS

There are Helios RDW 225/2 communal fans on the flat roofs of each block. The ductwork drops down each column of two flats in the service riser duct providing extraction for bathrooms.

The communal fans are in fair condition,

Condition Rating: Code 2

Where individual fans have been installed in kitchen areas these can either remain, be cleaned or replaced, depending on condition. Where none have been installed, new fans will be installed to comply with Part F of the approved document Building Regulations.

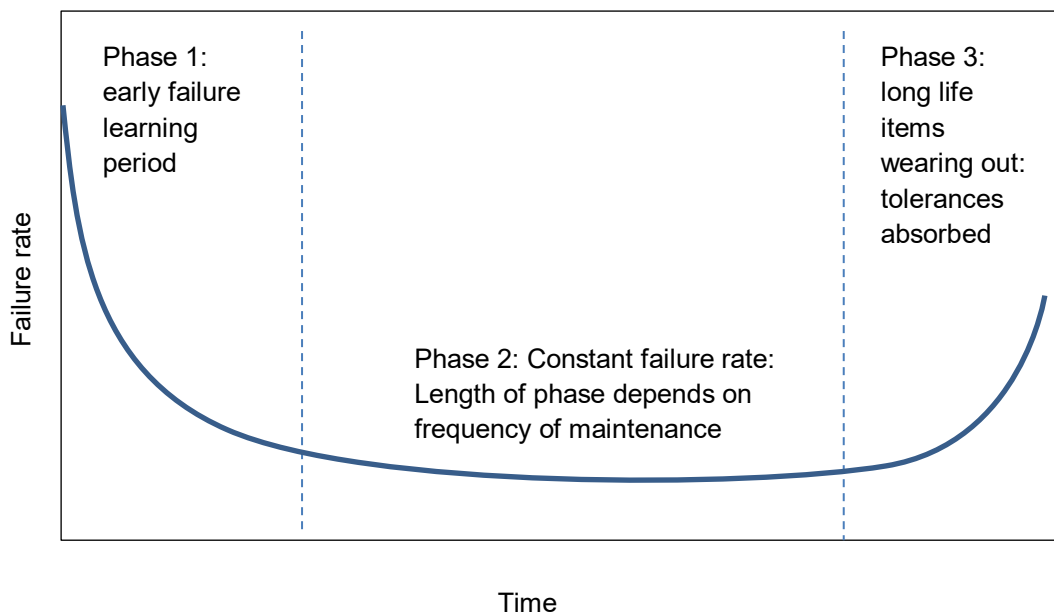
BATH GRAPH OF INDICATIVE MAINTENANCE REQUIREMENTS

It can therefore be confirmed that most of the mechanical installation is beyond its indicative and economic life expectancy. The guide also takes this into account and describes the process as a bath graph (see below) where the plant operates in its early phase of life needing care and attention (phase 1). Then as time progresses failures and maintenance drop down level out for a period of years (phase 2), then as it ages the plant wears out, tolerances increase and plant failures increase (phase 3) to an extent where it should be replaced.

Phase 1: Decreasing Failure Rate: This occurs when the system is new and is a consequence of teething problems such as design and installation errors, faulty components and manufacturing faults among other matters.

Phase 2: Constant Failure Rate: In maintained systems, after the early failure period, the system will be in settled state, random isolated faults and failures will occur, and parts that wear will need repair and/or replacement from time to time as part of preventative maintenance. Such parts typically include bearings, seals, printed circuit boards, control components, motors, heat exchanger components and compressors on packaged heat pumps/air conditioners or multiple compressor chillers.

Phase 3: Increasing Failure Rate: This is the point where major components begin to fail and random failures increase with time. At this stage the cost of repair of plant and equipment begins to exceed the cost of replacement.

Therefore it should be noted that the age and condition of equipment within the building is in phase 3 part of our description, with the exception of the replacement primary pumps which are Phase 1, but could be considered Phase 2, as they are connected to existing poor water quality system.
