APPENDICES 1 TO 4 FOR NORTH - SOUTH CYCLE SUPERHIGHWAY PHASE 2

CS North-South Cycle Route (Phase 2)

TfL Proposals (Rev 2B.1 / 2C)

Stage 1 Road Safety Audit

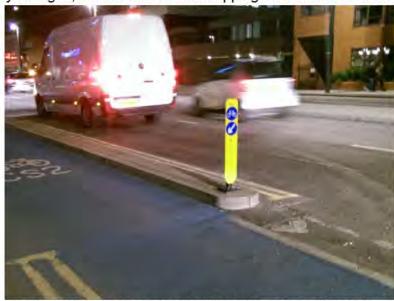
Part Accepted: There are two start points with 300mm wide segregation; the northbound start point at the Charterhouse St junction, and the southbound start point at the Greville St junction.

At the Greville Street junction heading southbound, the preceding mandatory cycle lane directs adjacent vehicles past the segregation strip, however it is still important that it is visible. Cycle logos, double red line 'no stopping' restrictions and the retro-

reflective wands (similar to the photo above) highlight the segregation strip. Therefore the design team rejects that this is a hazard at the Greville Street junction.

Also, any increase in the lateral clearance between the wand and vehicles either side would reduce the physical space for those vehicles. It is recommended that the wands specified at detailed design are of a height below handlebars and wing mirrors to mitigate against striking. It should be noted that the wands are self-correcting.

It is recommended that visibility of the kerb edge is bolstered by retro-reflective paint at the detailed design stage.

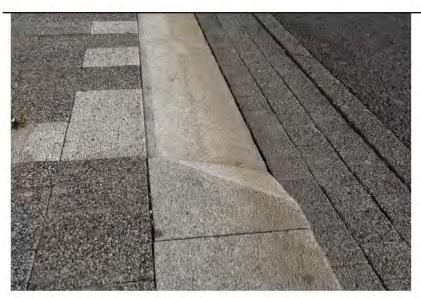
Part-accepted: The current proposals show an angled 300mm wide kerb with a 50mm upstand. The pre-consultation drawings proposed a 150mm wide half battered kerb which would have been more severe for P2W to cross. The use of 150mm wide kerbs was raised in audit Ref: 2462/VAR/A201/TLRN/2016 and the design was amended.

An example of the angled kerbs is shown in the image below. These have a gradient of 1 in 6 because the whole kerb is angled rather than just the edge battered. This type of solution will be recommended to the detailed designers.

Dropping the kerb to a flush or very low upstand across the mouth of the motorcycle bays would reduce the physical separation between cyclists and general traffic lanes, potentially compromising the safety and effectiveness of the scheme. P2W users and other vehicles may be more likely to enter a cycle track with less physical separation when accessing the side roads or parking bays along Farringdon Street.
