### 8. THE MONUMENT CONSERVATION MANAGEMENT PLAN - APPENDICES

THE MONUMENT TO THE GREAT FIRE OF LONDON

VOLUME I: CONSERVATION PLAN

MARCH 2025

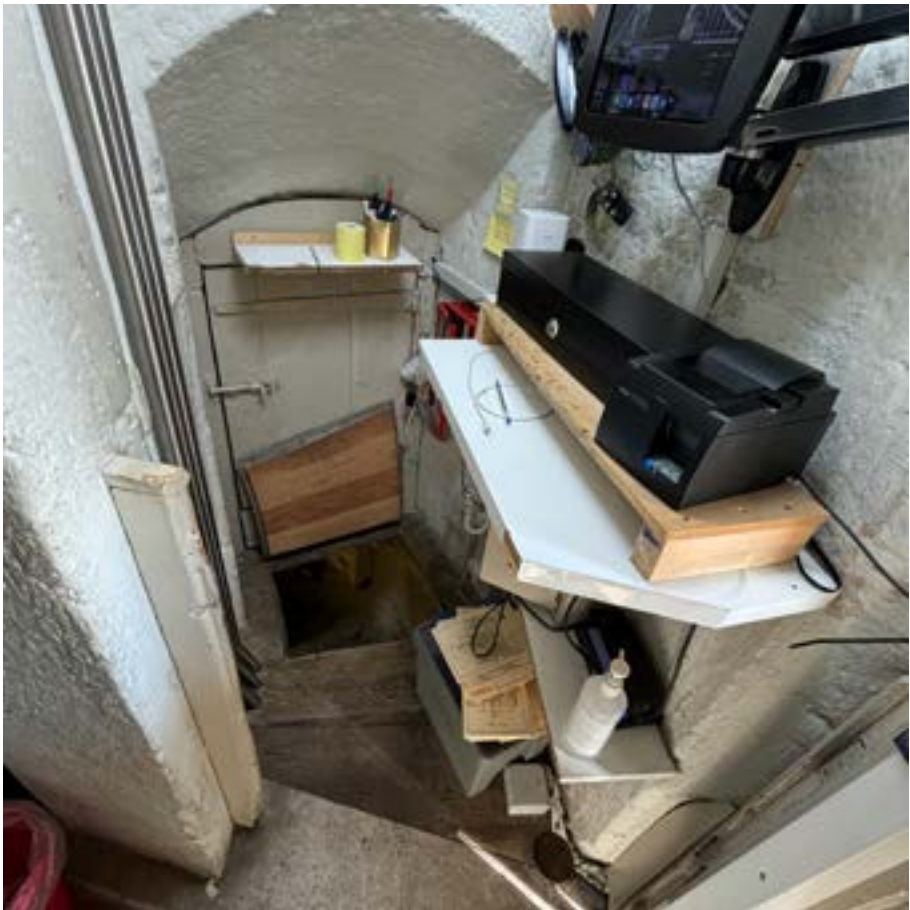
INTERIOR: JOINERY			
ELEMENT	CONTRIBUTION TO SIGNIFICANCE	REASON	
High-level Timber Enclosure	LOW	A simple (non-original) boarded enclosure with the patina of age.	
Staircase Balustrade Handrail	MEDIUM	Curved oak balustrade handrail with many original steamed-timber sections, but later replacement sections of poorer quality workmanship reduce the potential significance.	
Entrance Lobby Historic Joinery	LOW	The joinery appears to be of differing ages, maybe both eighteenth and nineteenth century designed to suit the locations. The attendants' door and rear cupboard with an interesting build-up of paint layers, appears older than the wall cupboards.	
Entrance Lobby C21 Joinery	DETRIMENTAL	The joinery is no longer fit for purpose and chipboard shelves have been added.

Fig. 87 C21 joinery with some additional shelving, 2024

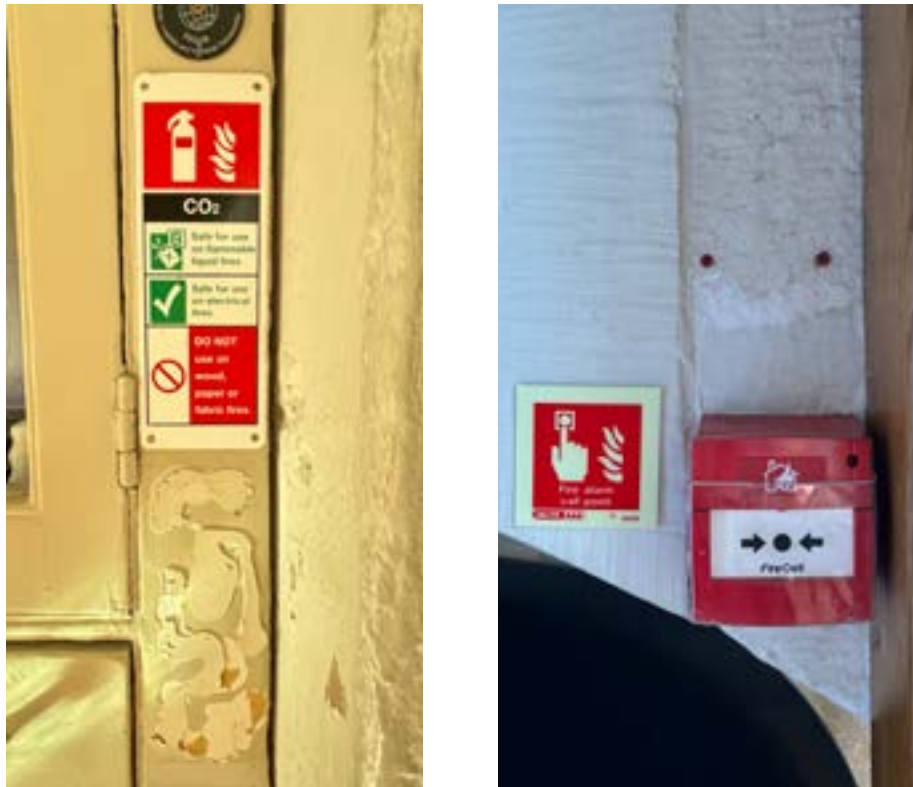
ENTRANCE LOBBY: FIXTURES, FITTINGS & SIGNAGE		
ELEMENT	CONTRIBUTION TO SIGNIFICANCE	REASON
Entrance lobby folding chair	NEUTRAL	Bespoke discreet seat and seat-back designed for this location, late twentieth century and of its time.
Perspex screen	DETRIMENTAL	One of several modern fixtures/fittings /signs introduced into the Entrance Foyer, which are not high quality in terms of design, materials or workmanship, and together greatly detract from this small simple historic interior.
Curved perspex storage screen	DETRIMENTAL	Primary reason is that the Perspex screen obscures the circular floor opening (oculus), an feature of architectural, historic & scientific significance.
Signage: <ul style="list-style-type: none"><li>- Duplication of Statutory H&amp;S signage (fire extinguishers)</li><li>- Standard signage replaces hand-painted signage</li><li>- Dark blue standard payment signage stuck on Perspex screen</li><li>- Multiple signs advising 'CCTV in operation'</li><li>- Paper sign in plastic wallet Sellotaped to front door glazing</li><li>- Remains of fixings to removed signs: adhesive on joinery, rawl plugs into stonework</li></ul>	DETRIMENTAL	Many signs introduced into the Entrance Foyer, are not high quality in terms of design, materials or workmanship, and together detract from this small simple historic interior; some signs are duplicated and unsightly adhesive or rawl plugs are evident where signs have been removed.

Fig. 90 Signage and former signage fixings, 2024

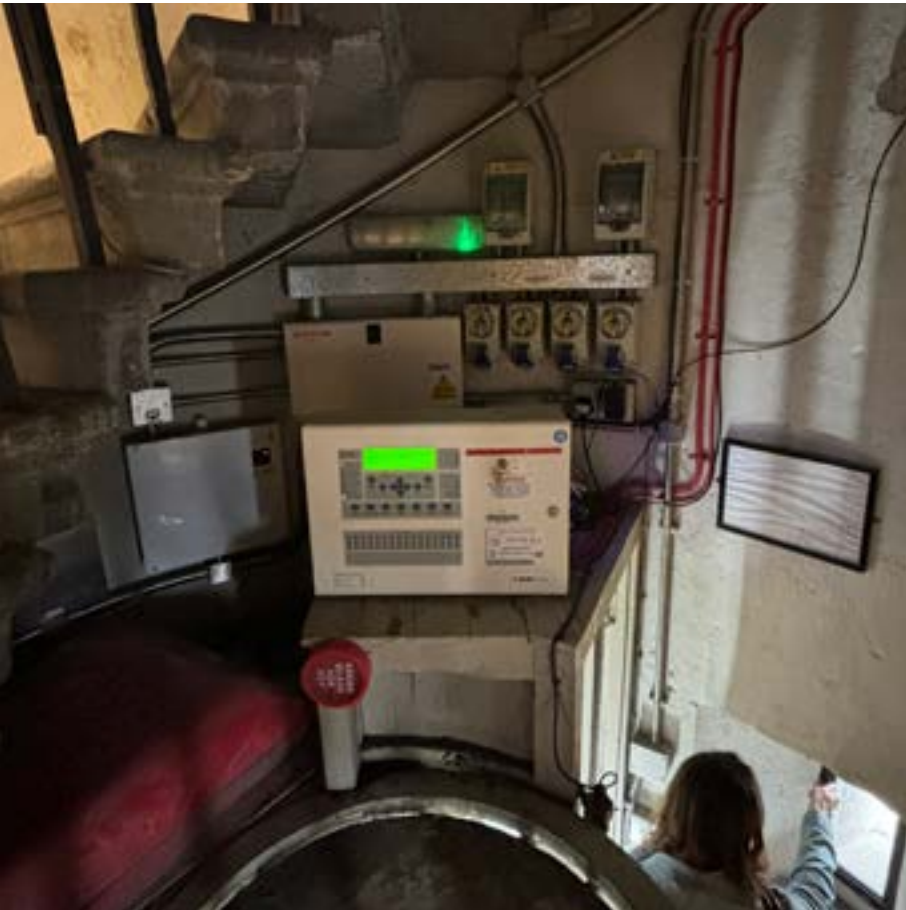
STAIRWELL ELECTRICAL SERVICES		
ELEMENT	CONTRIBUTION TO SIGNIFICANCE	REASON
Electrical Cables in Upper Stairwell	DETRACTS	Electrical cables recently added at high level are not (all) in existing stainless-steel conduits or neatly tied to existing conduits and look a mess.
Smoke Detector & Sounder	DETRACTS	Detrimental to a small historic interior, but important for safety and reasonably well-located.
Staircase Lighting	DETRIMENTAL	Replacement baluster lights produce harsh cold light and are no longer directed onto stair treads but are twisted away from the tread to avoid glare for the visitor climbing the stairs. The replacement fittings are wider than the balusters and black, contrasting with the pale grey paint of the iron balusters.
Emergency Lighting	DETRACTS	Emergency lights have been introduced into the stairwell replacing the previous emergency lighting, which was some of the existing baluster lights, with a battery back-up and therefore entirely unobtrusive within the stairwell.

Fig. 94 Electrical equipment above viewing platform level, 2024

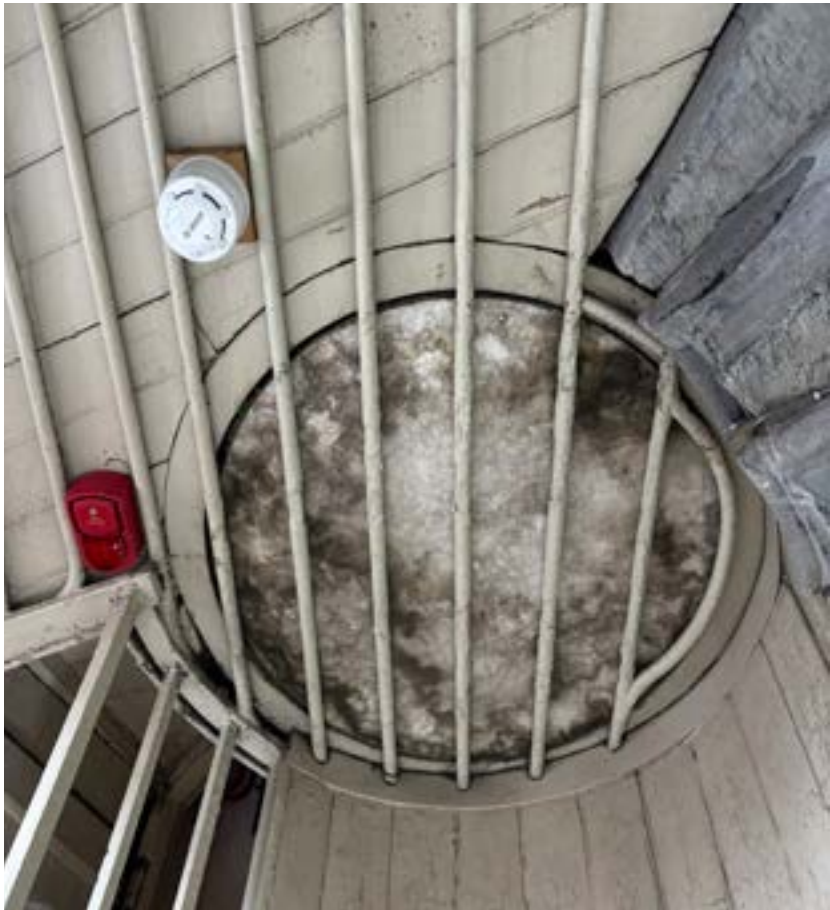
Fig. 95 Electrical conduits & junction boxes, 2024

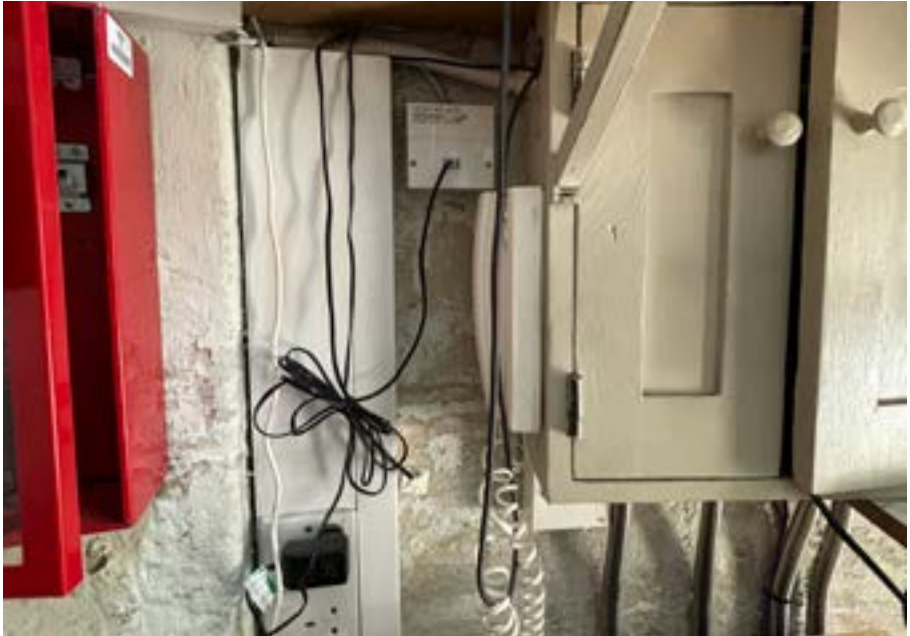
ENTRANCE LOBBY: ELECTRICAL SERVICES		
ELEMENT	CONTRIBUTION TO SIGNIFICANCE	REASON
Overhead Radiant Heater	NEUTRAL (wiring detracts)	Quality stainless steel coloured, reversible, location along one side of the barrel vault, necessary in winter. Thick black visible cabling detracts.
Plinth Heater	NEUTRAL	Located in plinth of cupboard in attendants' recess, not visible to visitors and providing heat to attendants where it is needed.
Smoke Detector	DETRACTS	Detrimental to a small historic interior, but important for safety and reasonably well-located.
Lighting: Strip Luminaires located either side of Entrance Door within door architrave	LOW	Warm soft light back-lights historic turnstiles and enhances the entrance.
Lighting: Strip Luminaire located along the Barrel Vault, South-Side (assumed redundant)	DETRACTS	It is assumed that this light is not operational since the radiant heater was installed.
Lighting: LED Strip Light in Attendant's Recess

Fig. 100 Electrical services in the attendants' recess, 2024

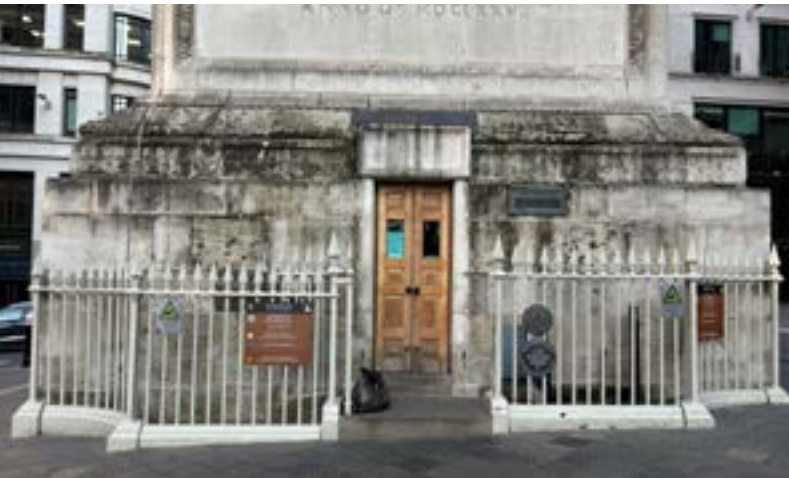
IMMEDIATE SETTING		
ELEMENT	CONTRIBUTION TO SIGNIFICANCE	REASON
19th century boundary marker	LOW	Historic boundary marker. E&S Poynder are brothers Edward & Samuel Poynder, Plumbers by profession, who lived outside of London in Hawkhurst, Kent. The S M.N.F denotes the parish of St. Margaret New Fish Street.
External Paving	NEUTRAL	The Yorkstone paving scheme to Monument Yard, which surrounds The Monument was laid c.2006. Yorkstone is an appropriate material for the setting of the building, although early paving slabs are likely to have been larger.
External Signage	DETRACTS	Excessive number of signs, signs are uncoordinated and are generally not of high quality in terms of design and materials. Some signs repeat the same information (there are at least five advising that CCTV is in operation), some signs are poorly maintained and fixed without consideration to appearance.

Fig. 101 East front showing signs on the railings, 2024

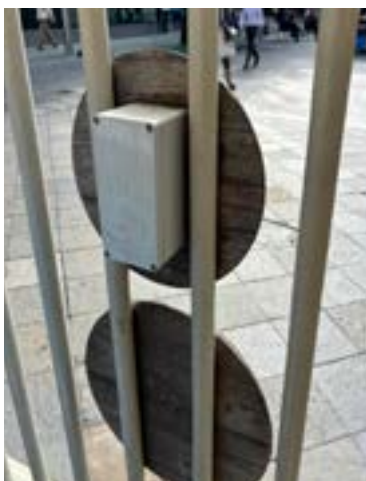
Fig. 107 Back of award signs, 2024

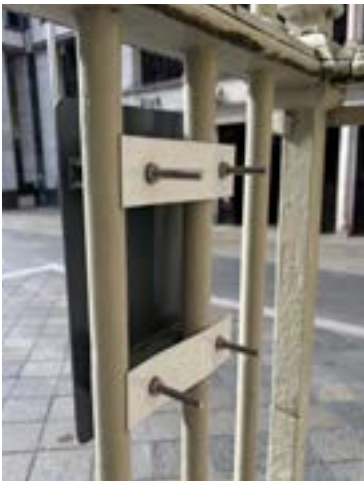
Fig. 108 Crude fixings to CoL sign, 2024

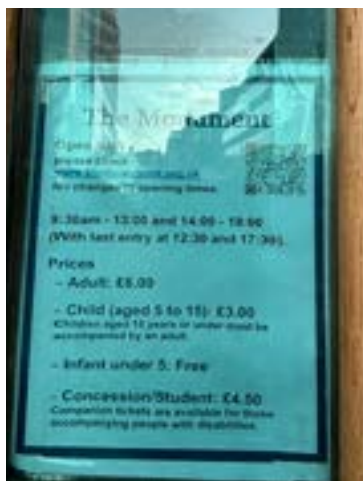
Fig. 109 Paper sign stuck to entrance door glazing, 2024

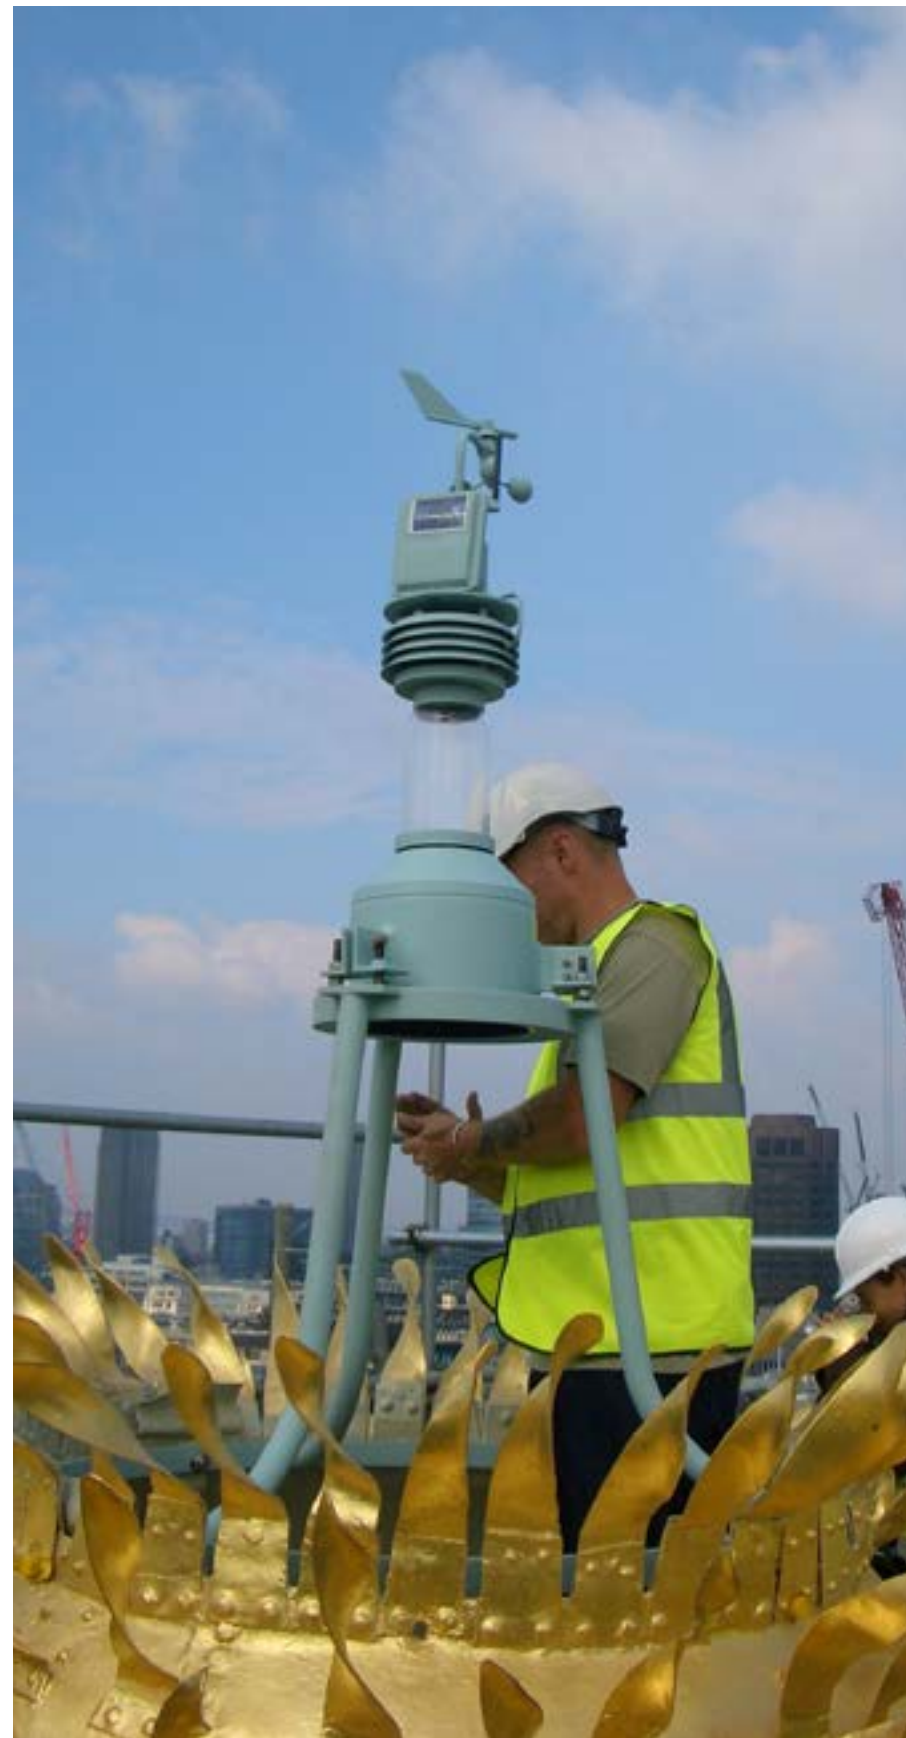
Fig. 112 Installation of the temporary camera, casing, weather station and steel support frame, 2008

PA37. The City Corporation will explore solutions for the disused panoramic camera and weather station and associated equipment and consider providing a simpler and less obtrusive system.

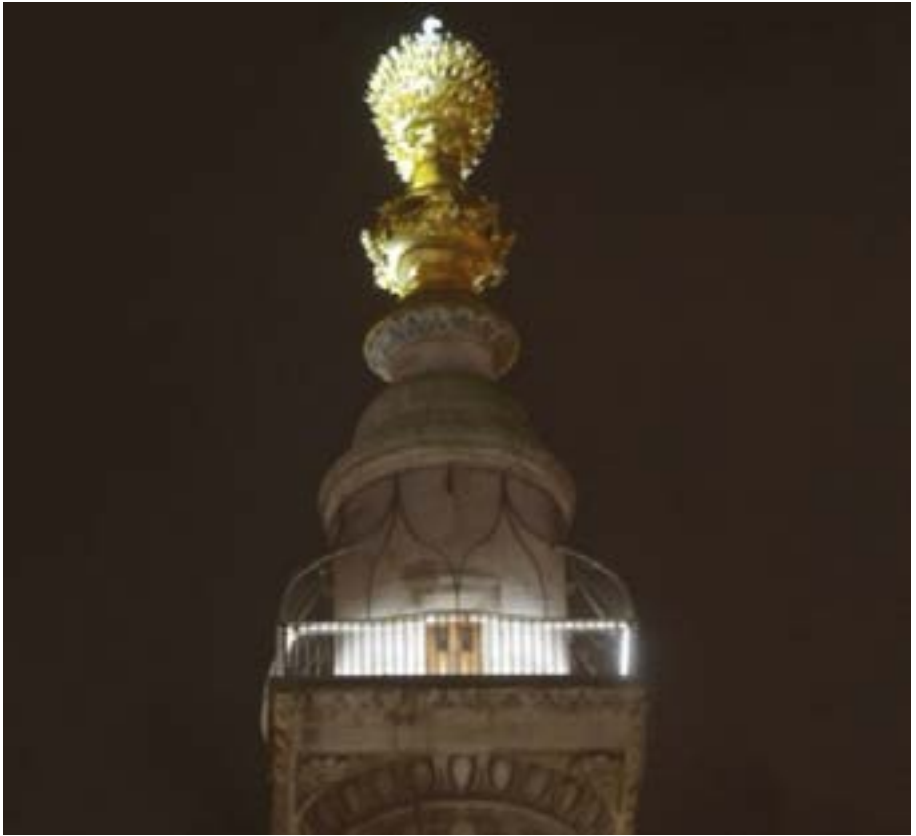
Fig. 117 LED rope to underside of balustrade handrail, 2018

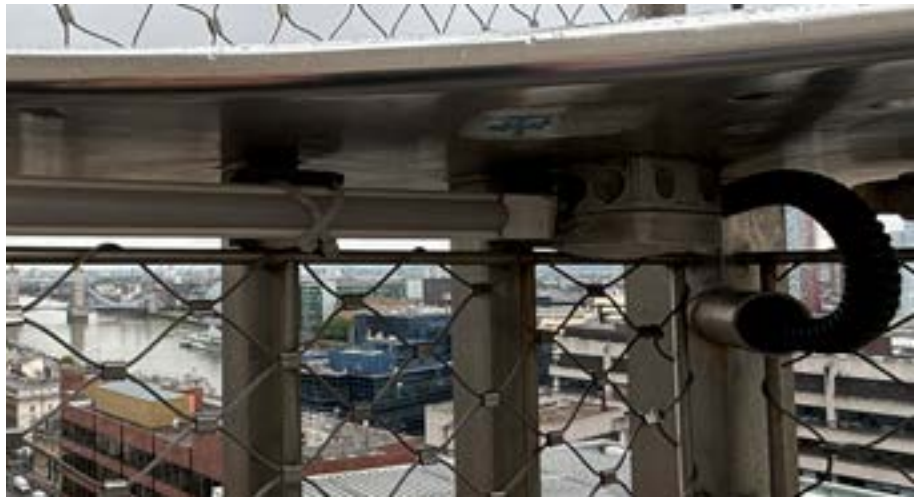
Fig. 115 Viewing platform LED rope light, 2024

PA42. The City Corporation to consider implementing a consented architectural lighting design, to replace the existing temporary light fittings.

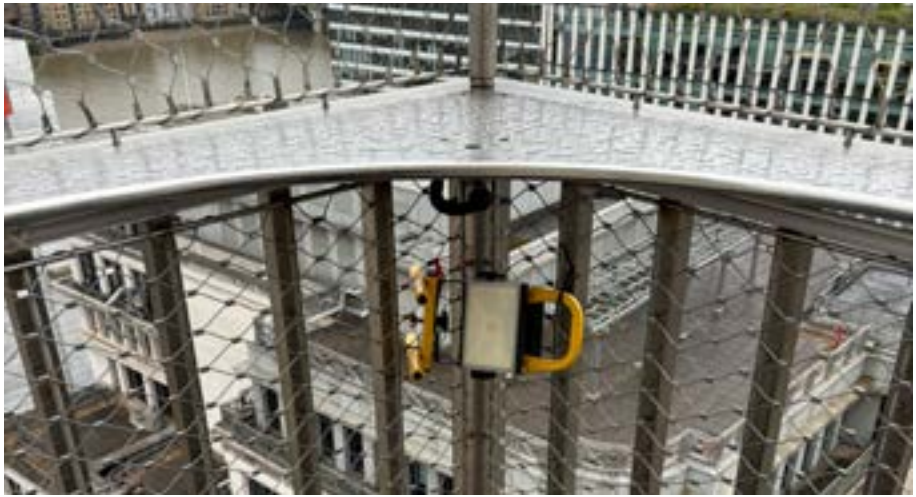
Fig. 116 Viewing platform temporary spotlight, 2024

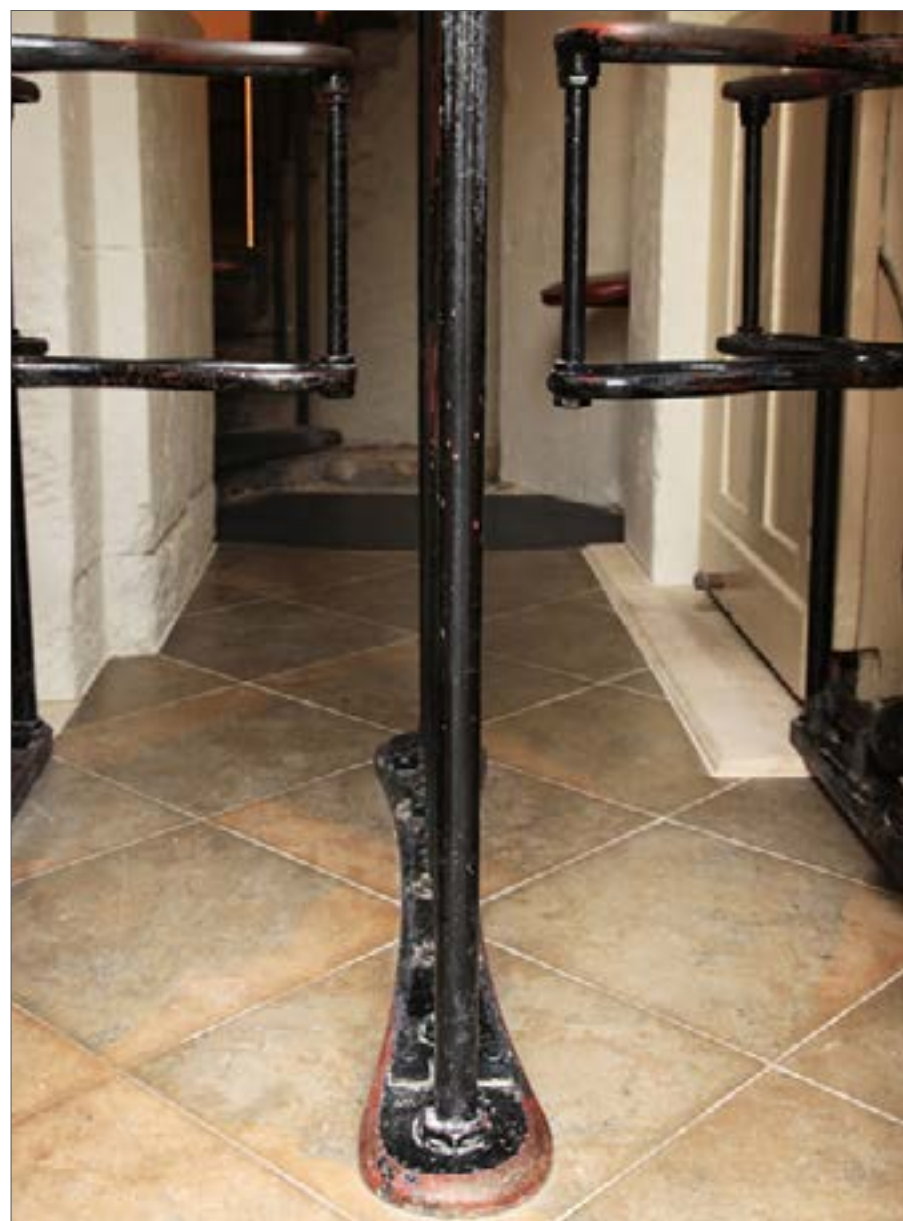
Following the 2007-2009 repair contract, the central barrier and parts of the wrought-iron hoop gates were removed by the City Corporation on a temporary basis.

It is understood by JHA that these are safely stored at Tower Bridge in the diesel room. The permanent removal of these historic fixtures is likely to be a planning and Scheduled Monument Consent issue.

Fig. 1 c.1981 turnstiles reinstated in 2009, now partly removed, 2009

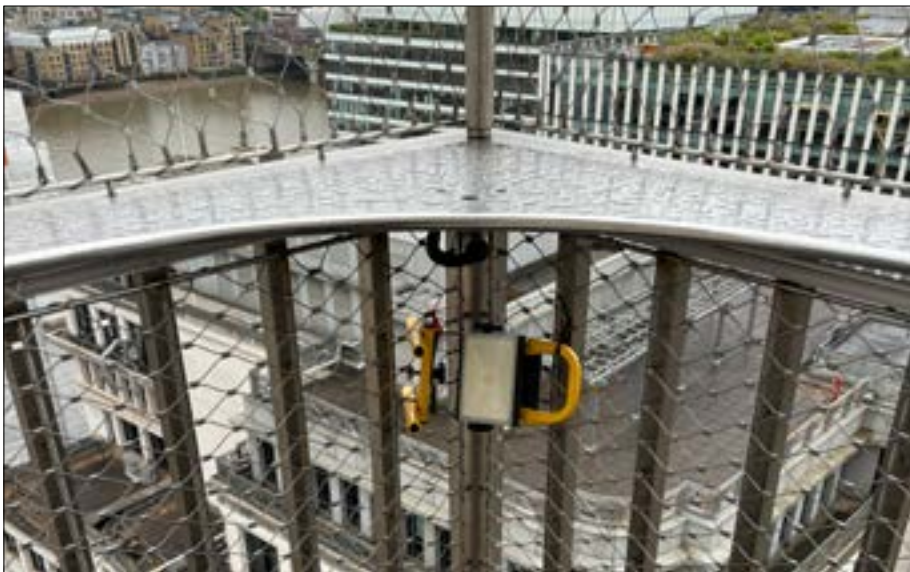
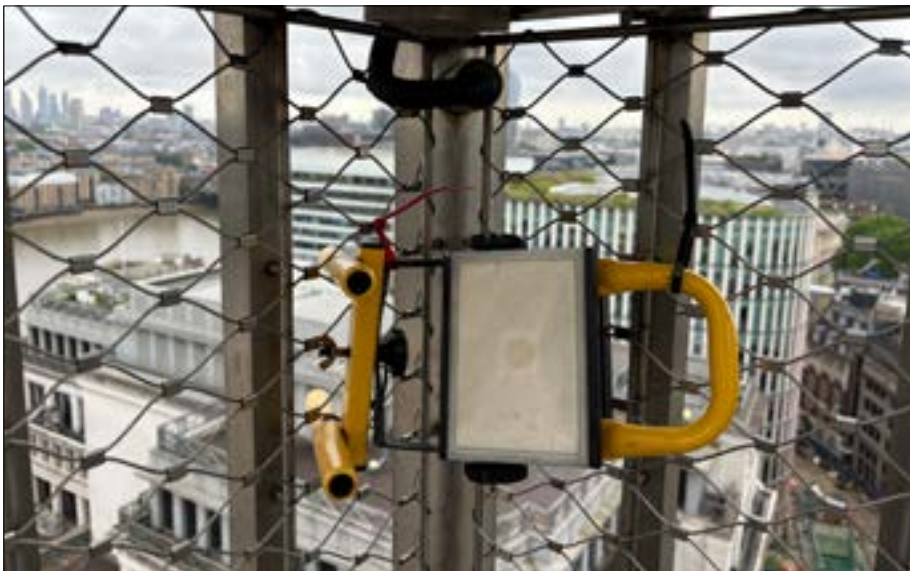
Fig. 4 & 5 Single uplighter, 2024

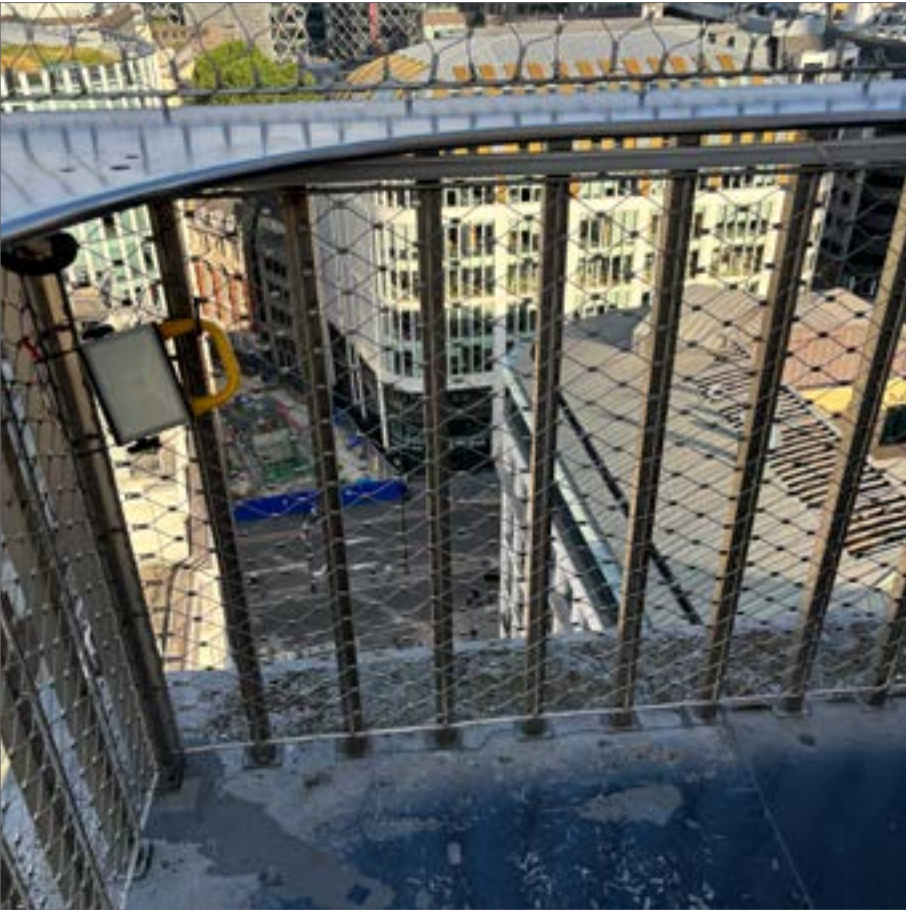
Fig. 11 Southeast corner of the viewing platform, 2024

<p>ii) Provisional sum for injecting crack repairs and using resin anchors across cracks subject to results from monitoring and inspections (minor structural interventions only)</p>	<b>C</b>	£7,600

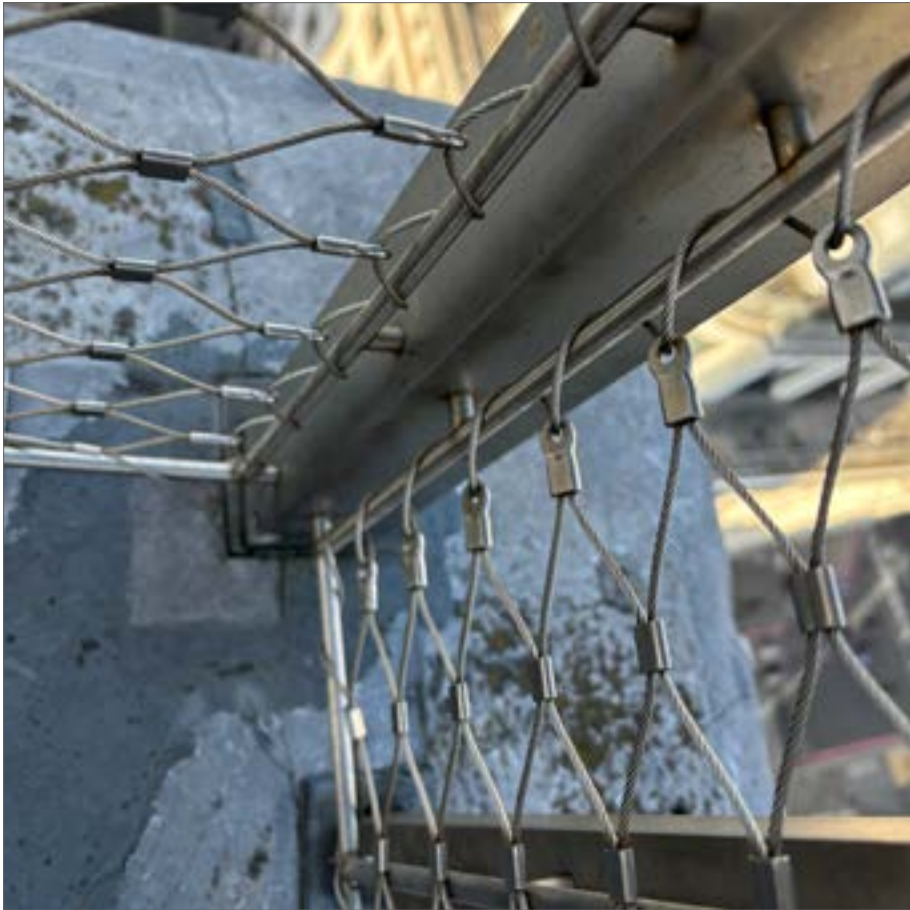
Fig. 13 Detail of a balustrade corner post, 2024

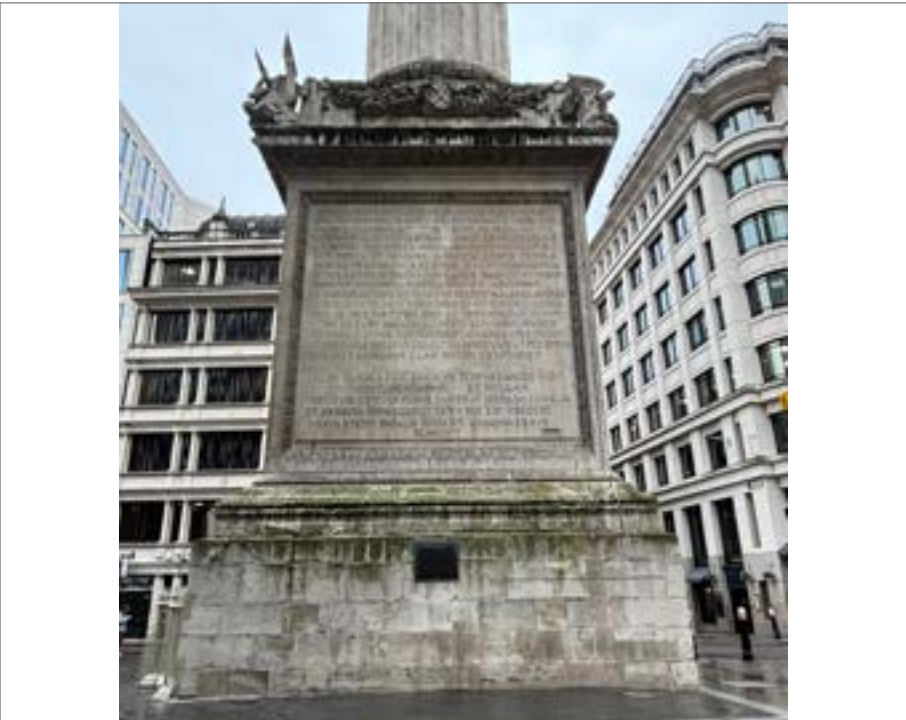
Fig. 18 Pedestal North side, 2024

DESCRIPTION	CONDITION	RECOMMENDATION	PRIORITY	COSTS
The Pedestal is of Portland stone ashlar blockwork, comprising a plinth surmounted by a sunken dado panel beneath the moulded and enriched Column Base and Cornice.	<p>The relief and lettering panels are in good condition although are unevenly cleaned by rainfall. The mouldings to the top of the base to the column plinth are heavily stained with green algae, especially on the east and west elevations, which is rather unsightly. Algae is an indicator of damp problems which should disappear when the stonework dries out and is not known to damage stonework but can be disfiguring.</p> <p>North: Border to tablet carved work: very good condition. Plinth: algae staining to plinth at high-level under roll moulding, Pointing: very good condition East:Border to tablet carved work: carved border to tablet very good condition; some erosion at bottom in north and south corners. Tablet &amp; window surround: very good condition Roll moulding: some erosion to top of roll moulding but historic at north and south corners only, good condition slight soiling Plinth: generally good condition heavy soiling Plinth ashlar base: all very good condition, heavy algae at bottom course north side of door Pointing very good condition</p>	<p>i) Roll moulding as COLUMN BASE, above</p> <p>ii) Lightly steam (Doff) clean the Plinth from a Moving Elevated Working Platform (MEWP) to reduce black staining. Last undertaken in November 2024.</p> <p>(English Heritage Practical Building Conservation: Stone, p75). Steam cleaning can be used for removing algae.</p>	C	£10,600

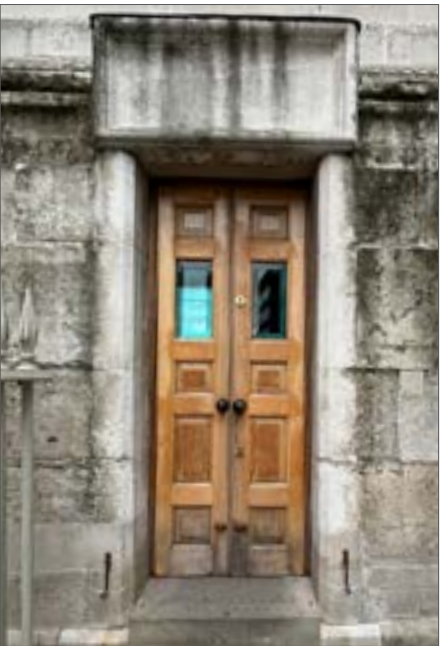
Fig. 23 Pair of oak entrance doors, 2024

DESCRIPTION	CONDITION	RECOMMENDATION	PRIORITY	COSTS
<p>The entrance doors are a pair of substantial four-panel doors on pivot hinges, held open within the stone reveals of the doorway by a pair of heavy iron hooks. The south door can be bolted shut and the north door has a latch and mortice locks, to latch/lock it to the south door.</p> <p>The doors are of solid oak, glazed within their upper two panels with bevelled and polished 3x15mm laminated glass panels, set within an oak frame. Following construction and installation of the doors in 2009, the fabricator advised: The doors are of timber and will therefore expand and contract in relation to the ambient humidity and will be affected by direct heat, moisture and sunlight.</p>	<p>The doors are a bit stiff to open; there are gaps between the door and frame due to the pivot hinge design in order to leave space for the oak to expand and contract.</p> <p>The lower parts of the doors are particularly weathered</p>	<p>i) Remove paper sign from glazing to entrance door</p>	<b>A</b>	Incl. Staff budget

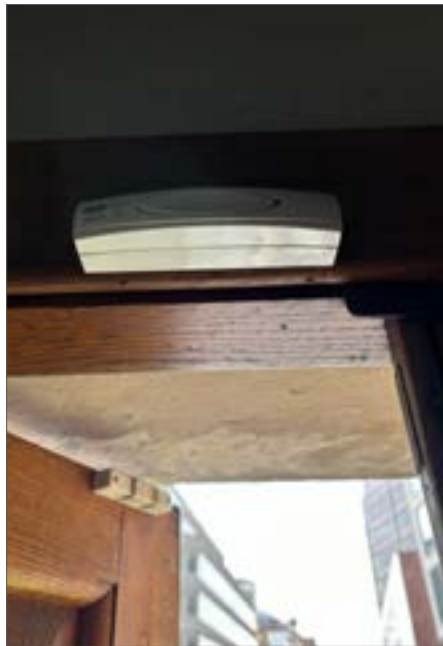
<p>Ironmongery:</p> <p>Pivot hinges: Doors are a bit stiff to open</p> <p>Lock : 2no. mortice locks with interior escape latches, attendant reported working well</p>	<p>ii) Entrance doors: consider replacing white plastic security door movement detector with more appropriate design</p>	<b>C</b>	£300
	<p>Internal bolts: iron floor bolt to south door, works well.</p> <p>iron top bolt and keep fixed to frame, working well</p>	<p>iii) Clean and oil with a coat of DEKS OLJE D1 oil.</p> <p>Inspect for signs of movement, overhaul the doors as required.</p> <p>Inspect ironmongery and oil moving parts as appropriate; ensure ironmongery is securely fixed.</p>	<b>C</b>	£2,100
	<p>Latches &amp; knobs: 2009 internal drop handle latches &amp; external knobs, good condition</p>			
	<p>Security door movement detector to north leaf: Unattractive white plastic</p>

Fig. 27 Door movement detector, 2024

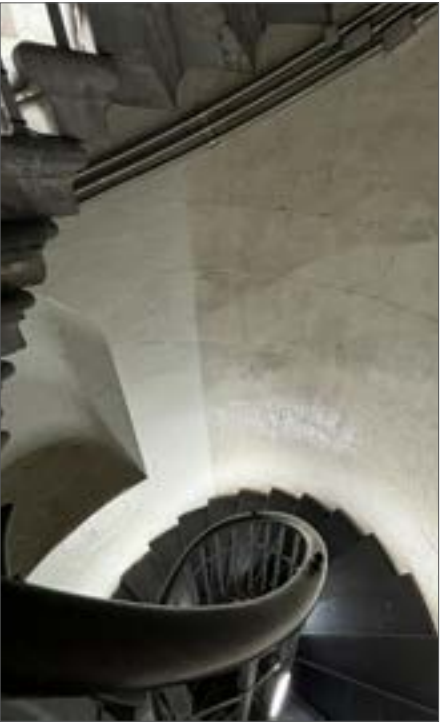
Fig. 30 3 wall finishes: repainted walls at bottom of stairwell; upper stair is cleaned to head-height, then dirty above, 2024

ii) Redecoration of the stairwell walls	C	£3,800

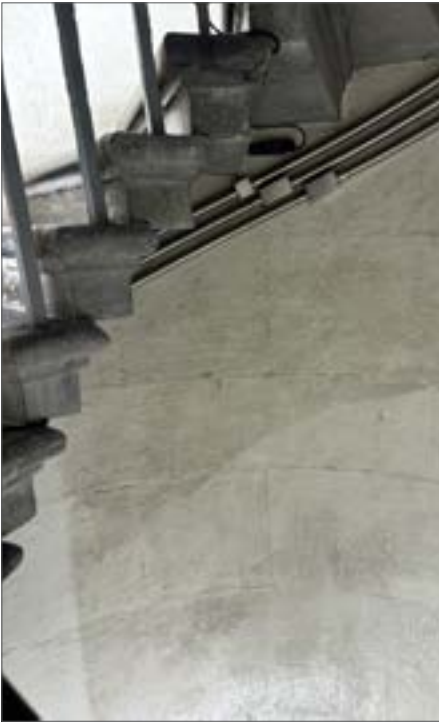
Fig. 31 Paintwork is difficult to clean above a certain level, 2024

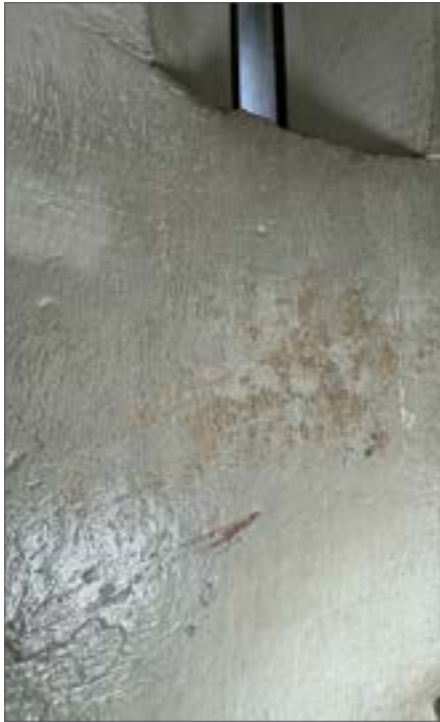
Fig. 32 Eroded paintwork, 2024

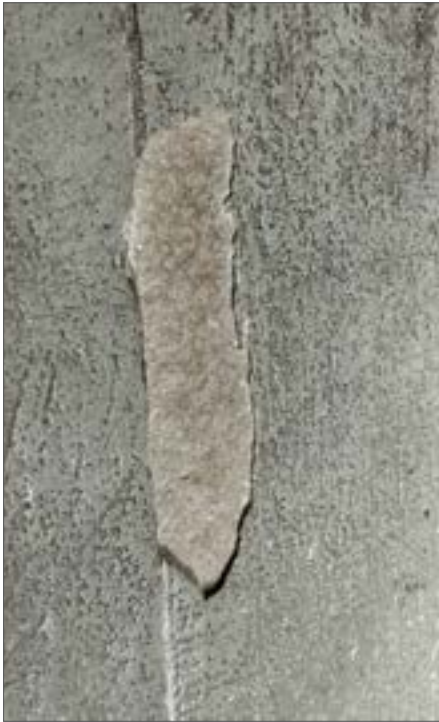
Fig. 33 Local spalling of stonework, 2024

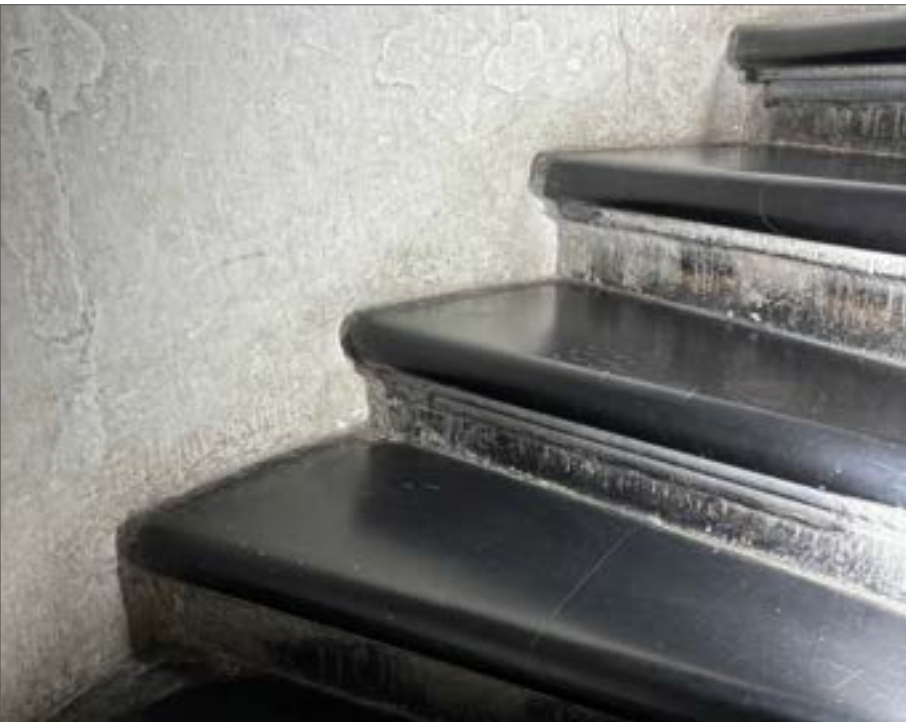
DESCRIPTION	CONDITION	RECOMMENDATION	PRIORITY	COSTS
<p>The continuous spiral staircase is the original 1670s cantilevered stair structure constructed from black limestone, with a wrought iron balustrade, lead-caulked into the stone steps, supporting the curved oak handrail.</p>	<p>As structural engineer’s Condition Inspection report</p>	<p>i) Crack monitoring of steps to be put in place, recommended to be 6 monthly [subject to review of previous balustrade records]</p>	<p>A</p>	<p>See St.Eng. Fees</p>
	<p>The stair treads, extensively repaired in 2009, are wearing well. The undersides of the historic treads are generally in good condition, but several are locally spalling.</p> <p>Defects noted:</p> <p>Some crumbling to underside some steps</p> <p>Extensive delamination to underside of 2no. steps (1 no. at approx sixth window from top, 1 no.at number 18 window)</p> <p>Badly hacked underside of tread at window no.4 and tread above Oval window</p> <p>Corner nosing to one tread end is missing</p> <p>Badly cracked tread 30 treads up from entrance</p>	<p>ii) Review of the noted cracking and stone condition against previous records</p>	<p>B</p>	<p>See St.Eng. Fees</p>

Fig. 34 Black limestone indents to stair treads, 2024

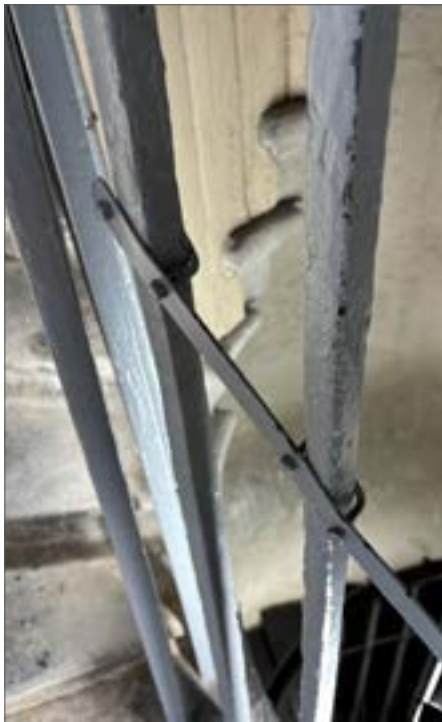
Fig. 39 Steel flat clasped to balusters, 2024

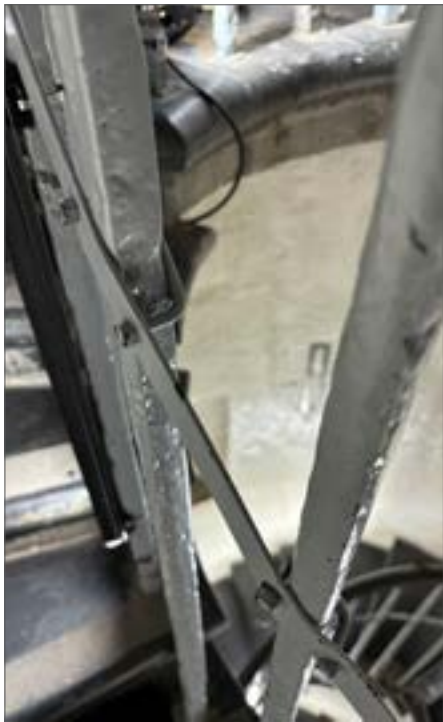
Fig. 40 Steel flat bends around baluster, 2024

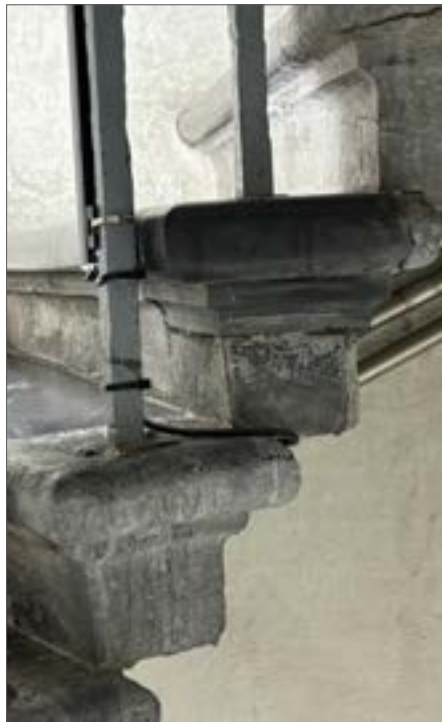
Fig. 41 Balusters lead-caulked into treads, 2024

DESCRIPTION	CONDITION	RECOMMENDATION	PRIORITY	COSTS
<p>The original wrought iron balustrade, comprises 1”square-section wrought iron balusters, each fixed at the top to a slim flat wrought iron spiral rail supporting a curved spiral oak handrail. Each baluster is lead-caulked into a black limestone step; caulking to one baluster end is missing or loose</p>	<p>The balustrade was not designed for the intensity of use it has received in the last fifty or so years and has previously been found to move slightly, particularly near the top of the stairwell. Since the 2016 condition survey, a flat steel band has been fixed, clasped, to the balustrade, approximately two-thirds up the balusters, to restrict movement. The steel strap and baluster clasps are a reasonably neat solution but overall they detract from the appearance of the balustrade and simplicity of the interior. The strap does not appear to be parallel to the handrail and the strap is slightly too thin and easily bends; the strap is not curved in a spiral around the balusters, rather it is multi-faceted. No information is available about the reinforcing straps, their design, designer or any consents obtained. Structural Engineer’s Condition Inspection report refers to condition of balustrade as currently appearing to be stable.</p>	i) Re-caulk baluster ends where lead caulk is missing or loose	C	£2,500

ii) Redecoration, locally	C	£1,500
		iii) Redecoration, fully	C	£14,000
		iv) The structural engineers report recommends the balustrade strengthening details are undertaken, as proposed by Hockley & Dawson in 2016	C	£55,000

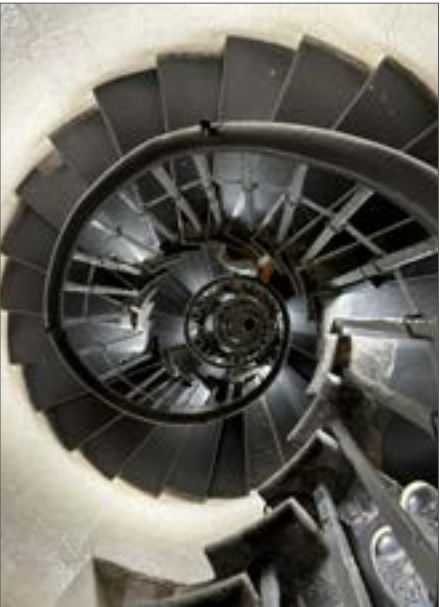
Fig. 42 Carved oak spiral handrail, 2024

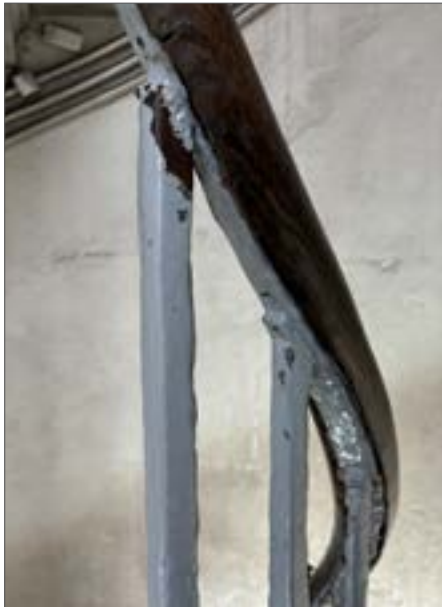
Fig. 43 Fixing of timber to ironwork, 2024

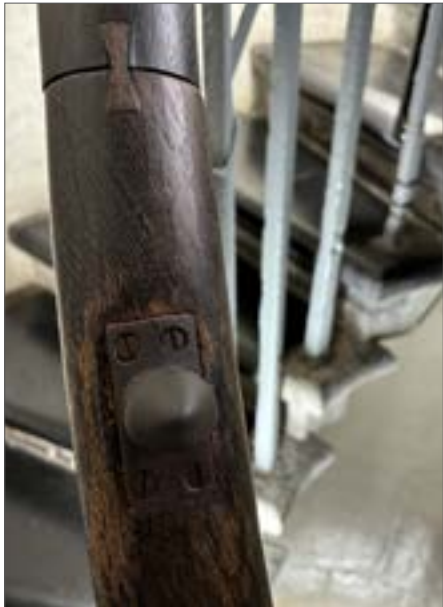
Fig. 44 Brass 'anti-sliding' knob, 2024

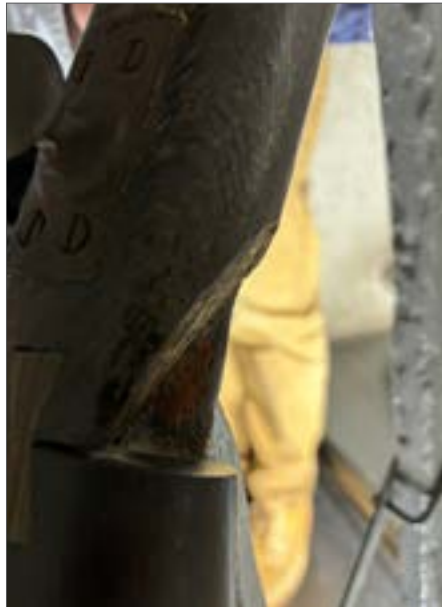
DESCRIPTION	CONDITION	RECOMMENDATION	PRIORITY	COSTS
<p>The curved oak handrail is screwed to the wrought iron flat which is either welded to the top of the wrought iron balusters or screw-fixed where balusters have been replaced.</p> <p>The spiral handrail is made up of shaped lengths of oak sections, butted together.</p> <p>The spiral oak handrail was removed during a repair contract in the late twentieth century and some sections were replaced.</p> <p>The original timber sections appear to have been cut along the grain and steam-bent into the curve required.</p> <p>Replacement sections have been cut out of a large oak block to a curved shape, across the wood grain.</p> <p>Timber movement and shrinkage have caused the joints to open and misalign. This was addressed in the 2007-2009 repair contract by sanding off sharp timber edges and introducing timber slithers and butterfly repairs at junctions between sections of handrails.</p> <p>The 2016 inspection noted that timber had continued to move and in some cases parts of the timber slithers had come out, or butterfly repairs snapped; good quality further repairs have since been undertaken</p>	<p>From the 2024 inspection, the movement of the curved timber continues: some reinforced joints are slightly opened-up, though the oak butterfly reinforcement remains intact, there are several splits along the handrail, typically located where the timbers are most restrained, at their ends; in one place a section of timber has broken off</p> <p>All the brass knobs on the top of the oak handrail are present except one, where the knob is missing from its back-plate, (knobs installed to dissuade people from sliding down the balustrade)</p>	<p>i) Detailed inspection of the oak handrail by a suitably qualified carpenter, to check if there is any splintered timber immediately above the iron bar supporting the timber, if so, ensure the splits are sanded to avoid damage to hands.</p> <p>ii) Repair the handrail where a timber section has broken off</p> <p>iii) Replace the missing knob on the existing back plate</p>	<p>B</p> <p>2 YEARS</p> <p>D</p>	<p>-</p> <p>£2,000</p> <p>£400</p>

Fig. 45 Damaged section of handrail, 2024

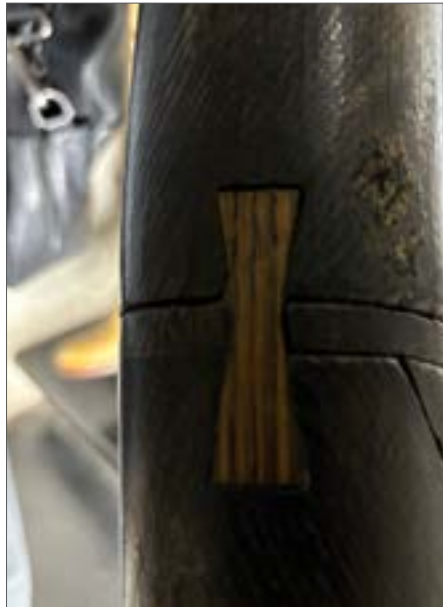
Fig. 46 Recent unstained butterfly joint, 2024

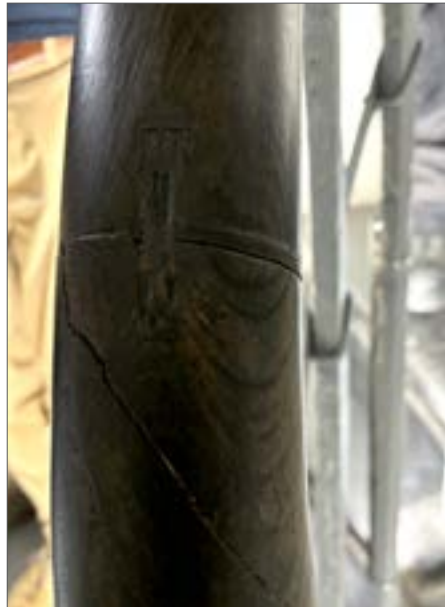
Fig. 47 Stained butterfly joint c.2009

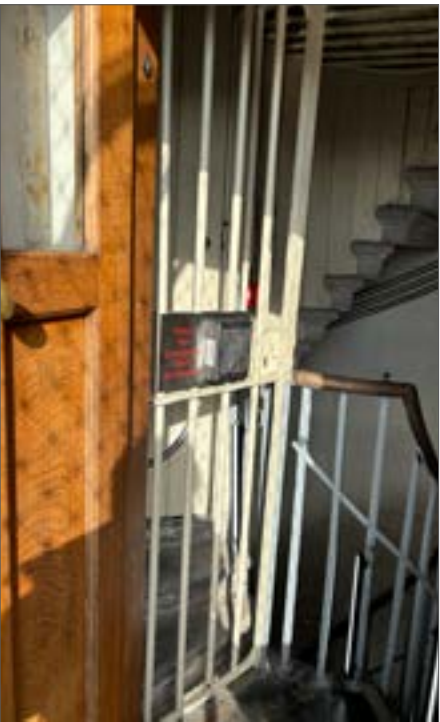
Fig. 48 Balustrade strap detracts from the simplicity of the interior, 2024

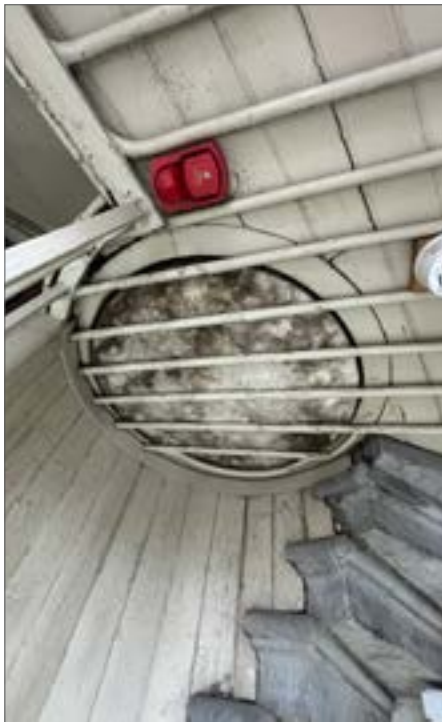
Fig. 49 Steel flat clasped to balusters, 2024
