### 8. THE MONUMENT CONSERVATION MANAGEMENT PLAN - APPENDICES

THE MONUMENT TO THE GREAT FIRE OF LONDON

VOLUME I: CONSERVATION PLAN

MARCH 2025

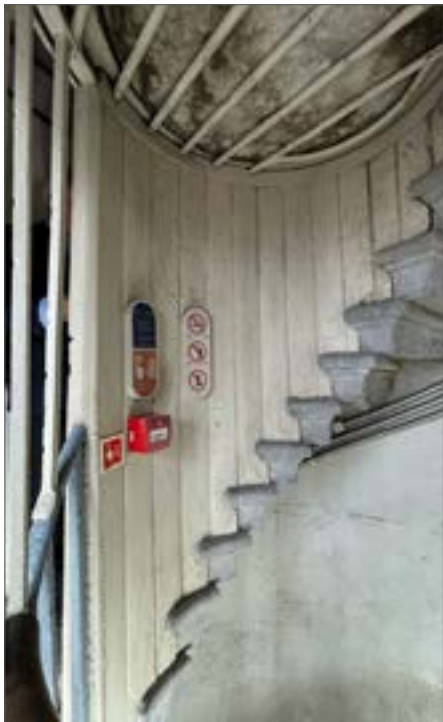
Fig. 50 Steel flat bends around baluster, 2024

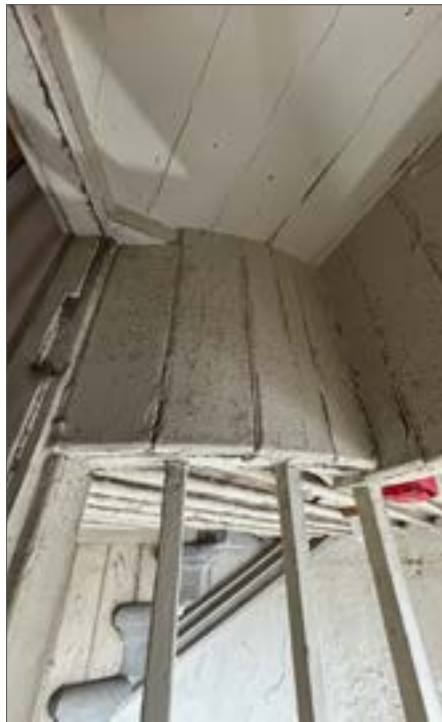
Fig. 51 Balusters lead-caulked into treads, 2024

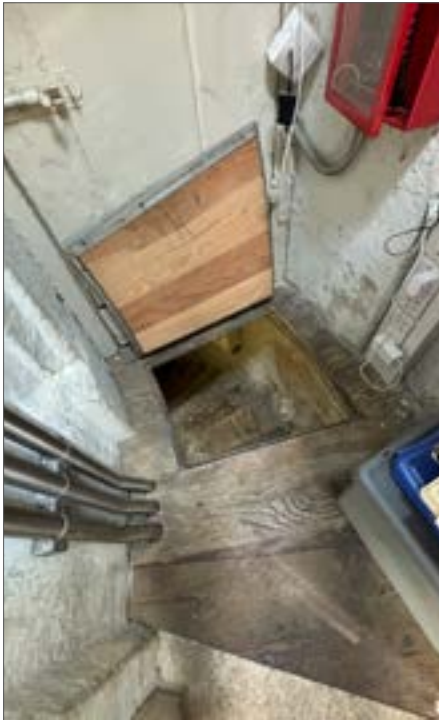
Fig. 55 Floor hatch access to the basement, 2024

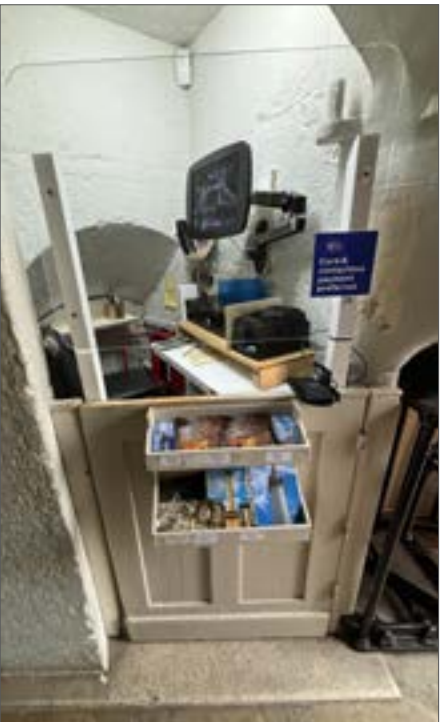
6.6B GROUND FLOOR ENTRANCE LOBBY: JOINERY - HISTORIC TIMBER GATE DOOR TO ATTENDANT'S RECESS				
DESCRIPTION	CONDITION	RECOMMENDATION	PRIORITY	COSTS
Two-panelled painted timber gate fixed to a simple timber frame, timber skirting, 3no. hinges, small brass bolt. Added since the 2016 inspection:  2no. timber display boxes attached to front of gate containing postcards, etc for sale Obtrusive laminate glass screen fixed to pair of timber posts, each fixed to the rear of the historic timber gate	Painted timber wear pattern at top One screw missing to hinges	i) Redesign the Perspex screen (if still needed) to be more appropriate for the historic interior	C	£1,000
		ii) Replace missing ironmongery	C	£200
		iii) Redecoration	FIVE YEARLY	£750

Fig. 56 Painted timber gate to attendants' recess, With display boxes attached, 2024

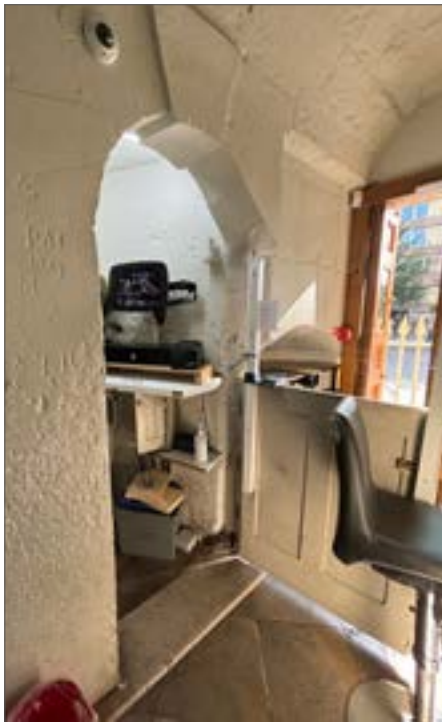
Fig. 57 The gate shown opened, Recent Perspex screen support timbers, 2024

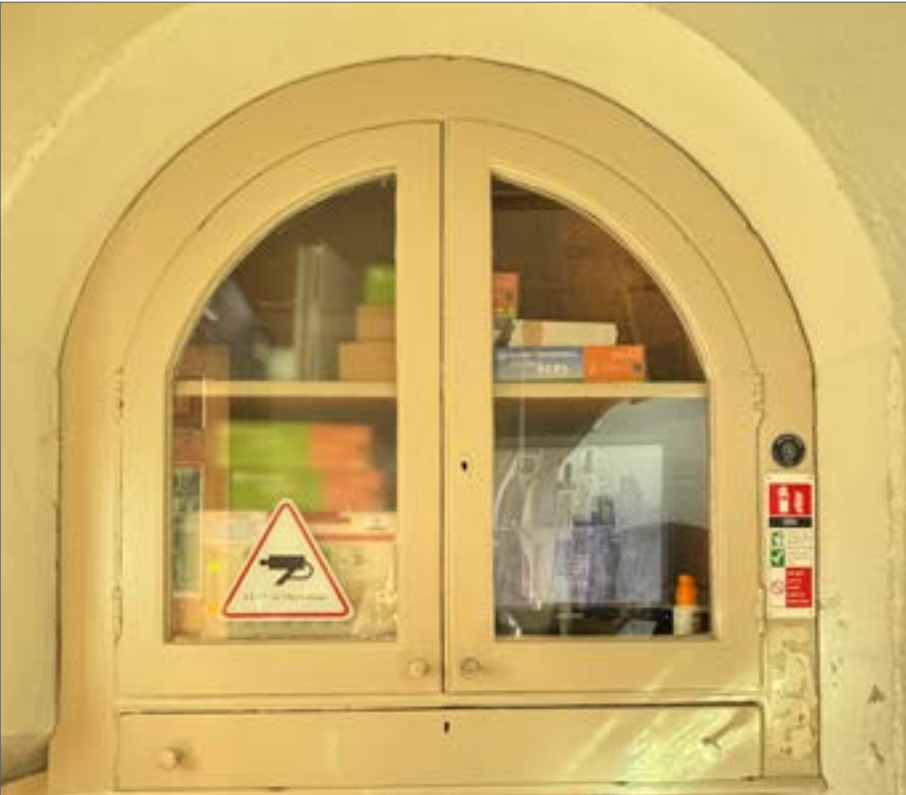
6.6C GROUND FLOOR ENTRANCE LOBBY: JOINERY - GLASS FRONTED PAINTED SOFTWOOD CUPBOARD				
DESCRIPTION	CONDITION	RECOMMENDATION	PRIORITY	COSTS
<p>Above turnstile on south wall, built into niche: pair of glazed doors with wide drawer below, 1 shelf in cupboard. Appears to be nineteenth century. East leaf bolts shut, west leaf mortice locks to fixed leaf. Neat keyhole, not known if key exists. Each door has pair of original hinges and small painted iron knobs.</p>	Reasonable, except for surface damage from adhesive remnants	i) Carefully remove remains of adhesive applied to the historic joinery, make-good the damage by redecorating the frame	<b>FIVE YEARLY</b>	£200
	Comments on Appearance:			
	Modern notices fixed to the front of the historic glass fronted cupboard disproportionately detracts from the appearance of the entrance to the Monument:	ii) Redecoration	<b>FIVE YEARLY</b>	Incl. in 6.6B ili) Page 38

Fig. 59 Glass fronted painted softwood cupboard, 2024

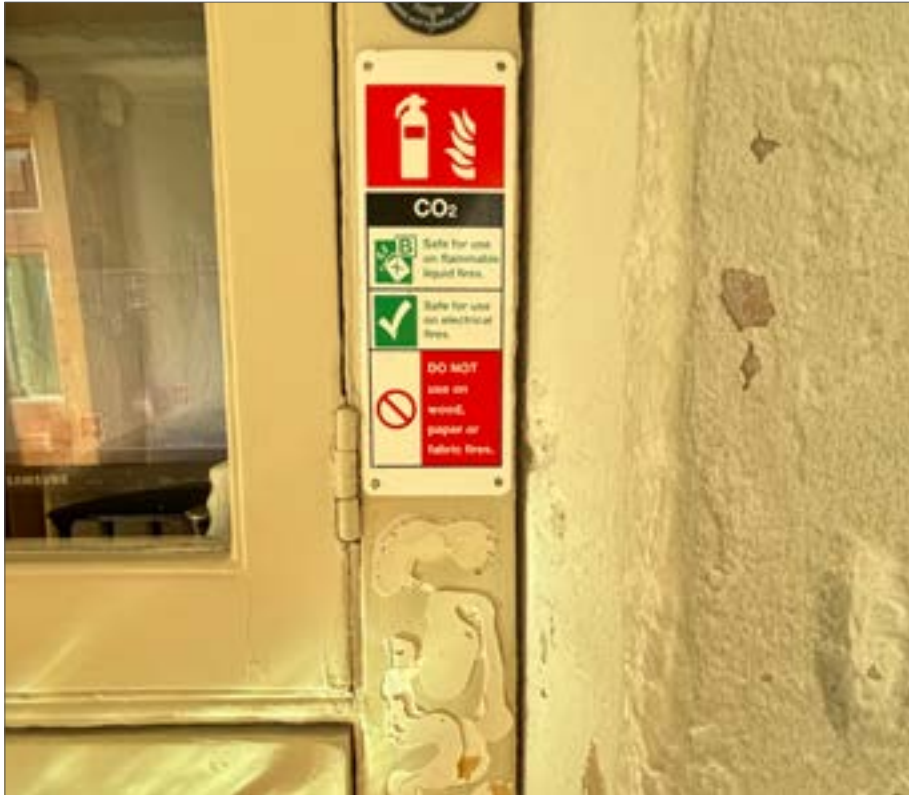
Large CCTV in Operation sign stuck onto the glass of the left hand side glazed door CO2 Fire Extinguisher sign glued to the right hand side timber frame, which appears to duplicate the CO2 Fire Extinguisher sign fixed to the stone wall above the CO2 fire extinguisher. Remains of adhesive from a former sign, now removed, same size as the above sign World Tag disc – possibly used as part of the security system, whereby security officers use a wand/pipe tool and scans the point to prove they made the round.	iii) Avoid duplication of Fire Extinguisher notices. Locating the notices directly above the fire extinguishers is preferable for the presentation of the historic interior.  iv) Review the number of CCTV signs displayed at the Monument, reduce the number to the recommended minimum by eliminating those which detract from the visitor experience of the historic building.	<b>B</b>   <b>B</b>	-   -

Fig. 60 Detail showing remains of adhesive applied to the joinery, 2024

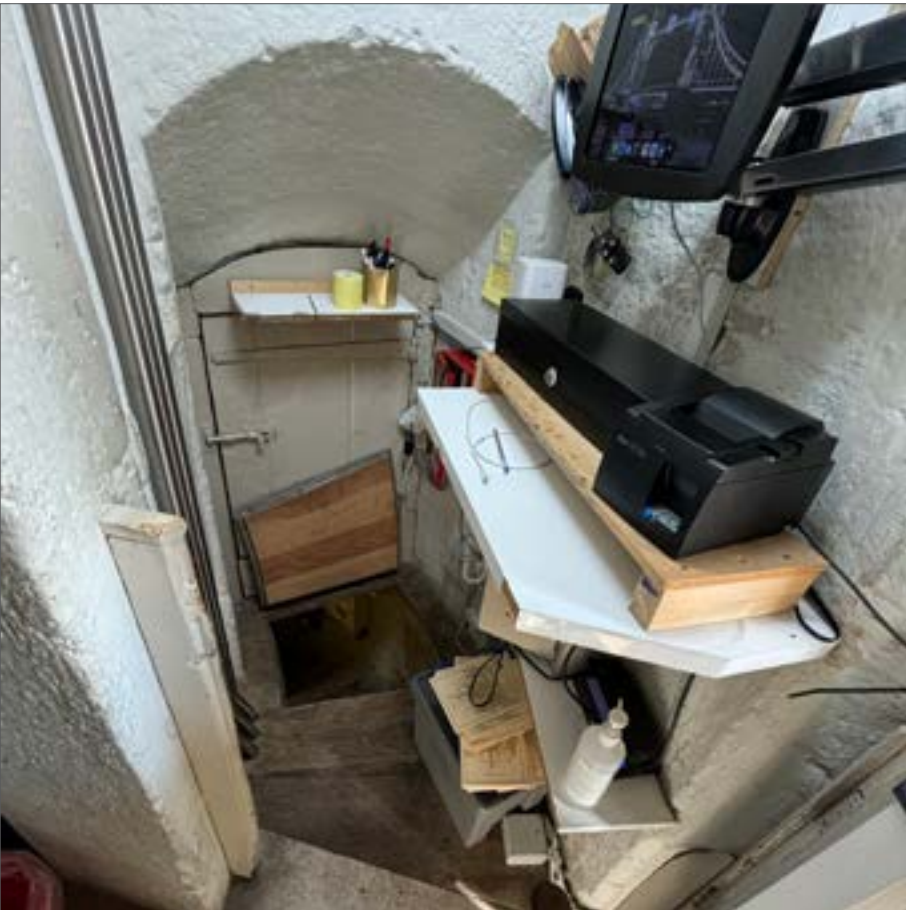
DESCRIPTION	CONDITION	RECOMMENDATION	PRIORITY	COSTS
<p>A historic single cupboard door of flush boards in a softwood frame built across the back of the attendant's recess, with small fixed-panel above and fixed skirting below, iron strap hinges and a large iron bolt. Appears to be nineteenth century.</p> <p>Timber skirting has been altered to accommodate a heating grille.</p>	<p>Adequate. Door operates smoothly, ironmongery is historic and functional. Altered skirting board has paint chipping and appears poorly prepared for decoration</p>	<p>i) Redecorate, particularly to skirting which requires careful preparation before redecoration</p>	<p><b>FIVE YEARLY</b></p>	<p>£200</p>
	<p>Comments on Appearance:</p> <p>A crude chipboard shelf with chipped melamine top has been screw-fixed to the historic timber panel above the doorway, (since 2016). This detracts from the appearance of the historic door and together with other poorly designed joinery in the attendant's recess, disproportionately detracts from the appearance of the entrance to the Monument</p>	<p>ii) Rationalise and tidy cupboard contents</p>	<p><b>B</b></p>	<p>Incl. Staff Budget</p>

Fig. 61 Looking into the attendants' recess at the historic cupboard front at the back of the recess, 2024

<p>iii) Redesign the new shelf (if needed) above the cupboard door to a more appropriate design for the historic interior</p>	<p><b>B</b></p>	<p>£400</p>

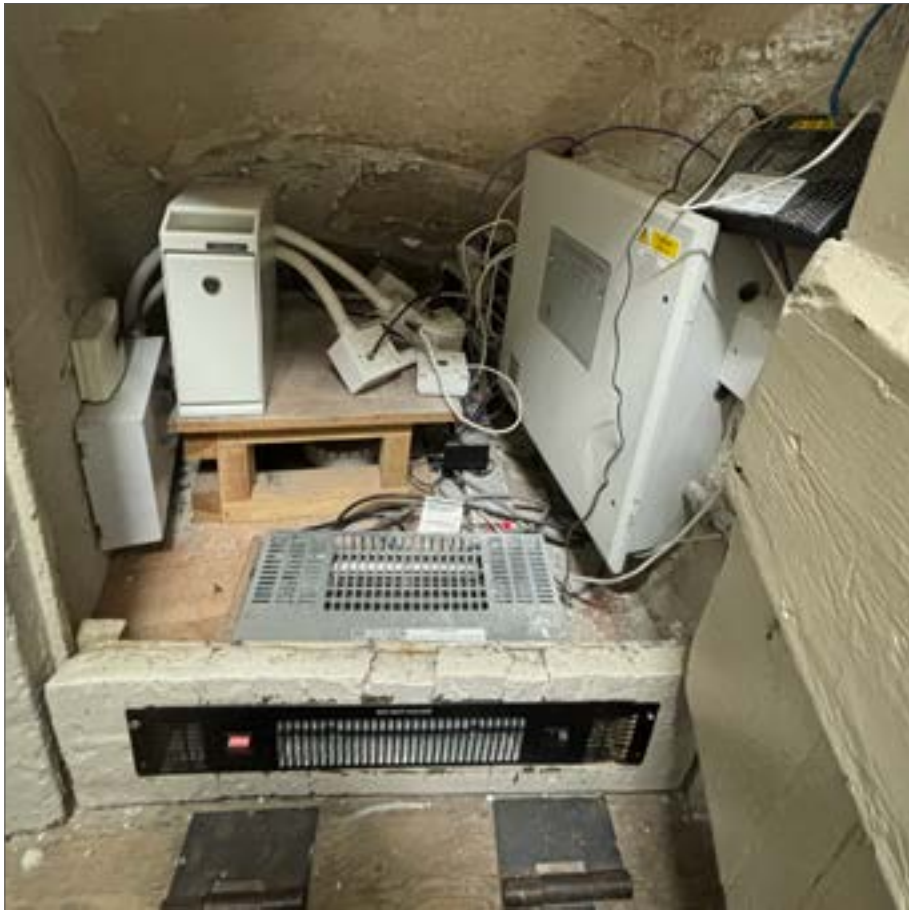
Fig. 62 Inside the rear cupboard showing the skirting heater and cupboard contents, 2024

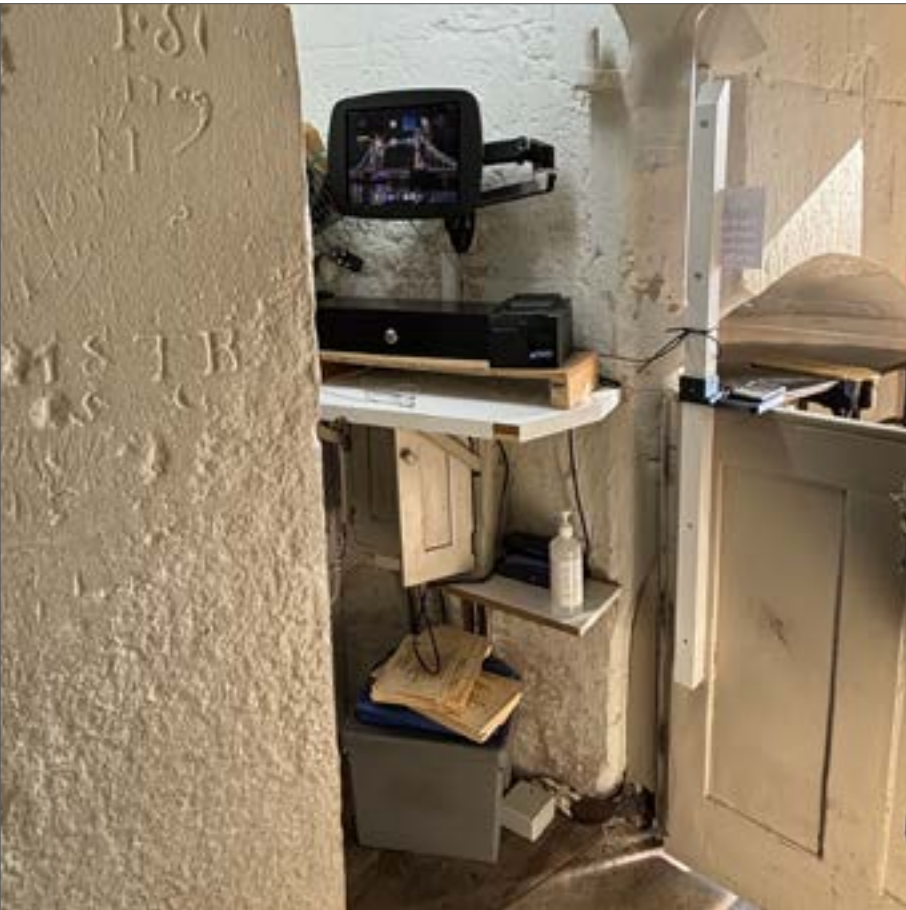
6.6E GROUND FLOOR ENTRANCE LOBBY: JOINERY - SMALL TIMBER ELECTRICAL SERVICES CUPBOARD WITH SHELF OVER				
DESCRIPTION	CONDITION	RECOMMENDATION	PRIORITY	COSTS
<p>This cupboard was designed in 2008 as a temporary cupboard (for approximate lifespan 5 years) to accommodate electrical services required at that time. It was acknowledged that technology and demands for electrical services change frequently and the adequacy of this cupboard would need to be reviewed in future.</p> <p>The timber shelf has since been replaced with chipped melamine-faced boarding with a MDF &amp; softwood shelf above and a chipped melamine shelf adjacent.</p>	<p>The cupboard is no longer fit for purpose; it cannot contain all the electrical services and equipment currently required in the attendant's recess.</p>	<p>i) Review and rationalise the equipment and services required in the attendant's recess.</p>	<b>B</b>	-
	<p>Comments on Appearance:</p> <p>The C21 built-in furniture and fittings in the attendant's recess are poor quality and not to the design and construction standards appropriate for a Grade I listed building. They detract from the appearance of the entrance to the Monument</p>	<p>ii) Redesign and fabricate the cupboard and countertop, together with any shelving required in the attendant's recess, to the quality standard appropriate for a grade I interior.</p>	<b>C</b>	£2,300

Fig. 64 Looking into the attendants' recess at ad hoc shelving fixed to the services cupboard, 2024

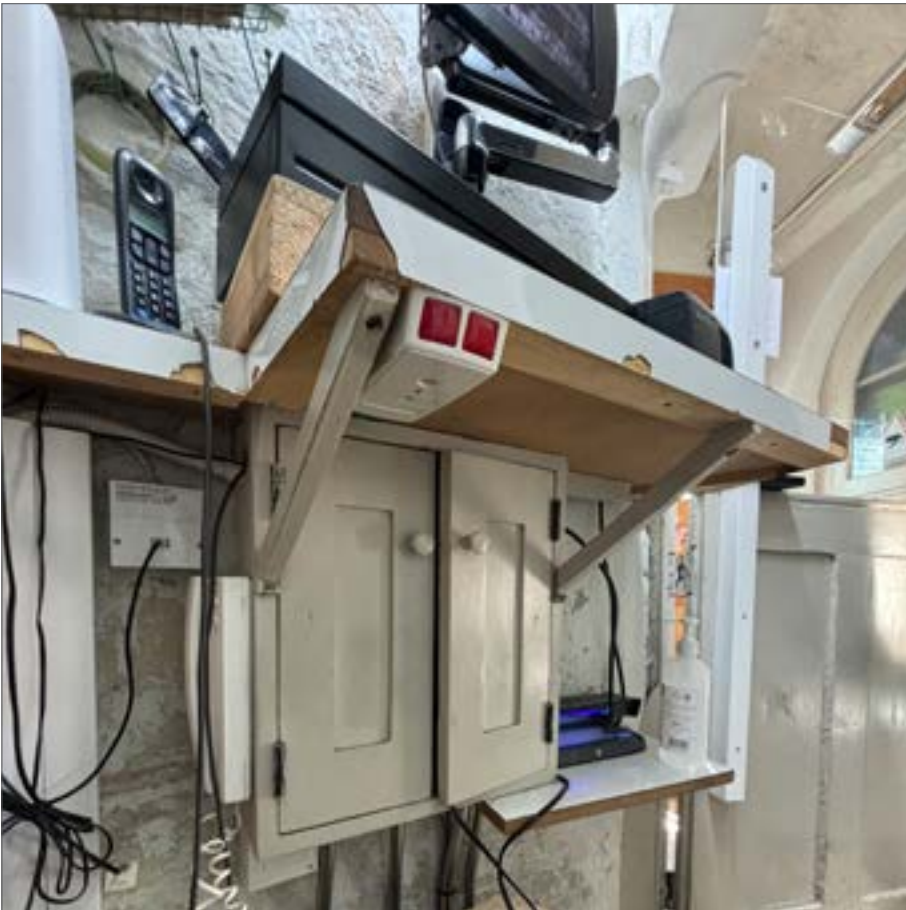
Fig. 65 The electrics' cupboard c.2009 can no longer contain all electrical services, 2024

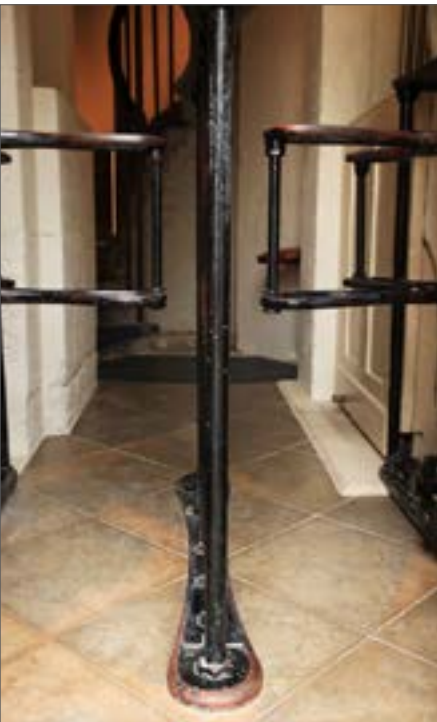
6.6F GROUND FLOOR ENTRANCE LOBBY: TURNSTILES				
DESCRIPTION	CONDITION	RECOMMENDATION	PRIORITY	COSTS
<p>The cast-iron turnstile, made by Le Grand &amp; Sutcliff was installed in 1891. It comprises a central barrier of 7 no. circular iron balusters, 25mm diameter with two end newels 32mm diameter, with a flat iron top rail, (temporarily removed). The painted iron gates, one each side of the barrier have brass digital counters and are semicircular on plan with 11 no. square section balusters and flat iron top rail. The wrought-iron hoop gates are pegged in position and operated by a floor mounted ratchet mechanism. The mechanism was in good working order until parts of the gates were temporarily removed c.2010 (without Scheduled Monument Consent).</p>	<p>The central bar and parts of the gates have been removed off site and have not been inspected. The remaining frames and gate parts appear to be in good condition, but the gates are held open with plastic ties so were not rotated.</p> <p>Comments on Appearance: Removal of the central bar and turnstile gates detracts from the understanding of how the turnstiles operated, and from the appearance and enjoyment of entering the Monument.</p>	i) Inspect the missing parts of the turnstiles to ensure they are recorded and safely stored.	B	Incl. Staff Budget

Fig. 67 Turnstile central rail, 2009

ii) Give consideration to either reinstating the working turnstiles or obtaining the statutory consents required to alter the formerly working turnstiles.	C	£3,200

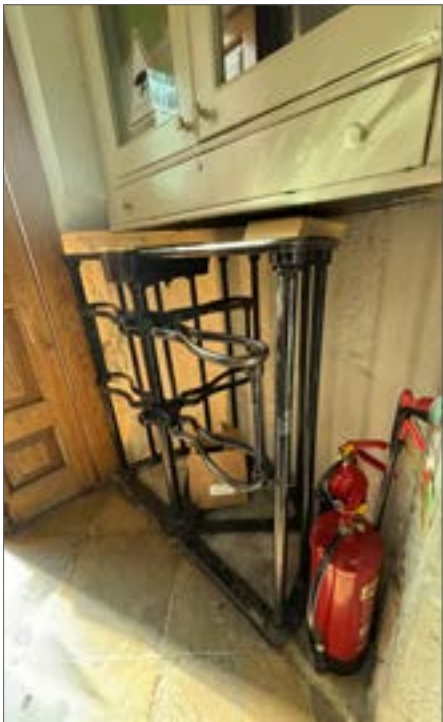
Fig. 70 Turnstile in south recess (arms missing), 2024

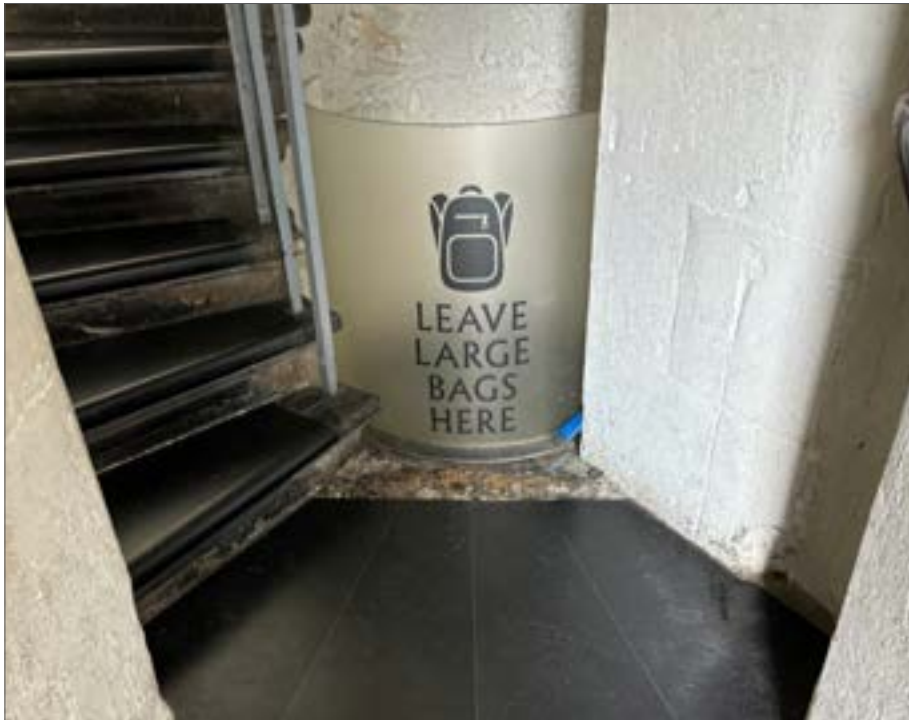
DESCRIPTION	CONDITION	RECOMMENDATION	PRIORITY	COSTS
<p>Central at the base of the helical staircase is an oculus (circular opening in the centre of the stone dome of the basement room below); the oculus is an important architectural feature.</p> <p>Within the oculus is a historic wrought iron grille which allows some daylight and ventilation to the circular basement room below, (formerly Robert Hooke’s seventeenth century workshop)</p> <p>A circular disc of painted plywood now conceals the grilled opening which is used for storing visitors’ bags when they ascend the Monument. The bag store is enclosed with a neat bespoke curved Perspex panel. Neither plywood disc or curved Perspex panel are fixed to the historic fabric and both are easily removable.</p>	<p>The wrought iron grille was refurbished and redecorated in the 2009 contract and appears to be in good condition.</p> <p>Covering the grille reduces ventilation of the basement room below, likely contributing to the damp conditions and decay of the masonry in the basement room and staircase</p> <p>Comments on Appearance:</p> <p>The location of the bag store and the blocking up of the historic oculus greatly detracts from the enjoyment of the Monument as many visitors enjoy and photograph the extraordinary view down the centre of the spiral staircase.</p> <p>Formerly the view ended at the historic circular floor grille, with the basement glowing from the red lighting (installed in 2009) within it. Now the view is down onto visitors’ bags which greatly detracts from the view, experience and understanding of the building. (It is appreciated that visitors’ bags are a real problem at the Monument as they cannot be taken up the stairs, due to the very restricted width towards the top).</p>	<p>i) Reinstate the main means of ventilating the basement, by removing the plywood which is blocking the grille.</p> <p>ii) Ensure the red basement lighting is switched on during visiting hours to allow the possibility of visitors understanding the form of the building and obtaining a glimpse of Hooke’s workshop</p> <p>iii) Decorate Ground Floor grill</p>	<p>A</p> <p>B</p> <p>C</p>	<p>Incl. Staff Budget</p> <p>Incl. Staff Budget</p> <p>£400</p>

Fig. 72 The view of the oculus at the base of the stairwell is concealed by a bag-store Perspex screen, 2024

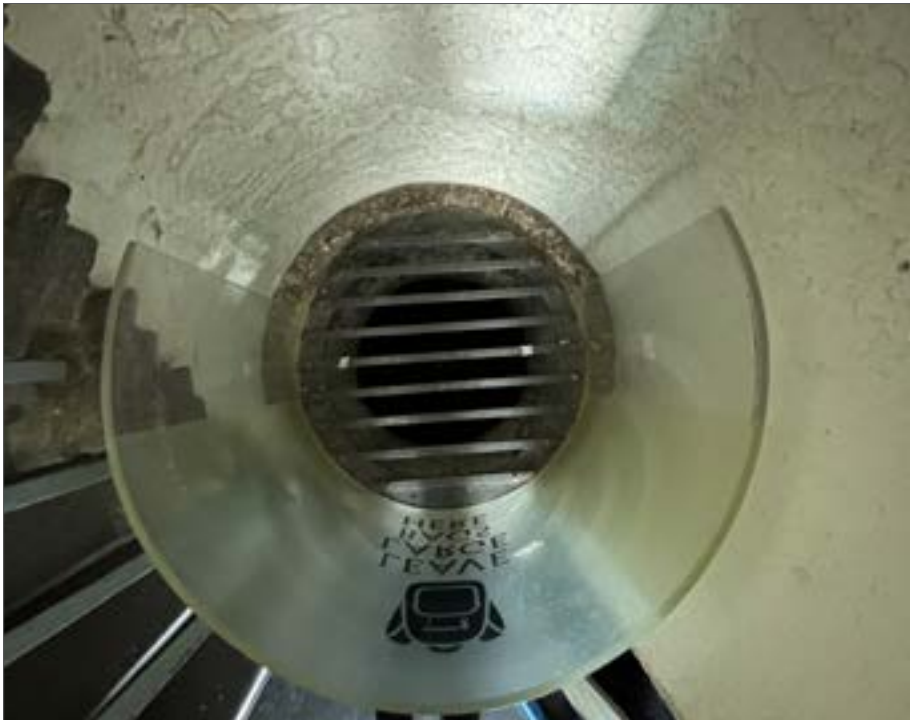
Fig. 73 Looking down at the iron grill in the oculus, with the board-cover removed

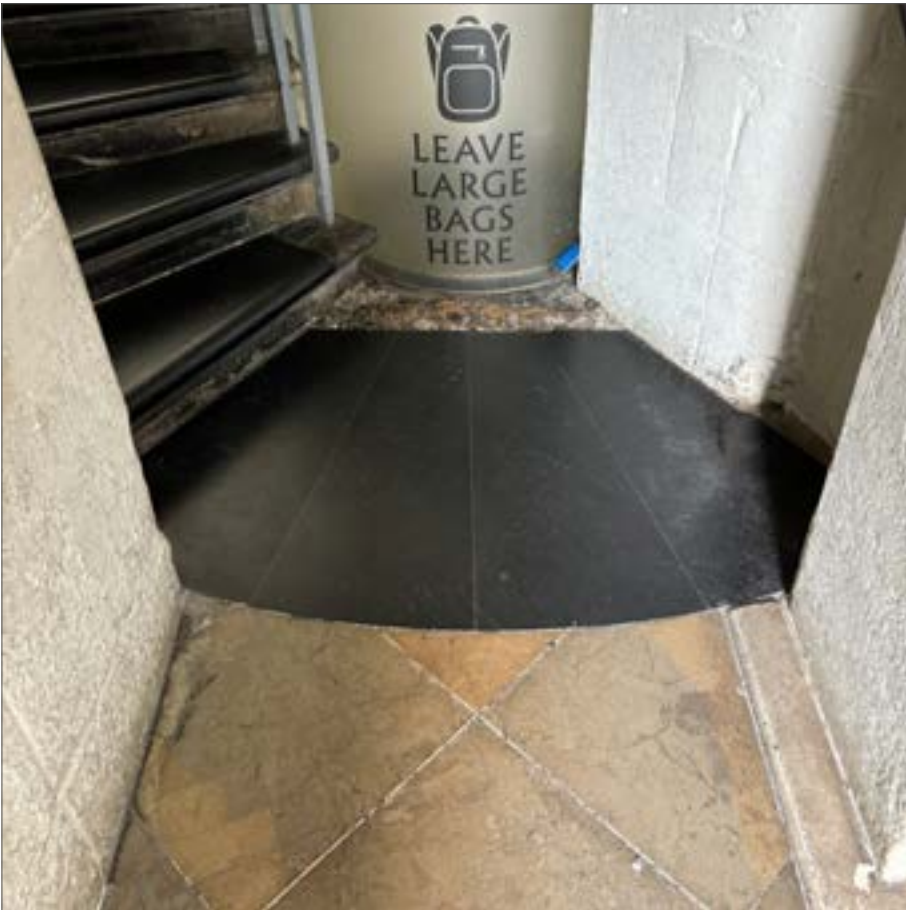
6.6H GROUND FLOOR ENTRANCE LOBBY: FURNITURE & EQUIPMENT				
DESCRIPTION	CONDITION	RECOMMENDATION	PRIORITY	COSTS
<p>The following have been brought into the ground floor of the Monument:</p> <p>Floor mop and large yellow plastic sign warning about a Wet Floor, prominently stored at the base of the stairwell in full view of the visiting public.</p> <p>Curved Perspex panel with the large, printed instruction: LEAVE BAGS HERE</p>	<p>Comments on Appearance:</p> <p>Storing cleaning equipment at the centre of the helical stair, spoils one of the principal views (and photo opportunities), within the Monument.</p> <p>The curved Perspex panel with the large, printed instruction obscures the historic oculus</p>	i) Do not store cleaning equipment within public view at the base of the helical stair. Store with the other cleaning equipment, in the Pavilion building in Monument Yard.	A	Incl. Staff Budget
		ii) Review the bag store and consider alternative locations to store bags, to allow the grille to the basement to remain unobstructed.	A	CS

Fig. 75 Perspex screen to bag storage area, 2024

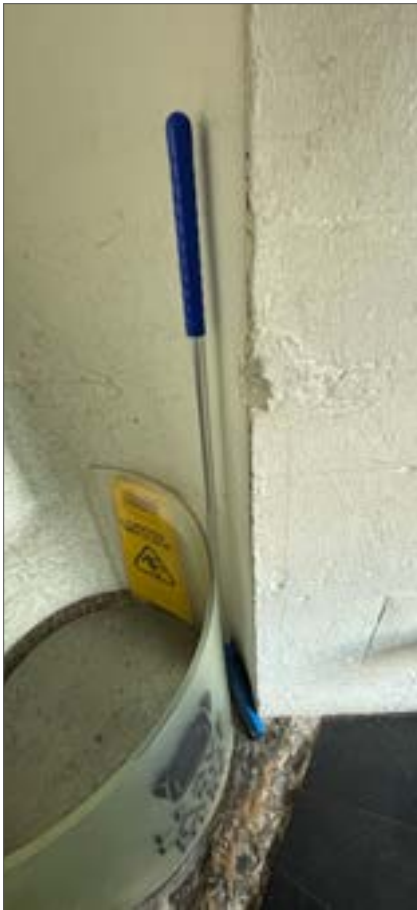
Fig. 76 Detail: mop and yellow sign, 2024

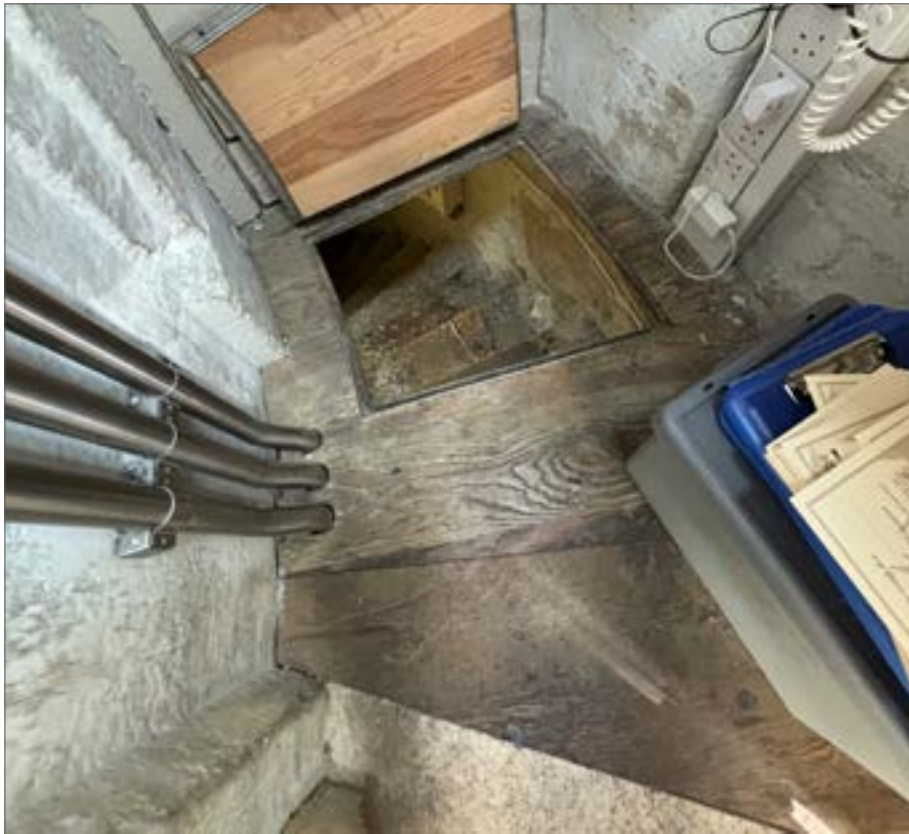
DESCRIPTION	CONDITION	RECOMMENDATION	PRIORITY	COSTS
<p>Within the entrance hall is a small recess where the attendant stands. The floor of the attendants' recess is timber boarding, with access to the basement is via a small, hinged timber boarded hatch set in the floor. Access to the basement is difficult, but there is little scope for easing the situation due to the limited space in the attendant's recess. Walls, steps and soffits are Portland stone, walls &amp; soffit are painted with silicate masonry paint.</p> <p>Seven stone steps, curved on plan, lead down to a stone landing. To the north of the landing is a recessed bay which may have been a flue or vent, ventilating the basement in combination with the oculus opening in the domed ceiling. A stainless-steel platform, on pull-out runners, was installed in the recess in 2009 to support and access the Uninterrupted Power Supply unit (USP) formerly located there.</p> <p>To the south, a further five stone steps lead down into the circular basement chamber</p>	<p>Stone steps and landing are in good condition</p> <p>Painted stone walls have extensive paint flaking, some erosion, efflorescence and several severely eroded blocks</p> <p>There is an excessive accumulation of stone particles under stainless steel platform which indicates active erosion of the stonework.</p> <p>At the back of the flue recess, beneath the flue is a streaking paint stain and extensive calcite staining</p>	i) Sweep steps and landing.	A	Incl. Staff Budget

Fig. 79 Floor access hatch to basement, shown open, 2024

ii) Clear away metal platform, if no longer in use (retain at present)	B	No cost
		iii) Reinstate (what is likely to have been) the original basement ventilation system: allowing air to enter the basement via the flue in the north wall recess and for air to be drawn up out of the basement via the large oculus opening in the domed ceiling of the circular basement room. Ventilation to be improved before any redecoration, local stonework repointing or repairs are undertaken	C	£3,500

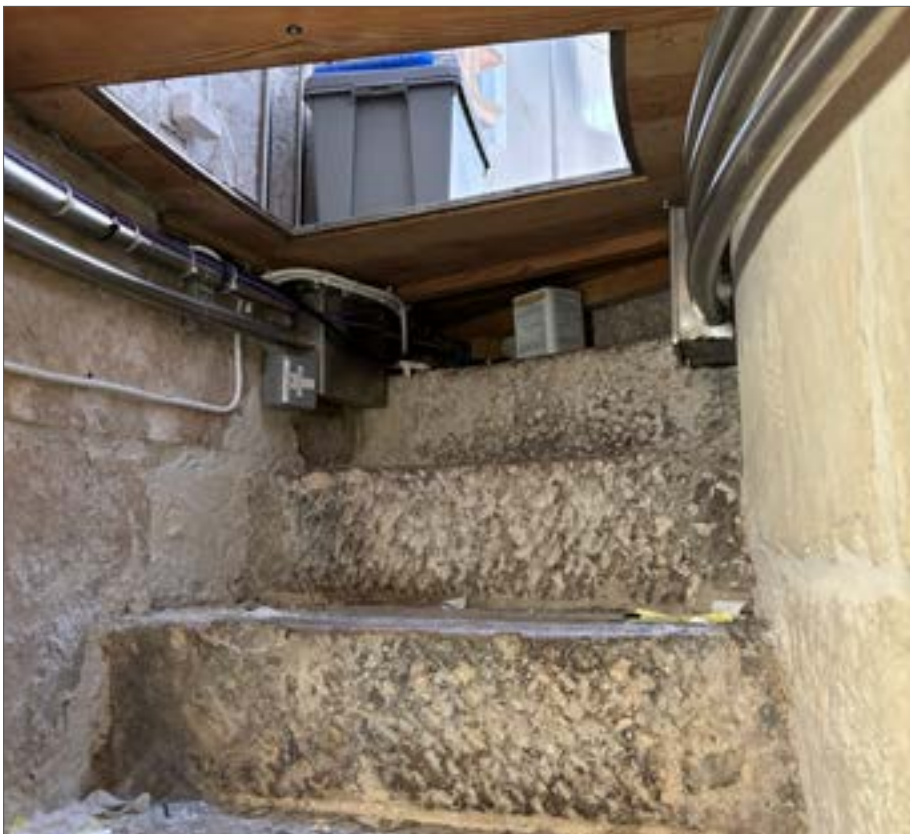
Fig. 80 Looking up from the basement steps to the floor access hatch opening, 2024

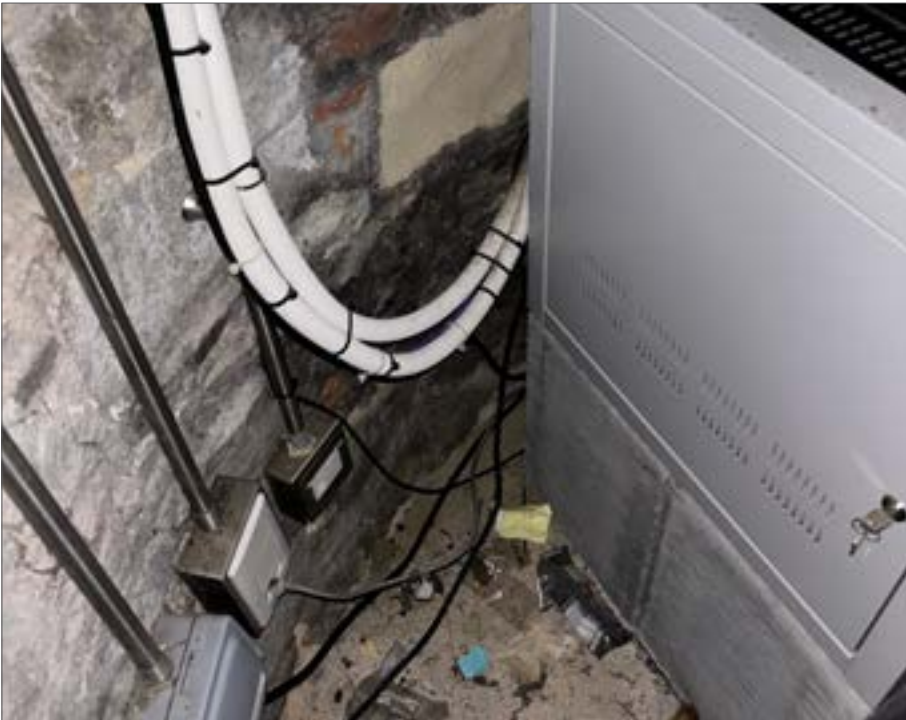
6.7A BASEMENT: BASEMENT CIRCULAR CHAMBER (HOOKE'S WORKSHOP)				
DESCRIPTION	CONDITION	RECOMMENDATION	PRIORITY	COSTS
<p>The floor hatch in the attendants' recess leads via a series of radiating stone steps to a circular chamber 2.14 metres (7 feet) in diameter with a semi-circular domed Portland stone ceiling. The chamber lies directly beneath the circular staircase enclosure. The walls are constructed of coursed rubble stone blocks and red clay brickwork, all unpainted. The floor to the chamber is made up of a compacted lime screed c.2009.</p> <p>A steel angle is fixed across the circular basement just above floor level. This is to support the verticality testing equipment used to regularly (but infrequently) measure the verticality of the Monument to assess any movement.</p> <p>Computers and large protection boxes are located in the basement, together with what appears to be rubbish.</p>	<p>The stonework is very damp when the Moisture Condition tested. There is efflorescence on stonework in places, some spalling of pointing and calcification of stones, some eroded stones and bricks very severely decayed.</p> <p>The large circular ventilation grille at the apex of the vault is closed-off with a board, reducing natural ventilation in the basement</p> <p>The limecrete floor is damp but in good condition.</p> <p>The stainless still conduit is all in good condition</p>	i) Inspect all stored items, remove all redundant items.	C	£400

Fig. 82 Debris and redundant wiring in the central circular basement, 2024

ii) Sweep all floors and ledges.	A	Incl. Staff Budget
		iii) Computer & electrical equipment in connection with former temporary panoramic camera system (now disused), to be removed together with all the associated equipment and cabling in the Monument.	C	£1,600
		iv) Re. the steel angle fixed across the circular basement just above floor level used for verticality testing of the Monument, it is important that this steel bar is not damaged in any way.	NOTE	-

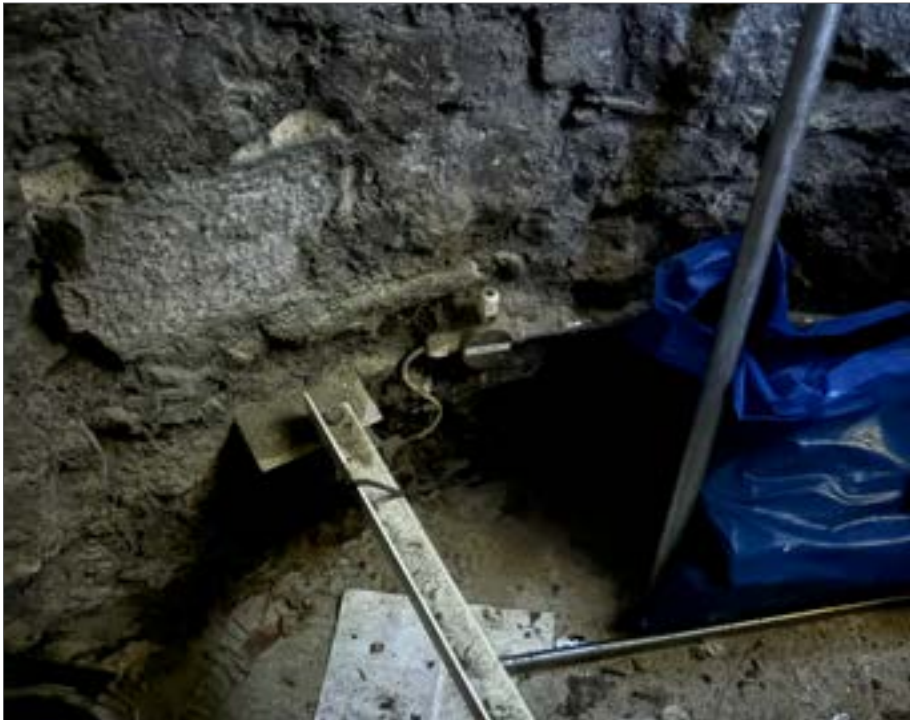
Fig. 83 Steel angle to support the verticality testing equipment

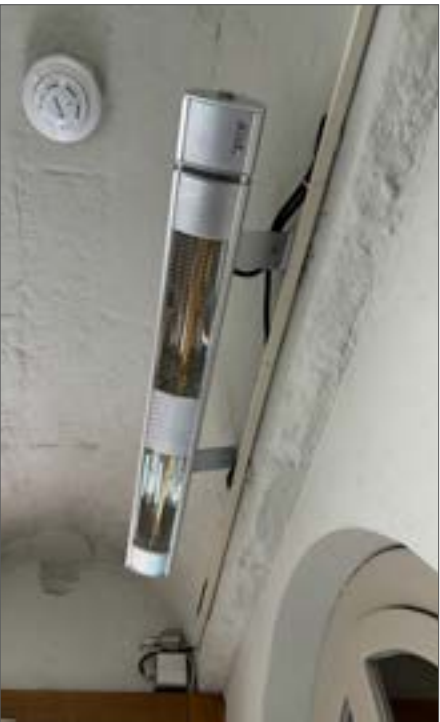
7.2 HEATING					
DESCRIPTION	CONDITION	RECOMMENDATION	PRIORITY	COSTS	
<p>An electric radiant heater has been installed in the entrance foyer at the top of the south wall.</p> <p>This replaces the previous electric heater in this location, which replaced the over-door fan heater installed in 2009.</p> <p>A kick-space or plinth fan heater installed at the base of the cupboard at the back of the attendant's recess</p>	<p>Appearance</p> <p>The entrance foyer heater has a smart appearance and is a good colour (silver) against the light-coloured painted stonework. It is located just above the LED strip uplighter, which was not switched on, (or possibly was not working), at the time of the inspection.</p> <p>The appearance of the heater is marred by the thick black electric cable, tied to the slim white LED strip light with white cable ties.</p>	i) It may be advisable not to turn on the LED strip uplighter along the south side of the barrel vault, as this will directly light, and draw attention to, the electric radiant heater.		-

Fig. 84 Radiant electric heater, black cabling is visible, 2024

ii) Consider removing the strip uplighter if the heater is to be permanently located here and installing a slim stainless-steel conduit to take the black cable.	C	£800	
		iii) City Corporation to provide information on heaters, installation dates and testing certification	B	CS

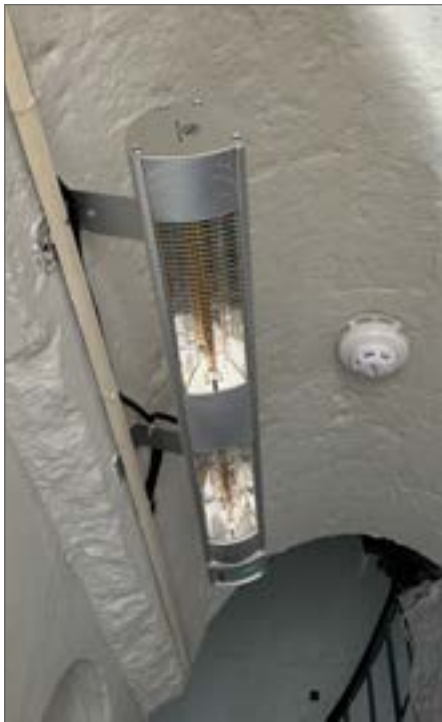
Fig. 85 Heater is located just above LED strip lighting, 2024

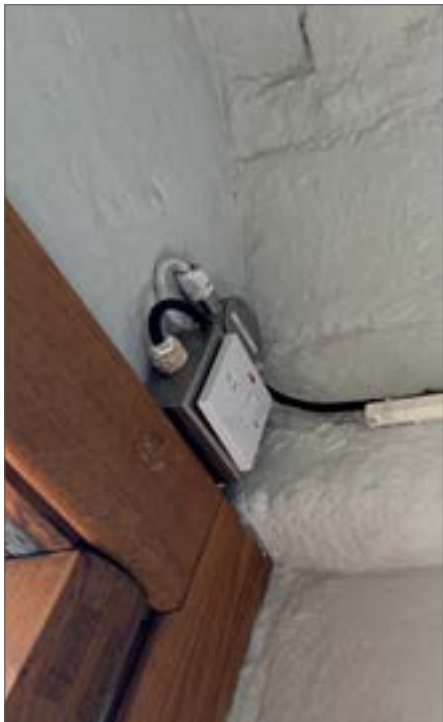
Fig. 86 Power supply and isolator, 2024

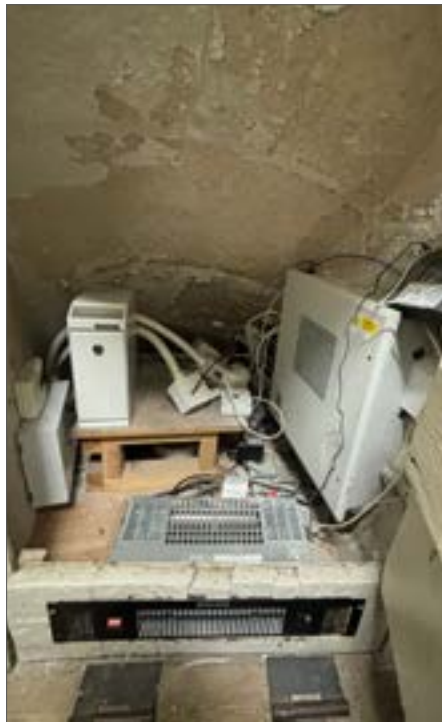
Fig. 87 Kick-space fan heater in skirting of cupboard, 2024

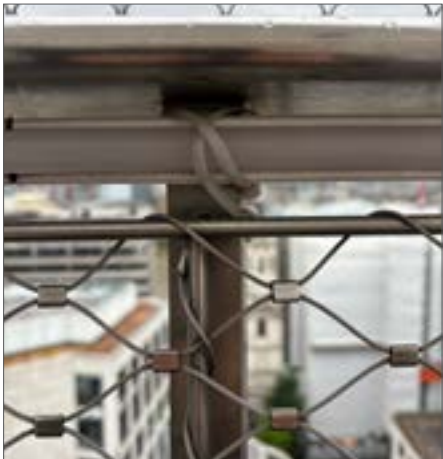
Fig. 90 A rope of LED lights fixed to the underside of the handrail, 2024

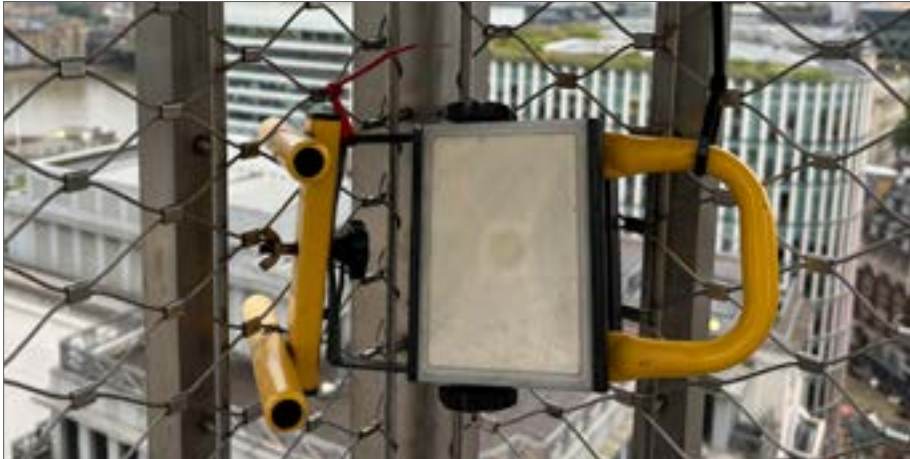
Fig. 91 A portable LED work-light fixed to the balustrade mesh, 2024

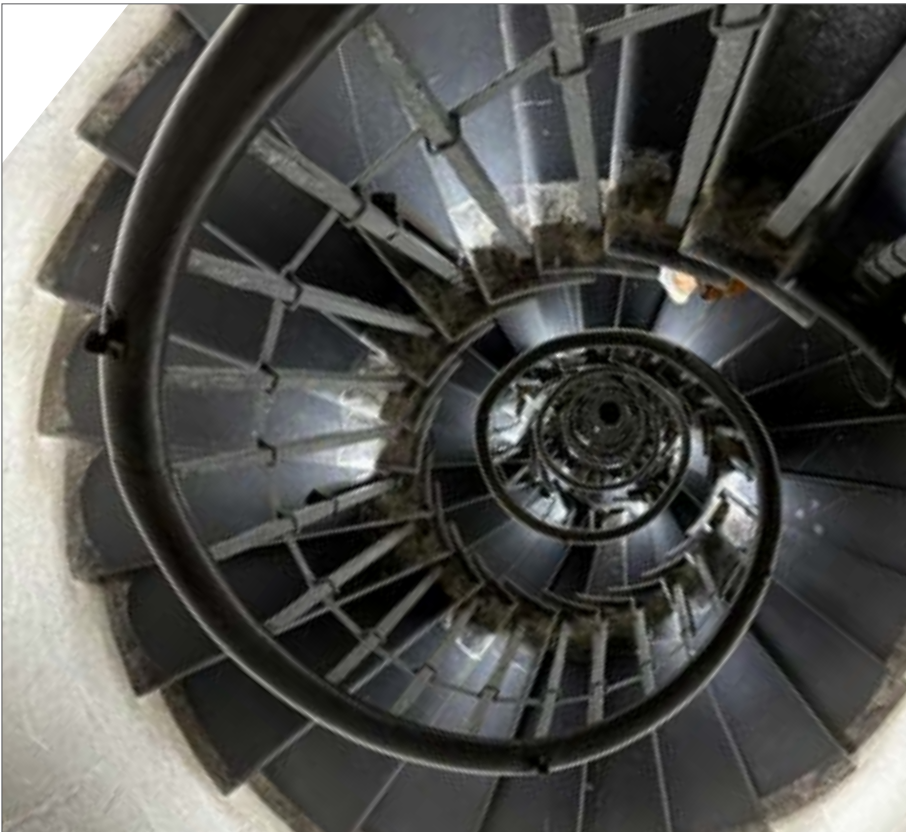
At the 2024 inspection, it was noted that all the 2009 baluster light fittings have been replaced except for those above viewing platform level, where the original bespoke light fittings remain.

Fig 97 2024 lighting: cold strong light

DESCRIPTION	CONDITION	RECOMMENDATION	PRIORITY	COSTS
<p>In 2009, the stairwell was lit by bespoke light fittings mounted onto every fourth baluster with light directed onto the steps rather than flooding the whole stairwell with light (as the previous scheme).</p> <p>The baluster light fittings are the same width as the iron balusters, approx. 25mm, and fixed to the flat face of the baluster, facing the stair tread.</p> <p>Each fitting is fitted with micro louvres to prevent a direct view of the lamp source and long life, low energy warm white LED lamps, which, according to the Maintenance Plan, should only require maintenance once every ten years. The powder-coated finish colour-matched the paint colour of the balusters, then a dark grey colour.</p>	<p>The replacement baluster light fittings are inferior in appearance to the bespoke fittings, as the replacement lights:</p> <ul style="list-style-type: none"><li>• are wider than the iron balusters</li><li>• have a black finish, which contrasts with the light grey painted iron balusters, to which they are fixed</li><li>• do not have micro louvres to prevent a direct view of the lamp source</li><li>• are not positioned on the flat-face of the balusters, but are tilted away from the stair tread to try to reduce glare</li><li>• emit a harsh cold light, rather than a warm white light</li><li>• are not all well fixed to the balusters</li></ul>	<p>i) Consider the merits of the 2009 staircase baluster lighting scheme to inform the brief, when replacing the lights on the main staircase.</p> <p>ii) The existing light fittings should be fixed to the balusters with the base of the light fitting in line with the top of the adjacent tread.</p>	<p>C</p> <p>A</p>	<p>£88,000</p> <p>Inc. Staff Budget</p>

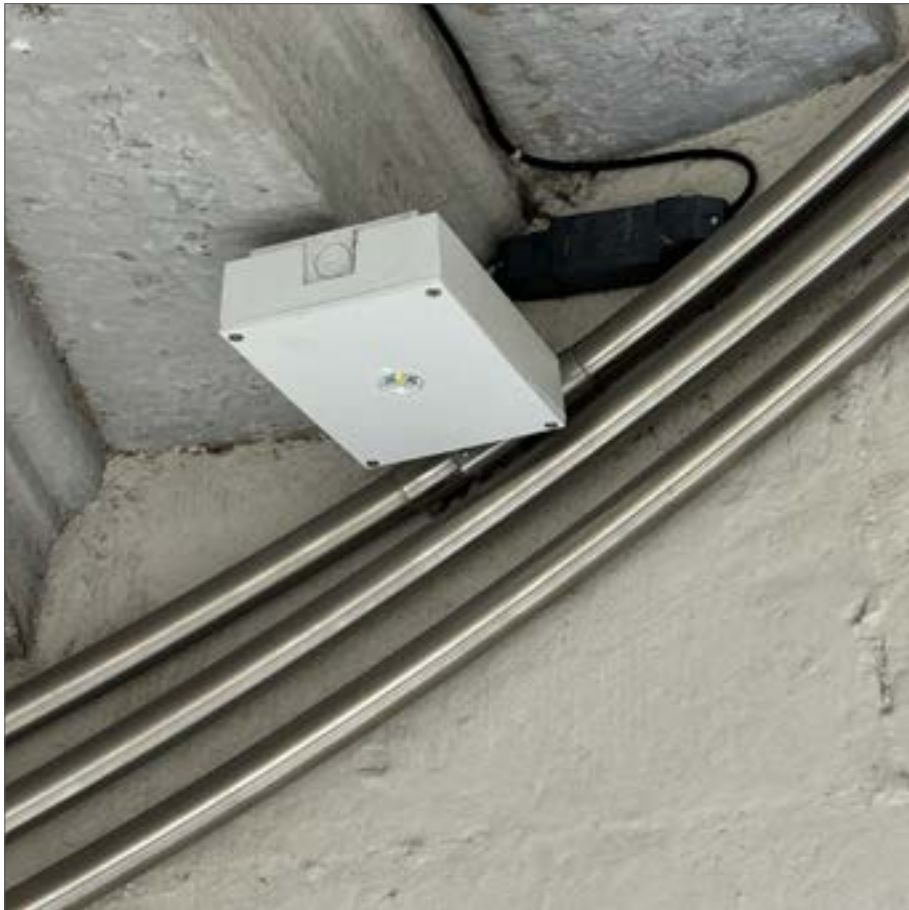
Fig. 100 Recent emergency lights in the stairwell, replacing baluster emergency lights, 2024

7.3D EMERGENCY LIGHTING				
DESCRIPTION	CONDITION	RECOMMENDATION	PRIORITY	COSTS
<p>The Monument Risk Assessment describes emergency lights as being located in the entrance, cellar, stairs &amp; flame room area. (CoL Risk Assessment for Monument &amp; Pavilion, ref. no. TB FIRE 14, date: January 2024)</p> <p>White plastic emergency lights have been introduced into the stairwell, replacing the previous emergency lighting system, which was a battery back-up to selected baluster lights, and therefore entirely unobtrusive within the stairwell.</p>	<p>Appearance</p> <p>The white plastic emergency lights in the stairwell detract from the historic interior</p> <p>Condition</p> <p>The Monument Risk Assessment describes the emergency lighting testing regime:</p> <p>“Emergency lighting tested monthly by Tower Bridge staff and annually by the facilities provider”</p> <p>(CoL Risk Assessment for Monument &amp; Pavilion, ref. no. TB FIRE 14, date: January 2024)</p>	<p>i) Consider the merits of the 2009 staircase baluster lighting scheme to inform the brief, when replacing the lights on the main staircase.</p>	<p>C</p>	<p>Incl. in 7.3C Page 52</p>

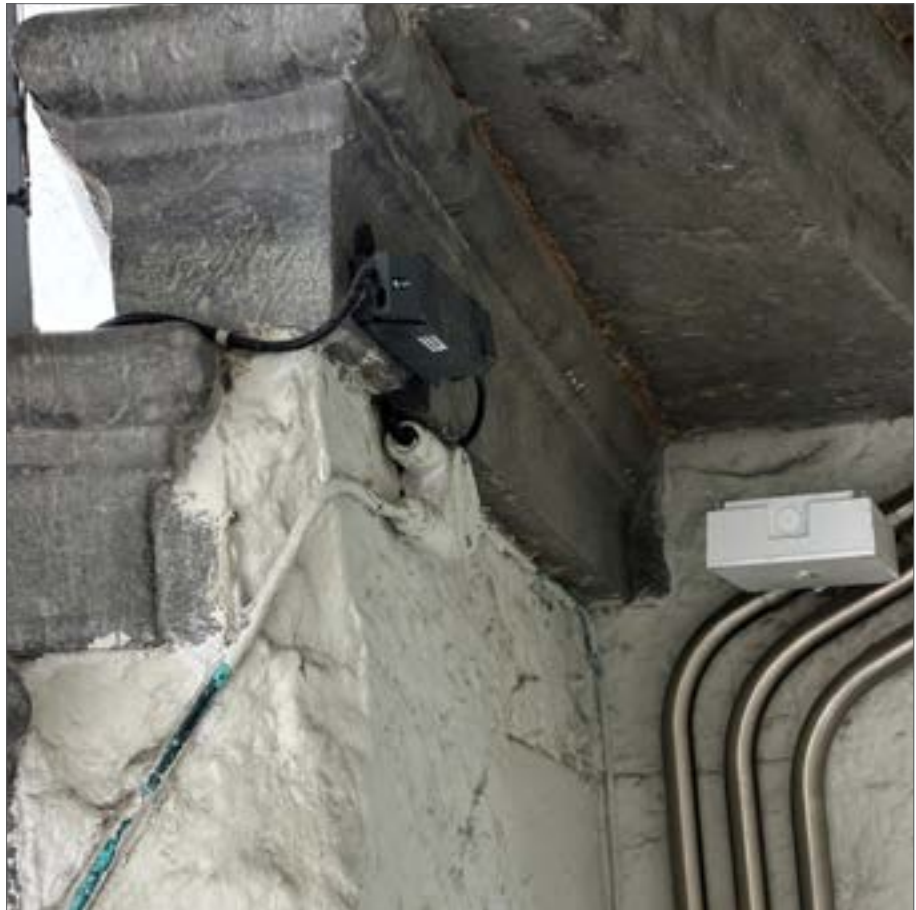
Fig. 101 White emergency light and black transformer, 2024
