### 8. THE MONUMENT CONSERVATION MANAGEMENT PLAN - APPENDICES

THE MONUMENT TO THE GREAT FIRE OF LONDON

VOLUME I: CONSERVATION PLAN

MARCH 2025

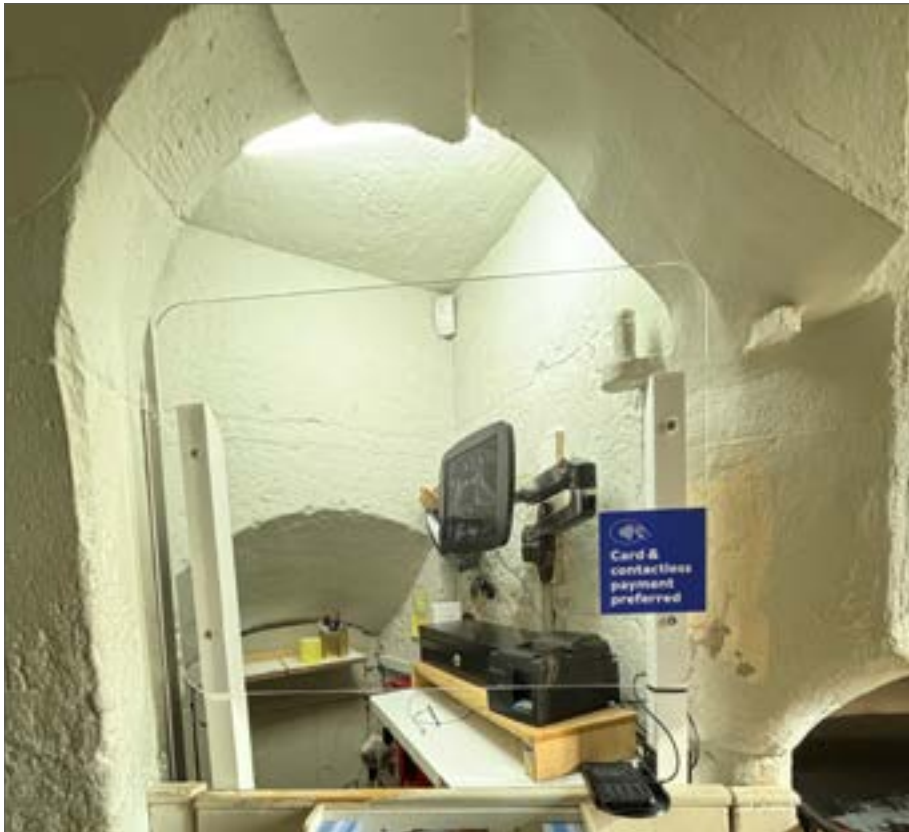
Fig. 103 Attendants’ recess with bright white ‘cold’ lighting, 2024

DESCRIPTION	CONDITION	RECOMMENDATION	PRIORITY	COSTS
<p>Door architrave lighting: the discreet LED luminaires located within door architrave light the turnstiles’ area and have pleasant warm light-colour</p> <p>Attendant’s recess lighting: the LED strip light in the attendant’s recess is a replacement (since 2016); the light colour is a harsh brilliant white, rather than the softer and warmer original light, the junction box &amp; conduit are white plastic rather than stainless steel as the 2009 designed set of conduits &amp; junction boxes within the Monument.</p> <p>Barrel vault uplighter: the LED luminaire uplighting the barrel vault were not switched on, or were not working at the time of inspection.</p> <p>Base of stair light: this appears to be the 2009 fitting, with a warm light.</p>	<p>Barrel vault uplighter: the LED luminaire was not working at the time of inspection. Check if it works and what effect it produces, as an electric heater has recently been installed directly above it.</p>	<p>i) Maintain the system of stainless-steel conduits and junction boxes when adding new ones, to prevent the general downgrading of the appearance of the historic interiors.</p> <p>ii) Remove the barrel vault uplighter if it is redundant, and make good at the fixings</p>	<p>NOTE</p> <p>B</p>	<p>£900</p> <p>Incl. in 7.2 ii) Page 49</p>

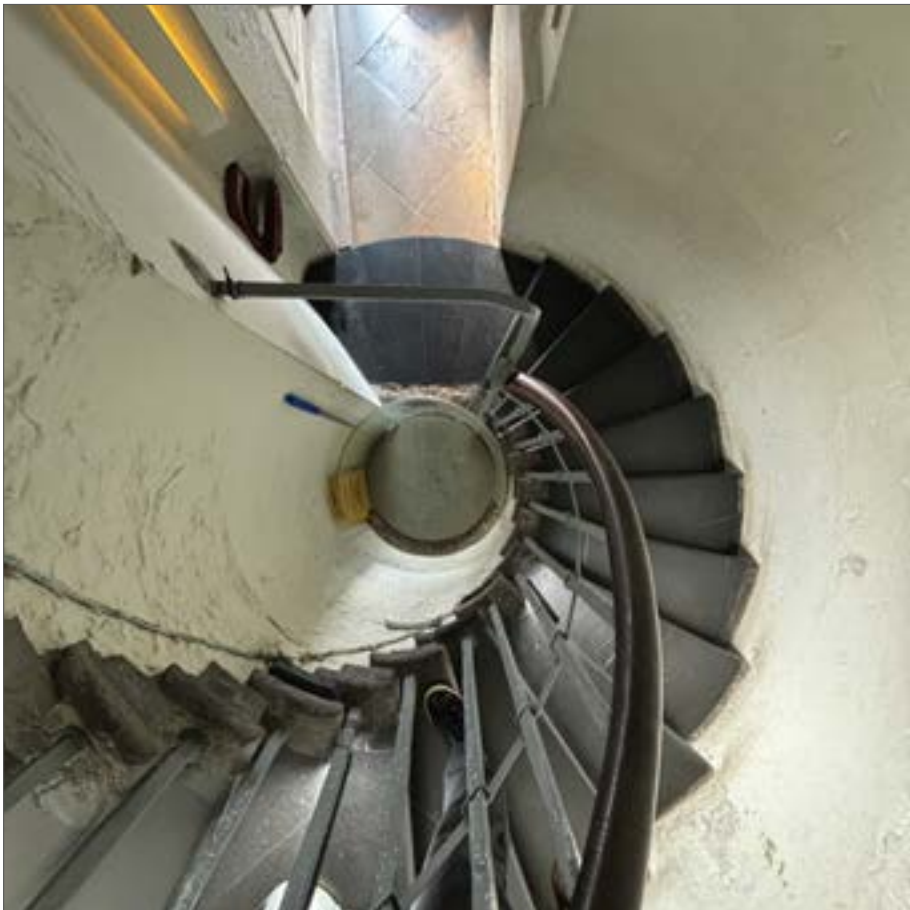
Fig. 107 2024 Blocked view to basement

7.3F BASEMENT DISPLAY LIGHTING				
DESCRIPTION	CONDITION	RECOMMENDATION	PRIORITY	COSTS
Looking down from the spiral staircase, before the bag store area was added, visitors could see through the circular opening in the stone ground floor down into the basement below, from where a gentle red-ish glow of light was previously visible through the iron floor grille.	The basement light was not switched on at the 2024 inspection, so it is not known if it is working.	i) It has been recommended elsewhere that the plywood board is removed for ventilation reasons, and that the iron floor grille remains unobstructed to allow air movement through the currently unventilated and damp basement.	A	Incl. Staff Budget
	The view down into the basement, (Robert Hooke’s former workshop), is blocked by a plywood board laid over the iron floor grille. Visitors are not aware of the basement workshop below and the effect of a red glow from the basement has been expunged.	ii) Ensure the red-tinted basement lighting is working and switched on daily.	B	Incl. Staff Budget

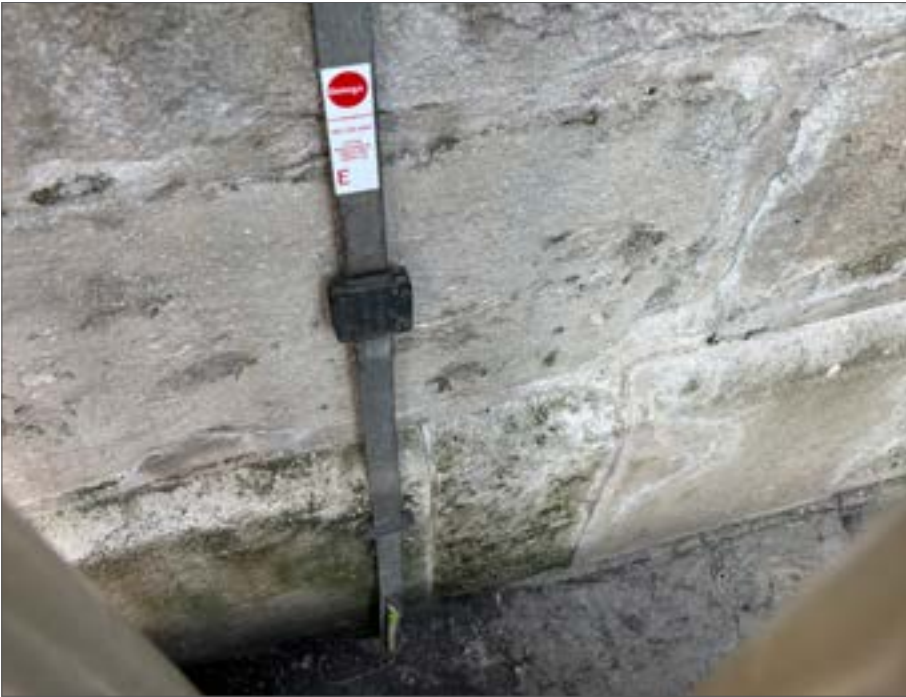
Fig. 109 East elevation down conductor, surface mounted, 2024

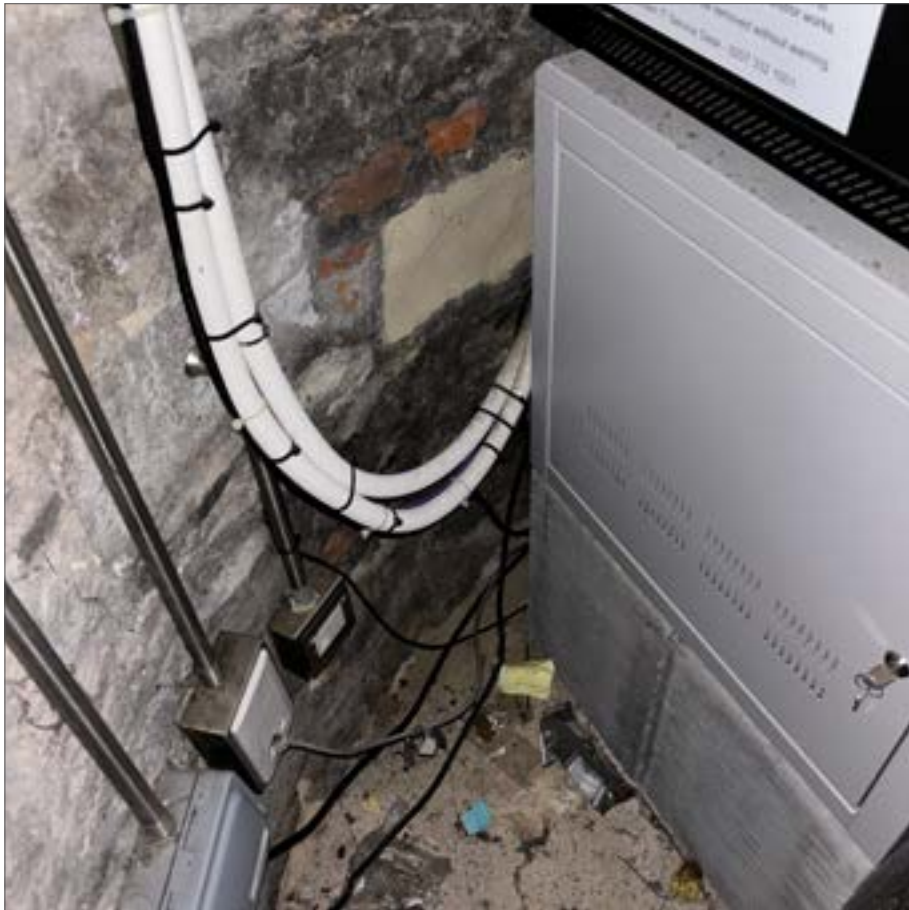
Fig. 112 Litter in cellar, 2024

7.6A FIRE RISK ASSESSMENT					
DESCRIPTION	CONDITION	RECOMMENDATION	PRIORITY	COSTS	
<p>CoL have provided JHA with copies of:</p> <ul style="list-style-type: none"><li>External Fire Risk Assessment for The Monument and Pavilion, by Fire Protection Association, dated 30.10. 2019.</li><li>CoL Risk Assessment for Monument &amp; Pavilion, ref. no. TB FIRE 14, date: January 2024</li></ul> <p>“CoL Risk Assessment for Monument &amp; Pavilion, ref. no. TB FIRE 14, date: January 2024”</p> <p>The assessment identifies the hazards, describes who may be harmed and how, describes the existing controls and risk rating and recommends any further action necessary.</p>	<p>The CoL Risk Assessment requires the flame area and the cellar to be cleaned regularly to remove any build-up of litter/dust or rubbish.</p> <p>At the 2024 inspection the flame area and cellar were not clean</p>	<p>i) Include regular cleaning of the flame area and cellar on the cleaning rota</p>	<p>A</p>	<p>Incl. Staff Budget</p>

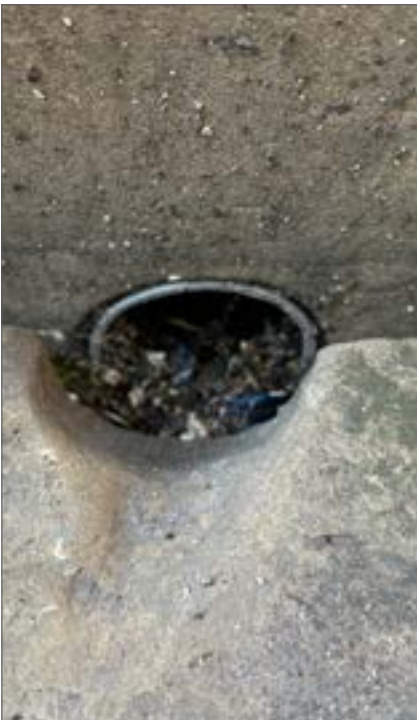
Fig. 116 Close-up blocked pipe, 2024

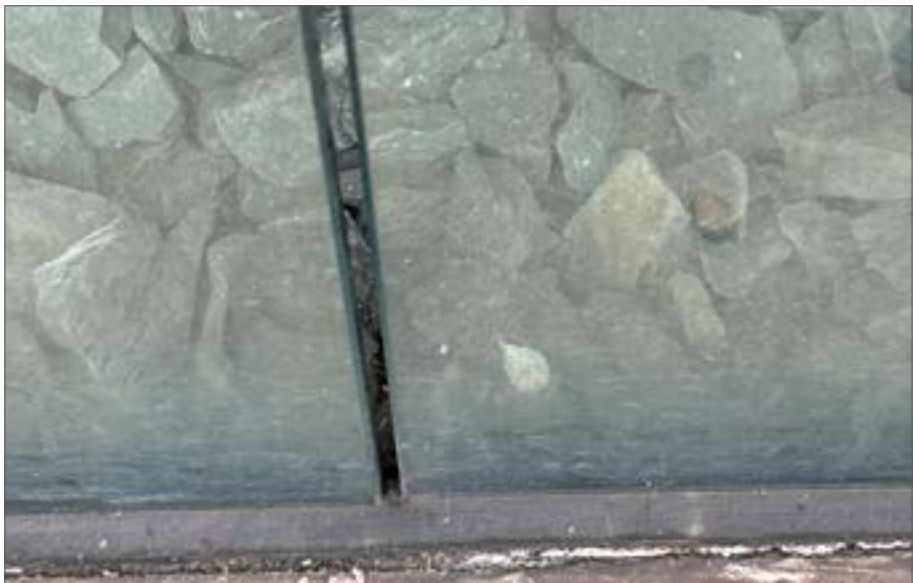
Fig. 120 Open joints between structural glass, 2024

DESCRIPTION	CONDITION	RECOMMENDATION	PRIORITY	COSTS
<p>Small pavilion building square on plan circa 5.4m x 5.4m and approx. 3m high.</p> <p>Structural glass enclosure around gabion walls lined with timber stud walls with insulation and plasterboard.</p> <p>Reflective angled glass panels on the flat roof. Steel door to attendants' room; 'temporary plywood door (originally a sliding door) to the public wc, now closed.</p>	<p>Exterior: the pavilion was designed as a 'temporary' structure and is not in good condition.</p> <p>Structural glass walls have open joints between panels, some joints now (badly) mastic-filled, glazing joint north side, above doorway, is temporarily taped over, some glass panels flex when pushed against. In s-w corner, glazing not aligned with metal ground trim around the paving 'rocks', revealing blue plastic shims and chipboard packing.</p> <p>Inside of glazing is dirty in places, particularly horizontal glazing above doorways,shattered glass remnants in gabions. Attendants' door, poor aluminium drip detail, door to (disused) public wc, temporary plywood, payment point is taped over, paint is peeling from threshold &amp; mastic detailing</p>	<p>i) Prepare detailed scope of exterior &amp; interior repairs and alterations to the Pavilion building to provide adequate facilities for Monument staff and a presentable exterior in the setting of the Listed Monument</p>	<p>B</p>	<p>Client to Provide Quote</p>

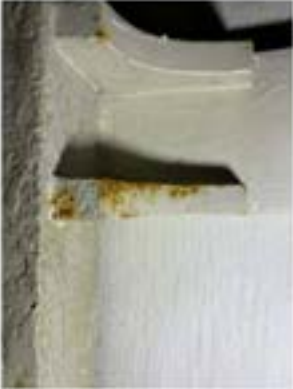
Example of typical corrosion to the modern brackets

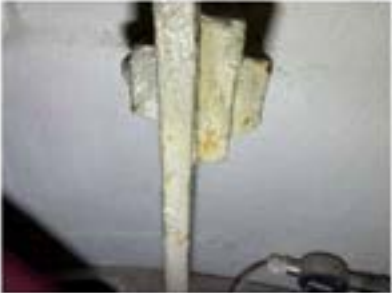
Minor surface corrosion to original rib and plate

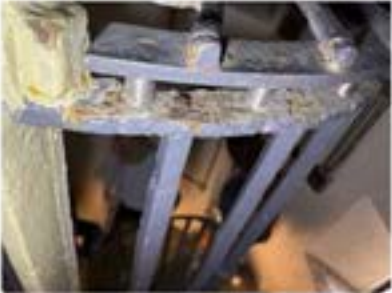
Corrosion to the internal railings below the orb

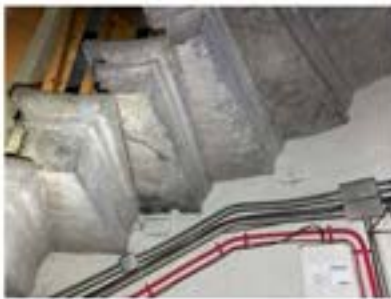
Loss of underside surface to stone steps within upper section (between observation deck and orb)

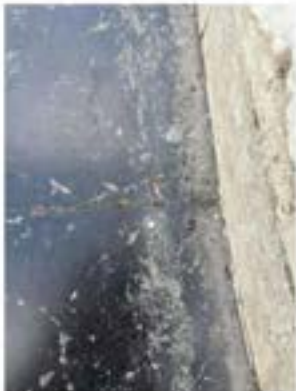
Example of incomplete set of monitoring studs – crack #1 from previous surveys

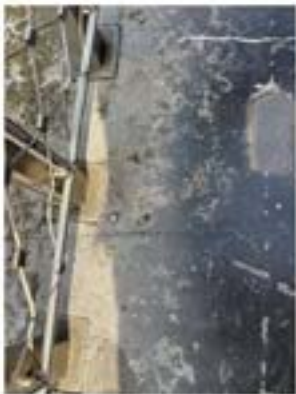
Example of incomplete set of monitoring studs – crack #2 from previous surveys

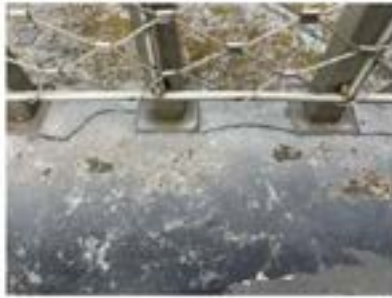
West elevation south end  
Crack along base of railings from southern corner, extending beyond mid length of the elevation

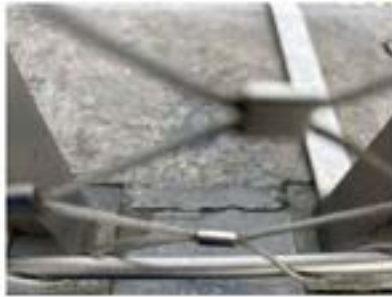
East elevation north end  
Crack along the base of the railings from the northern corner approximately to the mid point. In general less severe cracking than the western elevation.

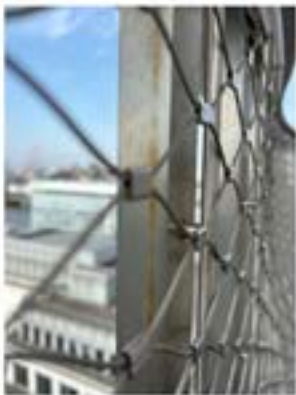
Typical minor surface corrosion on railing

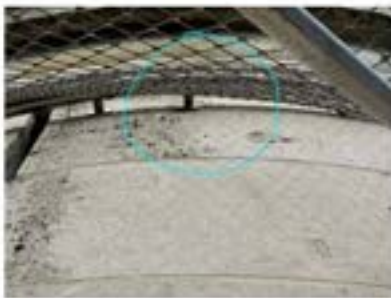
Spalled stone surface around the bracket – visible with binocular survey

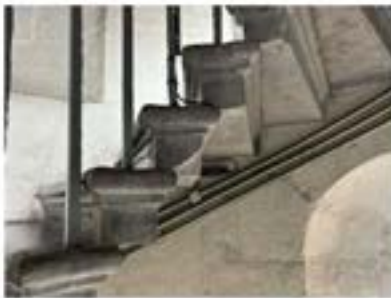
Underside corner of step #68 missing

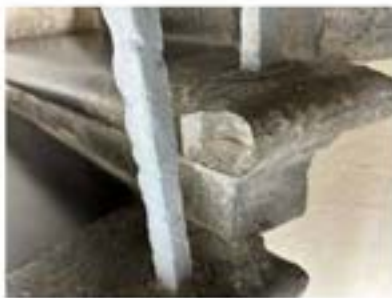
Damage to top corner of stone step #125

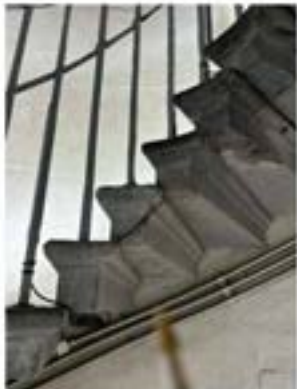
Crack through load path of cantilevered stone steps (#142)

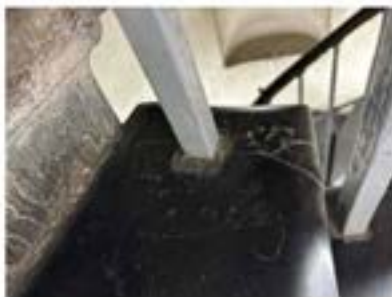
Cracked step at baluster base (#162)

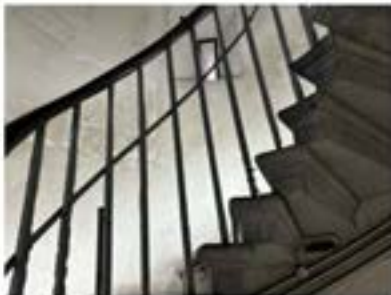
Railings not perpendicular to step

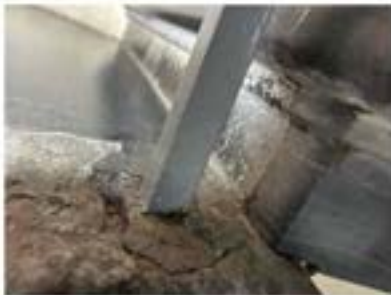
Damage around infill at base of baluster (#185)

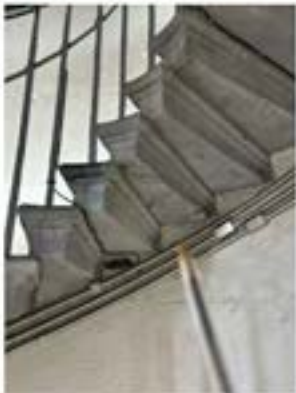
Loss of material to underside of step and cracking across underside corner at wall face (#202)

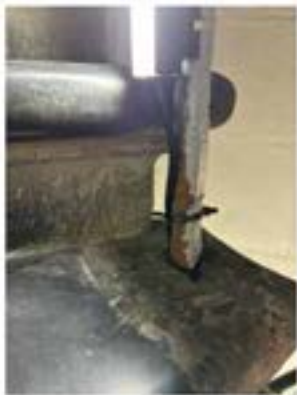
Corrosion at base of baluster and damage to stone around the base

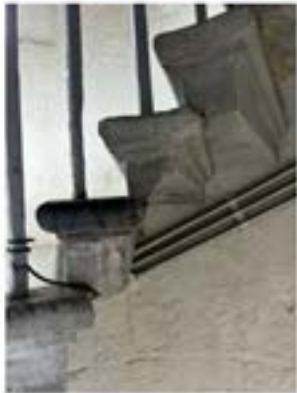
Significant loss of underside surface #218

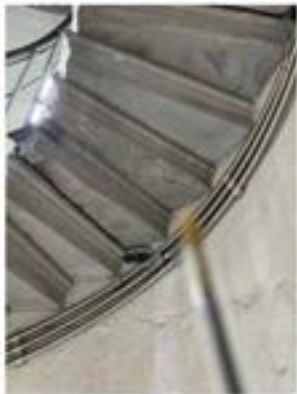
Scabbled underside #246

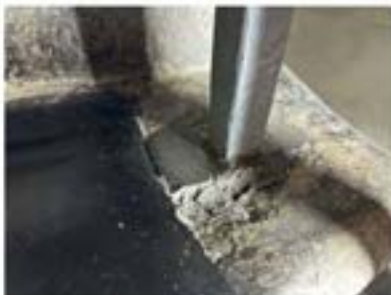
Damage to stone around base

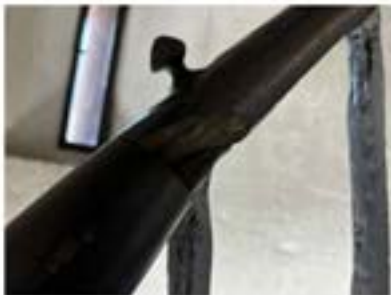
Damage to handrail timber (#234)

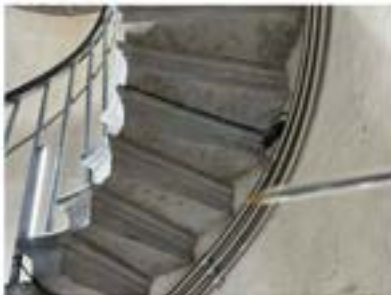
Horizontal crack across vertical back face of stone step #283

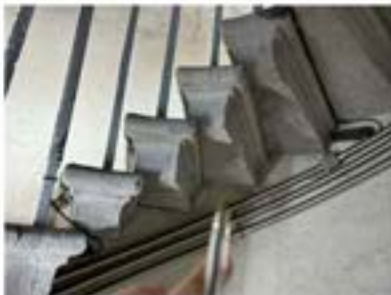
Uneven underside #287

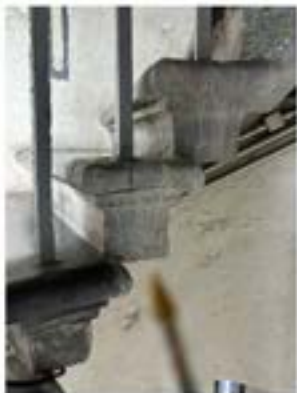
Cracking at base of baluster and horizontal cracking across the end of the stone step (#298)

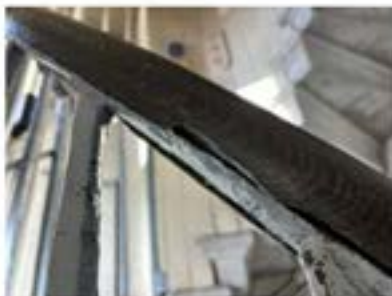
Damage to timber handrail – near observation deck level
