THE TEMPLE, WANSTEAD PARK
VOLUME 03: CONDITION, MECHANICAL AND ELECTRICAL, AND STRUCTURAL SURVEYS
FINAL ISSUE
MARCH 2024

THE TEMPLE, WANSTEAD PARK: CONDITION, MECHANICAL AND ELECTRICAL, AND STRUCTURAL SURVEYS

CONDITION SURVEY 04

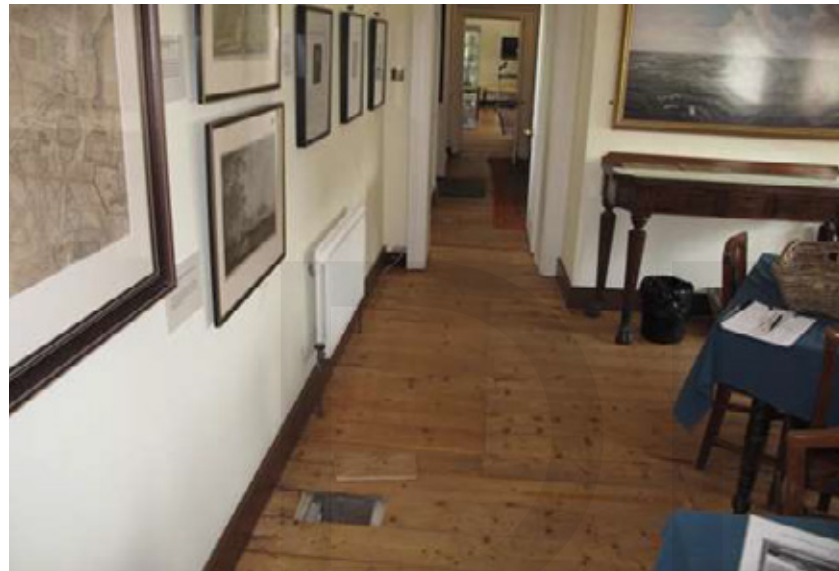
9. Access point

We have been asked to comment on the local failure of ceiling finishes to the underside of one of the rooms at first floor level in 2018. A structural report by Hockley and Dawson, dated June 2018, noted the failure was due to the breaking of the 'key' between the lime plaster and the timber laths. In some of the areas we saw during our visits we also noted the plaster key is damaged, as can be seen in photos 9 and 10. The damage may possibly be due to the installation of building services directly above the ceiling finishes within the floor void.

Based on what we have seen, we agree with Hockley and Dawson's conclusion that the local failure of the ceiling finishes is due to damage to the finishes rather than as a result of excessive movement of the floor structure. Any remedial work to repair and stabilise the finishes will be specified by the architect. On other similar projects this has involved the lifting of the floor boards to inspect the ceiling finishes followed by the application of a new bonding layer to enhance the connection between the plaster and timber laths.

Non-structural repairs are required to the ceiling finishes to address damage of the plaster key to the timber laths.
