THE MONUMENT TO THE GREAT FIRE OF LONDON

VOLUME II: QUINQUENNIAL INSPECTION SURVEY

MARCH 2025

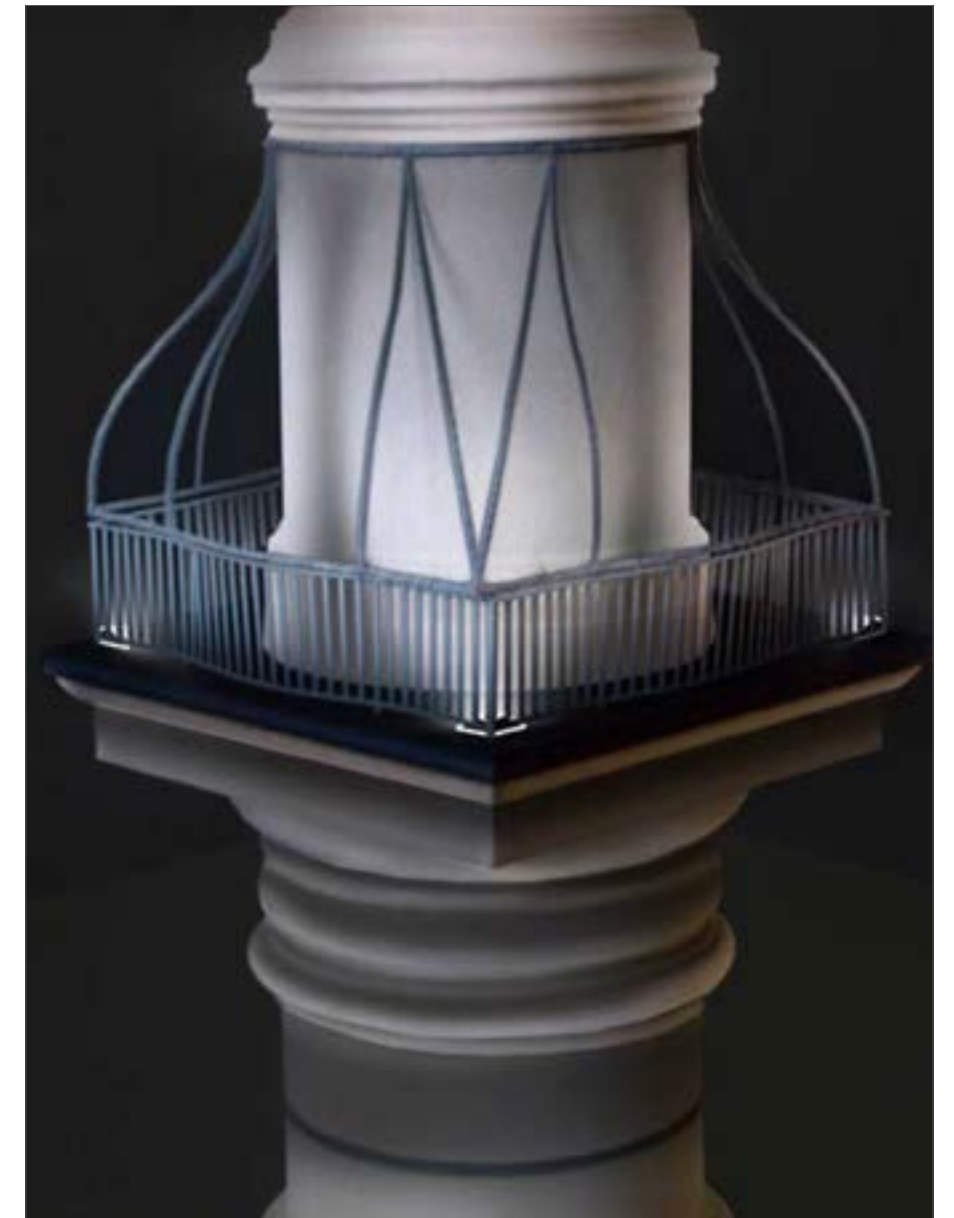
Fig. 2 Light Bureau's design drawing, 2008

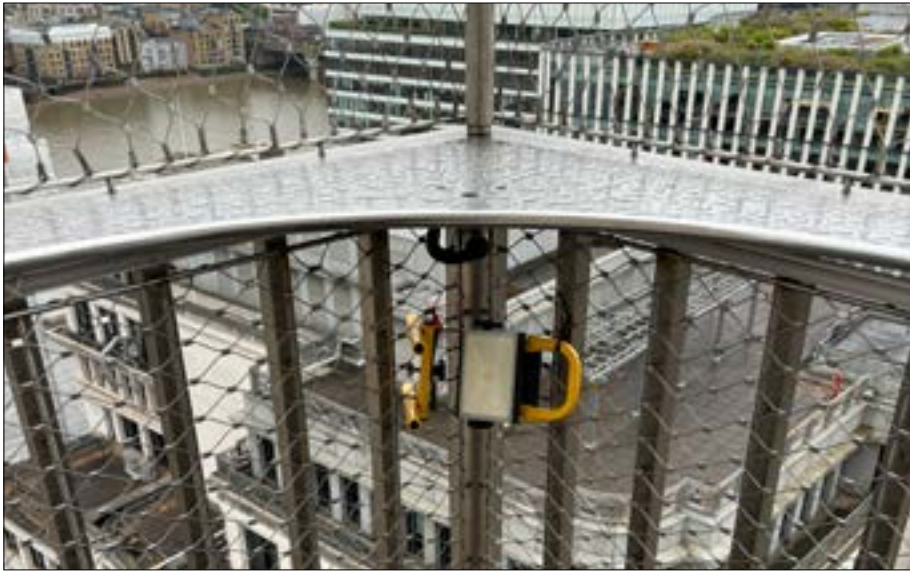
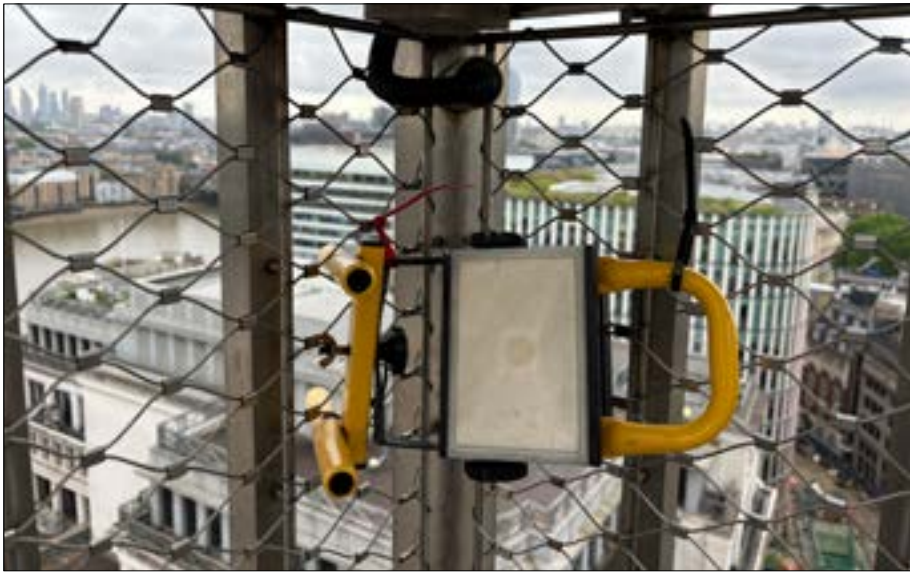
A temporary builder's spotlight is now located in the south-west corner of the viewing platform, fixed to the stainless-steel mesh inside the corner baluster with cable ties.

Fig. 4 & 5 Single uplighter, 2024

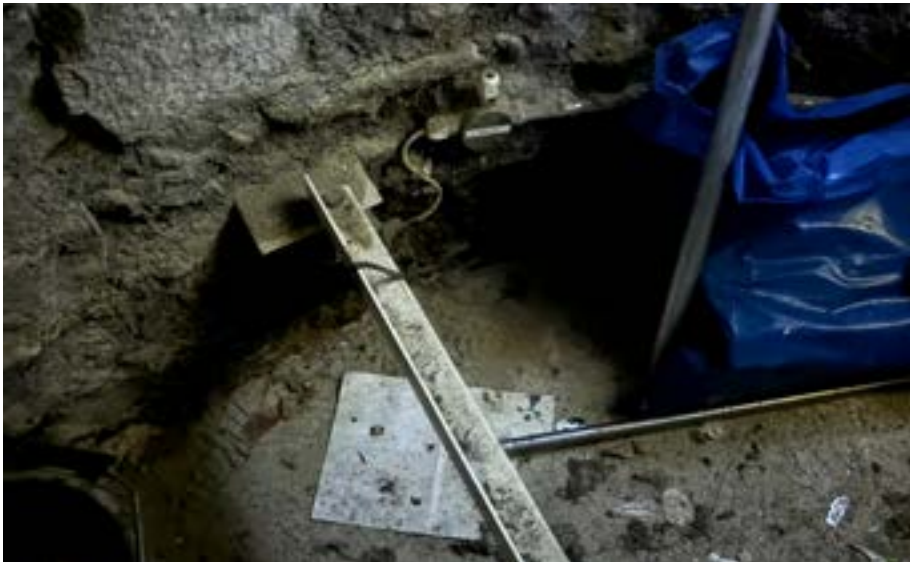
Fig. 7 Photo of steel angle locating survey plumb base point, 2024

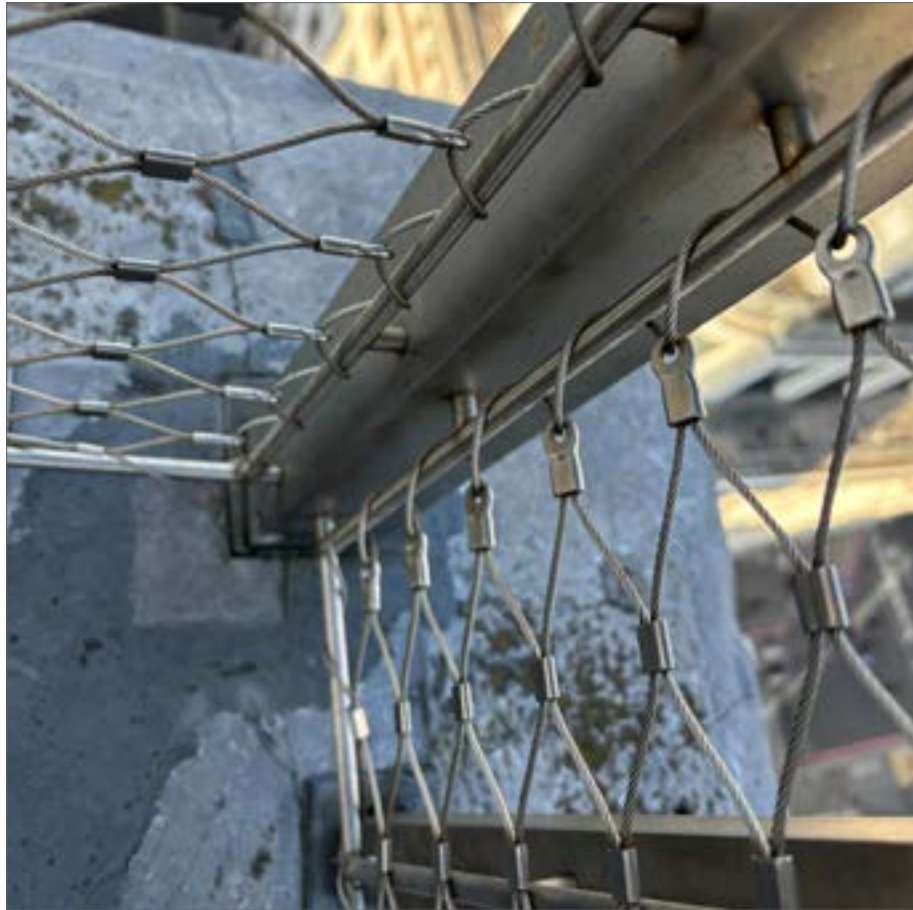
Fig. 13 Detail of a balustrade corner post, 2024

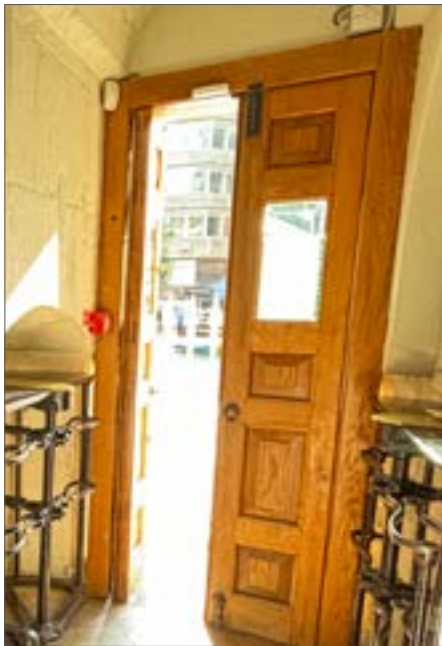
Fig. 24 Interior view of entrance doors, 2024

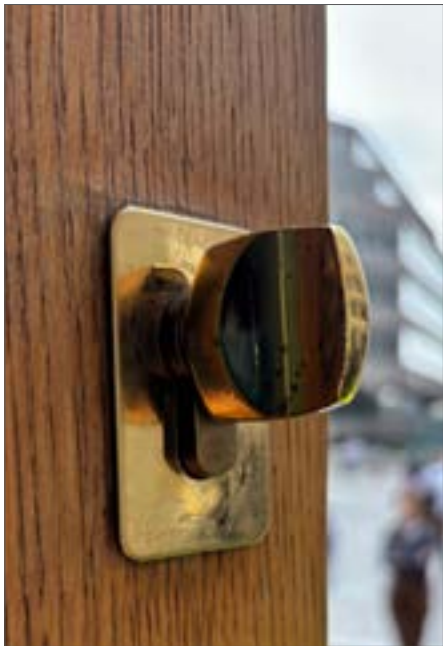
Fig. 25 Mortice escape latch, 2024

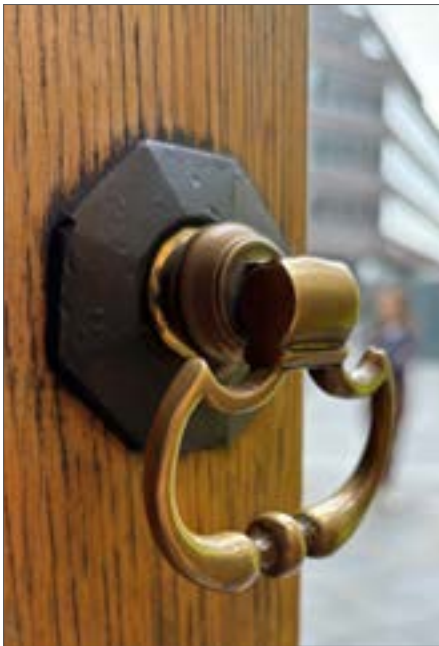
Fig. 26 Mortice interior escape latch, 2024

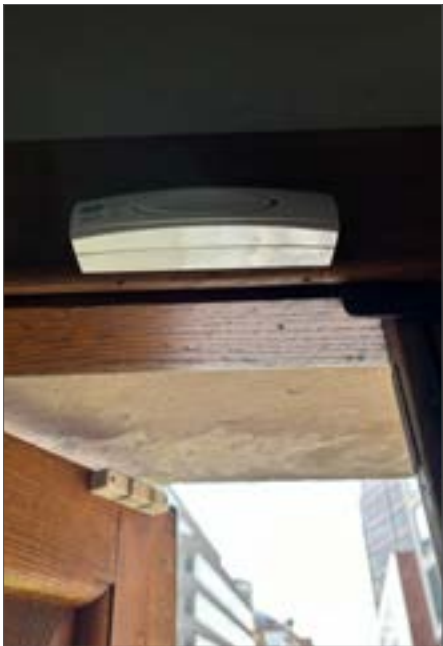
<p>Ironmongery:</p> <p>Pivot hinges: Doors are a bit stiff to open</p> <p>Lock : 2no. mortice locks with interior escape latches, attendant reported working well</p>	<p>ii) Entrance doors: consider replacing white plastic security door movement detector with more appropriate design</p>	C	£300
	<p>Internal bolts: iron floor bolt to south door, works well.</p> <p>iron top bolt and keep fixed to frame, working well</p>	<p>iii) Clean and oil with a coat of DEKS OLJE D1 oil.</p> <p>Inspect for signs of movement, overhaul the doors as required.</p> <p>Inspect ironmongery and oil moving parts as appropriate; ensure ironmongery is securely fixed.</p>	C	£2,100
	<p>Latches & knobs: 2009 internal drop handle latches & external knobs, good condition</p>			
	<p>Security door movement detector to north leaf: Unattractive white plastic</p>

Fig. 27 Door movement detector, 2024

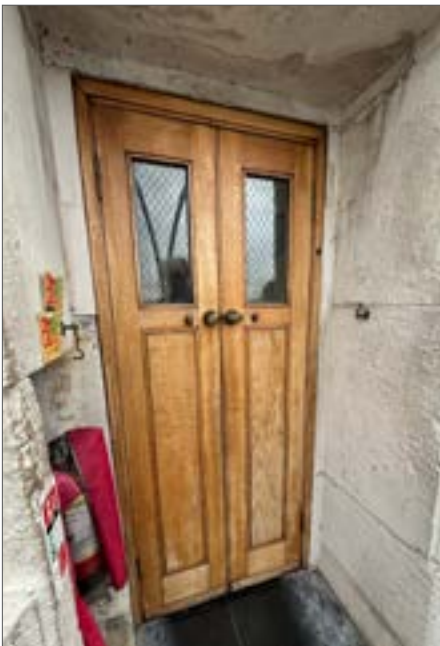
Fig. 28 Oak doors to viewing platform, 2024

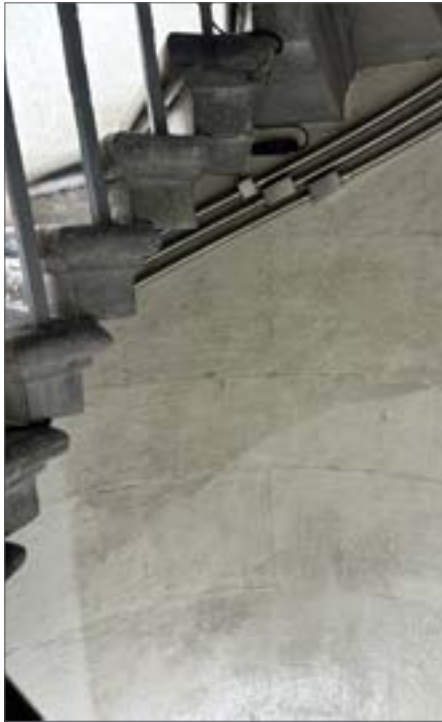
Fig. 31 Paintwork is difficult to clean above a certain level, 2024

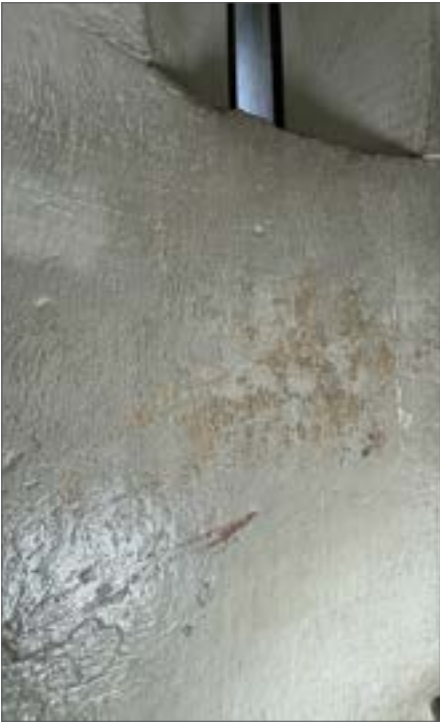
Fig. 32 Eroded paintwork, 2024

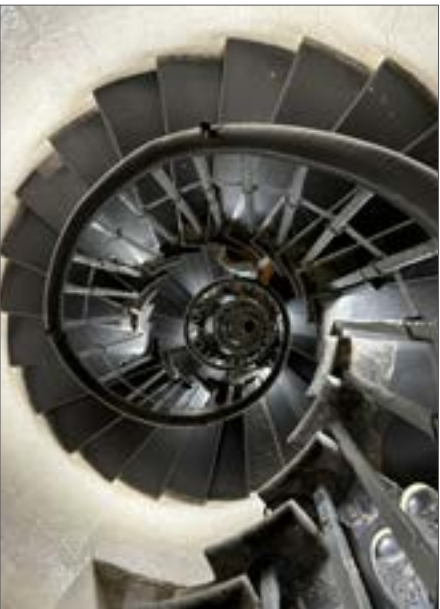
Fig. 42 Carved oak spiral handrail, 2024

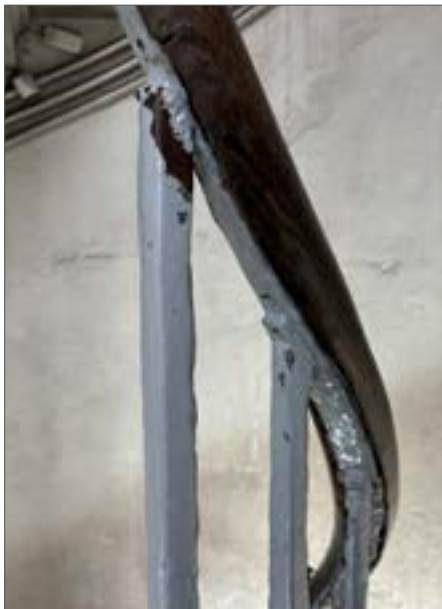
Fig. 43 Fixing of timber to ironwork, 2024

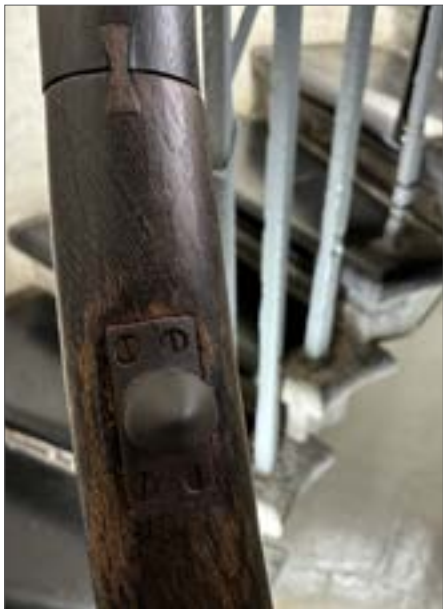
Fig. 44 Brass 'anti-sliding' knob, 2024

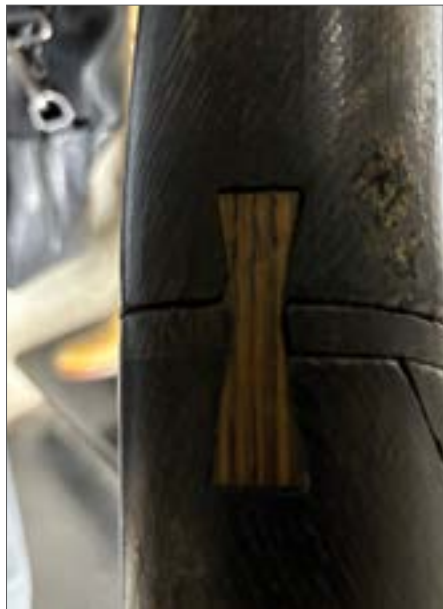
Fig. 46 Recent unstained butterfly joint, 2024

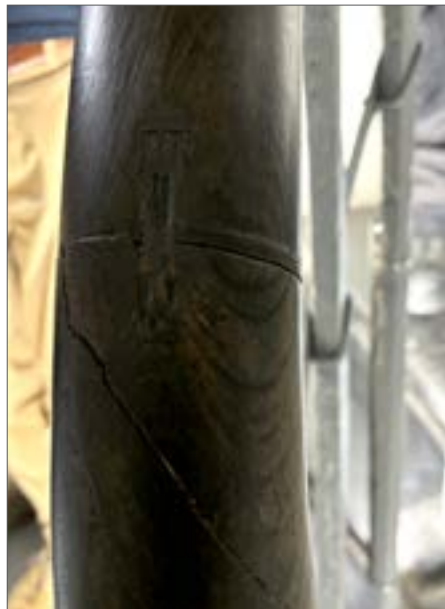
Fig. 47 Stained butterfly joint c.2009

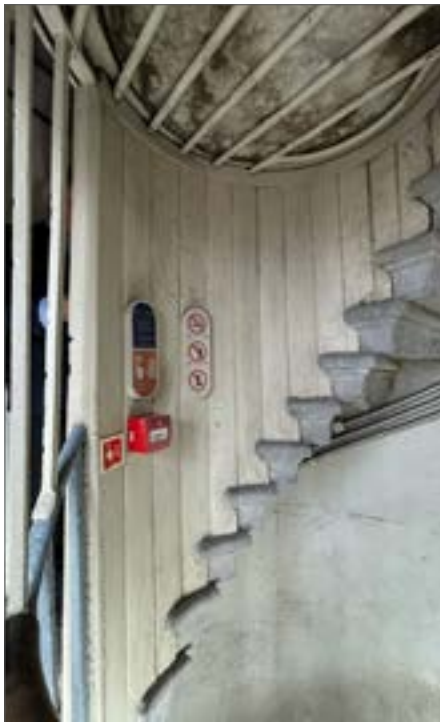
Fig. 50 Steel flat bends around baluster, 2024

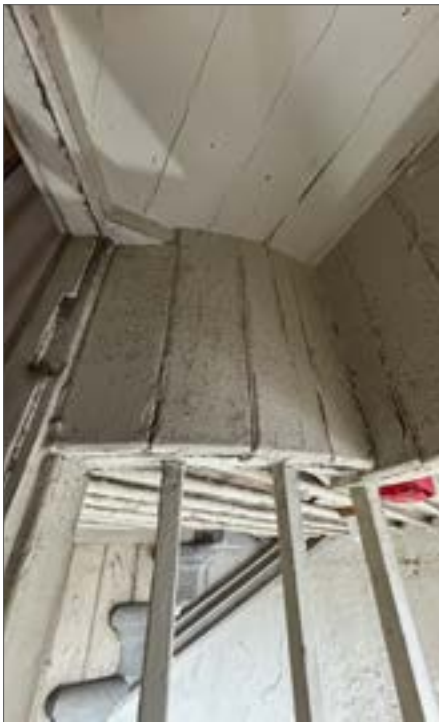
Fig. 51 Balusters lead-caulked into treads, 2024

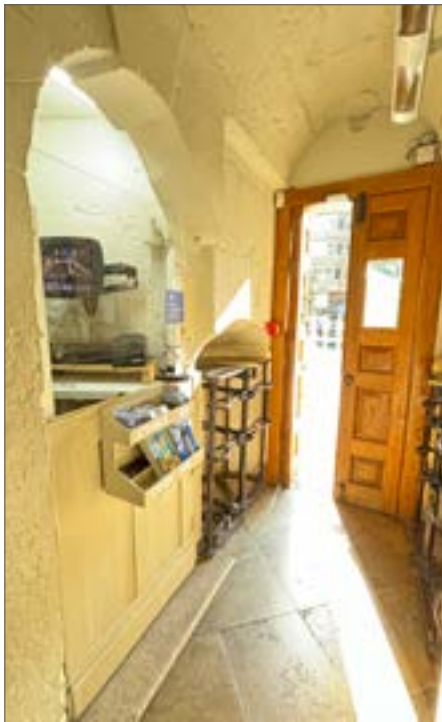
Fig. 53 Looking east to entrance door, 2024

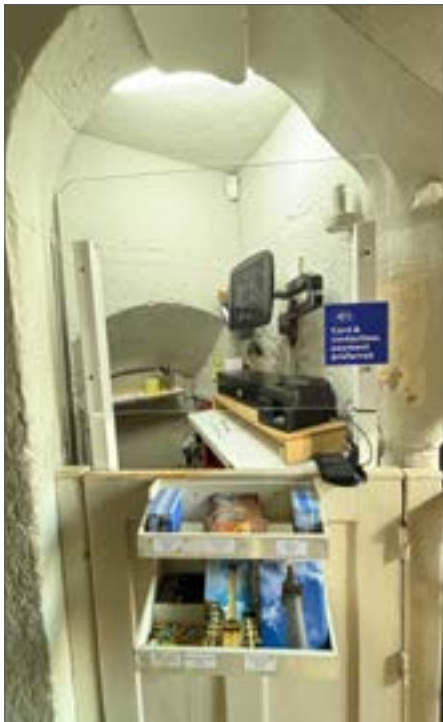
Fig. 54 The attendants' recess, 2024

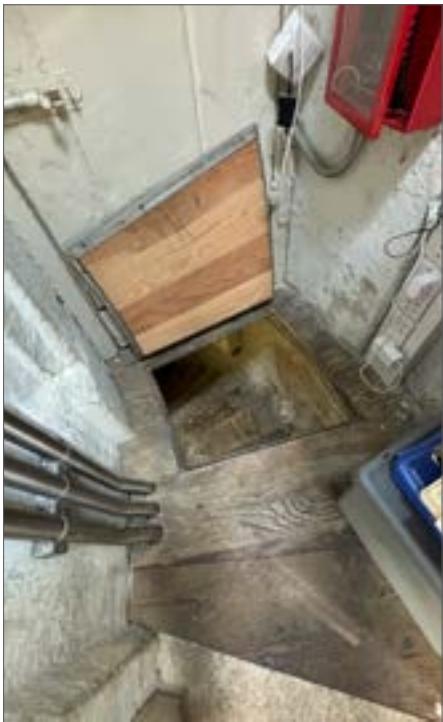
Fig. 55 Floor hatch access to the basement, 2024

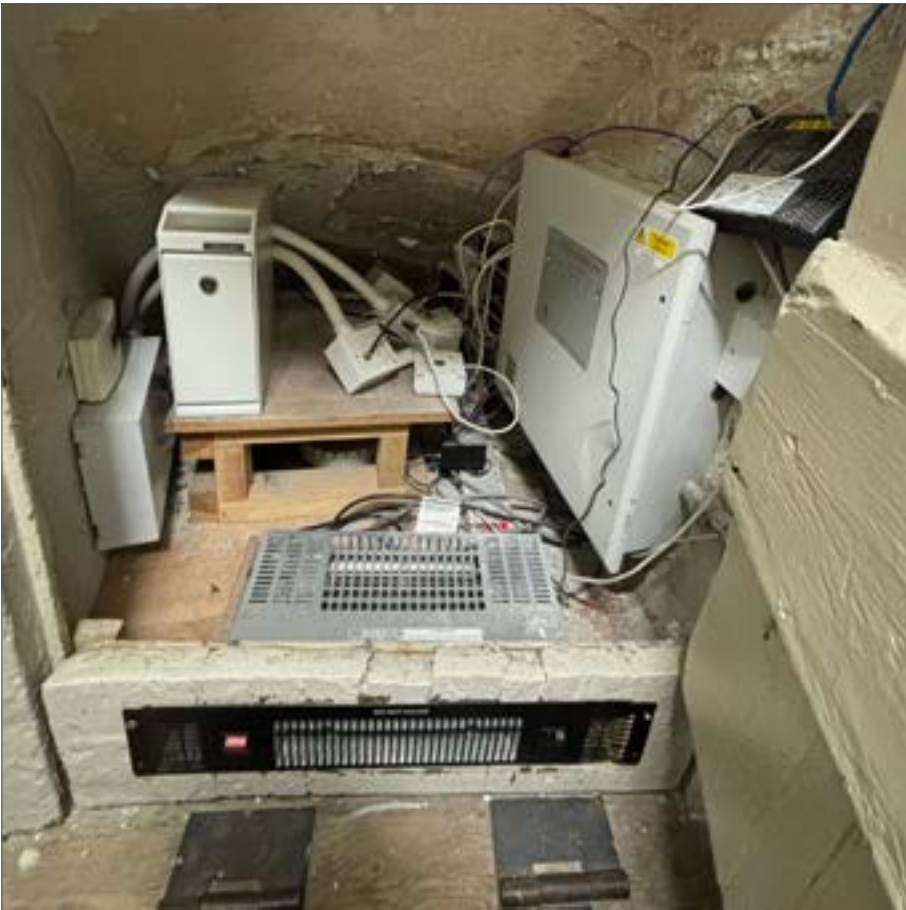
Fig. 62 Inside the rear cupboard showing the skirting heater and cupboard contents, 2024

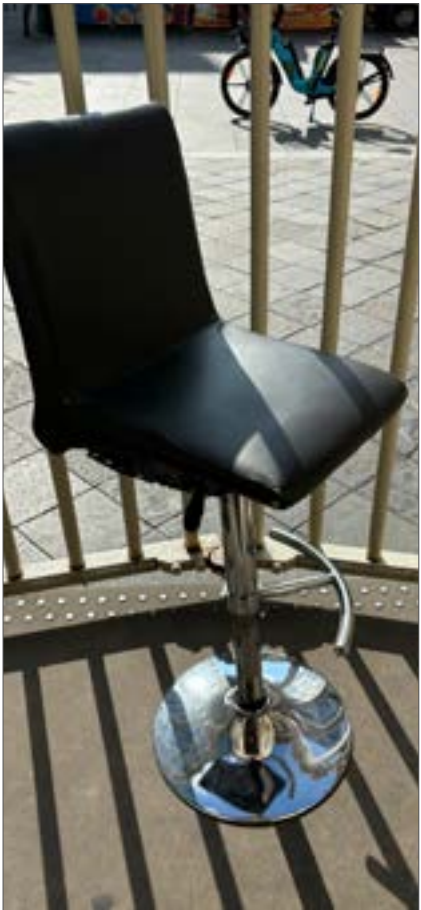
Fig. 77 Attendant's chair, 2024

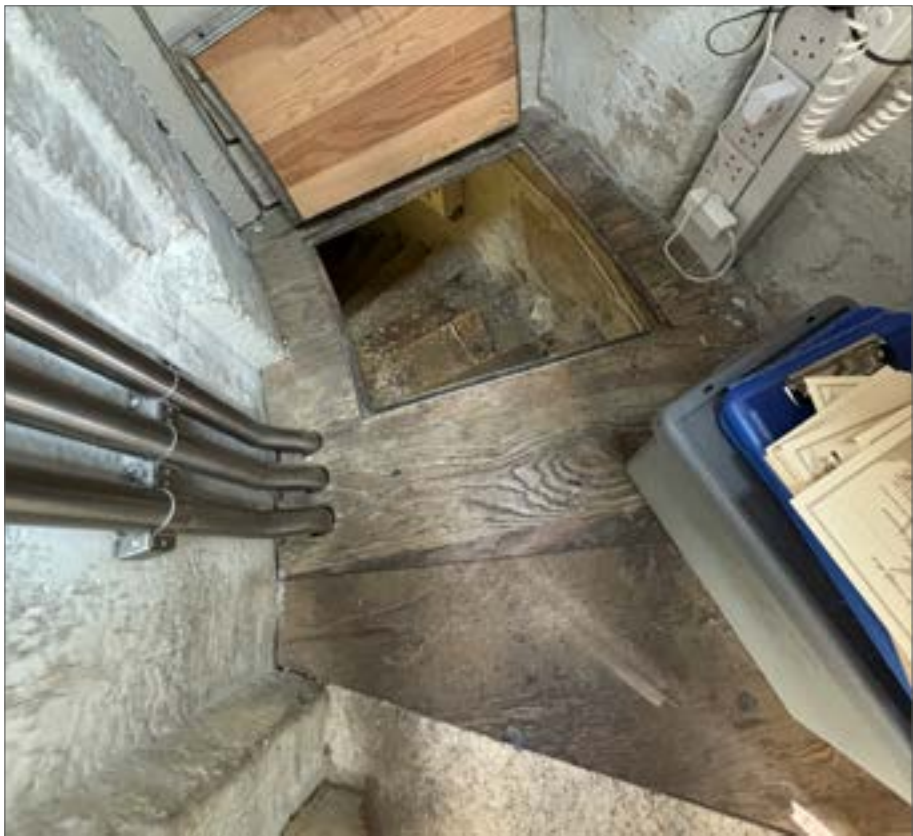
DESCRIPTION	CONDITION	RECOMMENDATION	PRIORITY	COSTS
<p>Within the entrance hall is a small recess where the attendant stands. The floor of the attendants' recess is timber boarding, with access to the basement is via a small, hinged timber boarded hatch set in the floor. Access to the basement is difficult, but there is little scope for easing the situation due to the limited space in the attendant's recess. Walls, steps and soffits are Portland stone, walls & soffit are painted with silicate masonry paint.</p> <p>Seven stone steps, curved on plan, lead down to a stone landing. To the north of the landing is a recessed bay which may have been a flue or vent, ventilating the basement in combination with the oculus opening in the domed ceiling. A stainless-steel platform, on pull-out runners, was installed in the recess in 2009 to support and access the Uninterrupted Power Supply unit (USP) formerly located there.</p> <p>To the south, a further five stone steps lead down into the circular basement chamber</p>	<p>Stone steps and landing are in good condition</p> <p>Painted stone walls have extensive paint flaking, some erosion, efflorescence and several severely eroded blocks</p> <p>There is an excessive accumulation of stone particles under stainless steel platform which indicates active erosion of the stonework.</p> <p>At the back of the flue recess, beneath the flue is a streaking paint stain and extensive calcite staining</p>	i) Sweep steps and landing.	A	Incl. Staff Budget

Fig. 79 Floor access hatch to basement, shown open, 2024

ii) Clear away metal platform, if no longer in use (retain at present)	B	No cost
		iii) Reinstate (what is likely to have been) the original basement ventilation system: allowing air to enter the basement via the flue in the north wall recess and for air to be drawn up out of the basement via the large oculus opening in the domed ceiling of the circular basement room. Ventilation to be improved before any redecoration, local stonework repointing or repairs are undertaken	C	£3,500

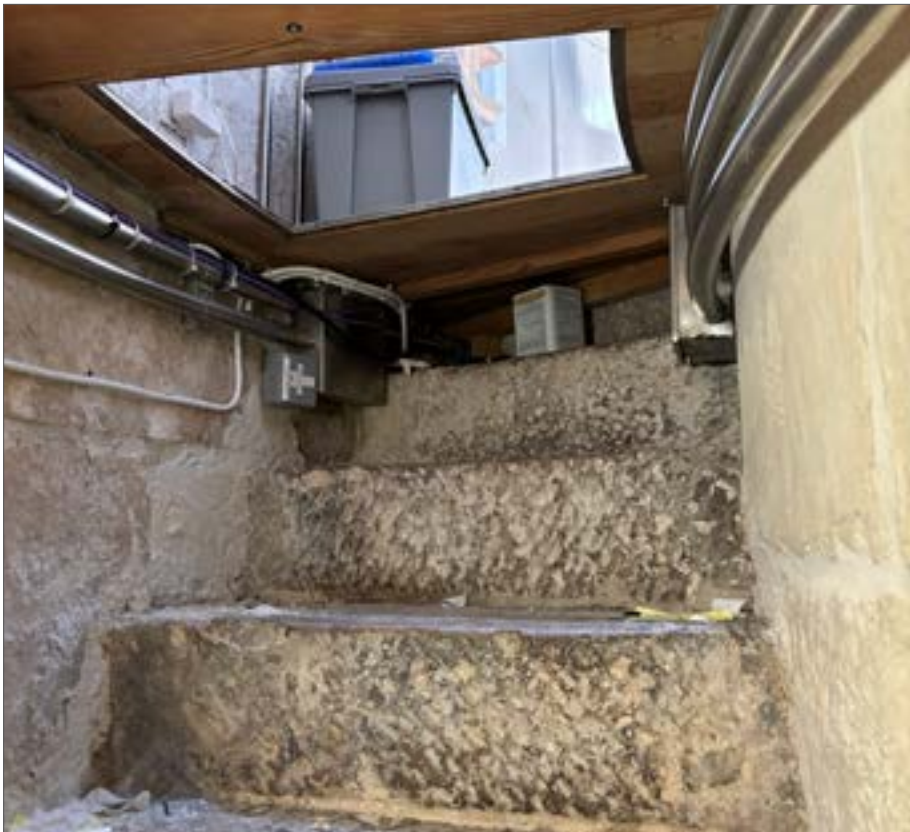
Fig. 80 Looking up from the basement steps to the floor access hatch opening, 2024

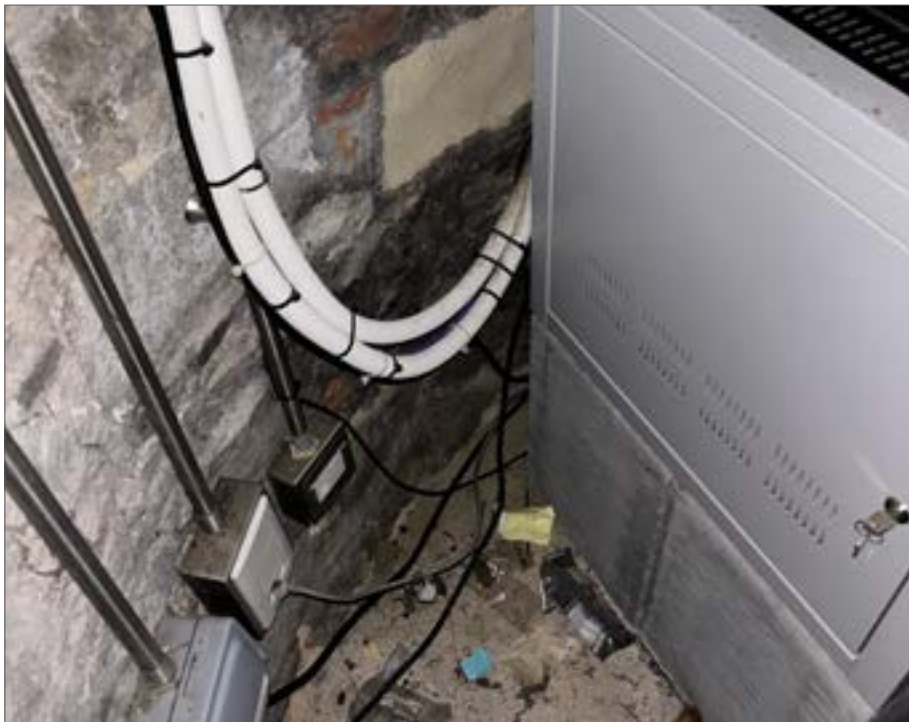
6.7A BASEMENT: BASEMENT CIRCULAR CHAMBER (HOOKE'S WORKSHOP)				
DESCRIPTION	CONDITION	RECOMMENDATION	PRIORITY	COSTS
<p>The floor hatch in the attendants' recess leads via a series of radiating stone steps to a circular chamber 2.14 metres (7 feet) in diameter with a semi-circular domed Portland stone ceiling. The chamber lies directly beneath the circular staircase enclosure. The walls are constructed of coursed rubble stone blocks and red clay brickwork, all unpainted. The floor to the chamber is made up of a compacted lime screed c.2009.</p> <p>A steel angle is fixed across the circular basement just above floor level. This is to support the verticality testing equipment used to regularly (but infrequently) measure the verticality of the Monument to assess any movement.</p> <p>Computers and large protection boxes are located in the basement, together with what appears to be rubbish.</p>	<p>The stonework is very damp when the Moisture Condition tested. There is efflorescence on stonework in places, some spalling of pointing and calcification of stones, some eroded stones and bricks very severely decayed.</p> <p>The large circular ventilation grille at the apex of the vault is closed-off with a board, reducing natural ventilation in the basement</p> <p>The limecrete floor is damp but in good condition.</p> <p>The stainless still conduit is all in good condition</p>	i) Inspect all stored items, remove all redundant items.	C	£400

Fig. 82 Debris and redundant wiring in the central circular basement, 2024

ii) Sweep all floors and ledges.	A	Incl. Staff Budget
		iii) Computer & electrical equipment in connection with former temporary panoramic camera system (now disused), to be removed together with all the associated equipment and cabling in the Monument.	C	£1,600
		iv) Re. the steel angle fixed across the circular basement just above floor level used for verticality testing of the Monument, it is important that this steel bar is not damaged in any way.	NOTE	-

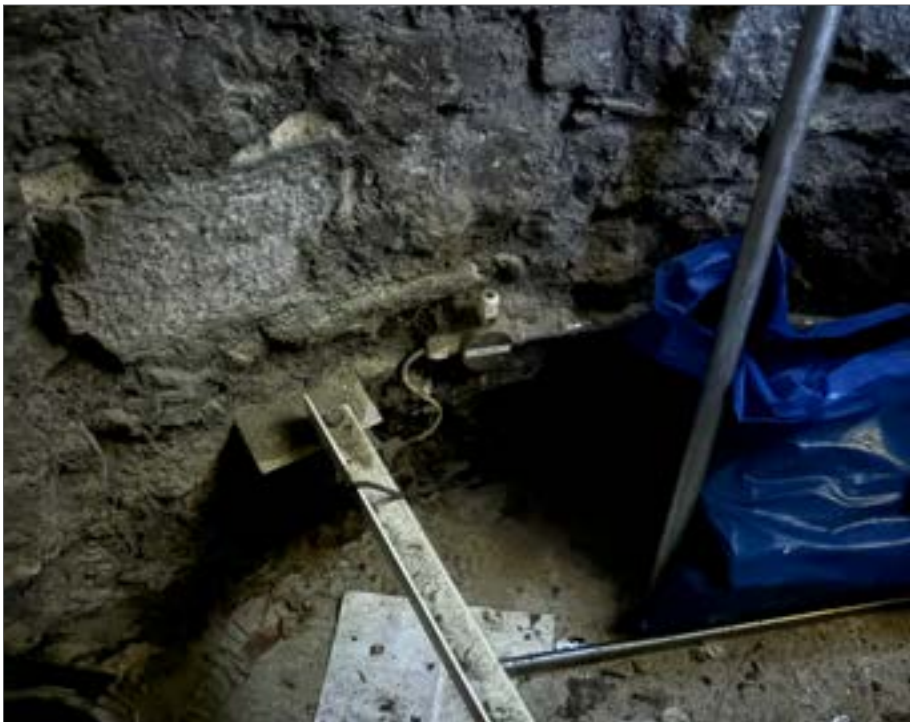
Fig. 83 Steel angle to support the verticality testing equipment

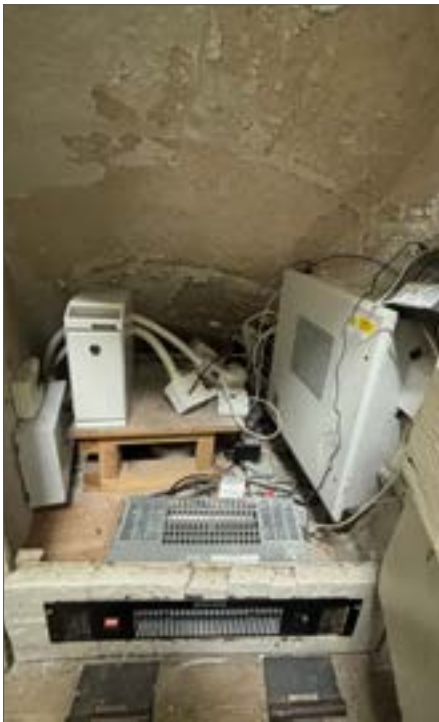
Fig. 87 Kick-space fan heater in skirting of cupboard, 2024

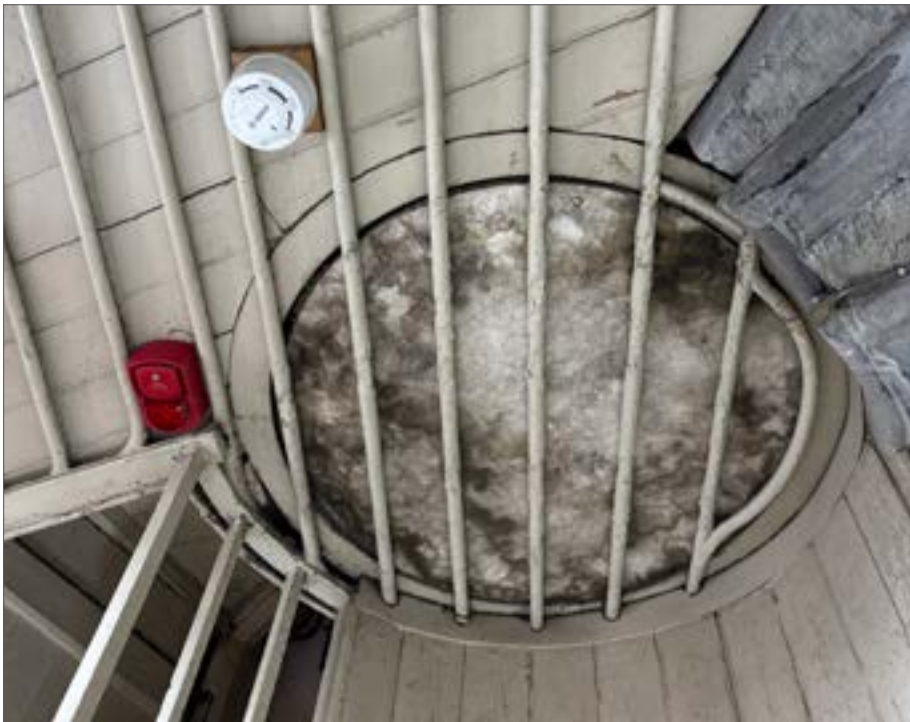
Fig. 95 Uplighter on top landing, 2024

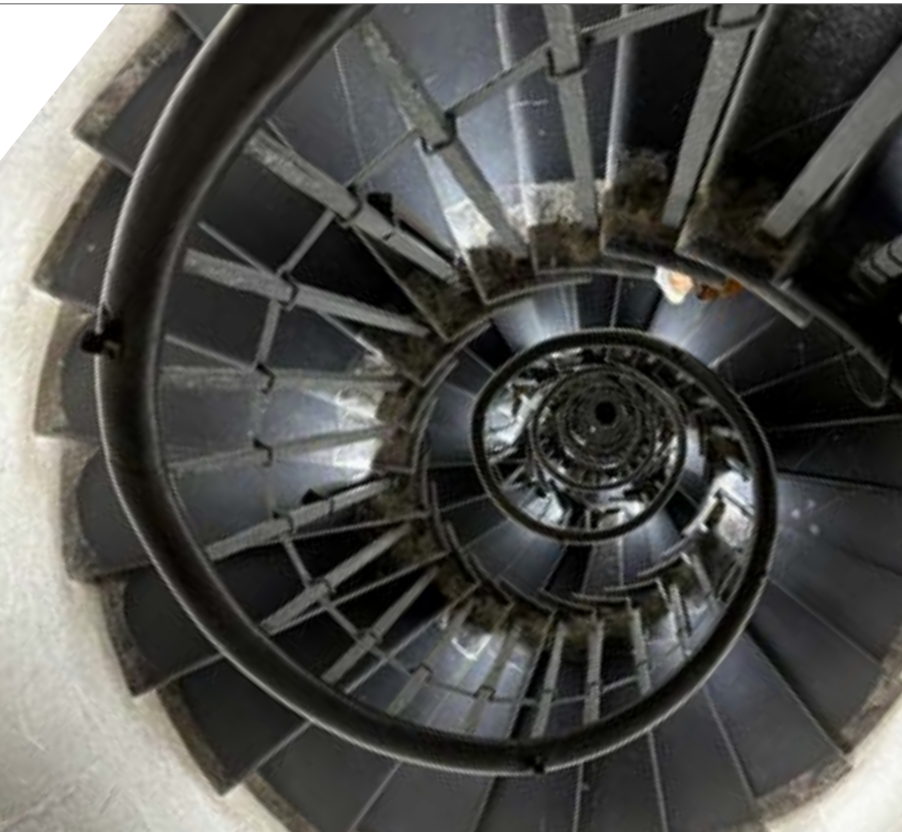
At the 2024 inspection, it was noted that all the 2009 baluster light fittings have been replaced except for those above viewing platform level, where the original bespoke light fittings remain.

The replacement baluster light fittings are inferior in appearance to the bespoke fittings, as the replacement lights:

Fig 97 2024 lighting: cold strong light

i) Consider the merits of the 2009 staircase baluster lighting scheme to inform the brief, when replacing the lights on the main staircase.	C	£88,000
ii) The existing light fittings should be fixed to the balusters with the base of the light fitting in line with the top of the adjacent tread.	A	Inc. Staff Budget

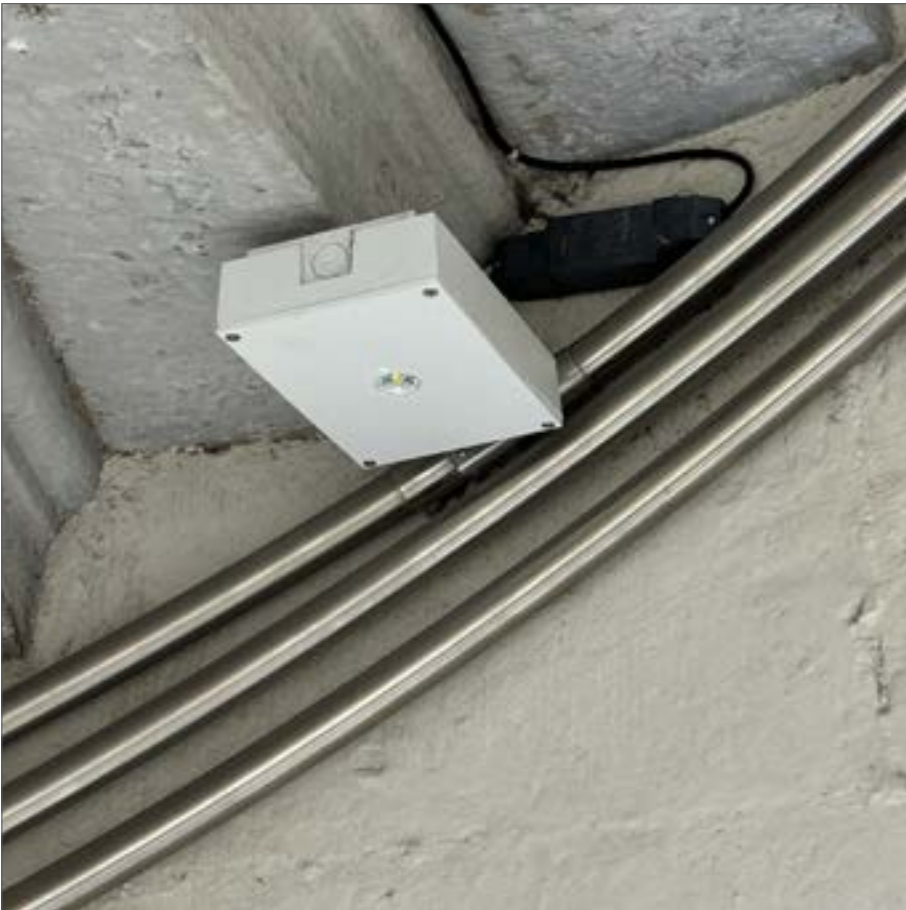
7.3D EMERGENCY LIGHTING				
DESCRIPTION	CONDITION	RECOMMENDATION	PRIORITY	COSTS
<p>The Monument Risk Assessment describes emergency lights as being located in the entrance, cellar, stairs & flame room area. (CoL Risk Assessment for Monument & Pavilion, ref. no. TB FIRE 14, date: January 2024)</p> <p>White plastic emergency lights have been introduced into the stairwell, replacing the previous emergency lighting system, which was a battery back-up to selected baluster lights, and therefore entirely unobtrusive within the stairwell.</p>	<p>Appearance</p> <p>The white plastic emergency lights in the stairwell detract from the historic interior</p> <p>Condition</p> <p>The Monument Risk Assessment describes the emergency lighting testing regime:</p> <p>“Emergency lighting tested monthly by Tower Bridge staff and annually by the facilities provider”</p> <p>(CoL Risk Assessment for Monument & Pavilion, ref. no. TB FIRE 14, date: January 2024)</p>	<p>i) Consider the merits of the 2009 staircase baluster lighting scheme to inform the brief, when replacing the lights on the main staircase.</p>	<p>C</p>	<p>Incl. in 7.3C Page 52</p>

Fig. 100 Recent emergency lights in the stairwell, replacing baluster emergency lights, 2024

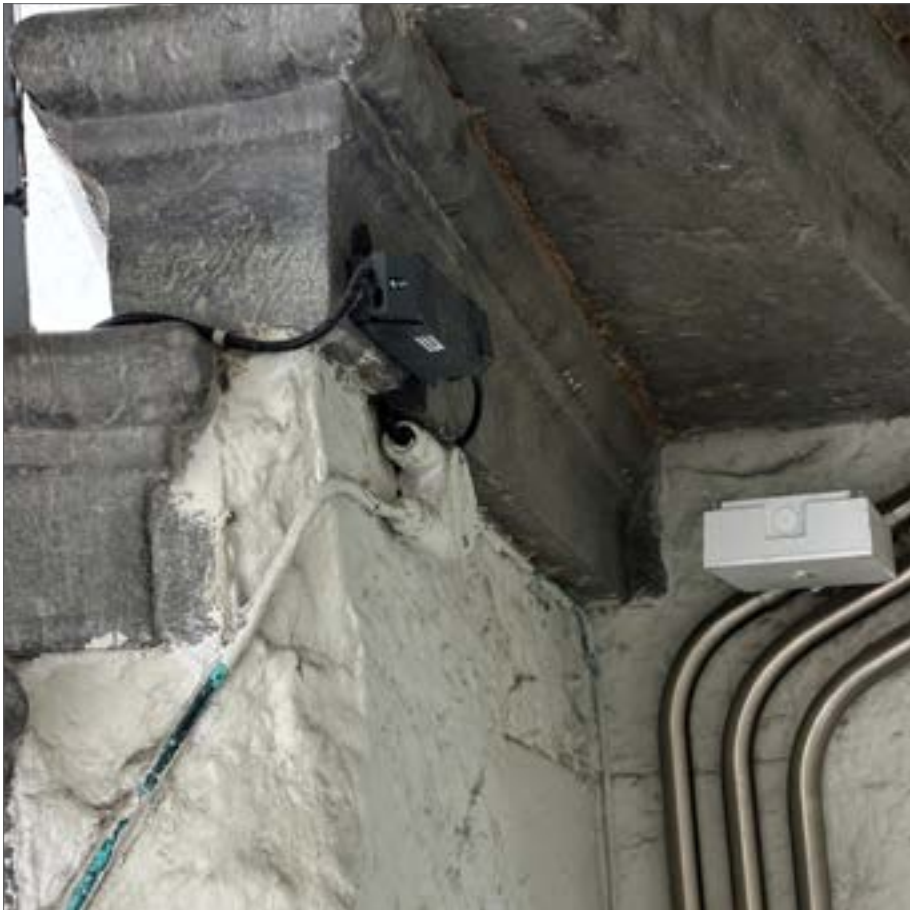
Fig. 101 White emergency light and black transformer, 2024

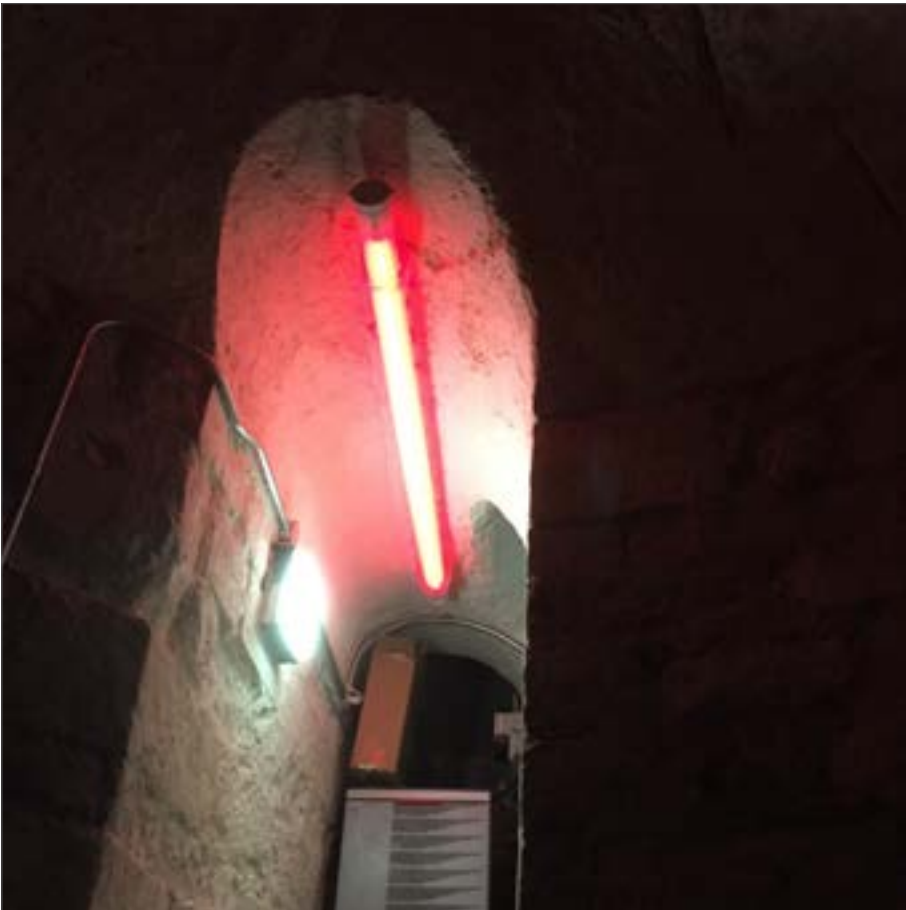
Fig. 106 2009 red tinted lighting in the basement

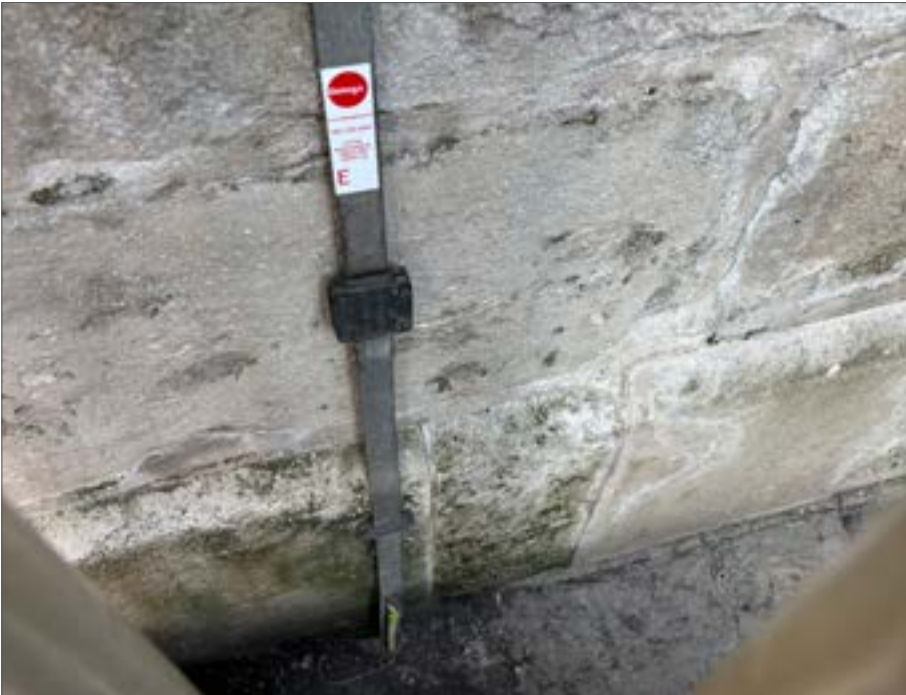
Fig. 109 East elevation down conductor, surface mounted, 2024

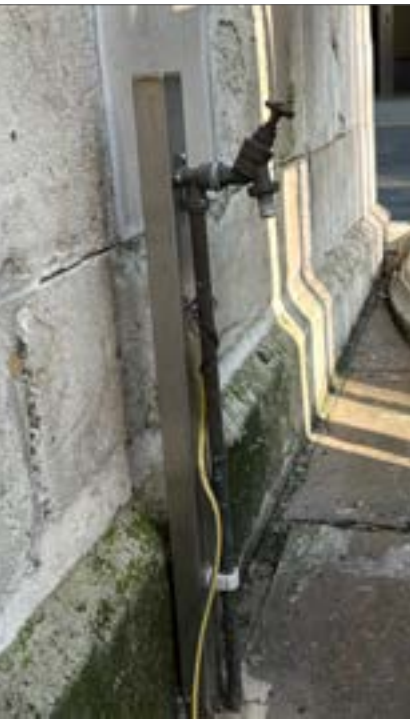
Fig. 114 Tap, with earthing cable, 2024

8.1 ENTRANCE STEPS & EXTERNAL PAVING				
DESCRIPTION	CONDITION	RECOMMENDATION	PRIORITY	COSTS
<p>Paving outside the entrance to the Monument and steps up to east entrance door.</p> <p>The stone steps were installed in 2009 in honed Yorkstone with “anti-slip”stainless steel studs resin-fixed into drilled holes into the edges of the treads. The riven Yorkstone paving slabs were laid in2005. There is an external water pipe and tap, both lagged.</p>	<p>Stone steps & studs: good condition, cleaning & chewing gum removal is desirable</p> <p>Drainage pipe beneath Yorkstone step, and drainage outlet from paving within railings (south end) appear to be blocked</p>	i) Wash Yorkstone steps with bristle brush and water and freeze remove chewing gum	B	£400
		ii) Clean paving and two paving drain-pipes within railings paved area	B	£1,000
		iii) Improve appearance of earthing cable to exterior water supply pipe	B	Incl. Staff Budget

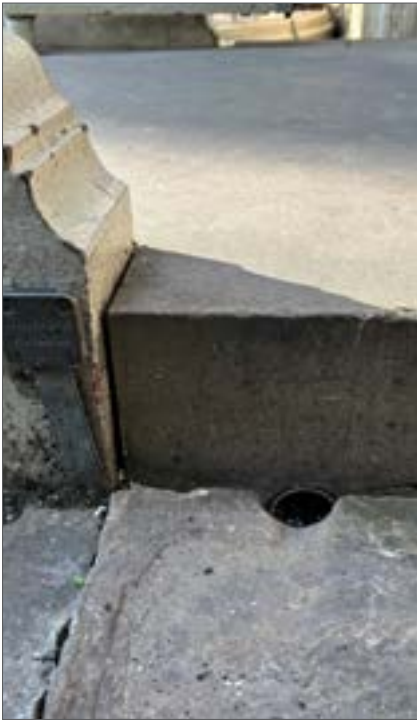
Fig. 115 Drain pipe from north area beneath entrance step, 2024

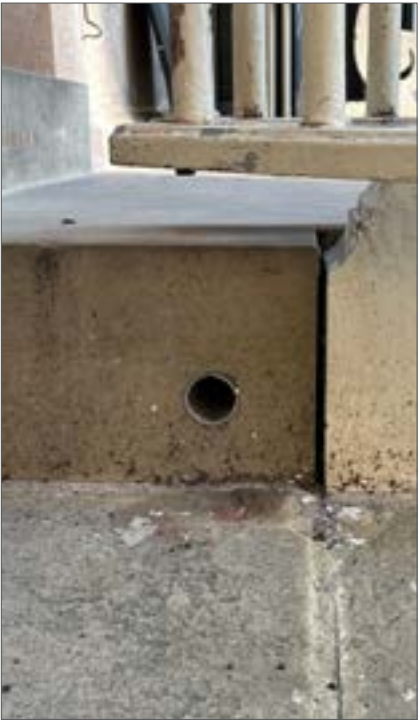
Fig. 117 Pipe discharges to south area, 2024

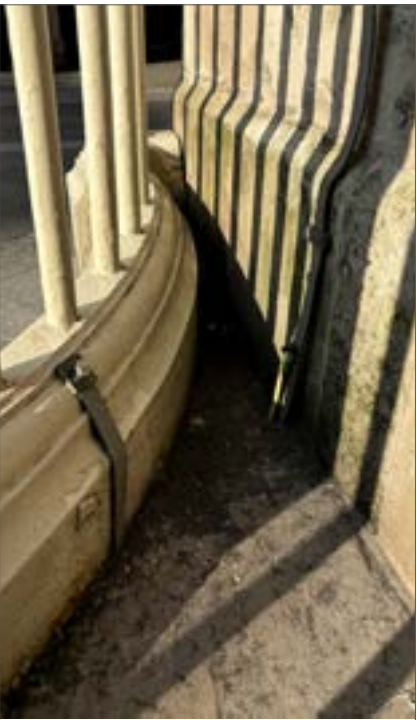
Fig. 118 Corner of south area (drain in corner), 2024

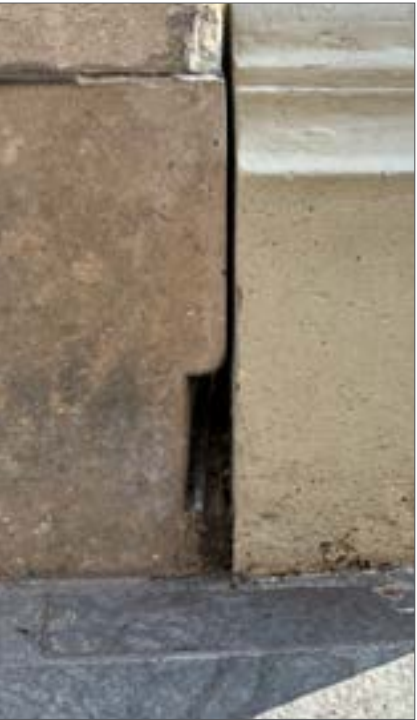
Fig. 119 Drainage gap from south Area to surrounding paving, 2024

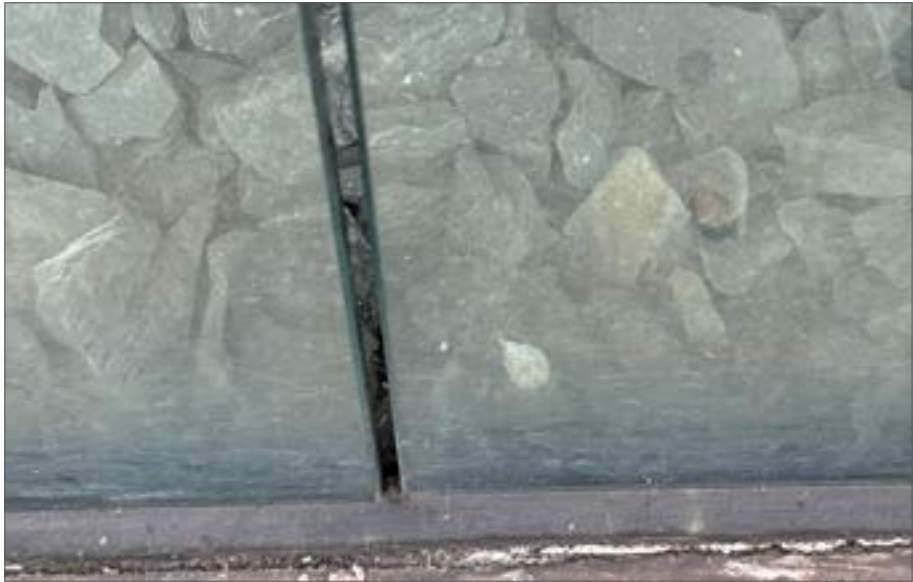
Exterior: the pavilion was designed as a 'temporary' structure and is not in good condition.
Structural glass walls have open joints between panels, some joints now (badly) mastic-filled, glazing joint north side, above doorway, is temporarily taped over, some glass panels flex when pushed against. In s-w corner, glazing not aligned with metal ground trim around the paving 'rocks', revealing blue plastic shims and chipboard packing.
Inside of glazing is dirty in places, particularly horizontal glazing above doorways,shattered glass remnants in gabions. Attendants' door, poor aluminium drip detail, door to (disused) public wc, temporary plywood, payment point is taped over, paint is peeling from threshold & mastic detailing

Fig. 120 Open joints between structural glass, 2024

i) Prepare detailed scope of exterior & interior repairs and alterations to the Pavilion building to provide adequate facilities for Monument staff and a presentable exterior in the setting of the Listed Monument
