THE MONUMENT TO THE GREAT FIRE OF LONDON

VOLUME II: QUINQUENNIAL INSPECTION SURVEY

MARCH 2025

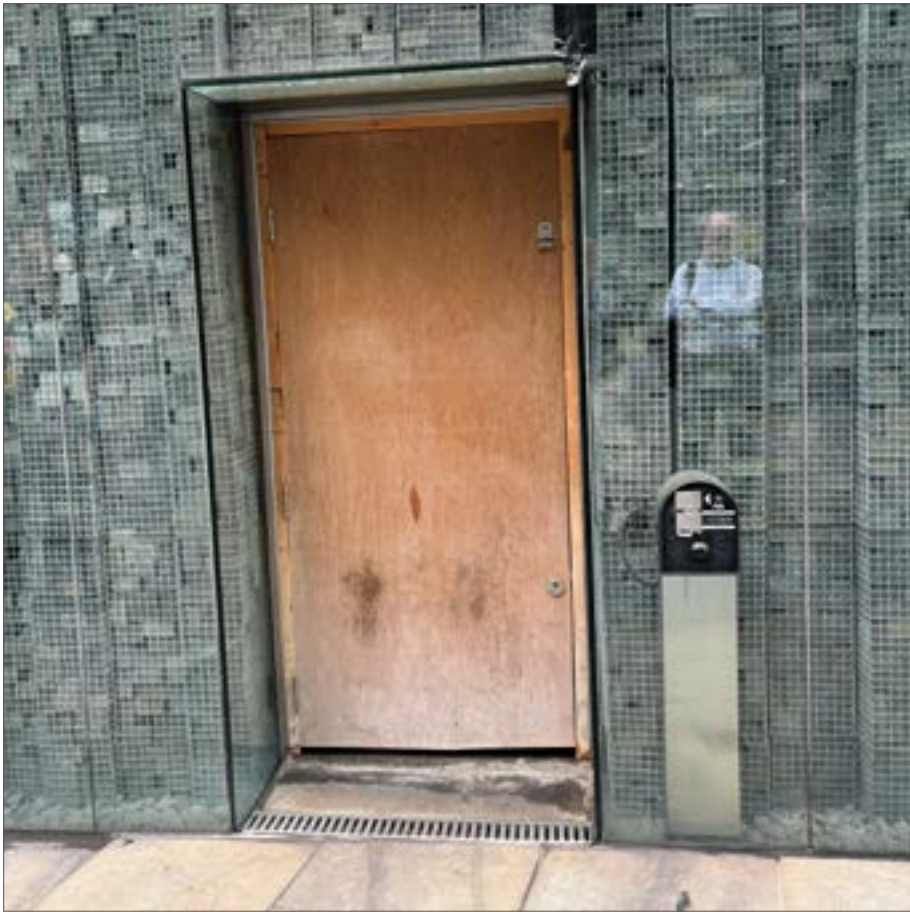
Fig. 121 Door to public WC, 2024

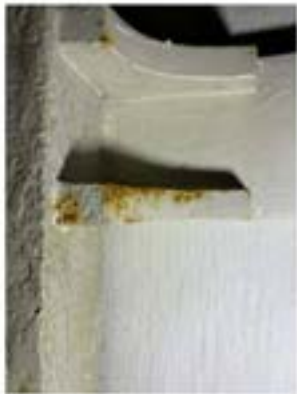
Minor surface corrosion to original rib and plate

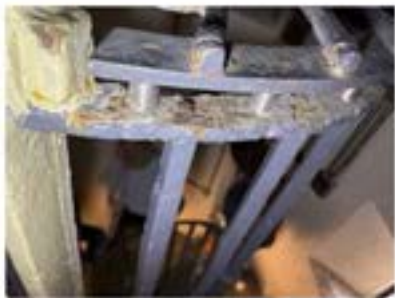
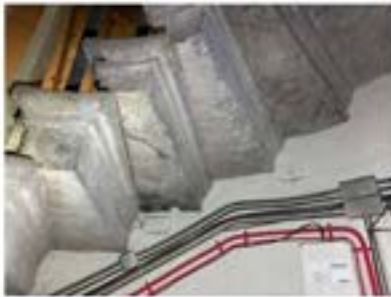
Loss of underside surface to stone steps within upper section (between observation deck and orb)

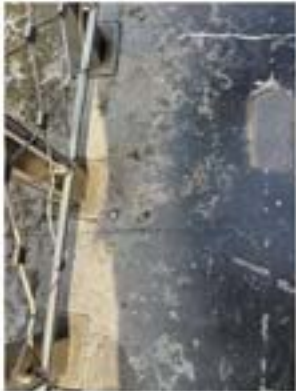
Example of incomplete set of monitoring studs – crack #2 from previous surveys

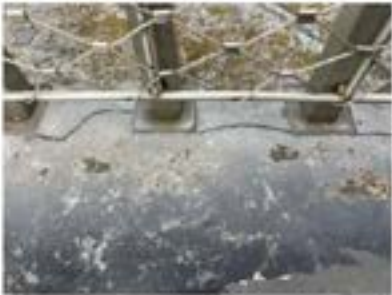
West elevation south end
Crack along base of railings from southern corner, extending beyond mid length of the elevation

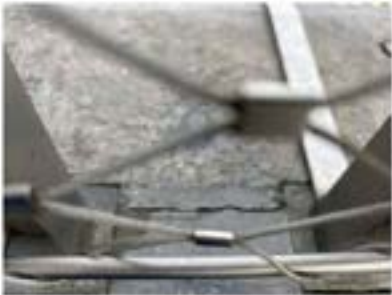
East elevation north end
Crack along the base of the railings from the northern corner approximately to the mid point. In general less severe cracking than the western elevation.

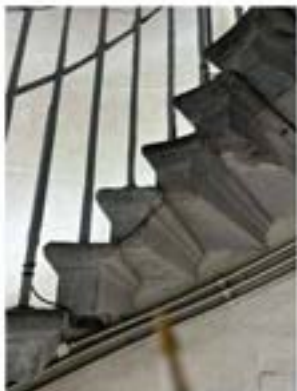
Crack through load path of cantilevered stone steps (#142)

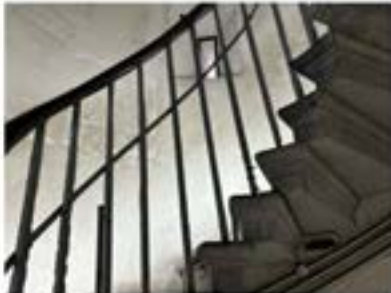
Railings not perpendicular to step

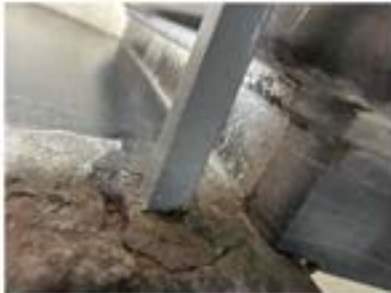
Damage around infill at base of baluster (#185)

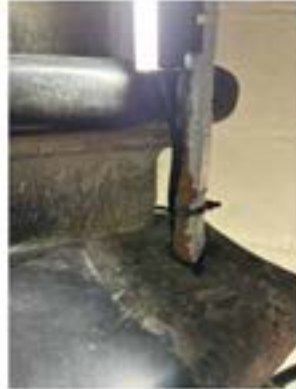
Corrosion at base of baluster and damage to stone around the base

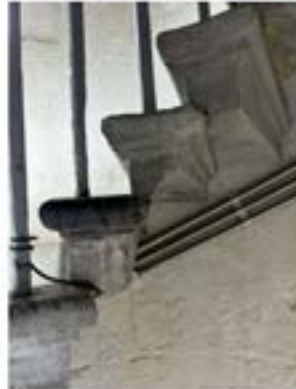
Significant loss of underside surface #218

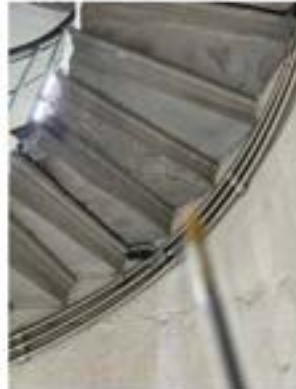
Scabbled underside #246

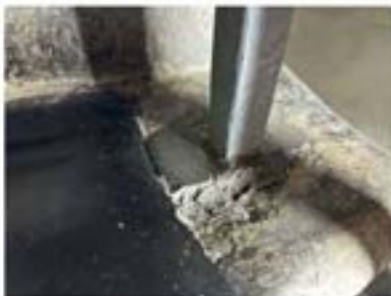
Damage to stone around base

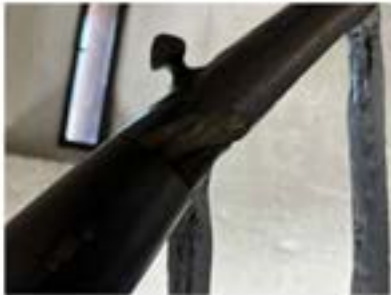
Damage to handrail timber (#234)

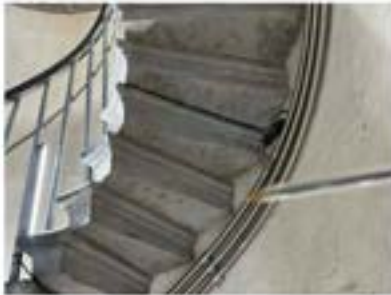
Horizontal crack across vertical back face of stone step #283

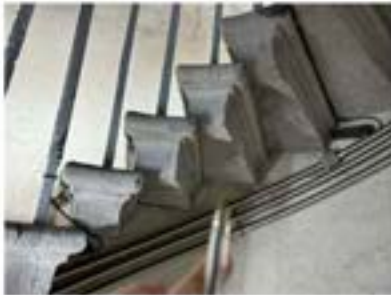
Uneven underside #287

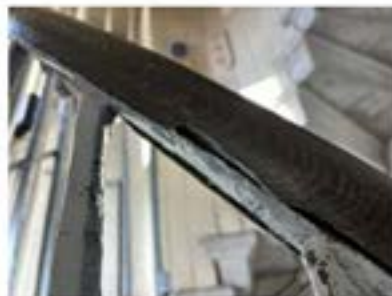
Damage to timber handrail – near observation deck level
